Memo

Subject Response to information request from DEHP
From Rohan Lucas
Distribution BMA
Date 12 February 2016
Project Broadmeadow EA amendment – Watercourse Subsidence

1 Isaac River condition, condition trajectory and management

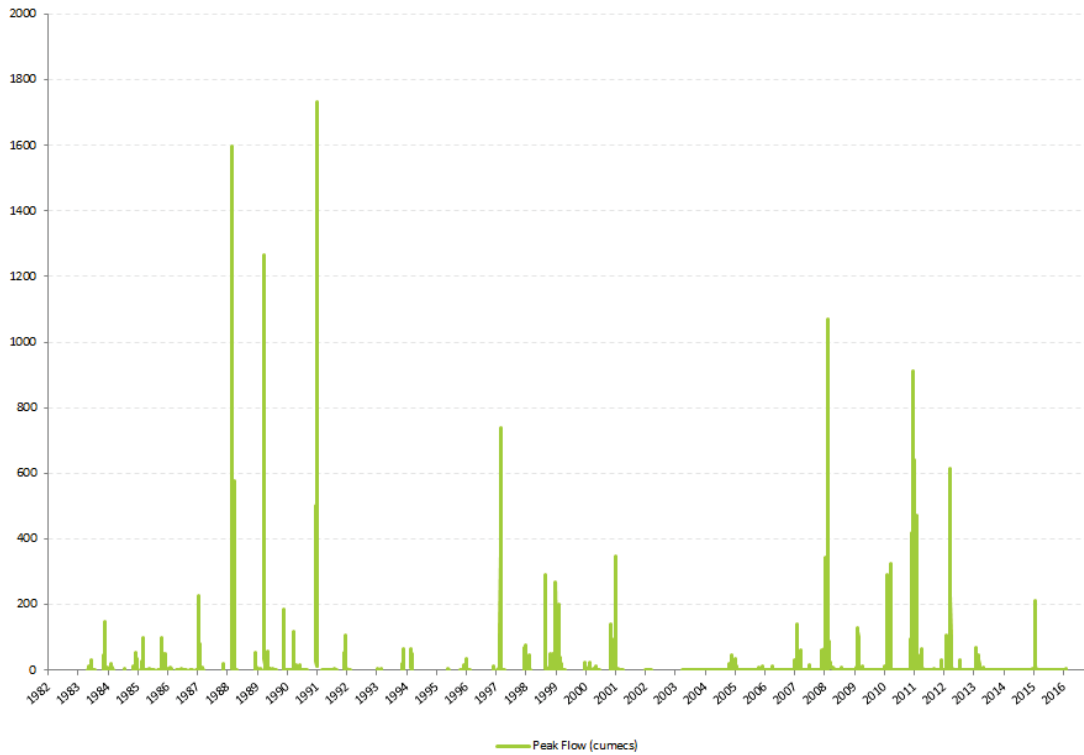
Based on observation (monitoring of the diversion and subsidence has been in place since 2007), it is flows in the order of 100-500m³/s that elevate this threat. Larger and sustained flows that infill the subsidence voids, have a short risk window until they mobilise enough sediment into the subsided sections from upstream to mitigate the threat from being ongoing.

Figure 1 – Isaac River peak flow record at the Goonyella Gauge at downstream end of diversion

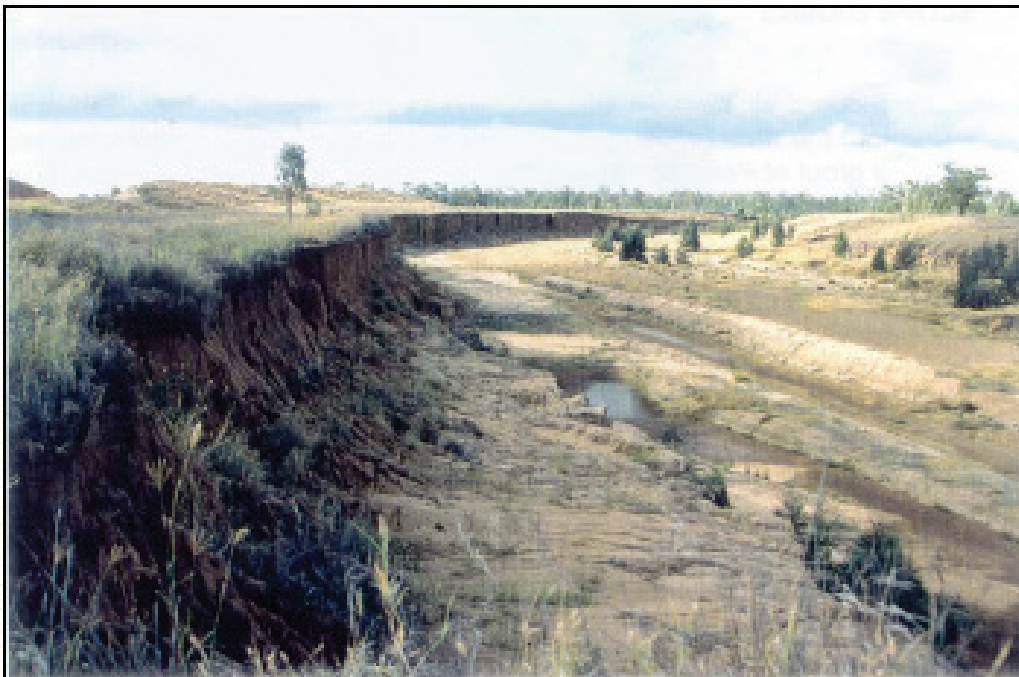
The Isaac River diversion, constructed in the mid 1980's was undertaken to a different standard to that which would be adopted today. The diversion underwent major erosional adjustment in the 1980's and 1990's (see Figure 2). Following some management intervention in the mid-late 1990's (including timber pile fields) and a period without any major flow events from 1991 to 2007 (refer to Figure 1), the diversion underwent substantial recovery. This recovery included the deposition of benches against toe of bank and colonisation of those benches with riparian vegetation, providing a near continuous coverage along the diversion. These vegetated benches protect the near vertical, erodible upper banks from erosion in the majority of flow events (refer Figure 3).

Figure 2 - Upstream view from top of bank near upstream drop structure of eroding outer bank of diversion with no vegetated bench, 1995

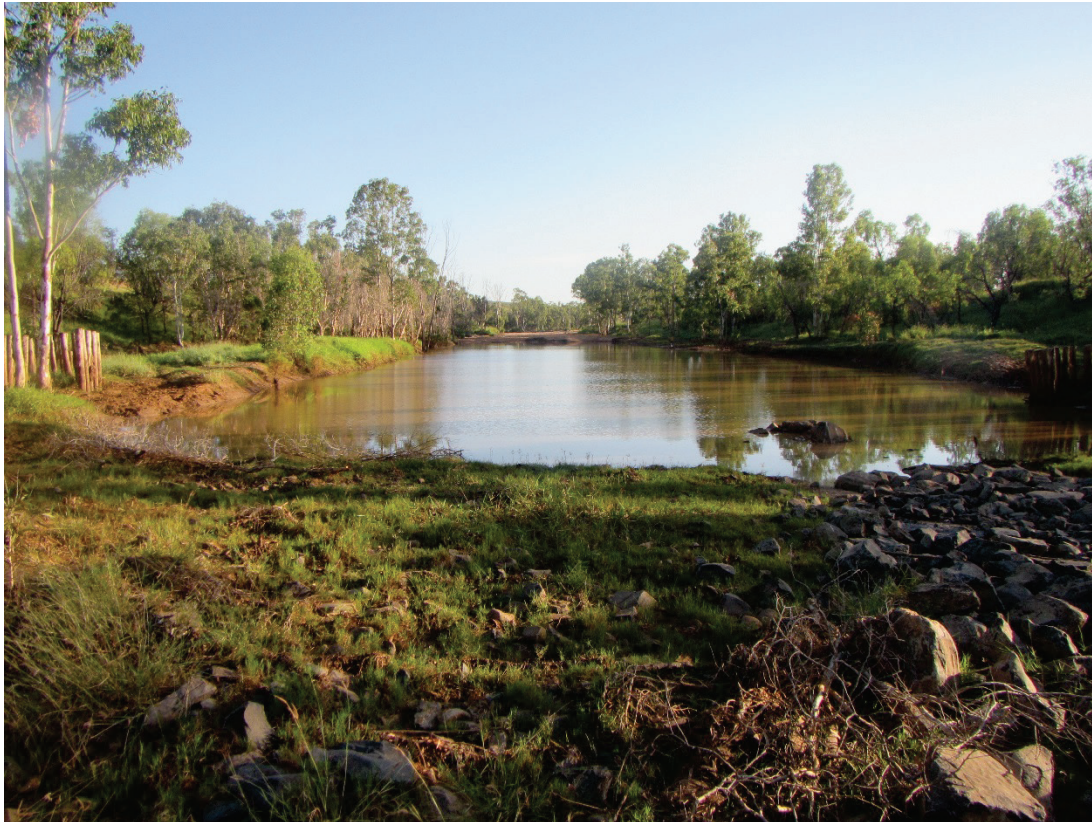
The diversion, which reduced river length by several kilometres, was constructed with two drop structures to compensate for the increase in gradient. One of these structures is now largely redundant and the other has been subject to damage from flow events and repair on numerous occasions. The remaining functional structure performs its design intent during smaller flows but is ineffective in larger flows in reducing energy conditions sufficiently. This means the diversion is subject to energy conditions that are greater than is suitable for the material through which it is constructed. An outcome of the damage to these structures in the diversion is that coarse armouring rock has been distributed along the diversion by high energy conditions, assisting in creation of pools and riffles. Pools are rare in the Isaac River due to the excess sediment inputs from catchment conditions and land use. The diversion, with elevated energy conditions and some rock inputs, provides some rare aquatic habitat refugia in the system (refer Figure 4). This habitat creation is enhanced by subsidence such as in Figure 3 (also refer to numerous photos in the SMP and the longitudinal section on page 117 of the SMP).

Figure 3 - Upstream view from channel bed on upstream drop structure of densely vegetated bench, 2015. Pool created by LW106 and LW107 subsidence

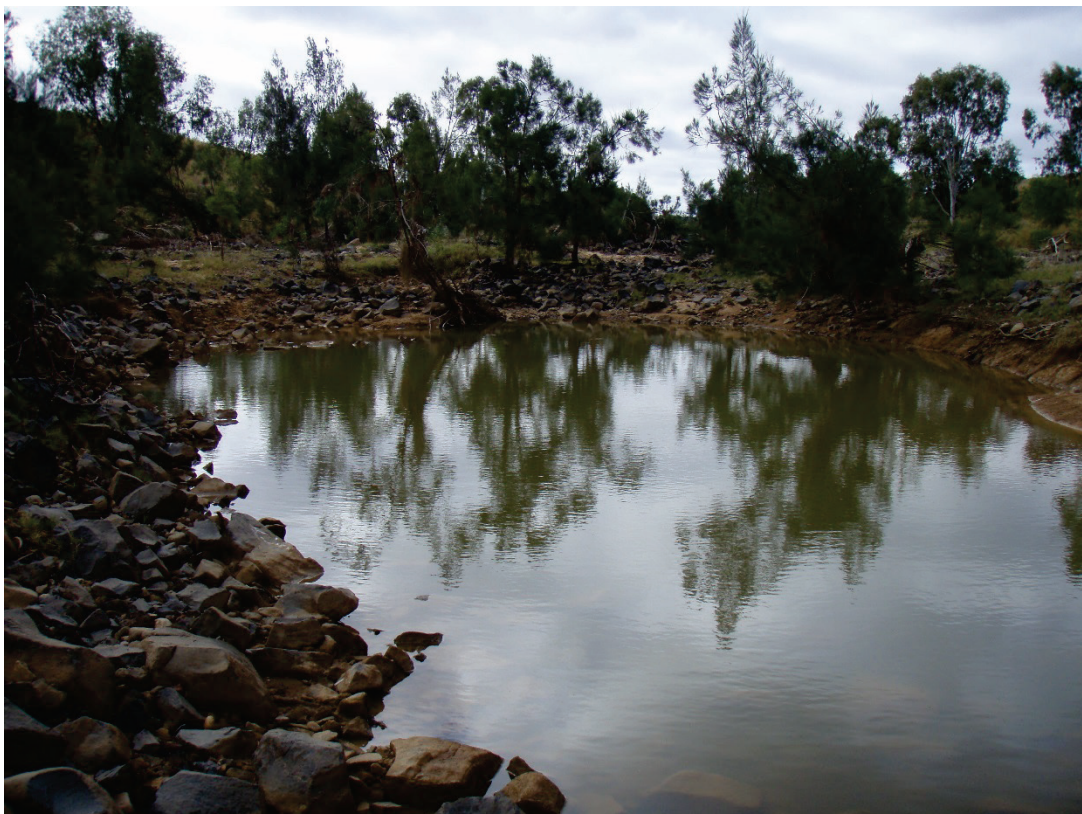
Figure 4 - Pool-riffle habitat in mid-section of diversion prior to subsidence influence

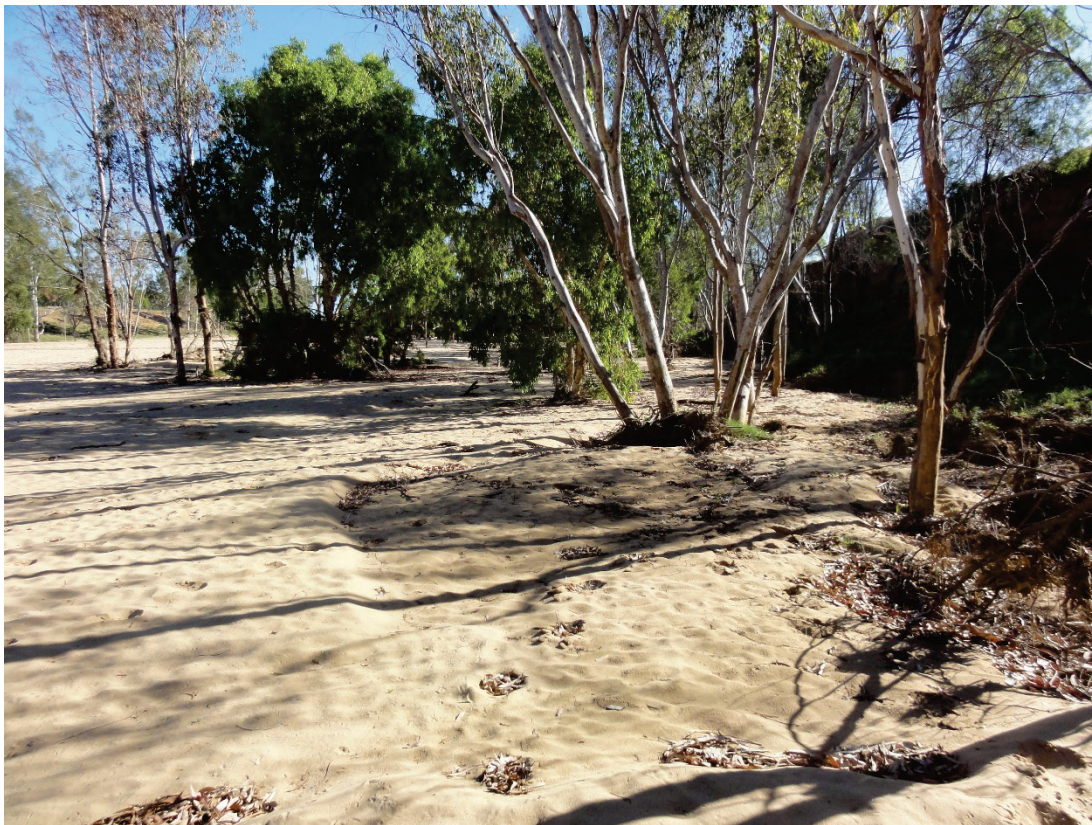
Management of bank stability through the subsided panels between the pillars, over the panels, has not yet been undertaken in the diversion. An increased risk to bank instability comes about when the panels infill with sand and the benches are no longer elevated above the low flow channel/mobile sand bed. In this case, the toe of the near vertical erodible bank may be subject to increased erosion risk (refer Figure 5). As much of the diversion is near straight, and should the vegetation on the benches survive when the subsided panel infill, this increased erosion risk is somewhat mitigated by the vegetation and deposition may occur through that vegetation. Where a bend is present, such as the upstream section of the diversion or where vegetation is thin or dies, additional bank stabilisation works may be required. There are options for this, mainly further use of timber pile fields and/or battering and revegetation of the near vertical upper banks. This is consistent with recommended management response and measures in the SMP and BMA TARP.

Figure 5 - Example of low flow channel migration to toe of bank where LW106 has infilled with mobile bedload, subjecting unstable upper banks to more frequent potential for erosion

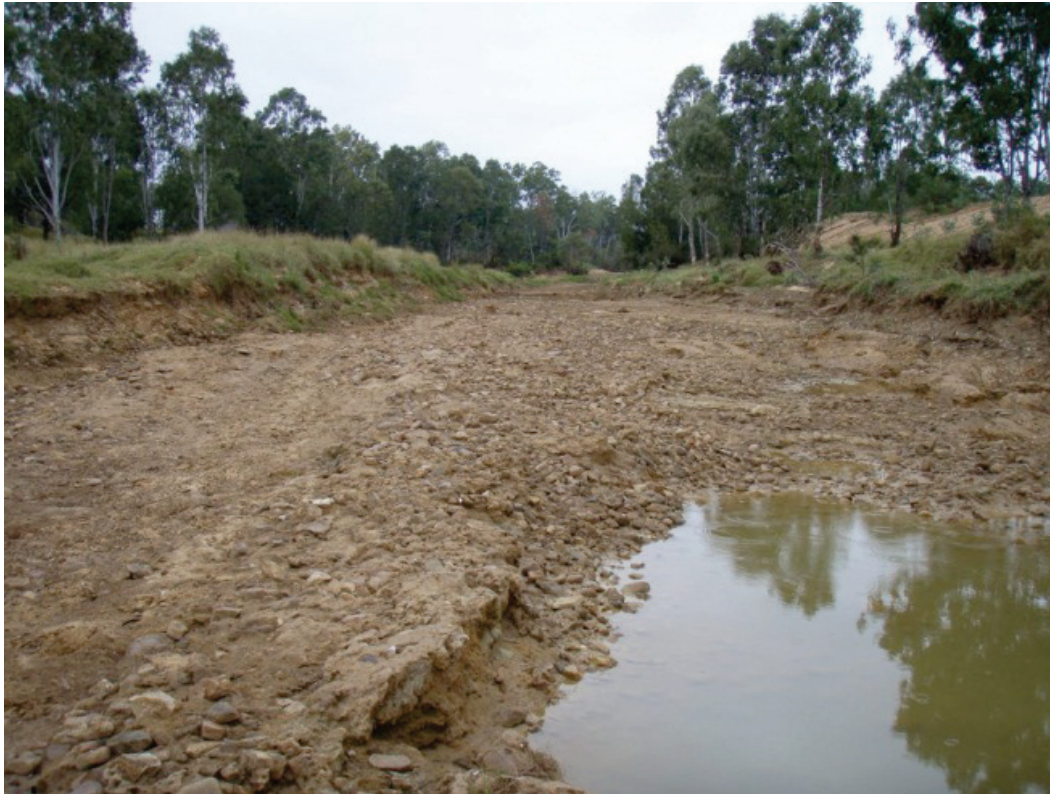
Figure 6 provides an illustration of the river bed deepening process described in Section 1, the benches maintained at toe of bank by timber pile fields and the subsequent re-establishment of bedload continuity (infilling) by large flows. Deepening of the river bed at this location was ~1.6m. This highlights that deepening of up to 2.2m will be manageable.

Upstream view from LW105-6 pillar in 2010. River bed deepening of ~1.6m to resistant strata

Figure 6 – Deepening following subsidence and subsequent infilling with bench maintained by pile fields, protecting diversion bank

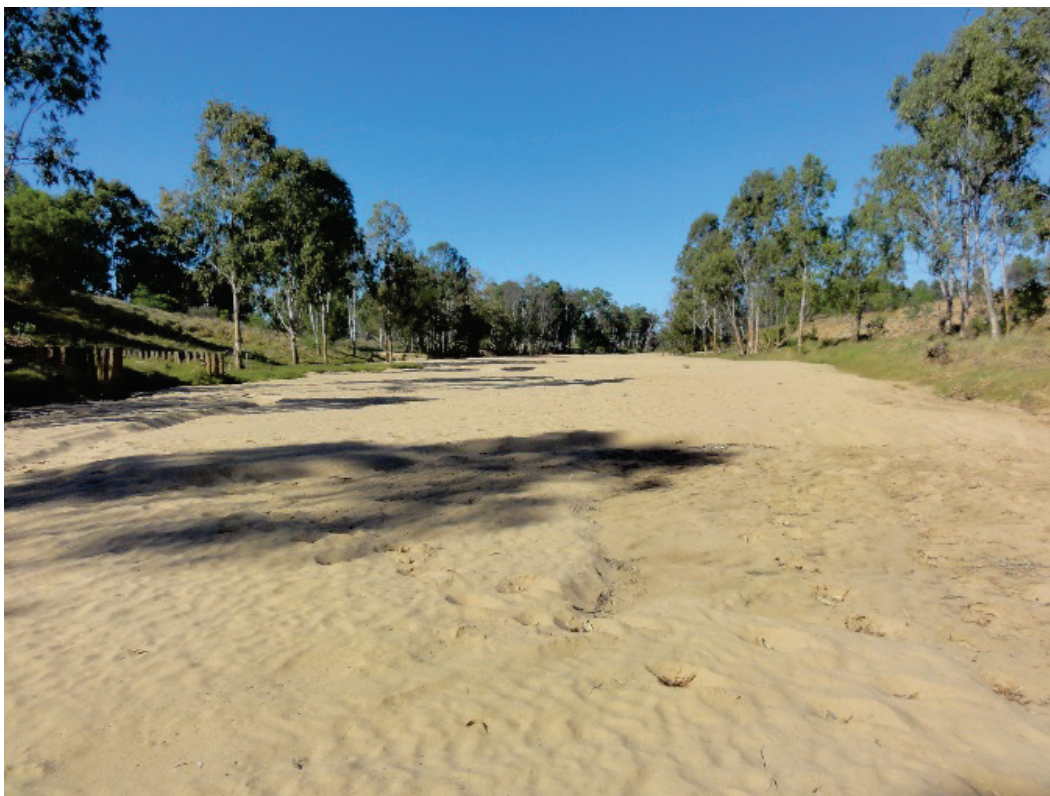
Upstream view from LW105-6 pillar in 2012. Large and extended duration flows infilled LW105 in the 2010-11 wet season and re-established bedload transport to this site and downstream.

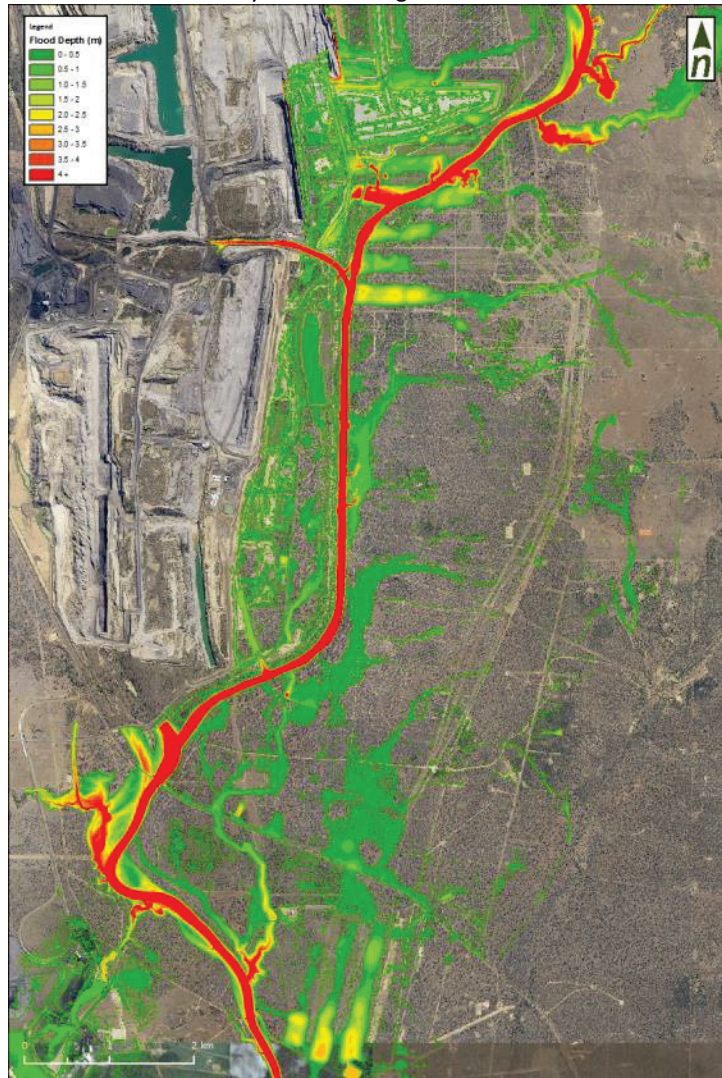
50-yr ARI –Existing Conditions

The magnitude of event to engage the floodplain will decrease slightly once all panels are subsided and the channel bed becomes infilled with sediment through the subsidence voids (the 1:50 and 1:1000 AEP events are provided below comparing 2015 conditions with full subsidence (no infilling) conditions). Where panels are perpendicular to flows, the pillar zones will form ridges between panels that will not provide for preferential concentration of flow. Should the panels be oriented parallel with flow, which has not been modelled for Broadmeadow, the potential for flood flow concentration increases. Hence the potential for avulsion increases if the materials are erodible. In the instance of the Isaac River terrace, the materials will be erodible.
