## URS Site Visit Notes

**BHP Billiton Mitsubishi Alliance**

27 February 2009

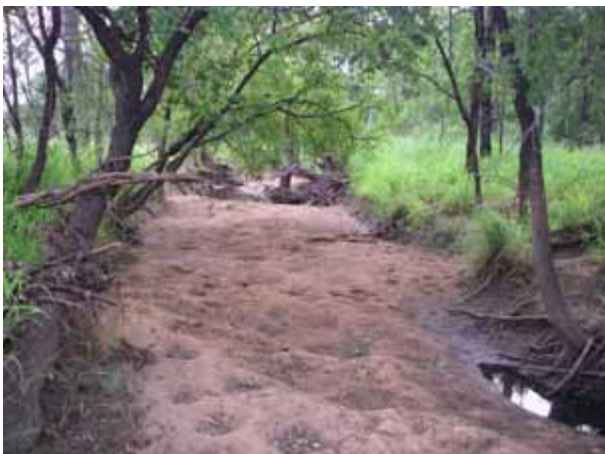
#### Plate 1-1 Cherwell Creek, Tributary 1 Site 1

Looking downstream from fence post

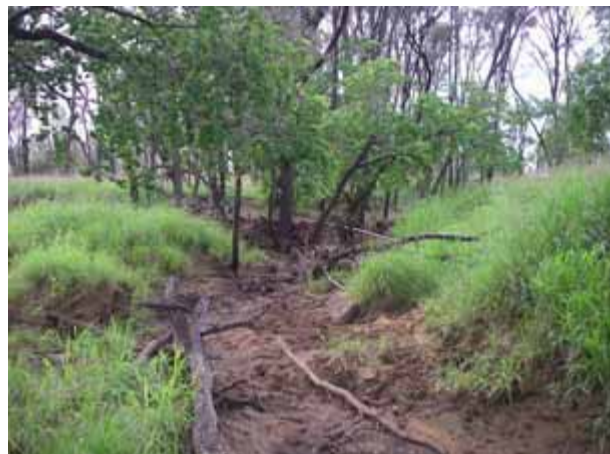
Debris and tree roots: Log jams present (approximately 30% waterway obstruction)

Looking upstream at a log jam.

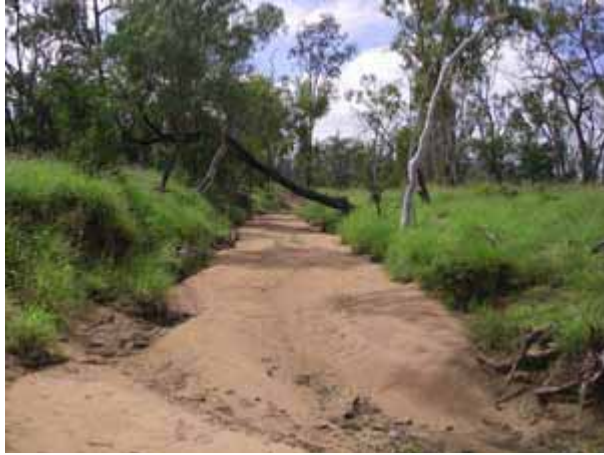
**Plate 1-3 Cherwell Creek Tributary 1 Site 2**

Looking downstream, sandy base

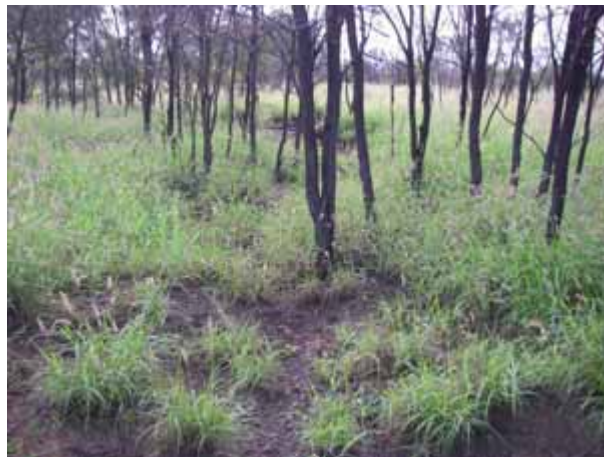
#### **Plate 3-1 Cherwell Creek Tributary 2, Site 1**

Looking downstream, dark silty soil bed material, undefined channel.

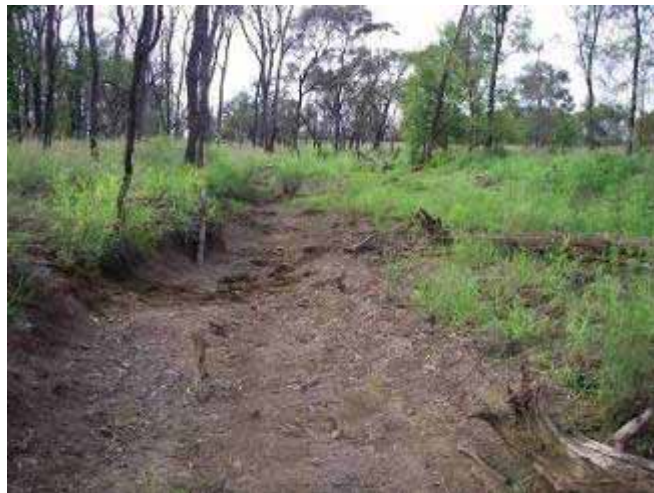
#### **Plate 4-1 Cherwell Creek Tributary 3, Site 1 Downstream**

Looking downstream, brown silty soil and sparse gravel

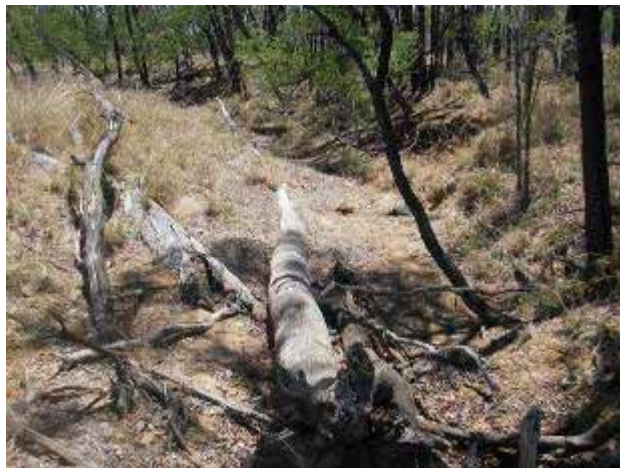
**November 2007****Plate 7-1 Horse Creek Site 1 Downstream from crossing**

Debris and tree roots: February: Small exposed tree roots downstream of the track crossing. November: A number of log jams were present – obstructing approximately 30-50% waterway area.

Downstream from road crossing

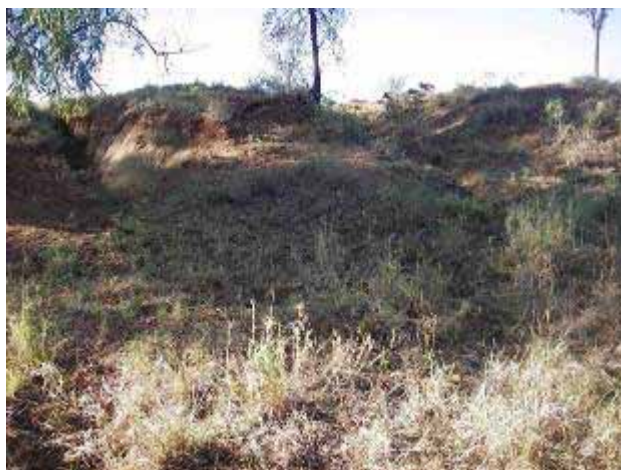
**Plate 7-4 Overbank Erosion**

Width of channel:	4.5m
Slope of banks:	45°
Stability of banks:	Moderate.
Substrate:	Sandy.
Water:	No water present.
Debris and tree roots:	A number of log jams were present – obstructing approximately 70% waterway area.
Overbanks:	Varying heights.
Additional comments:	More riparian vegetation than previously seen on Horse Creek and its tributaries.

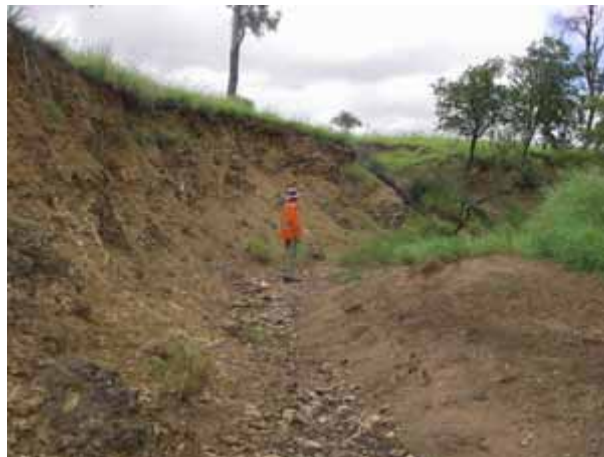
### Plate 7-5 Horse Creek Site 4

Stability of banks: Moderate. Most areas covered with vegetation (grasses and some trees), however some banks that are not vegetated are subject to erosion and this is exacerbated by cattle tracks up and down the banks.

Undermining of the banks is occurring at bends.

Weathered basalt on bend

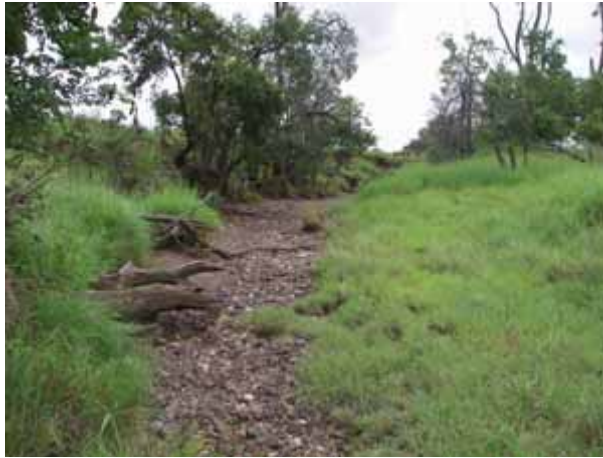
## Plate 7-6 Horse Creek Site 4

Rock bed material, approximately 15-20cm

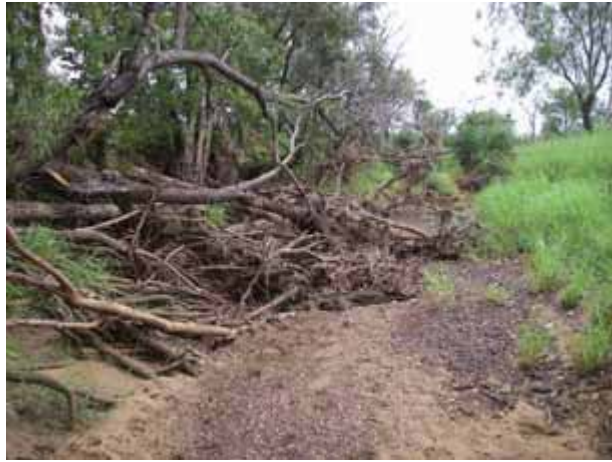
Plate 7-7 Horse Creek Site 5

Debris and tree roots: A number of log jams were present – obstructing approximately 40-70% waterway area. Deposition of sediment and rocks (approx D50 ≈ 20cm) was present upstream of these log jams.

Log jam. Looking west from log jam.

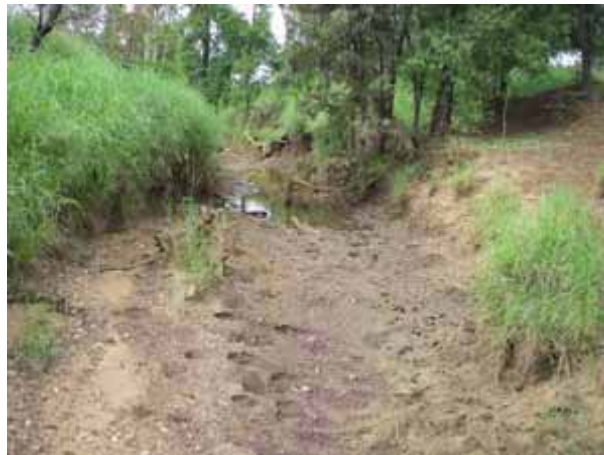
Plate 7-8 Horse Creek Site 5

Pool, just near power line, looking east.

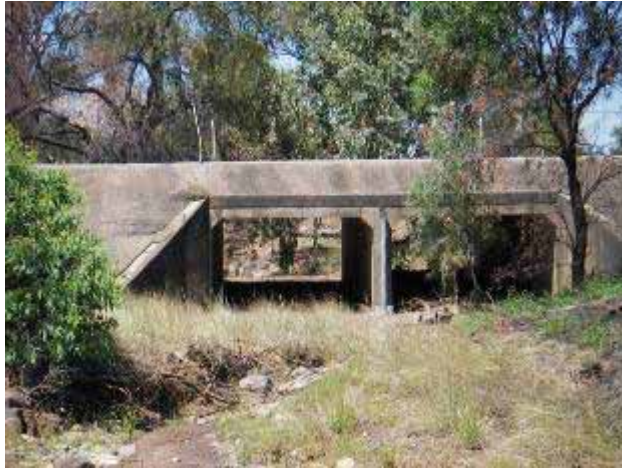
### Plate 7-11 Culverts on Horse Creek (Site 6)

This site is located at E609878, N7560360 (refer attached figure). It is upstream of the road crossing which consists of two 3m wide by 1.8m high culverts (located at E609997, N7560449). The distance from the obvert to the road crest is 1m.

Horse Creek crossing culverts, looking downstream

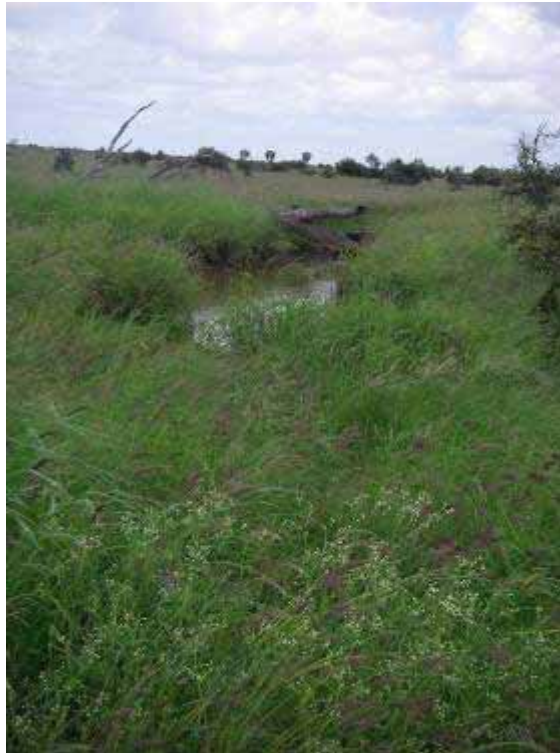
### Plate 8-2 Horse Creek Tributary 1 Site 1

Ponded water

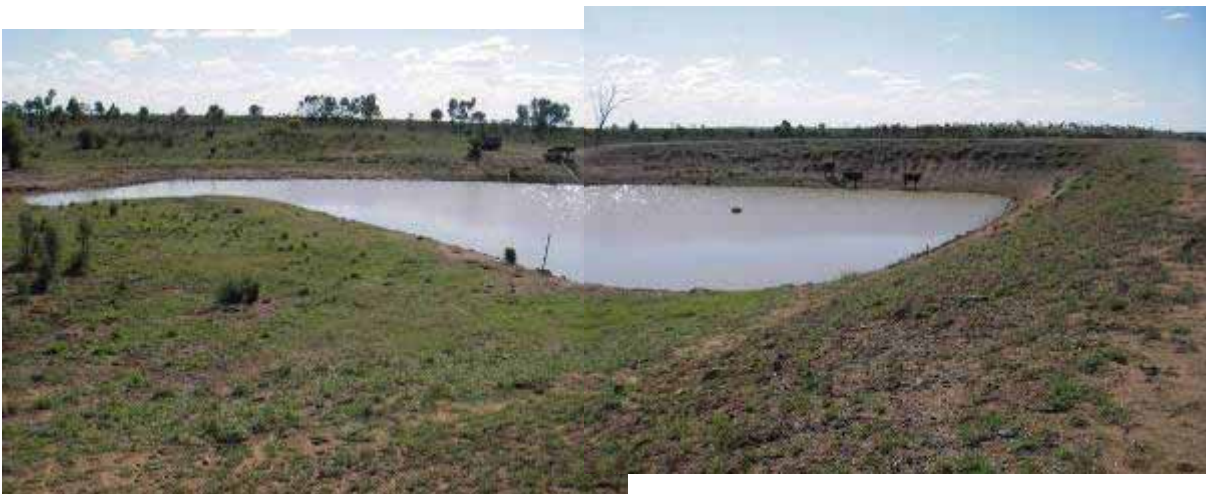
**Plate 9-1 Horse Creek Farm Dam**

Additional comments: Embankment of dam is on creek therefore if the rainfall is high enough water will flow into another channel.

Panoramic of dam

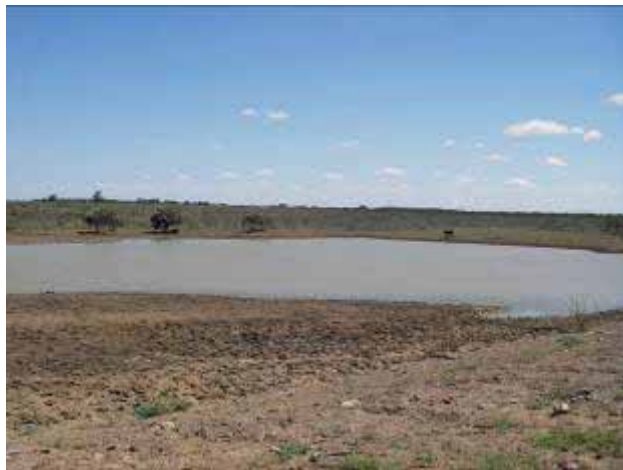
**Plate 11-2 Horse Creek Tributary 4 Site 2, Farm Dam**

Substrate: Muddy  
Water: Translucent (yellow/green)  
Debris and tree roots: None  
Overbanks: Grasses with sparse riparian vegetation  
Additional comments: Water backed up from dam.

Dam looking upstream
