Spotter Catcher Inspection

Score	0 / 0 (0%)	Flagged items	6	Actions	0
Mine site / Exploration area					Unanswered
Permit to Disturb in Place					Yes
Cvm_fy26_glup_bma324					
Conducted on					28 May 2026 08:42 AEST
Prepared by					Cameron Turner 1
Location					Lot 47 Peak Downs Hwy Moranbah QLD 4744 Australia
Personnel					
Andrew Dromjold operator Cameron turner, fauna spotter catcher					
Current Weather					Overnight rain, partly cloudy

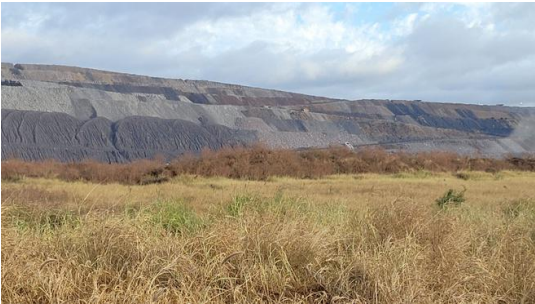
Photo 1

Area listed as Denisonia maculata habitat, area was thoroughly pre cleared, no evidenced of wildlife detected

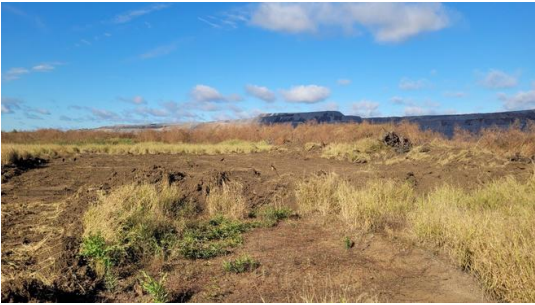
Photo 3

Pad cleared by dozer with FSC present
No wildlife interactions

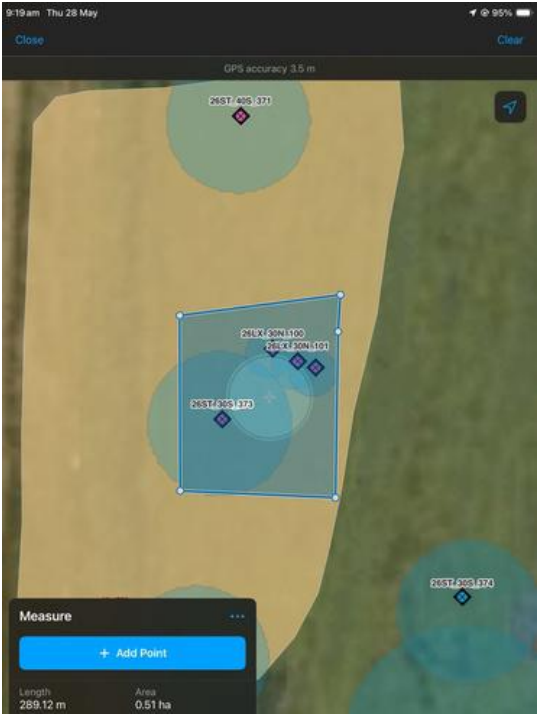
Photo 4

Area listed as Denisonia maculata habitat, area thoroughly pre cleared by FSC, no suitable habitat left in area and no evidence of D. maculata or other wildlife detected

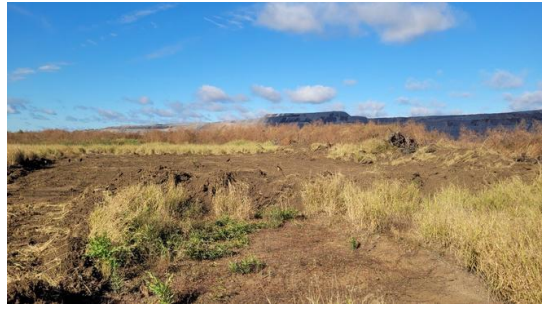
Photo 6

Area cleared by dozer with fsc present. No evidence of D. maculata or other wildlife interactions

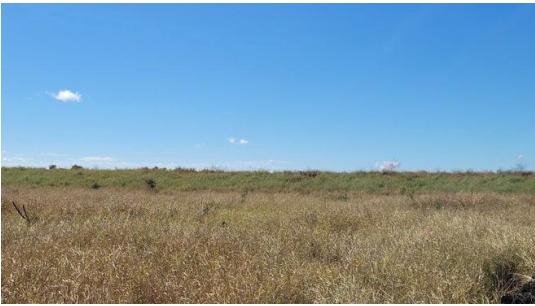
Photo 7

Area listed as Denisonia maculata habitat, area thoroughly pre cleared by FSC, no suitable habitat left in area and no evidence of D. maculata or other wildlife detected

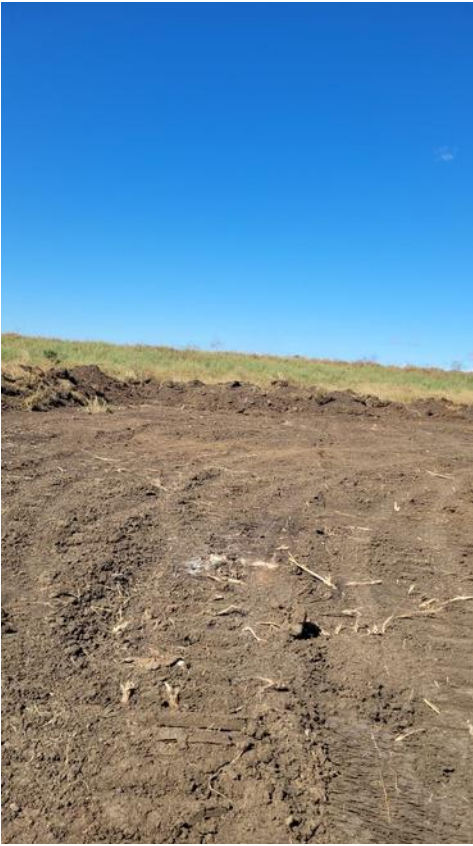
Photo 9

Pad cleared by dozer with FSC present, no wildlife interactions recorded

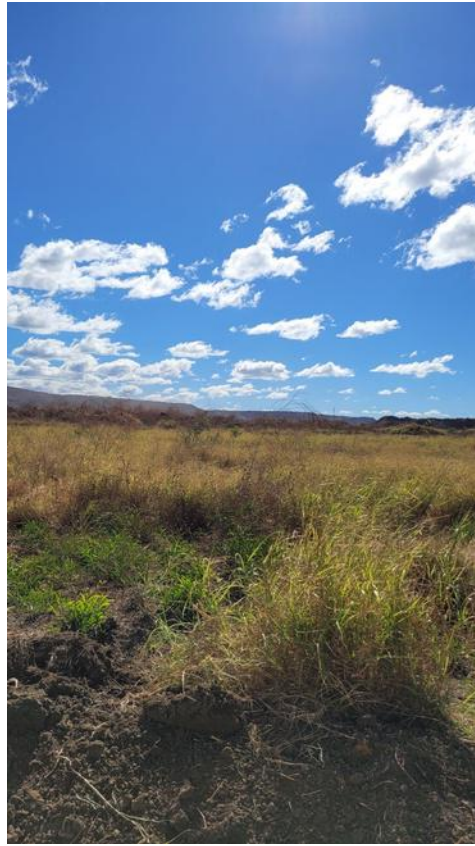
Photo 10

Area listed as Denisonia maculata habitat, area thoroughly pre cleared by FSC, no suitable habitat left in area and no evidence of D. maculata or other wildlife detected

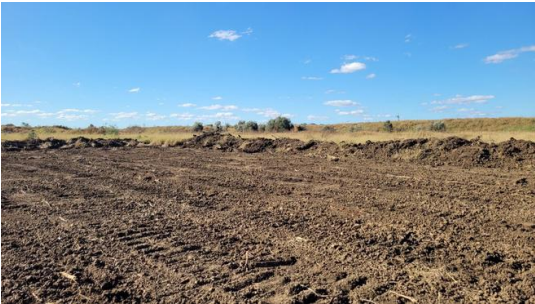
Photo 11

Area cleared by dozer, no interactions with wildlife and no evidence of D. maculata

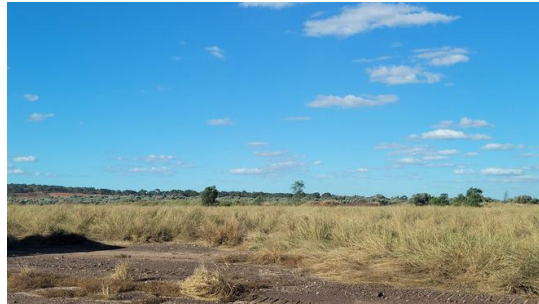
Photo 12

Area pre cleared by fsc, no wildlife detected.

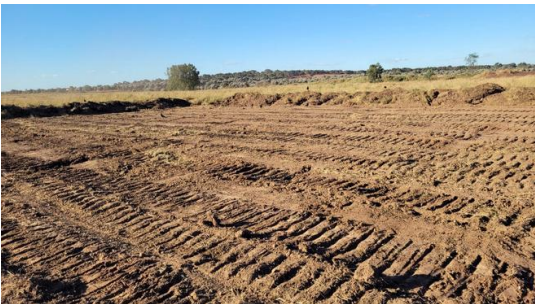
Photo 13

Pad cleared by dozer, no wildlife interactions
