Mt Keith Satellite Statement 1087 Compliance Assessment Report BHP Nickel West

29 March 2022

Condition 4-6 of the Statement 1087 approval requires BHP Nickel West to submit an annual Compliance Assessment Report which outlines the status of implementation of the Project and compliance with the approval conditions. This Report outlines the implementation status and compliance for the Project covering the period of 28 December 2020 to 31 December 2021. BHP Nickel West was in compliance with all conditions of the Statement 1087 approval during the reporting period.

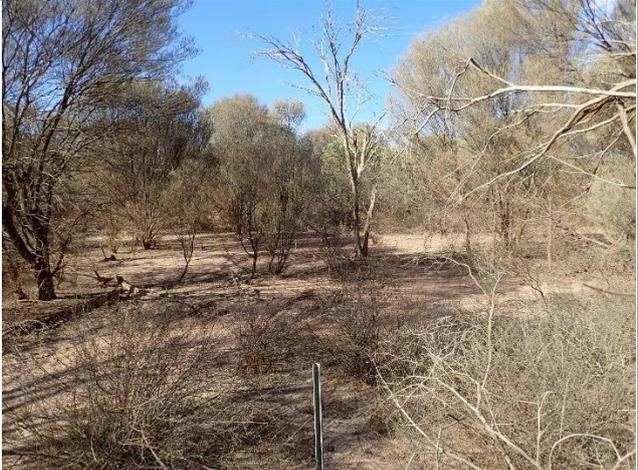
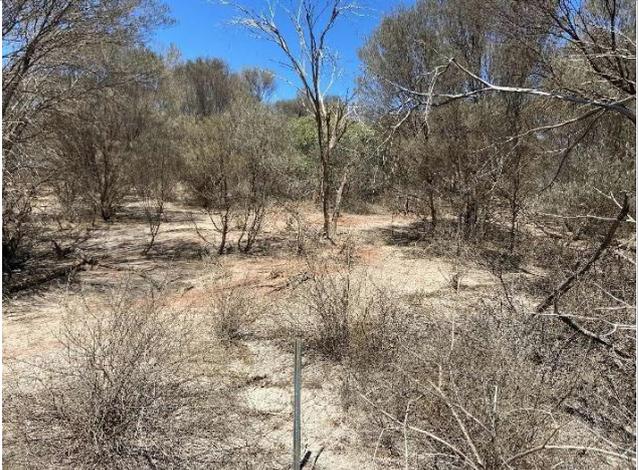
2020		2021

Site ID: MKS EIA 2		Co-ordinates: 51 J 261089 6972365	
Location: ~ 40 m west of MKS haul road	Comments: Water stressed vegetation. Multiple dead shrubs. Heavy dust cover over plants. Kangaroo scats and termite mounds present. Internal drainage in Grove.		
Veg. Type: Groved Mulga shrubland			
Veg. Condition: Degraded			
Grazing: Light, historic			
Weed cover: Nil			
Photo direction: NW			
Species	Cover (%)	Plant Health Score	Comments
<i>Acacia aneura</i>	50	7b	Okay, but dusty and dry.
<i>Eucalyptus lucasii</i>	2	7b	Mostly outside quadrat.
<i>Acacia tetragonophylla</i>	2	4	Post-flowering. Partially dead canopy.
<i>Sida ectogama</i>	<2	2	Little live foliage remaining.
<i>Eremophila latrobei</i>	<2	3	Little live foliage remaining. Dusty. Yellowing.
Other species: <i>Eragrostis eriopoda</i> , <i>Poaceae sp.</i> , <i>Psydrax latifolia</i> , <i>Eremophila pungens</i> (P4)

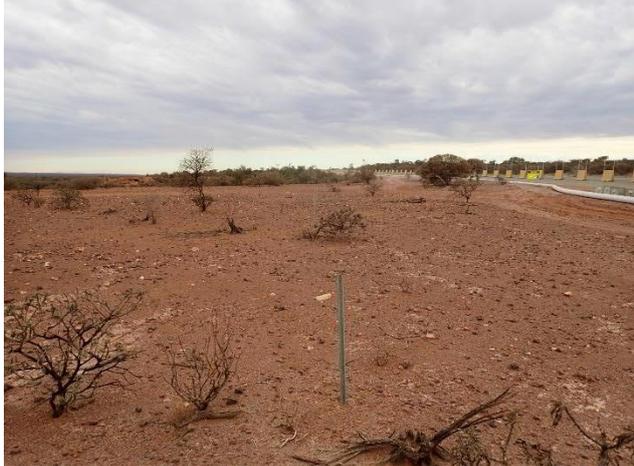
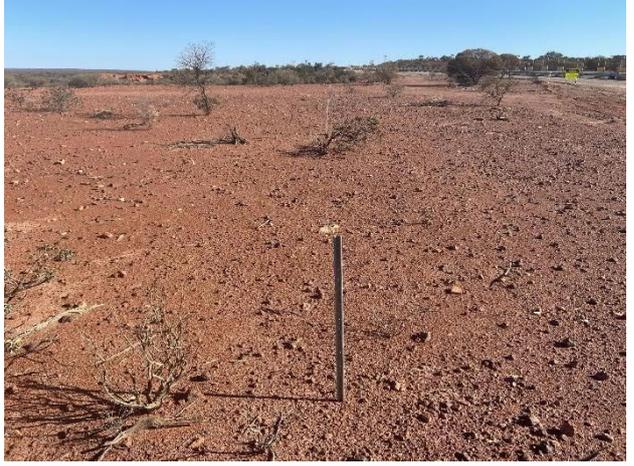
2020		2021

Site ID: MKS EIA 3		Co-ordinates: 51 J 261117 6971563	
Location: ~ 9 m west of haul road		Comments: Soil surface 95% gravelly stones, 5% silty sand and clay. All plants are water stressed. Some dead shrubs present, including all upper storey shrubs and trees. Dust affected. Track runs through the quadrat.	
Veg. Type: Groved Mulga shrubland / Archaean granite geology			
Veg. Condition: Degraded			
Grazing: Nil			
Weed cover: Nil			
Photo direction: NW			
Species	Cover (%)	Plant Health Score	Comments
<i>Eremophila galeata</i>	5	5	Partially dead canopy.
<i>Acacia pruinoarpa</i>	2	7b	Good condition.
<i>Ptilotus obovatus</i>	2	5	Partially dead canopy.
<i>Senna glaucifolia</i>	2	7c	Good condition.
<i>Solanum lasiophyllum</i>	0	1	Dead.
<i>Ptilotus schwartzii</i>	2	5	Replaces <i>Solanum lasiophyllum</i>
Other species: <i>Hibbertia</i> sp. Sherwood Breakaways (R.J. Cranfield 6771), <i>Poaceae</i> sp.

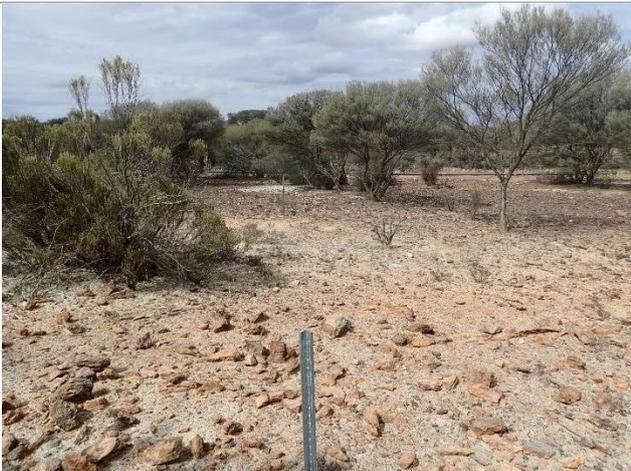
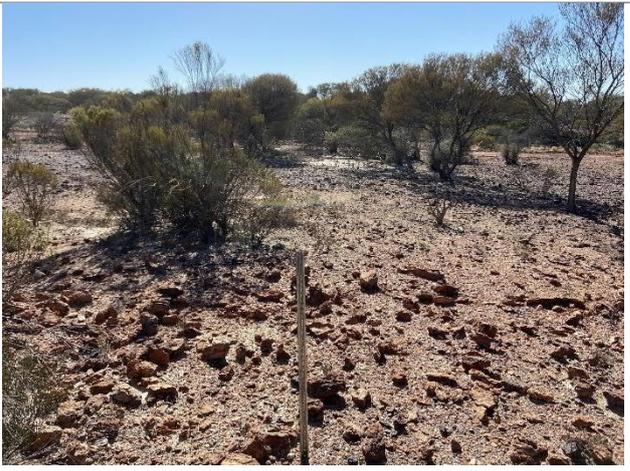
2020		2021

Site ID: MKS EIA 12		Co-ordinates: 51 J 259909 6964937	
Location: ~ 150 m east of Six Mile Well pit		Comments: All <i>Maireana</i> sp. plants stressed, likely reflecting extended dry seasonal conditions. High dust load present on foliage. No annuals. No cryptogams present. Rabbit scats and burrows observed.	
Veg. Type: Weathered basalt, <i>Hakea leucoptera</i> subsp. <i>sericipes</i> / <i>Eremophila pantonii</i> shrubland			
Veg. Condition: Good			
Grazing: Light			
Weed cover: Nil			
Photo direction: NW			
Species	Cover (%)	Plant Health Score	Comments
<i>Eremophila pantonii</i>	8	7c	
<i>Acacia aneura</i> sens. lat.	15	7c	
<i>Maireana triptera</i>	2	2	Very stressed.
<i>Senna artemisioides</i> subsp. <i>helmsii</i>	<2	2	Loss most of canopy.
<i>Grevillea inconspicua</i> (P4) (EIA_12_001)	2	7b	
Other species: <i>Eremophila scoparia</i> , <i>Maireana georgei</i> , <i>Maireana tomentosa</i> , <i>Sclerolaena eurotioides</i> , <i>Lysiana</i> sp.

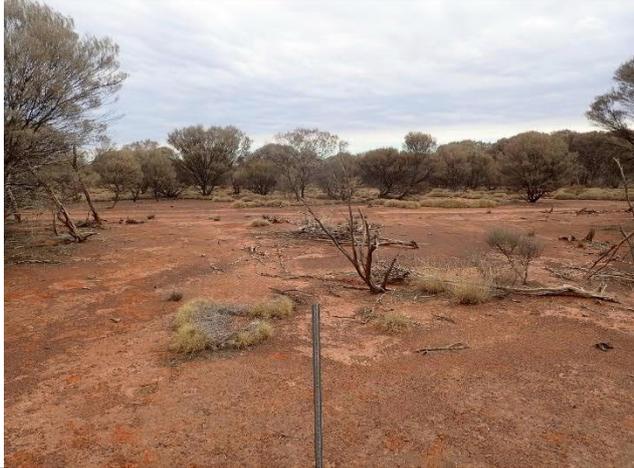
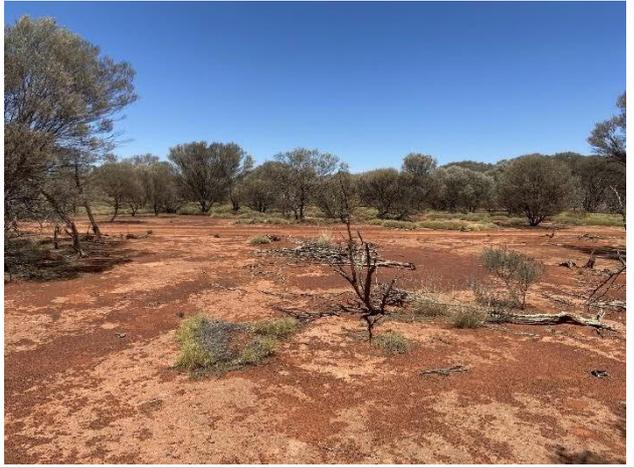
2020		2021

Site ID: MKS EIA 14		Co-ordinates: 51 J 263217 6963155	
Location: ~ 400 m south-east of WRL		Comments: Eastern side of MKS, outside clearing margin. Track runs through quadrat. Previous Acacia deaths observed as well as recent plant deaths. Vegetation is dry. Post missing.	
Veg. Type: Sandplain Mulga spinifex shrubland/ Hardpan Mulga shrubland			
Veg. Condition: Degraded			
Grazing: Light			
Weed cover: Nil			
Photo direction: NW			
Species	Cover (%)	Plant Health Score	Comments
<i>Acacia caesaneura</i>	10	7b	
<i>Acacia ramulosa</i> var. <i>linophylla</i>	5	7b	
<i>Triodia basedowii</i>	2	7d	
<i>Eragrostis eriopoda</i>	<2	7b	
-	-	-	-
Other species: <i>Eremophila spectabilis</i>

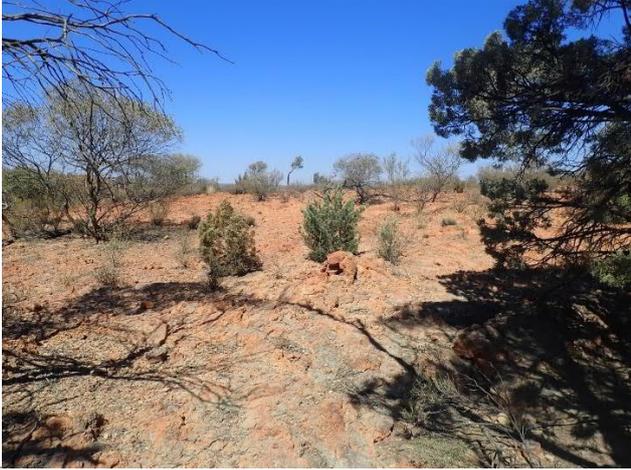
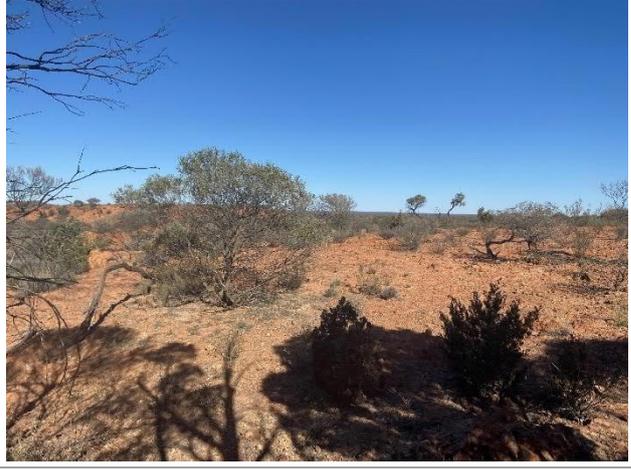
2020		2021

Site ID: MKS EIA 23		Co-ordinates: 51 J 261137 6971361	
Location: ~ 25 m east of haul road		Comments: Previously cleared by haul road, need to move quadrat. Minimal dust load despite close distance from haul road. Foliage vegetative.	
Veg. Type: Granitic Mulga shrubland on Archaean geology			
Veg. Condition: Excellent			
Grazing: Light			
Weed cover: Nil			
Photo direction: NW			
Species	Cover (%)	Plant Health Score	Comments
<i>Acacia quadrimarginea</i>	10	7b	
<i>Callitris columellaris</i>	5	7b	
<i>Thryptomene</i> sp. Leinster (P3)	10	6	Vegetative, post flowering.
<i>Ptilotus obovatus</i>	2	5	Declining, flowering.
<i>Dodoniaea petiolaris</i>	2	5	Declining, flowering.
Other species: <i>Eriachne helmsii</i> , <i>Acacia aneura</i> , <i>Hibbertia</i> sp. <i>Sherwood Breakaways</i> (R.J. Cranfield 6771), <i>Eremophila latrobei</i> , <i>Eremophila jucunda</i> subsp. <i>jucunda</i> , <i>Eriachne mucronata</i> , <i>Calytrix uncinata</i> , <i>Olearia stuartii</i>

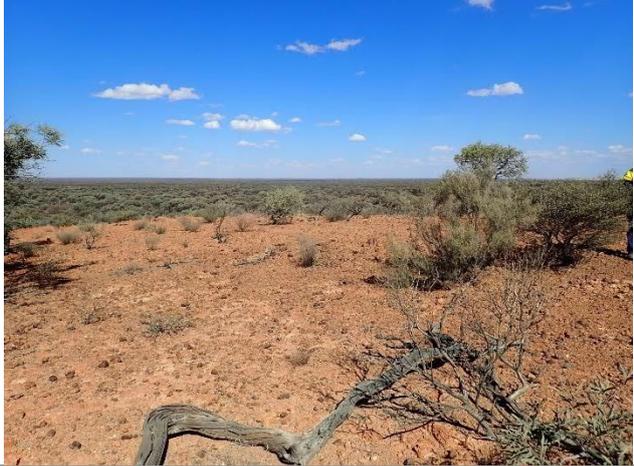
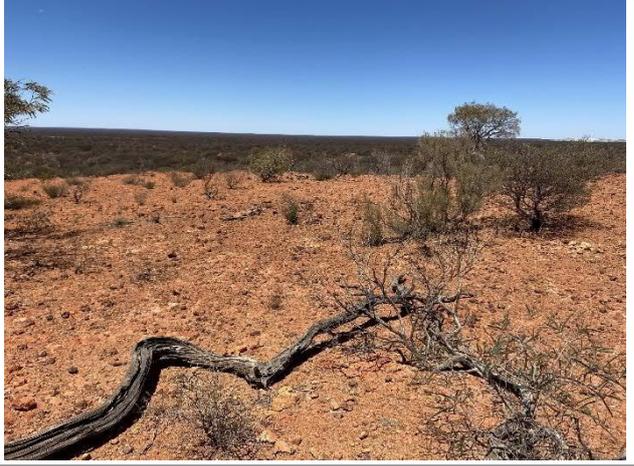
2020		2021

Site ID: MKS EIA 25		Co-ordinates: 51 J 261174 6971135	
Location: ~ 2 m east of haul road	Comments: Looking south, haul road to right. Quadrat moved away from haul road downslope from the MKS haul road. All vegetation in good condition. Light dust impact. No cryptograms.		
Veg. Type: Granitic Mulga shrubland on Archaean geology.			
Veg. Condition: Excellent			
Grazing: Nil			
Weed cover: Nil			
Photo direction: NW			
Species	Cover (%)	Plant Health Score	Comments
<i>Acacia pruinocarpa</i>	5	7b	Good condition.
<i>Acacia rhodophloia</i>	2	7b	Good condition.
<i>Acacia aneura</i>	2	7d	Some minor foliage loss and browning of leaves observed.
<i>Calytrix uncinata</i>	5	7b	Good condition.
<i>Dodonaea petiolaris</i>	<2	3	Some foliage loss of yellowing of leaves.
Other species: <i>Ptilotus obovatus</i> , <i>Ptilotus schwartzii</i> , <i>Thryptomene</i> sp. <i>Leinster</i> (B.J. Lepschi & L.A. Craven 4362), <i>Sclerolaena eriacantha</i>

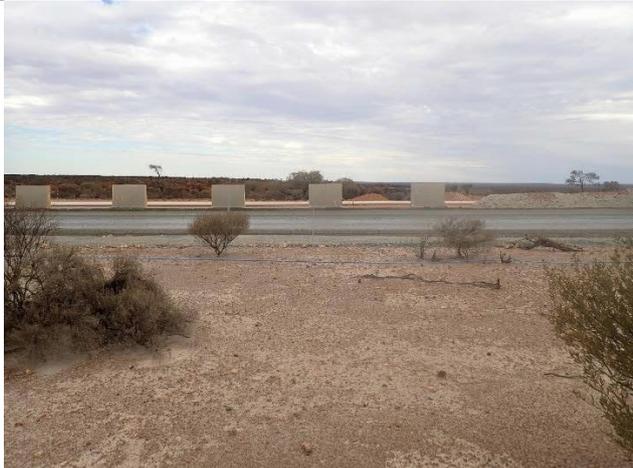
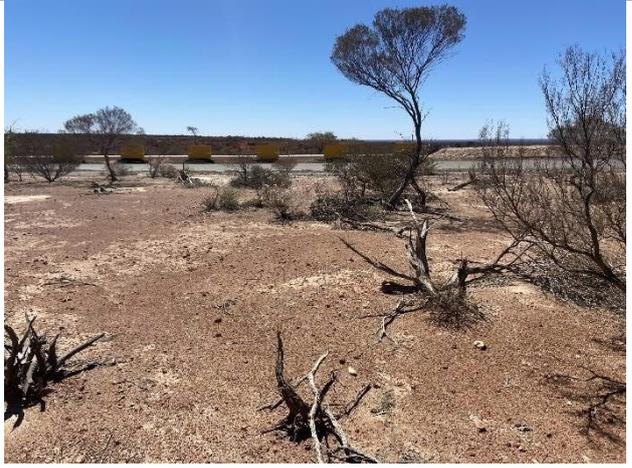
2020		2021

Site ID: MKS EIA 35		Co-ordinates: 51 J 261071 6971248	
Location: ~ 3 m west of haul road	Comments: Half quadrat on haul road boundary, moved 10m west from haul road. Sparse vegetation present. Dust on rocks and soil surface. Foliage loss on <i>Thryptomene</i> sp. Leinster (P3). Cryptogams present but covered in dust and dry.		
Veg. Type: Stony ironstone Mulga shrubland			
Veg. Condition: Good			
Grazing: Light			
Weed cover: Nil			
Photo direction: W			
Species	Cover (%)	Plant Health Score	Comments
<i>Eremophila latrobei</i>	<2	2	Stressed.
<i>Acacia aneura</i>	<2	7c	Dusty.
<i>Ptilotus obovatus</i>	<2	5	Flowering, some foliage loss.
<i>Thryptomene</i> sp. Leinster (P3)	<2	3	Dusty and dry.
<i>Acacia rhodophloia</i>	<2	7b	
Other species: <i>Maireana triptera</i> , <i>Eremophila jucunda</i> subsp. <i>jucunda</i> , <i>Acacia pruinocarpa</i> , <i>Eremophila pungens</i> , <i>Maireana georgei</i> , <i>Dodonaea microzyga</i> , <i>Rhagodia drummondii</i> , <i>Senna</i> sp. Meekatharra,

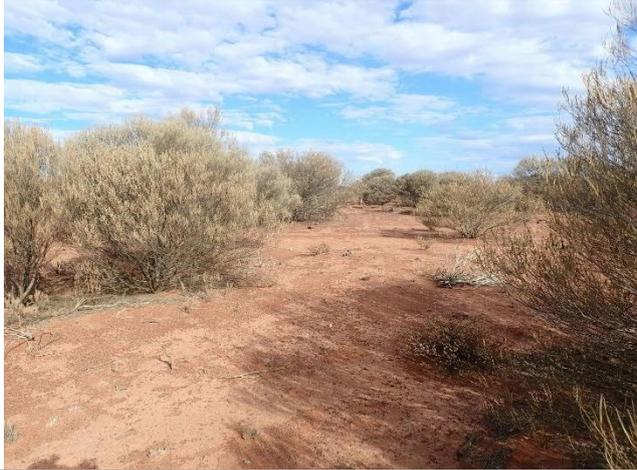
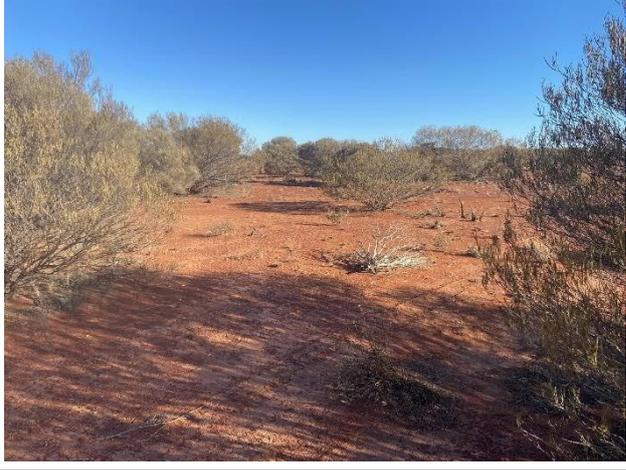
2020		2021

Site ID: MKS EIA 21		Co-ordinates: 51 J 261186 6973491	
Location: ~ 60m from haul road, within WNR	Comments: Old 4WD track nearby. No posts established at quadrat. Heavy dust load. Almost all plants are vegetative, but dry and dusty. Grazing of grasses evident. Soil is a red silty sand with abundant but discontinuous ferruginous pizolitic gravel.		
Vegetation Type: Hardpan Mulga shrubland with <i>Acacia thoma</i> co- dominant			
Veg. Condition: Very good			
Grazing: Medium			
Weed cover: Nil			
Photo direction: NW			
Species	Cover (%)	Plant Health Score	Comments
<i>Acacia thoma</i>	30	7b	Healthy but smothered in dust.
<i>Acacia aneura</i>	10	7b	High dust load.
<i>Eremophila jucunda</i> subsp. <i>jucunda</i>	5	7d	
<i>Eremophila spectabilis</i>	5	7d	
<i>Eragrostis eriopoda</i>	2	7d	
Other species: <i>Solanum lasiophyllum</i> , <i>Eriachne mucronata</i> , <i>Ptilotus schwartzii</i>

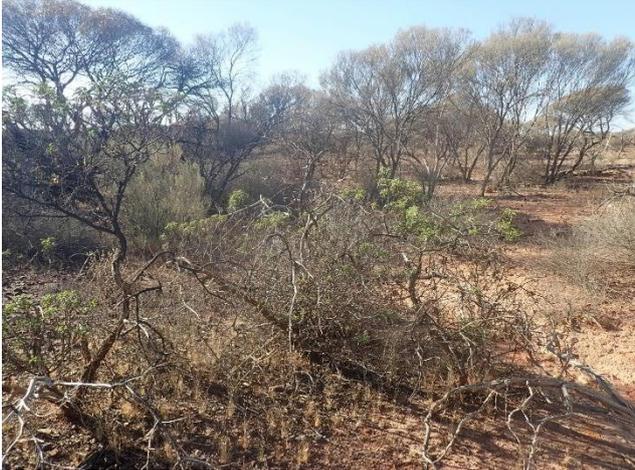
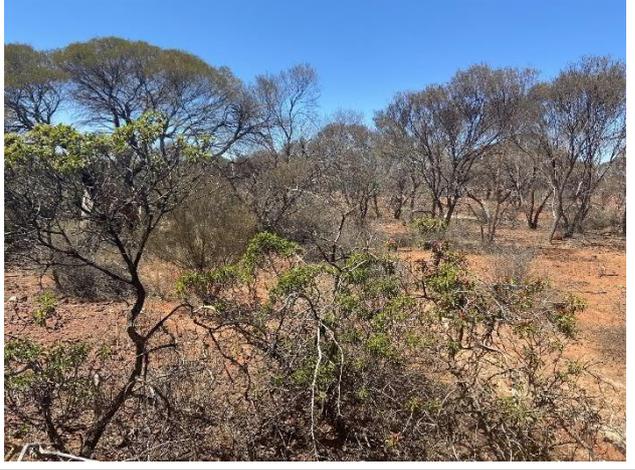
2020		2021

Site ID: MK SEIS 28		Co-ordinates: 51 J 261239 6970770	
Location: ~ 110 m east of haul road, within WNR	Comments: Site lies 100m downstream of the newly constructed road. The WNR fence line track is nearby with a high bund east of the track. Ants and termite mounds were present. Cryptograms on soil surface. Light dust load. At base of drainage line, depression in landscape.		
Veg. Type: Drainage line Mulga shrubland			
Veg. Condition: Very good			
Grazing: Light			
Weed cover: Nil			
Photo direction: NW			
Species	Cover (%)	Plant Health Score	Comments
<i>Sida ectogama</i>	30	2	
<i>Eremophila galeata</i>	5	5	Flowering.
<i>Acacia aneura</i>	25	4	Old pods present.
<i>Acacia quadrimarginea</i>	20	7c	
<i>Eremophila jucunda</i> subsp. <i>jucunda</i>	2	3	
Other species: <i>Ptilotus exaltatus</i> , <i>Enneapogon avenaceus</i> , <i>Senna glaucifolia</i> , <i>Psyrax suaveolens</i> , <i>Eremophila granitica</i> , <i>Dodonaea petiolaris</i> , <i>Lysiana</i> sp., <i>Senna</i> sp. <i>Meekatharra</i> , <i>Ptilotus helipteroides</i> , <i>Eremophila shonae</i> subsp. <i>shonae</i> , <i>Senna artemisioides</i> subsp. <i>xsturtii</i>

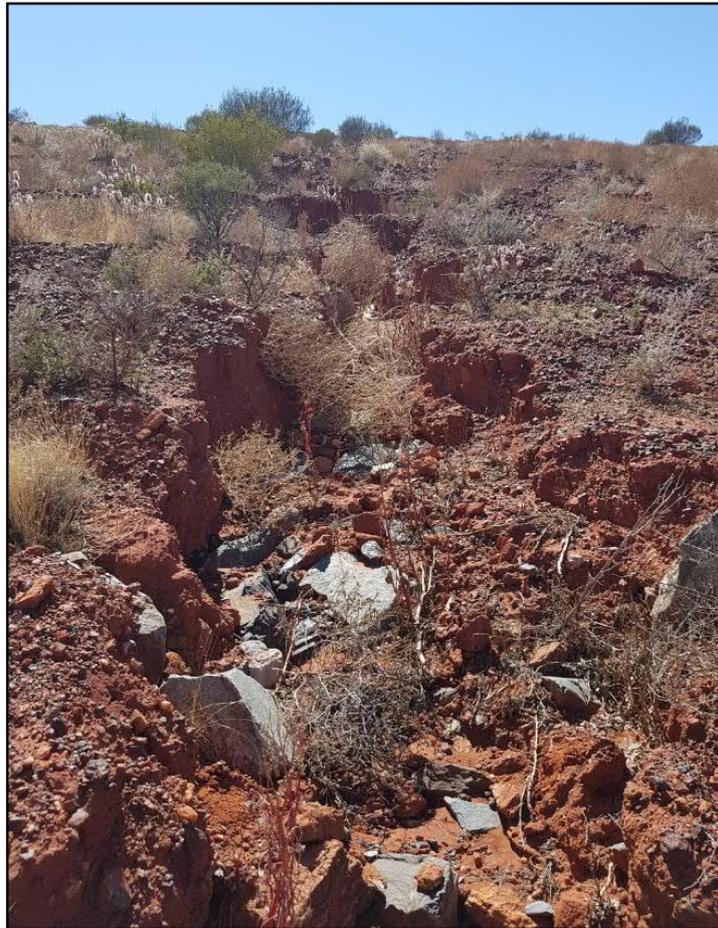
Plate 7-1: Erosion Gullies Observed in Concave Slope Trials

The performance to date of the concave slope has not been in line with expectations, with significant erosion evident in sections (**Plate 7-1**).

- Safe cross-ripping of steep slopes can be problematic limiting the potential for effective slope treatment; and
- There were shortfalls in the quality controls applied during the construction of the slope (e.g. excessive topsoil placement [~ 0.5 m] in sections, ripping 'across' not 'on' the contour). Closure requires effective QA control during design, execution and post-execution to ensure performance expectations are met.
