BM Alliance Coal Operations Pty Ltd
Hay Point Coal Terminal Expansion (HPX)
Marine Plants Restoration Project Plan
Hay Point, Queensland

ITEM	DETAIL
Project Name	HPX – Marine Plants Restoration Project Plan
Project Number	09CANPLA-0036
File location	Z:\Synergy\Projects\09CANPLA36
Prepared by	Tom Kaveney
Status	Final
Version Number	1
Last saved on	27 November 2010

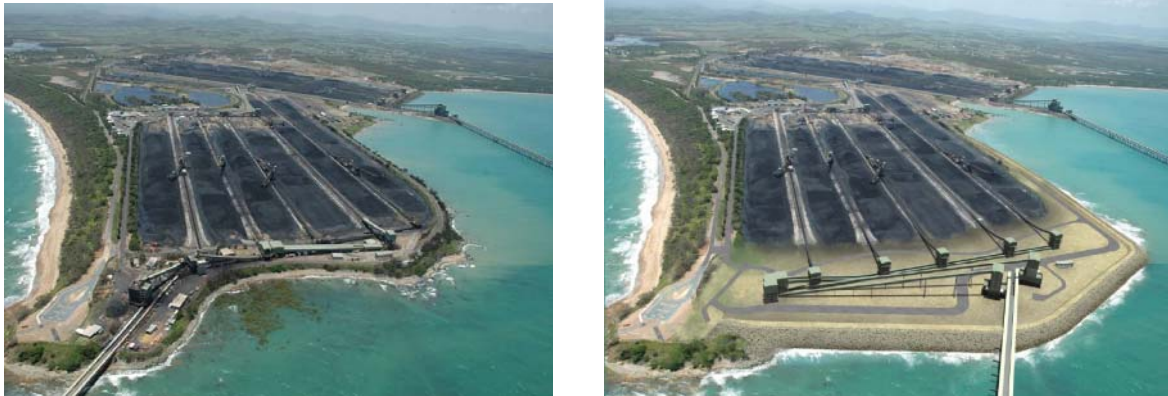
Figure 1: Hay Point Coal Terminal presently (left) and with proposed reclamation (right).

1. Reclamation of approximately 9.4 ha of land to the northeast of the existing stockyard area for the construction of the new onshore out-loading systems (see Figure 1 & Figure 1.2); and
2. Reclamation of approximately 32 ha of land along the western shore of the existing stockyard area to accommodate up to three additional stockpiles, associated conveyor systems, barge off-loader facilities and other port related infrastructure (see Figures 1 & Figure 1.2).

The reclamation will extend past the intertidal zone and into shallow subtidal seabed on the western shoreline of Hay Point (Figure 1 & 2). All benthic fauna and flora within the reclamation footprint will be lost.

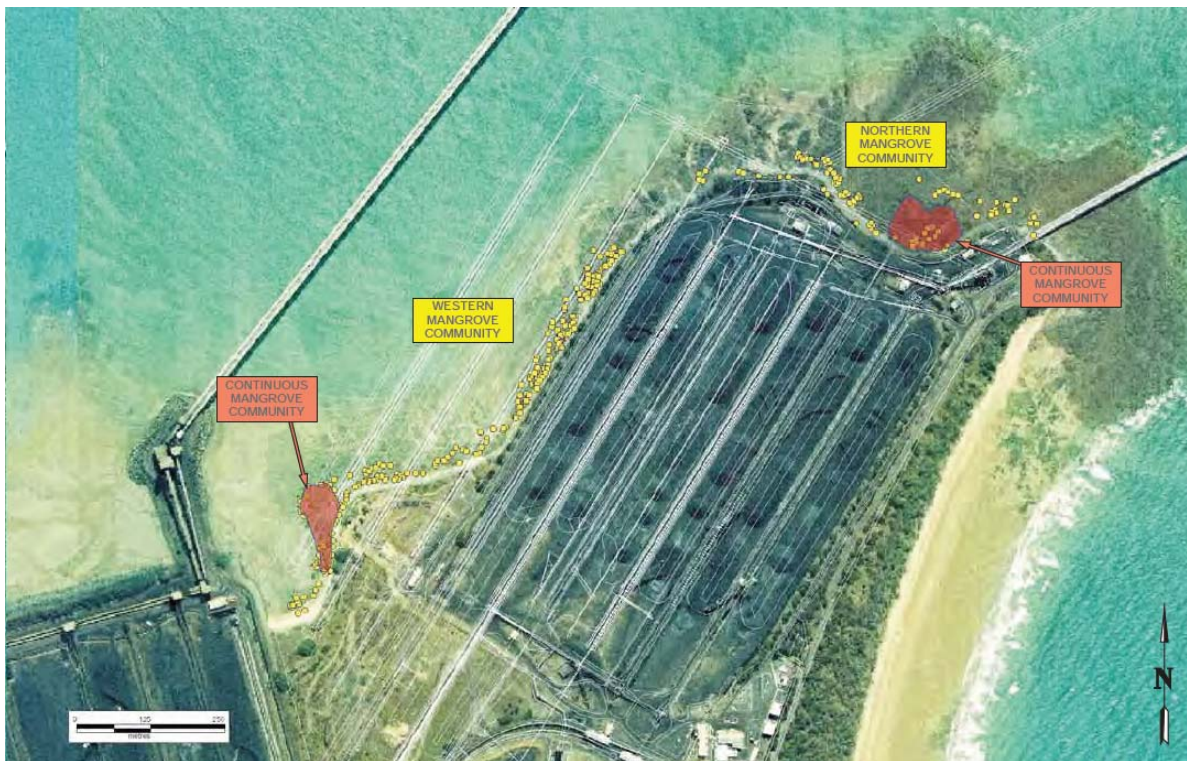
Figure 2 : Hay Point Coal Terminal showing mangrove communities and scattered individual distribution (yellow dots) in the proposed reclamation zone.

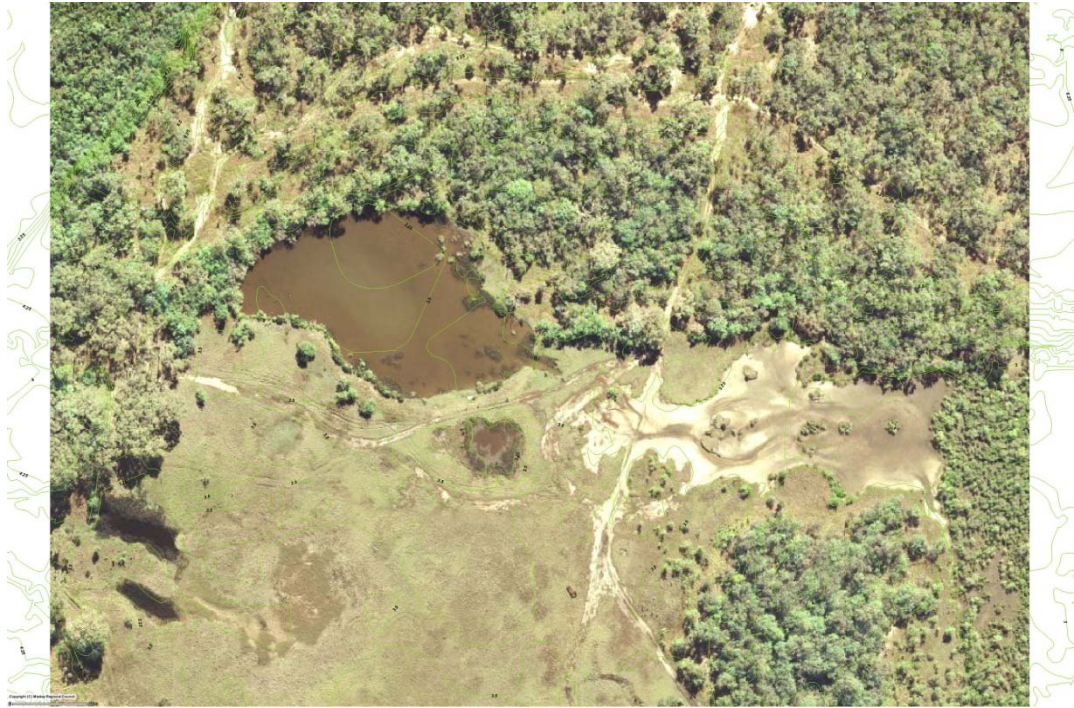
Figure 4 Erosion and Scalding of Saltmarsh habitat as a result of past vehicle use

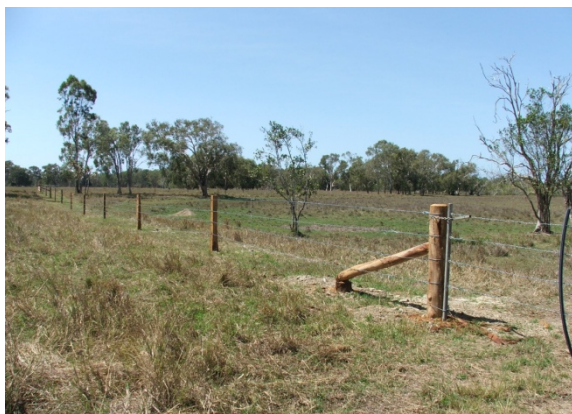
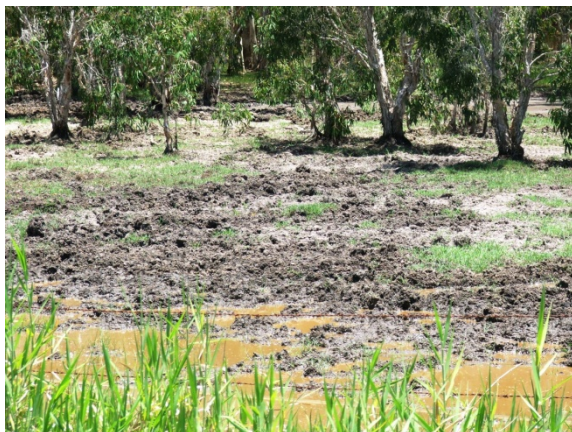
Figure 19: Feral pig damage to wetlands.

Feral animal surveys and fire management planning are ongoing and are currently being undertaken by EPA including adequate resourcing to ensure appropriate management is implemented. At certain times during the year feral pigs damage many hectares of wetland fringe (Figure 19), adjoining canelands and grazing land. Baiting programs are inappropriate due to the close proximity of the

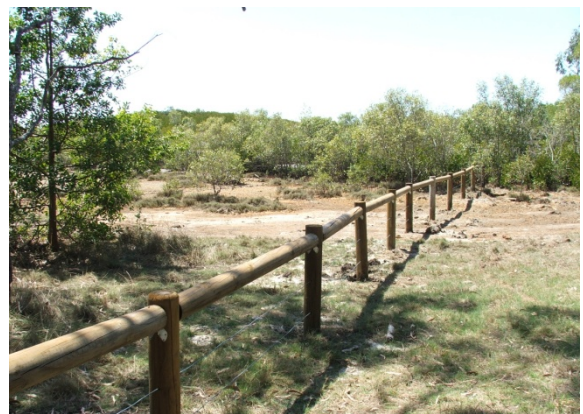
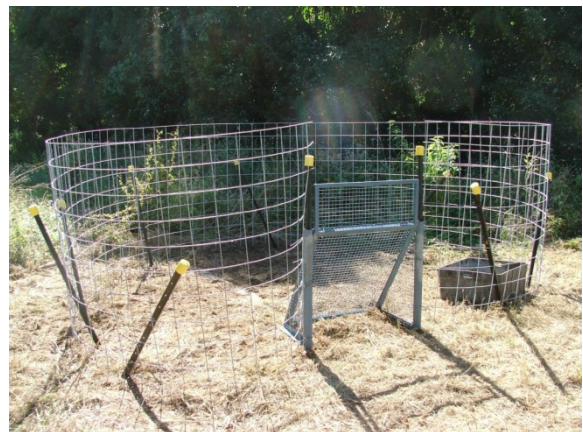
Figure 20: Pig Trap

residential areas. Trapping programs (Figure 20) are only partly effective (8 animals to date) due to shyness towards the take up of pre-feed. Further research is continuing in conjunction with EPA and adjoining land holders to monitor pig movements using radio tracking collars and to examine stomach contents to determine the food source. This may help in developing an appropriate attractant / bait for use in traps.

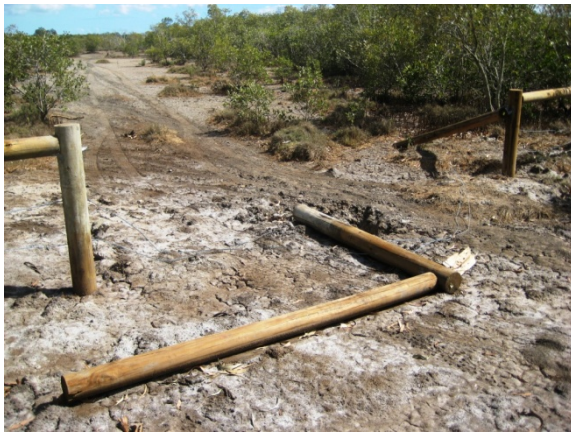
Figure 21: Damage to internal fences.

The roadside and internal exclusion fencing adjoining the wetland has initially proved effective in reducing off road vehicle activity however recent vandalism (Figure 21) has allowed vehicles to once again access these areas. Access was also gained by cutting through the mangroves at the end of the fence (Figure 22). It has been realised that short term projects of this nature are ineffective due to the limited timeframe for the project and for the public consultation process. Public education programs are required prior to commencement of the project and that this continues after the project has been finalised. There is also a need for a provision in the budget for future repairs to vandalised infrastructure.

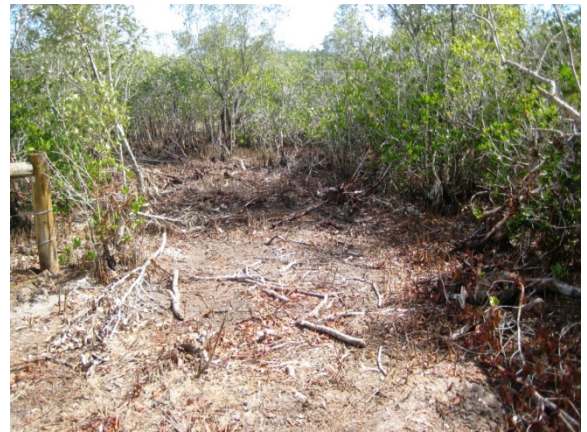
Figure 22: Vehicle access through mangroves.

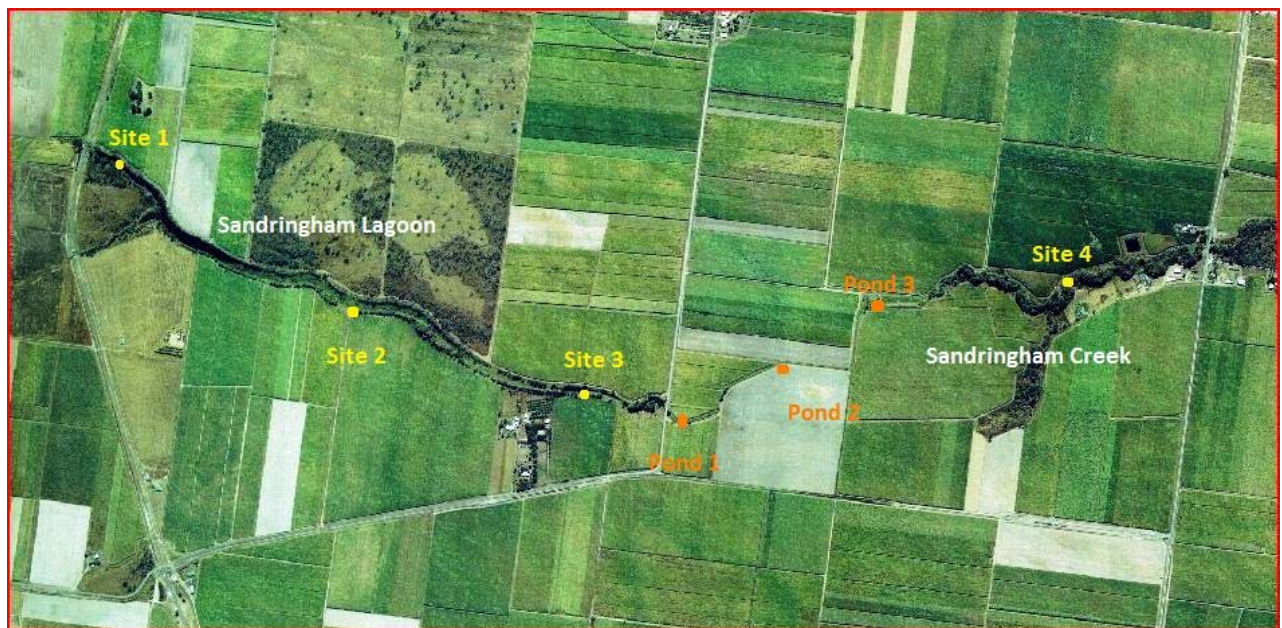
Figure 31: Sandringham Lagoon and Creek with monitoring points and detention pond sites. (Adapted from MiMaps 2008)

Sandringham Lagoon (Figure 31) is a 2.2km freshwater lagoon located approximately 20km south of Mackay. This lagoon has been part of an ongoing project to fully restore the site which previously was almost completely covered by Para grass, Hymenachne, Water hyacinth and a thick weed mat. This weed mat was so extensive it was supporting numerous Melaleuca species that were growing hydroponically on the mat (these trees were up to 9 metres in height).

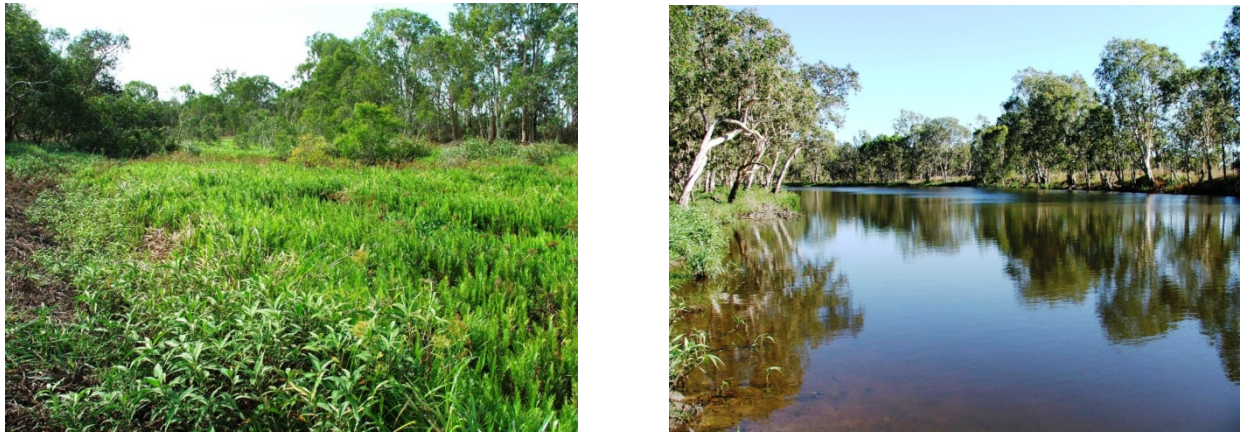
Figure 32: Sandringham Lagoon Site 2 before (5/12/2006) and after (29/07/2008) weed mat removal.

Water quality monitoring has been occurring on a monthly basis at three sites along Sandringham Lagoon since December 2006. Site 2 is located mid way along the lagoon and was highly degraded. Water quality data (Appendix 16) and accompanying graphs of this data (Figures 35 & 36) reveal the following improvements in water quality since commencement of the removal of Hymenachne mats in mid 2007:

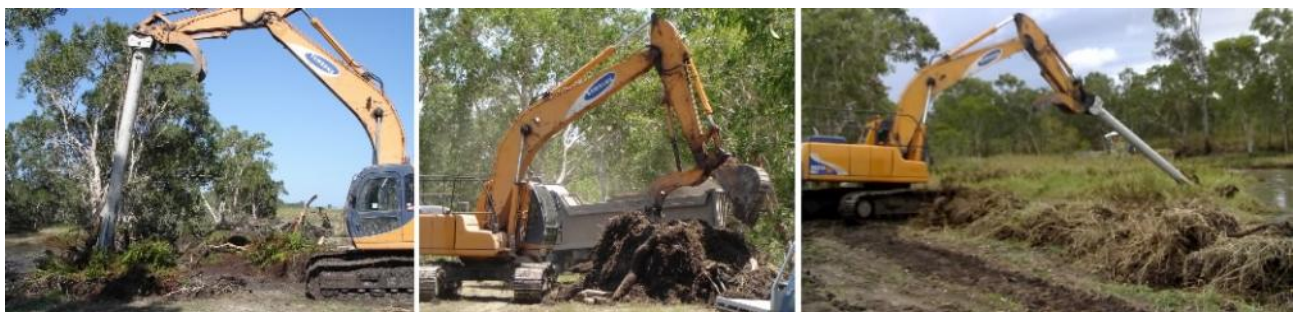
Figure 33: Removal of weed mat using an extension arm on an excavator. (Photos: A. O'Brien)

Mechanical weed removal (Figure 33) was the most appropriate method of weed control due to the extensive weed mat covering the lagoon. This was also combated with a chemical spray regime to reduce the amount of weeds along the banks.

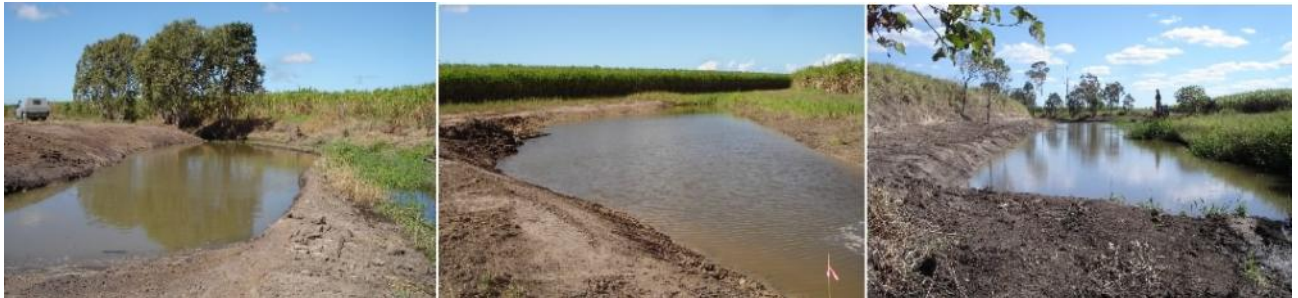
Figure 34: Three excavated detention ponds along the cane drain system.
(Photos: A. O'Brien)

Detention ponds (Figure 34) were constructed along Sandringham Creek as a means of reducing sediments and nutrients entering the downstream estuary and to increase fish passage between the creek and lagoon. This section had been previously converted into a narrow drain that reduced connectivity to the downstream section of Sandringham Creek. The detention ponds will also provide

a suitable settling point for sediments and nutrients in runoff from the surrounding sugar cane farms. The ponds were designed to reduce stream velocity during flood events allowing for the assimilation of nutrients and sediments from flows entering Sandringham Bay and the Great Barrier Reef Lagoon.

The effectiveness of the detention ponds will not be established until after the next wet season when the main lagoon (and the ponds) will be sampled to identify migratory species entering the system. These ponds have already withstood out of season rainfall (over 600mm) and only one of the ponds had minor erosion (which was repaired with a rock retaining wall). With this erosion a small number of plants were lost, however the success rate of the revegetation on a whole is approximately 85%. These trees were planted early in the year and have established themselves so their success rate is expected to stay high.
