MT ARTHUR COAL
ANNUAL ENVIRONMENTAL
MANAGEMENT REPORT FY14

Table of Contents

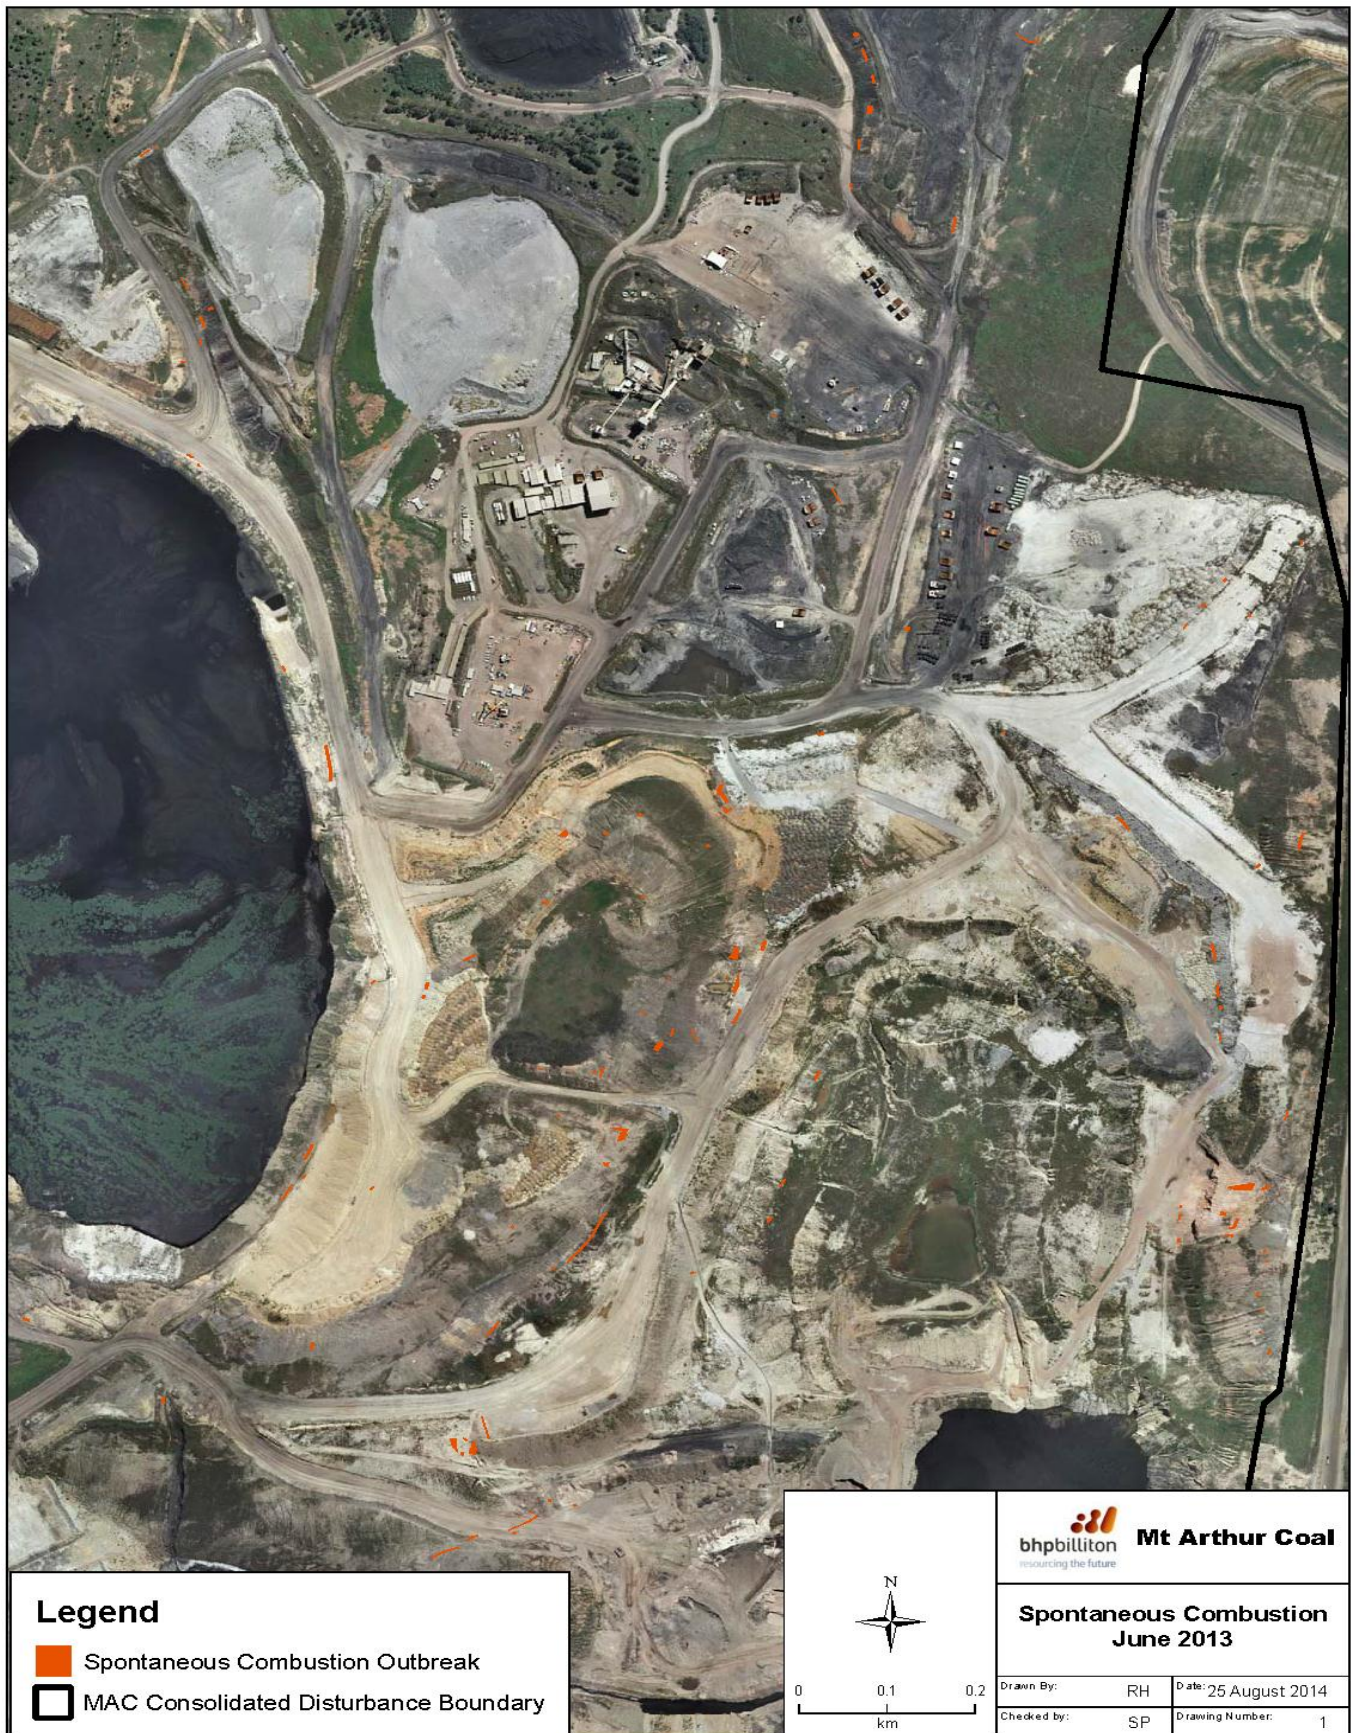
Figure 15: Locations of spontaneous combustion at Mt Arthur Coal at start of reporting period

A summary of the spontaneous combustion recorded for the period is presented in Table 41 and shown as a plot in Figure 14. A plan showing the location of remaining spontaneous combustion areas at the start of the reporting period is shown in Figure 15. The location of remaining spontaneous combustion areas on site at the end of the reporting period is provided in Figure 16.

Similar to previous reporting periods, monitoring during the period revealed a low spontaneous combustion hazard around the site. All areas affected by spontaneous combustion during the monitoring period were classified as minor intensity and evident in the form of occasional steam or smoke, posing a low risk to both employees and the environment, with the exception of the following five areas:

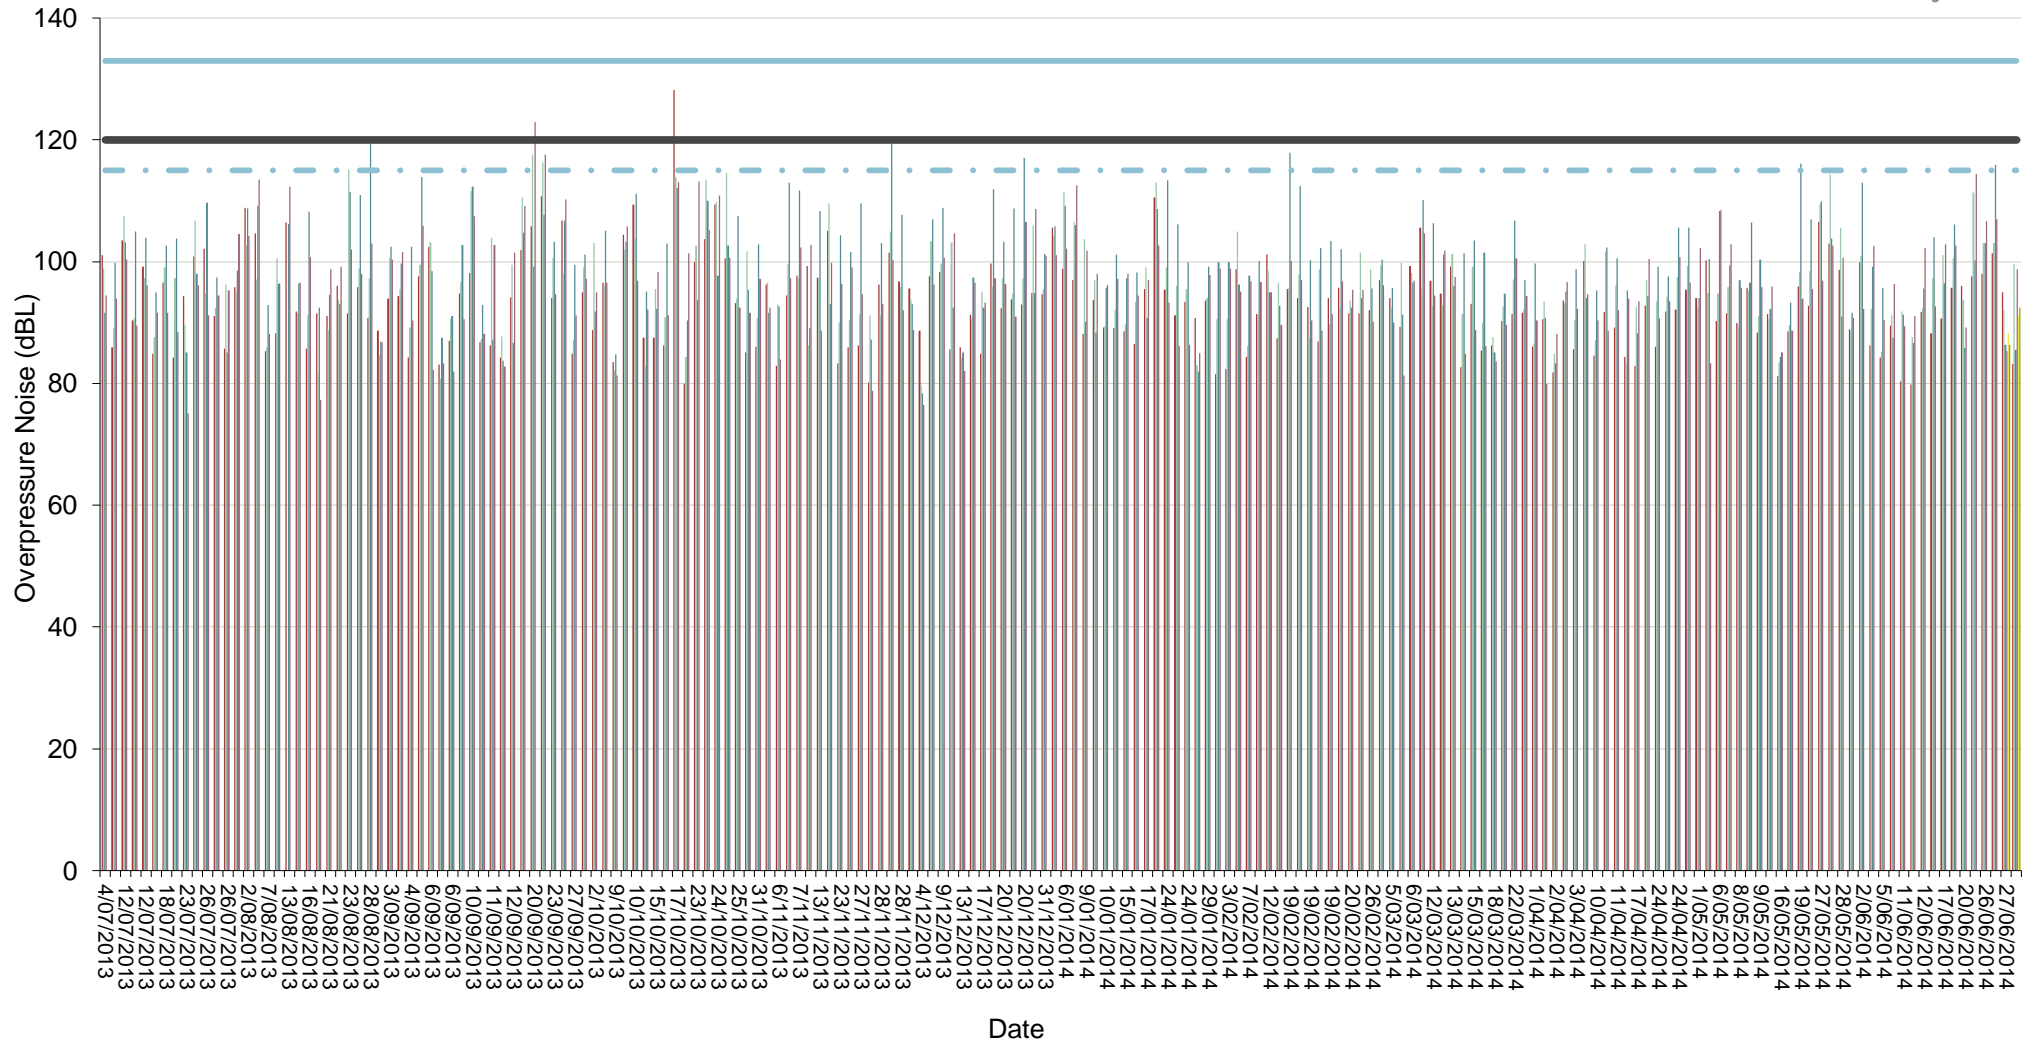
Mt Arthur Coal Blast Monitoring Results - Overpressure Noise FY14

- █ BP04 South Muswellbrook
 - █ BP09 Denman Road West
 - █ Limit for Overpressure Noise (dBL)*
- █ BP07 Sheppard Ave
 - █ BP10 North Yammanie
 - - - Edinglassie Limit for Overpressure Noise (dBL)
- █ BP08 Edinglassie
 - █ BP11 Balmoral Road
 - . - . - 115 dBL Criteria* [* Not applicable to BP08 Edinglassie]
