MT ARTHUR COAL
ANNUAL ENVIRONMENTAL
MANAGEMENT REPORT FY15

Date	29 September 2015

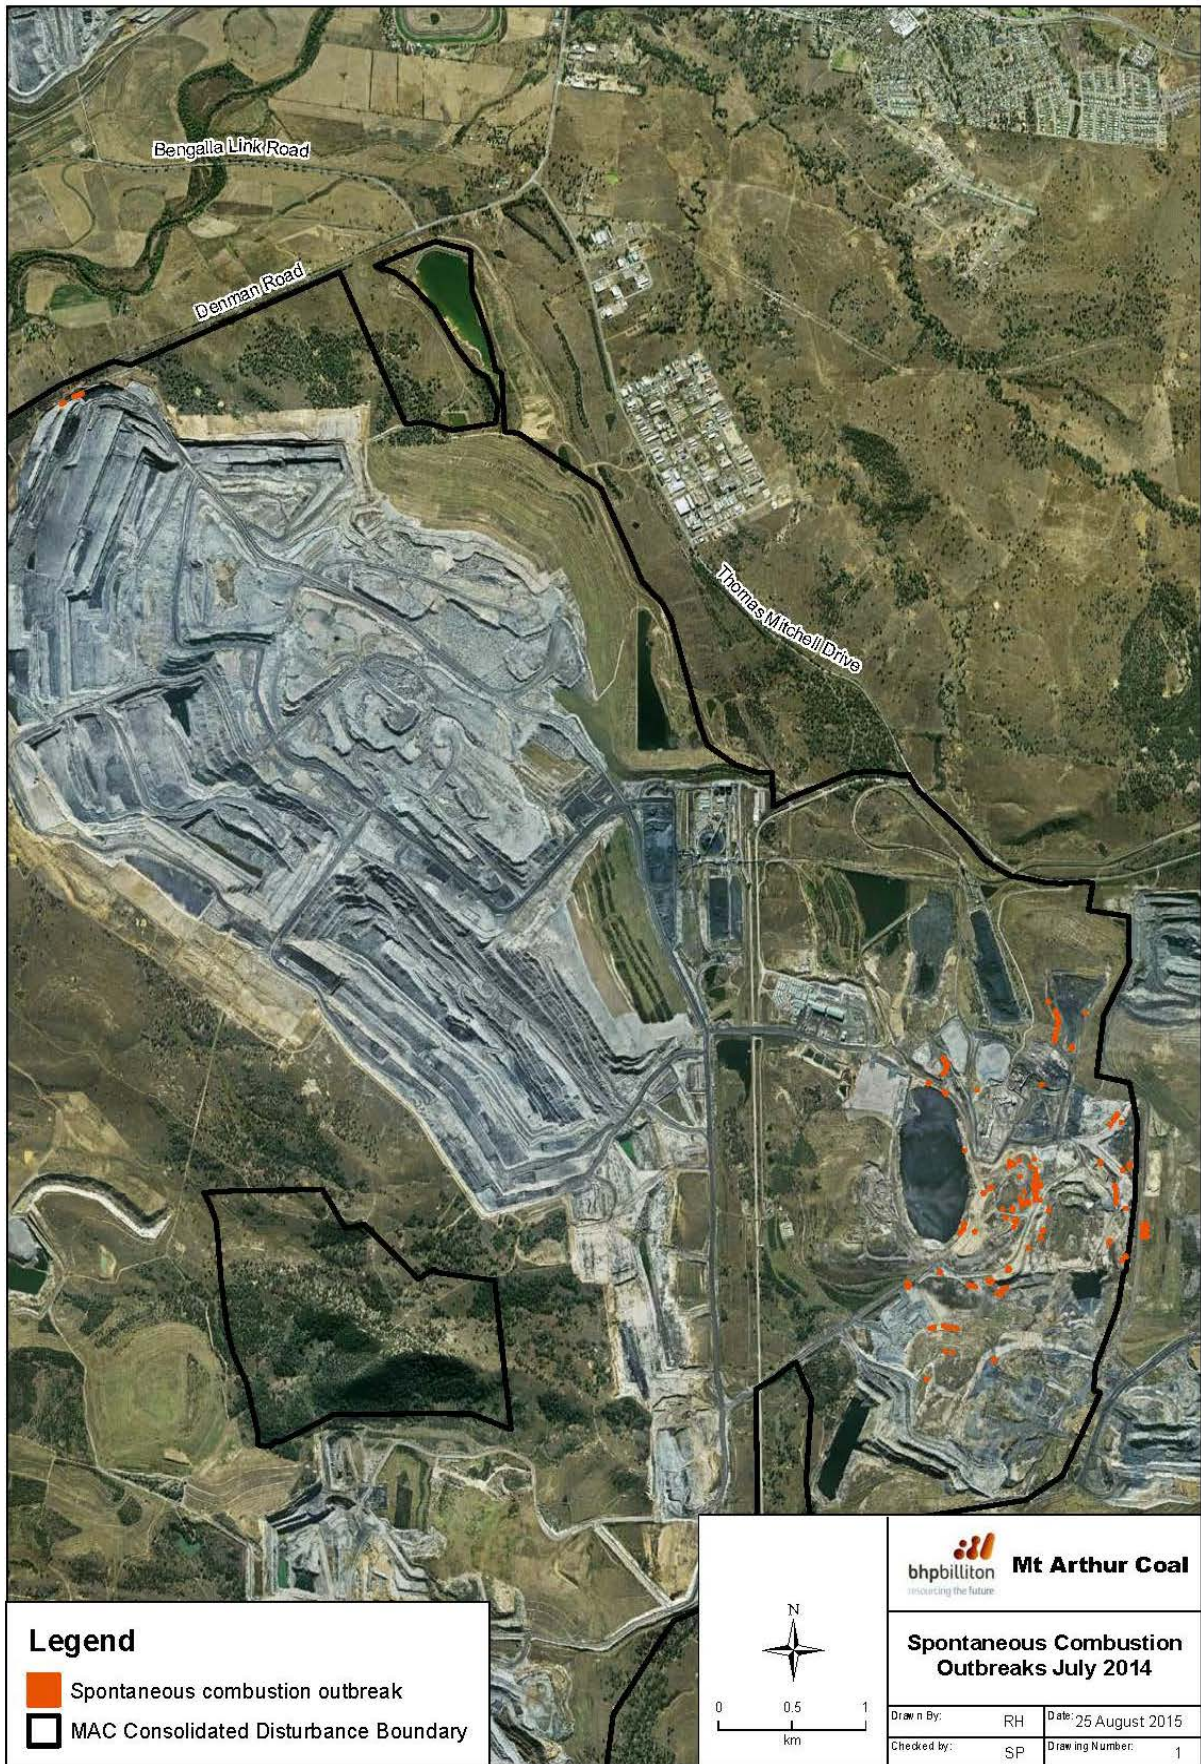
Figure 16: Locations of spontaneous combustion at Mt Arthur Coal at start of reporting period

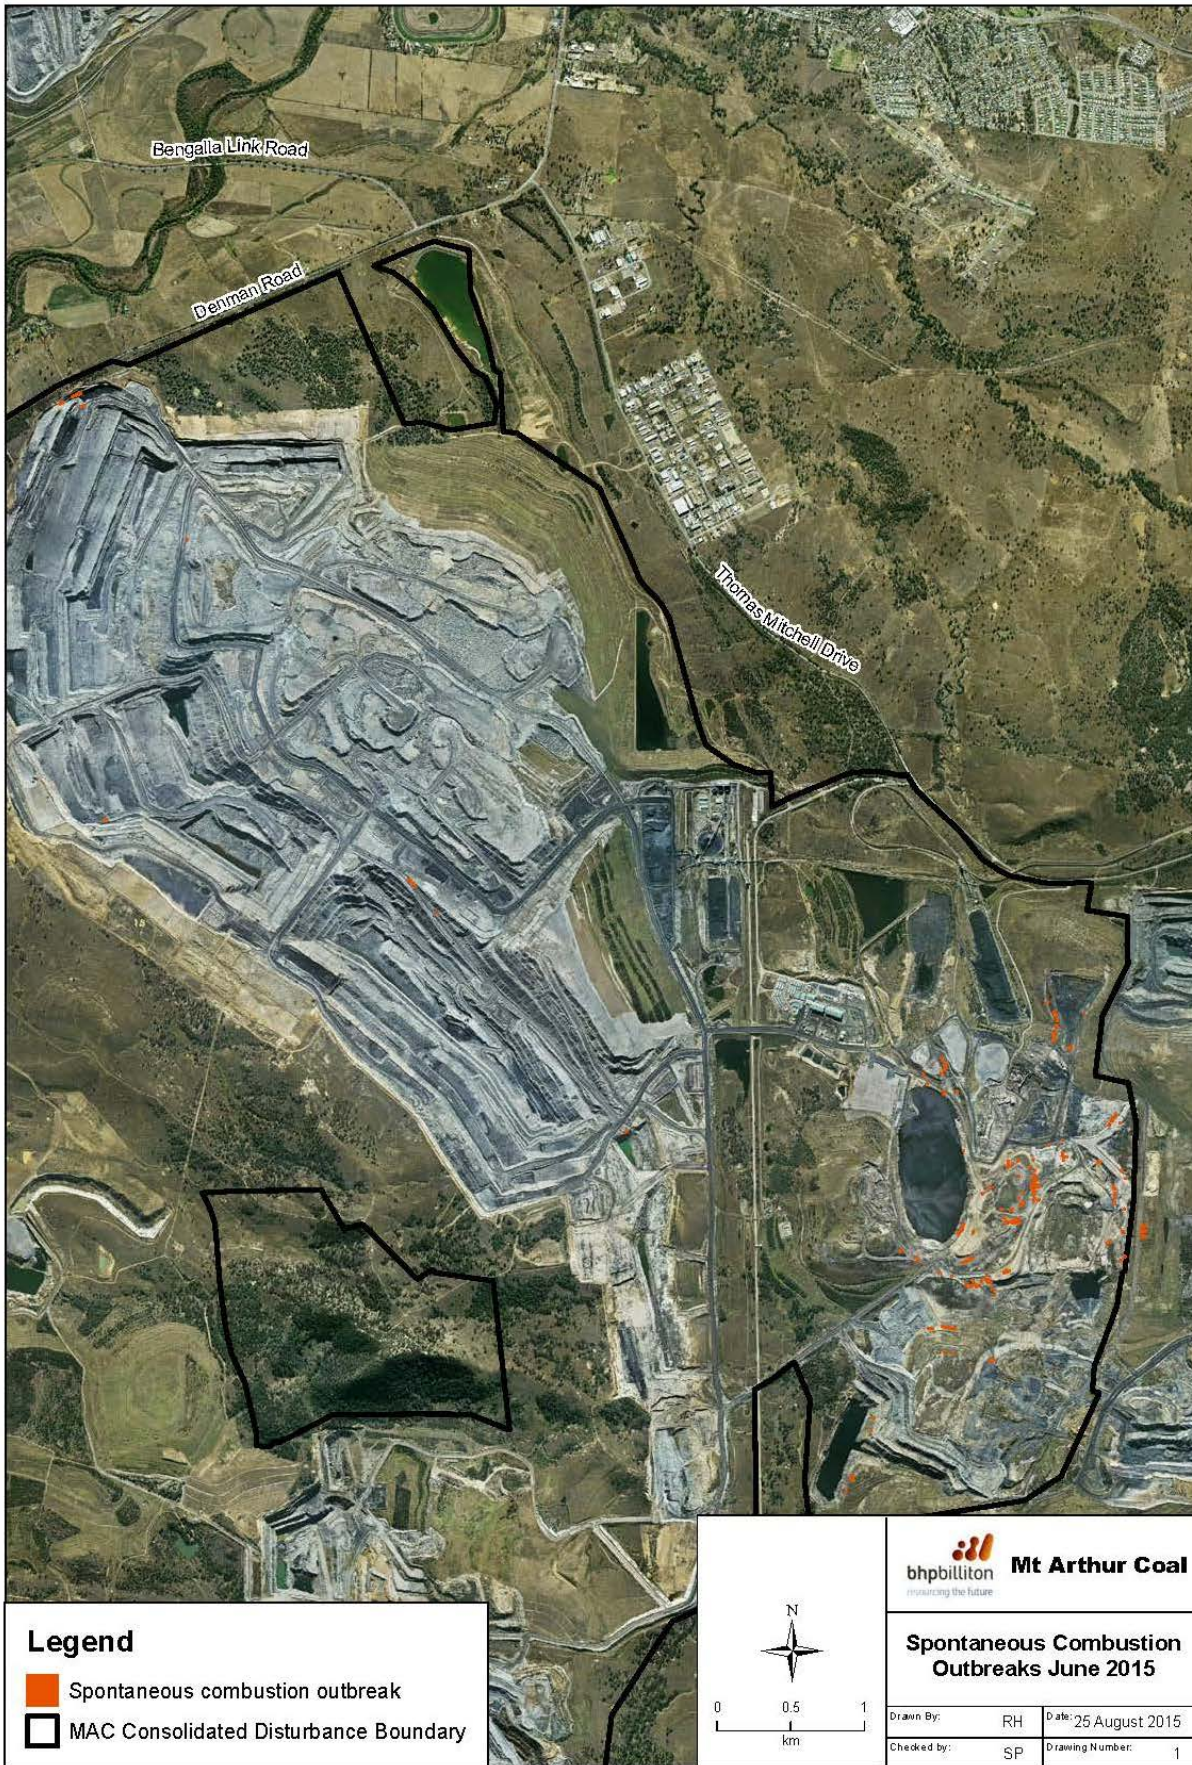
Figure 17: Locations of spontaneous combustion at Mt Arthur Coal at end of reporting period

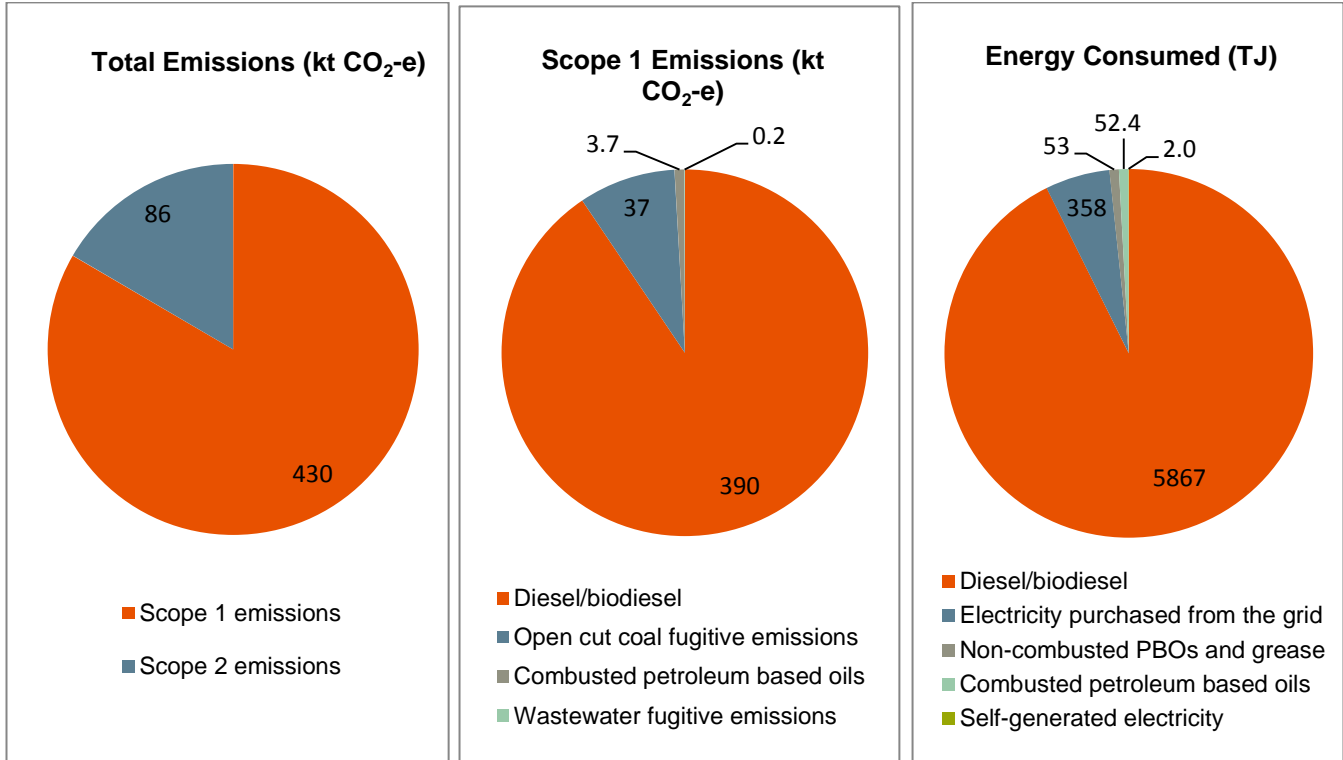
During the reporting period approximately 93 per cent of energy consumed at Mt Arthur Coal was attributed to diesel use in mobile and stationary equipment and in explosives, while electricity consumption from the grid accounted for approximately six per cent. Energy consumed from non-combusted PBOs and grease, combusted PBOs and self-generated electricity accounted for the remaining energy consumed for the reporting period, as displayed in Figure 18.

Figure 18: Composition of Mt Arthur Coal emissions and energy consumption during the reporting period

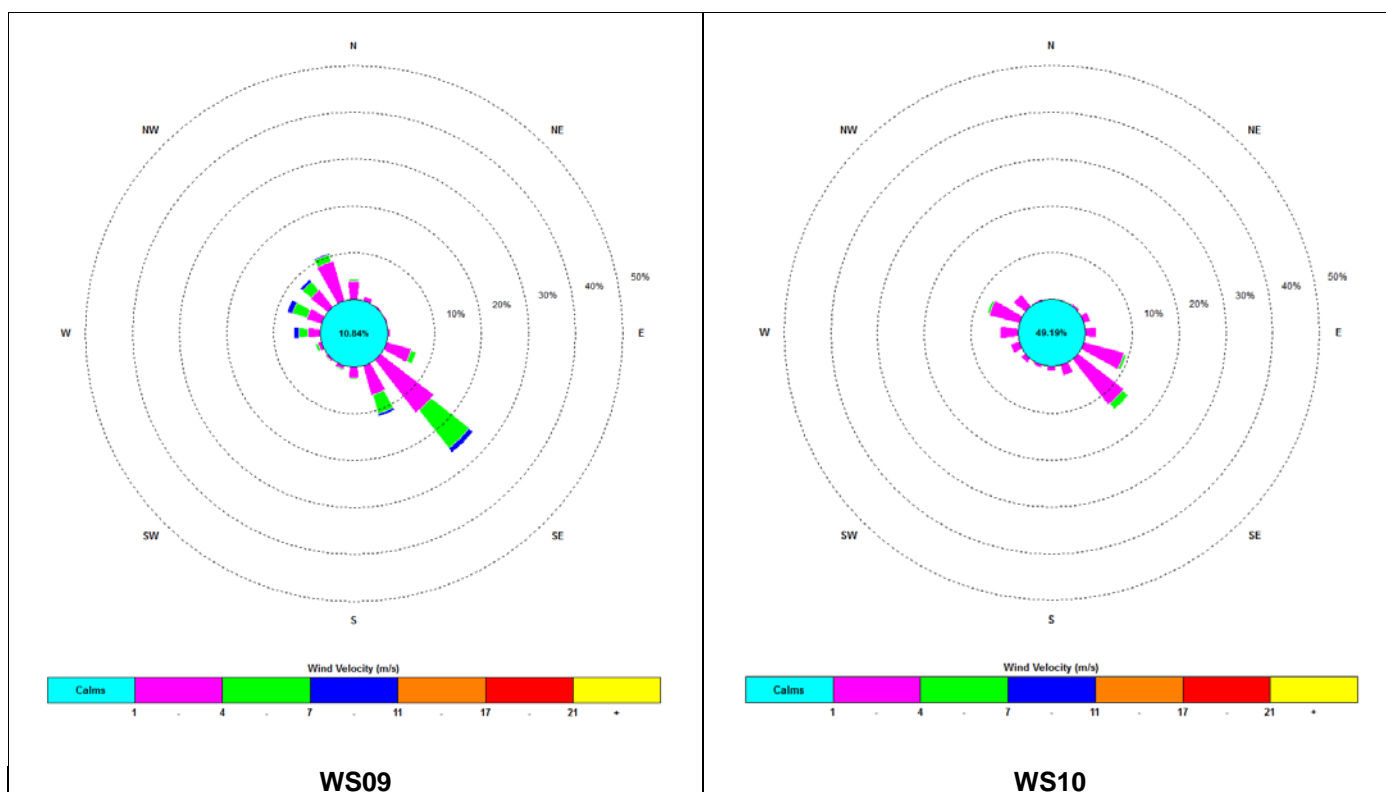
Similar to previous years, wind direction at Mt Arthur Coal during the reporting period was predominantly from the south east, with the second most common winds being from the north north-west at WS09 and west north-west at WS10, as shown in Figure 21.

Figure 21: Mt Arthur Coal annual wind rose for FY15 from WS09 and WS10

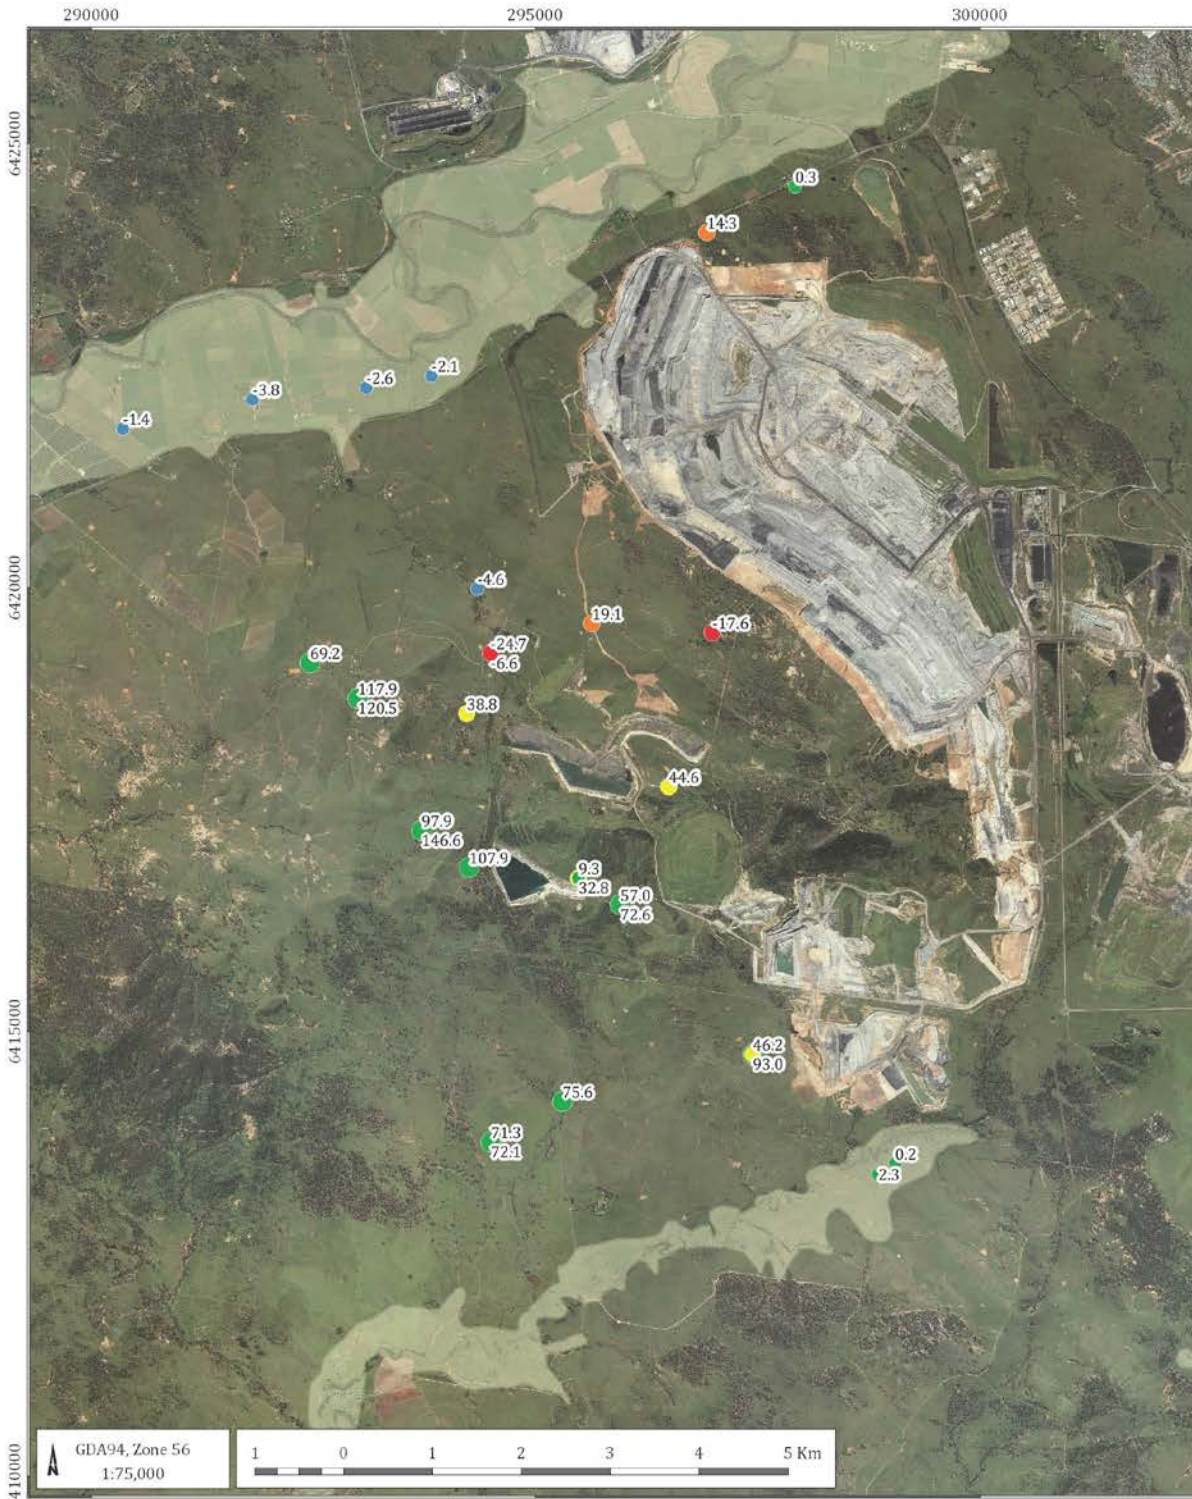
Figure 4B: Modelled versus measured ground water drawdown comparison

2015 modelled vs measured head

The modelled head for FY15 was extracted for all model slices from the consolidation project ground water model and compared to measured data in June 2015. Figure 4B in Appendix 4 shows the result, with negative values showing where the model under predicts mine impacts (blue and red markers) and positive values showing where the model over predicts mine impacts (green, orange and yellow markers). The largest difference in modelled versus measured results is 146.6 metres of drawdown being over predicted by the model at OR2051. This is likely to be due to a variation in actual mine progression in this area compared with modelled mine progression. The four bores in the alluvium showing negative values indicating the model may have slightly under predicted impacts in this area; however, future drawdown to the west of the bentonite wall within the alluvium is likely to be minimal.
