Mt Arthur Coal

Annual Environmental Management Report

2011

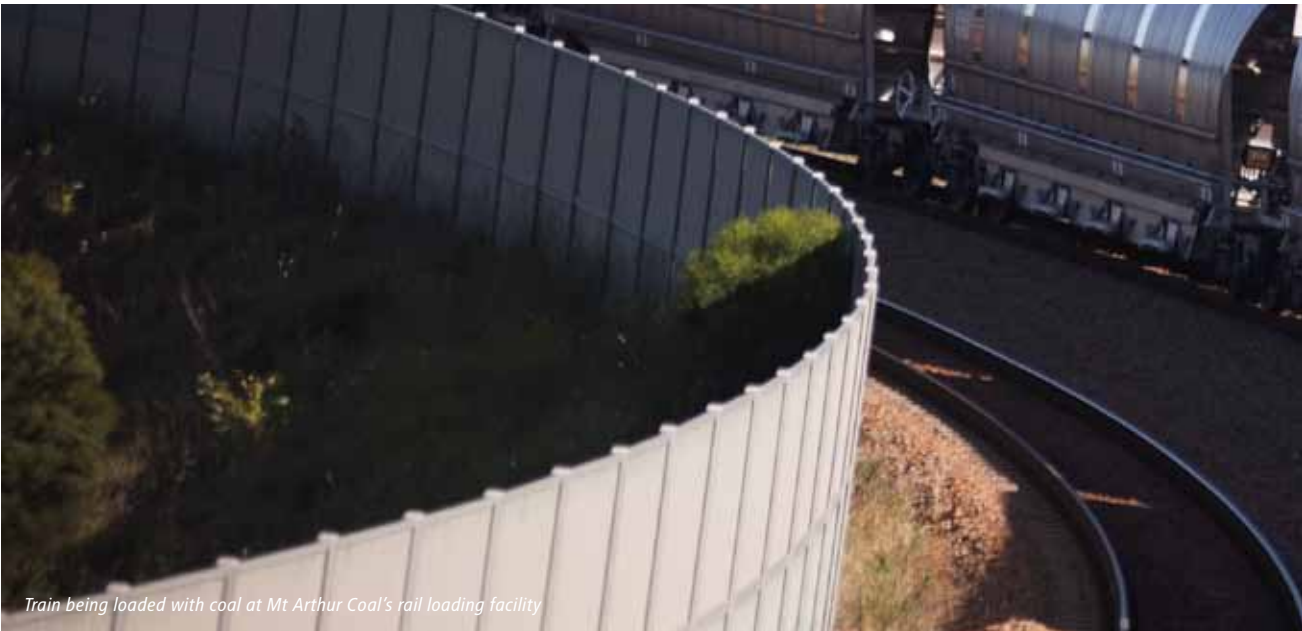
Train being loaded with coal at Mt Arthur Coal's rail loading facility

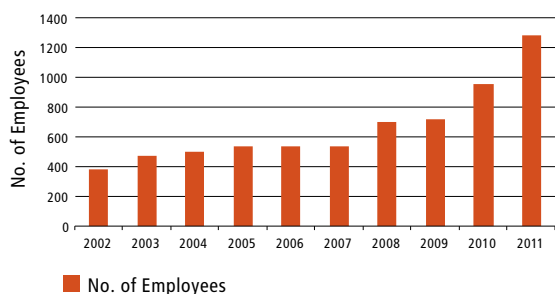
Figure 4: Mt Arthur Coal employee numbers from 2002 to 2011

At the end of 2011, Mt Arthur Coal employed 1,282 full-time permanent employees and approximately 760 contractors on a full-time equivalent basis. This was a 33.5 per cent increase in the number of permanent employees when compared to 2010 and was attributed to the ongoing growth of Mt Arthur Coal (see Figure 4).

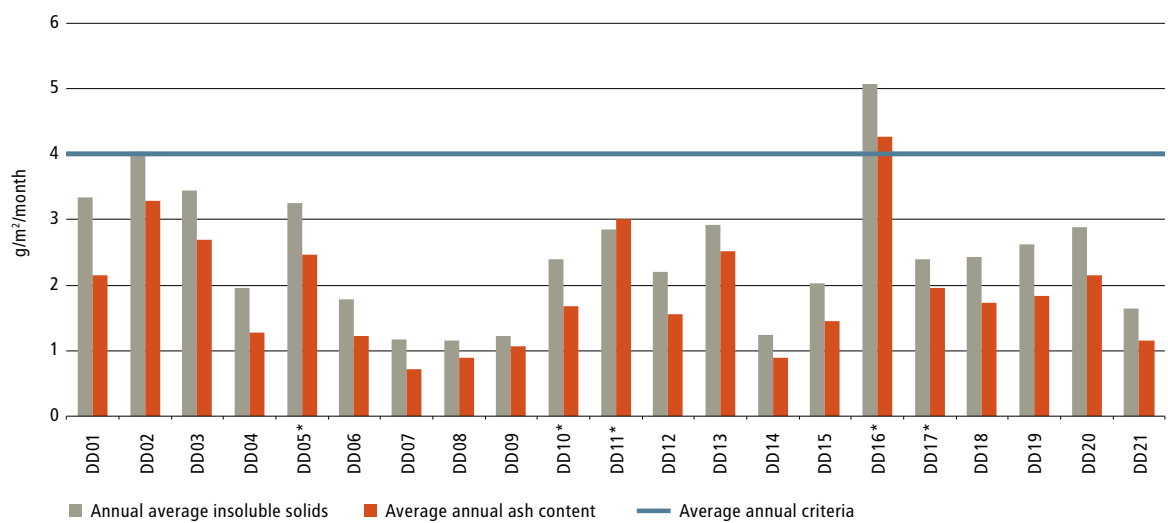
Figure 8: Mt Arthur Coal’s depositional dust gauge annual averages for 2011

* Depositional dust gauge is located on land owned by Mt Arthur Coal and is used for management purposes only.

The criterion for the maximum total deposited dust level is 4 grams per square metre per month (g/m²/mth) over an annual averaging period. The maximum increase in deposited dust levels due to Mt Arthur Coal’s operations over an annual averaging period at any one dust gauge is 2 g/m²/mth.

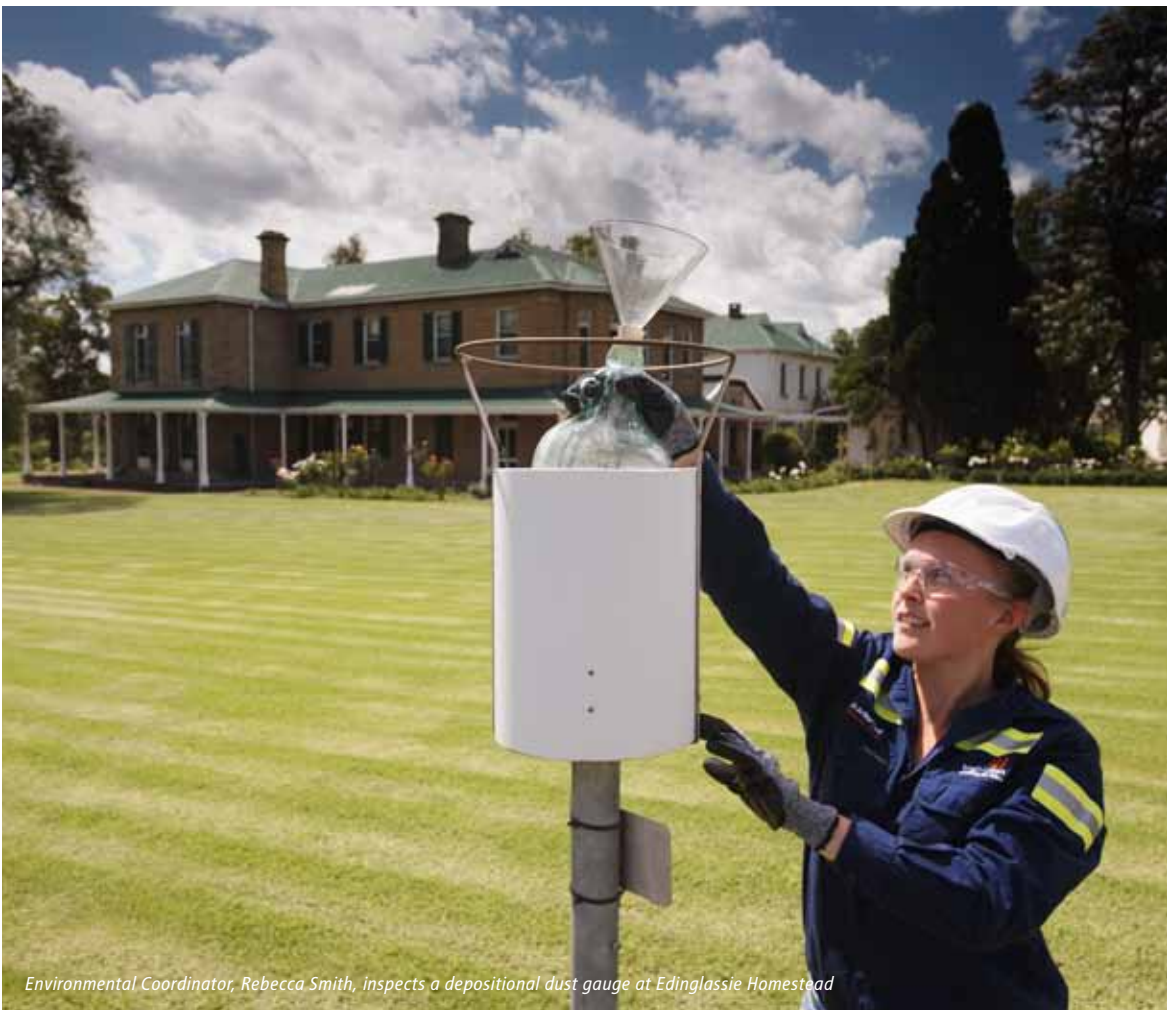
Environmental Coordinator, Rebecca Smith, inspects a depositional dust gauge at Edinglassie Homestead

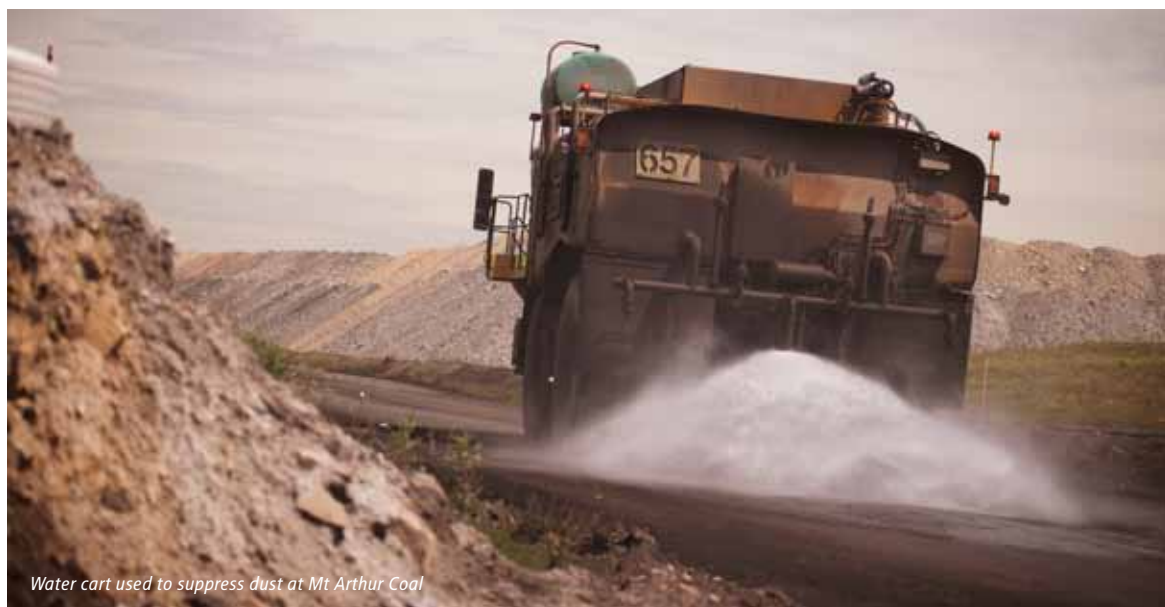
Water cart used to suppress dust at Mt Arthur Coal

The application of dust suppressants on haul roads was continued by Mt Arthur Coal in 2011 to minimise dust generation. This involved the use of a non-hazardous liquid polymer (water extender) known as RT9, which is added to the water cart using an automated dosing system from two separate water cart fill points across site. It is then sprayed onto haul roads to improve water penetration, bind fine dust particles and consolidate haul road surfaces.

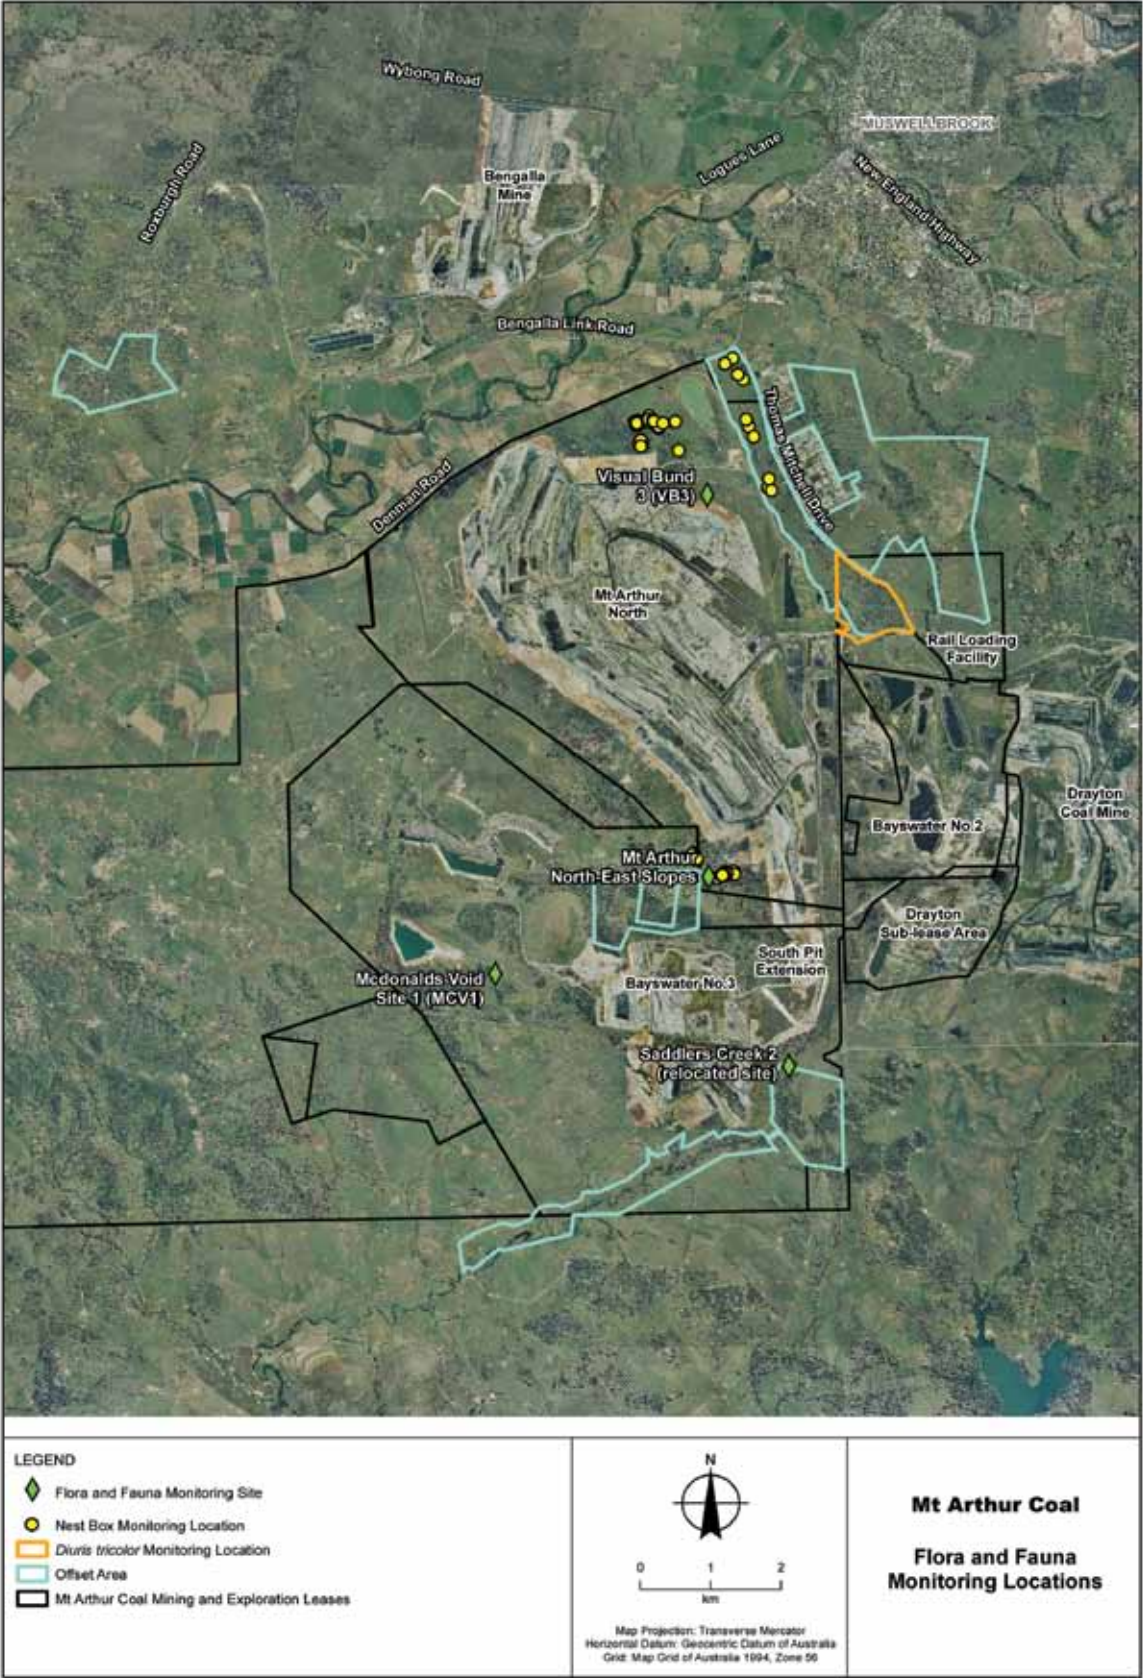
Figure 17: Mt Arthur Coal’s flora and fauna monitoring locations

Flora and fauna monitoring was undertaken at Mt Arthur Coal in early November 2011 by independent consultants. The annual survey assessed diversity and habitat condition across two remnant and two rehabilitation areas considered to be representative of the ecological communities found on site. The locations of these monitoring sites are shown in Figure 17.

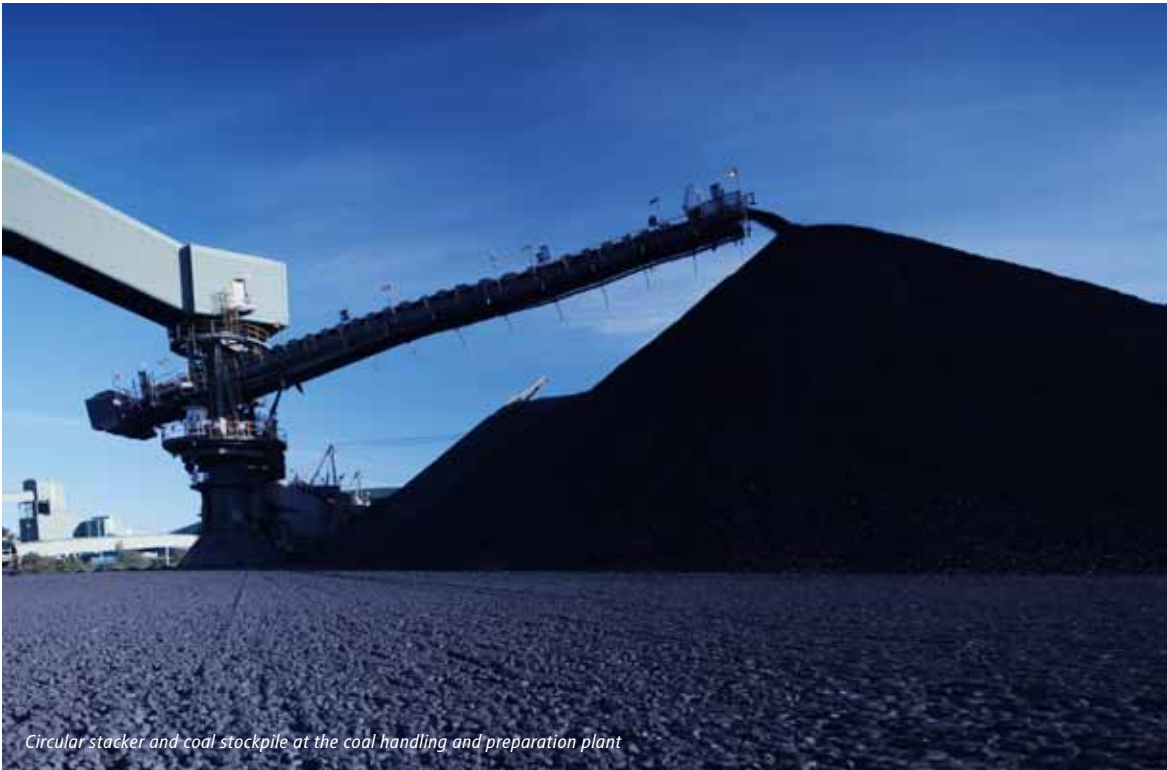
Circular stacker and coal stockpile at the coal handling and preparation plant
