BHP

Mt Arthur Coal

Annual Environmental Management Review FY17

29 September 2017

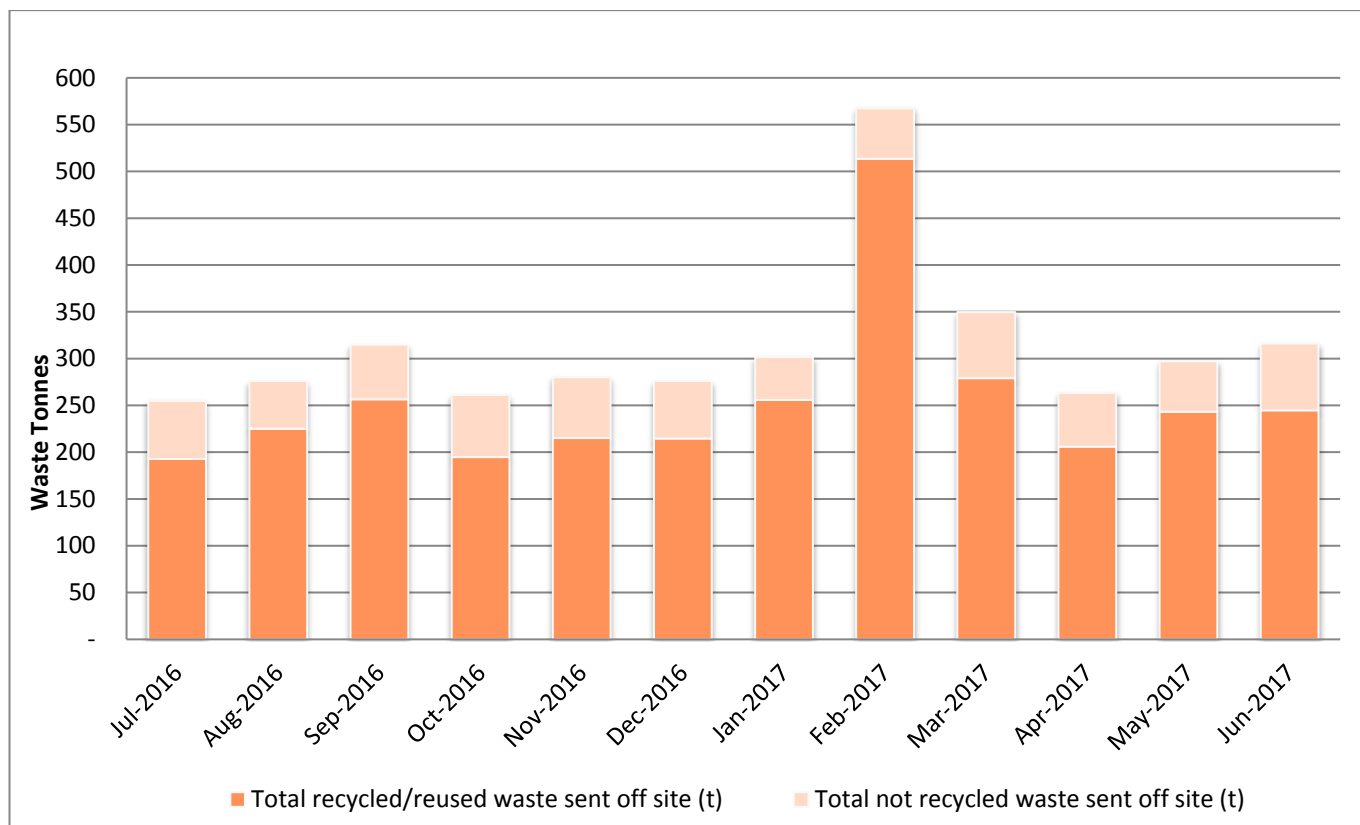
During the reporting period Mt Arthur Coal's activities generated approximately 3,758 tonnes of waste sent off site for management, which was approximately a 13 per cent increase on the previous financial year's result of 3,328 tonnes. Approximately 88.3 per cent of the total waste produced and sent off site for management was recycled, as shown in Figure 4. This is a slightly higher result when compared with results from FY16 (86 per cent).

Figure 4: Waste disposal from Mt Arthur Coal

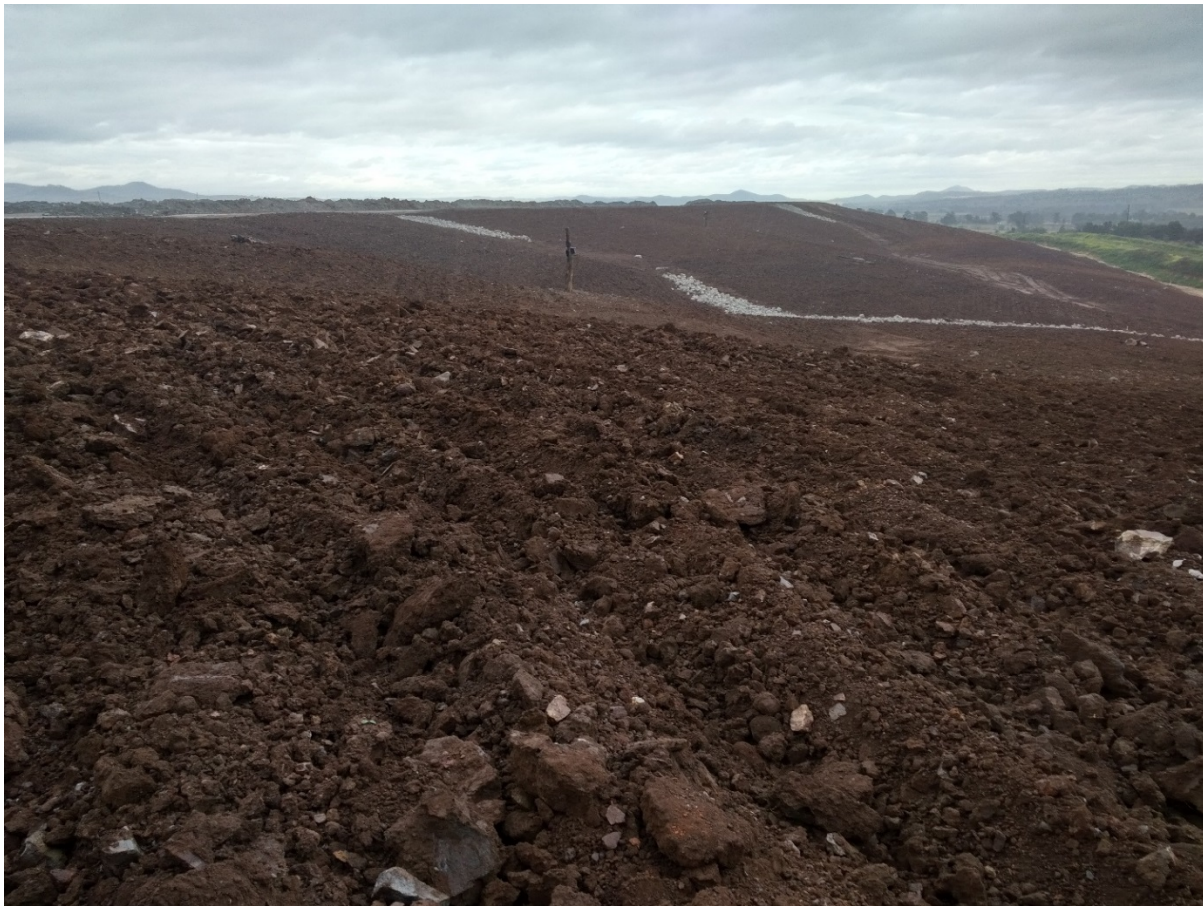
Figure 7: Newly seeded rehabilitation at Macleans emplacement using natural landform design

Topsoil was placed and spread to an approximate depth of 200 to 300 millimetres on rehabilitation areas. The newly spread topsoil surface was contour cultivated prior to sowing to provide a suitable environment that encourages water infiltration in the soil. Large rocks were removed from the ripped soil surface prior to sowing.

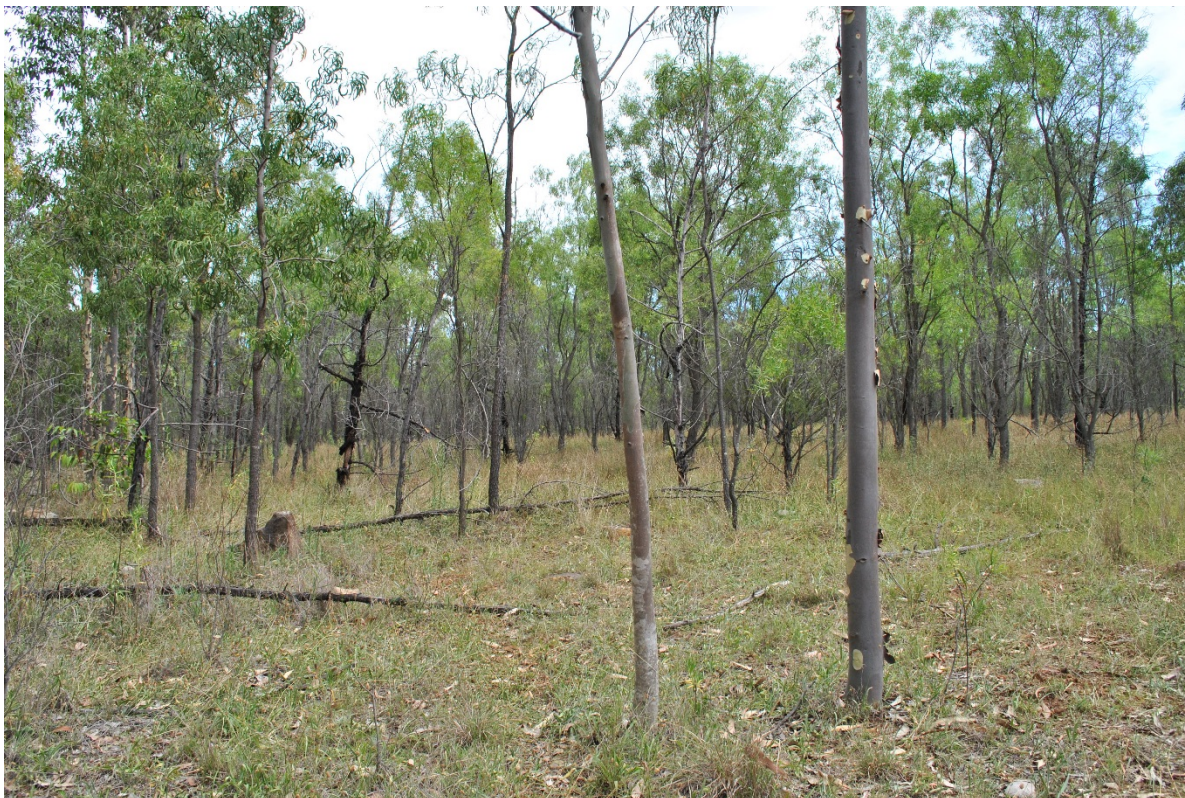
Figure 8: Open native woodland rehabilitation at McDonalds Pit which was rehabilitated in 2003

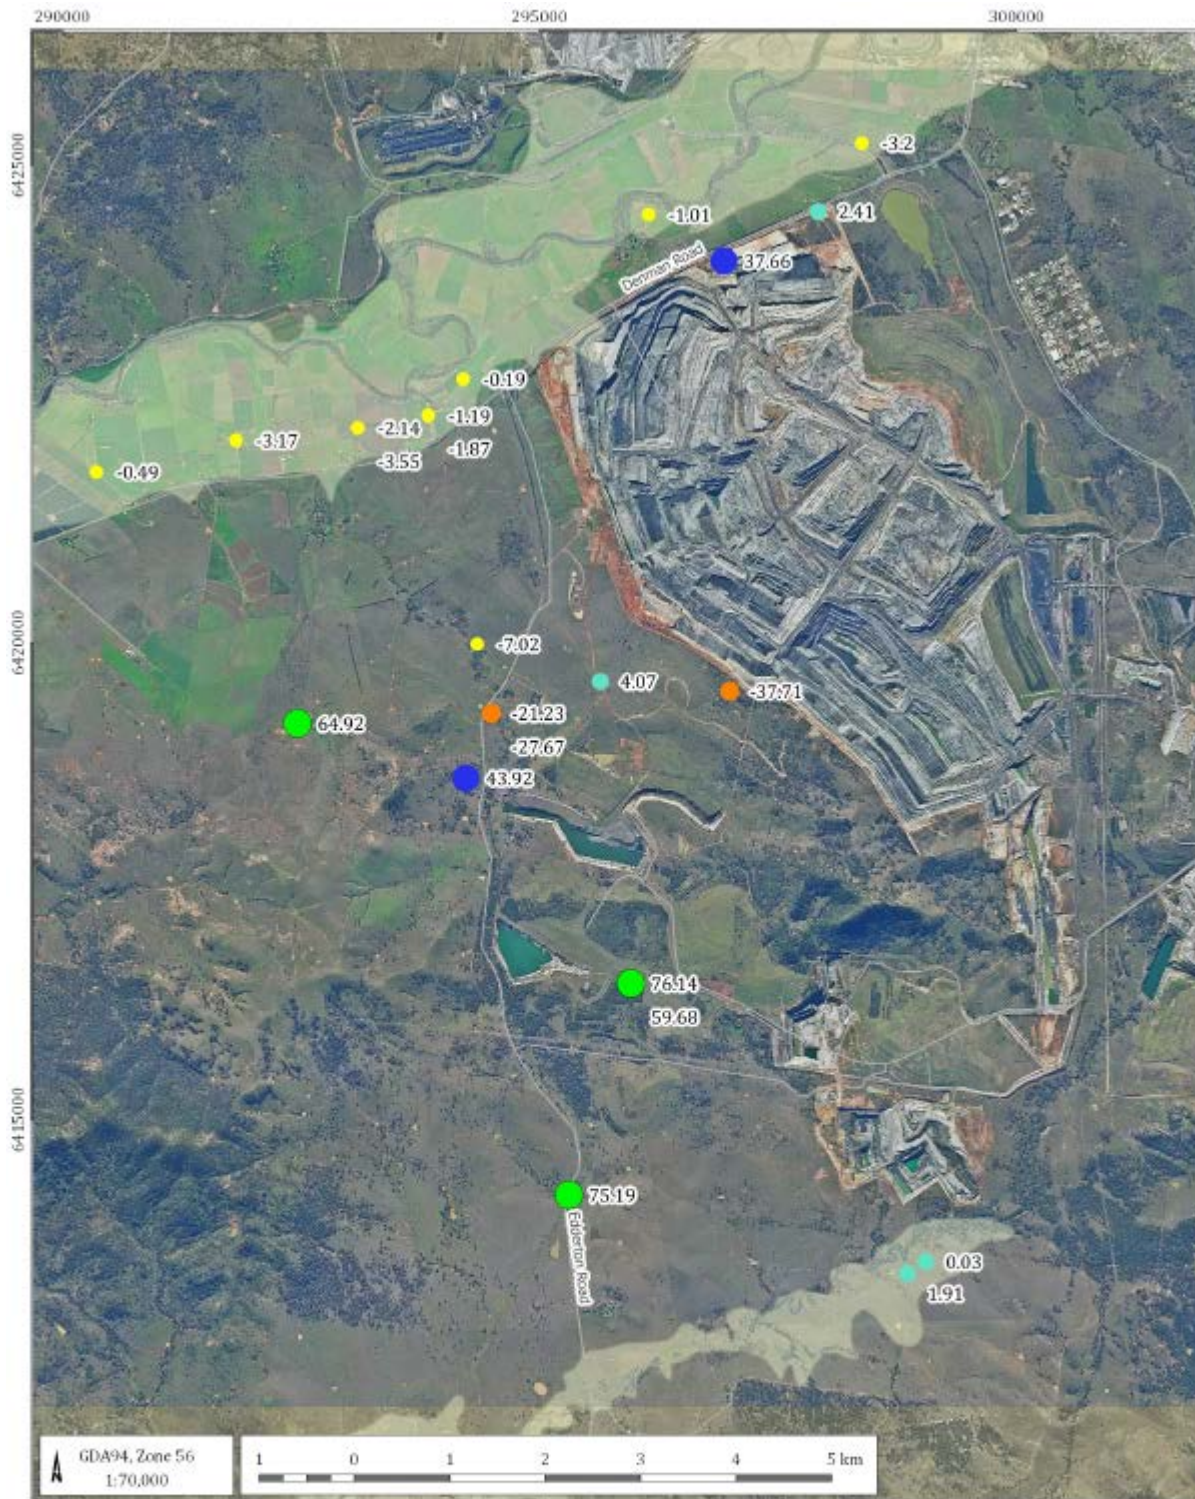
FIGURE No
3.2

2017 modelled versus measured heads (m)

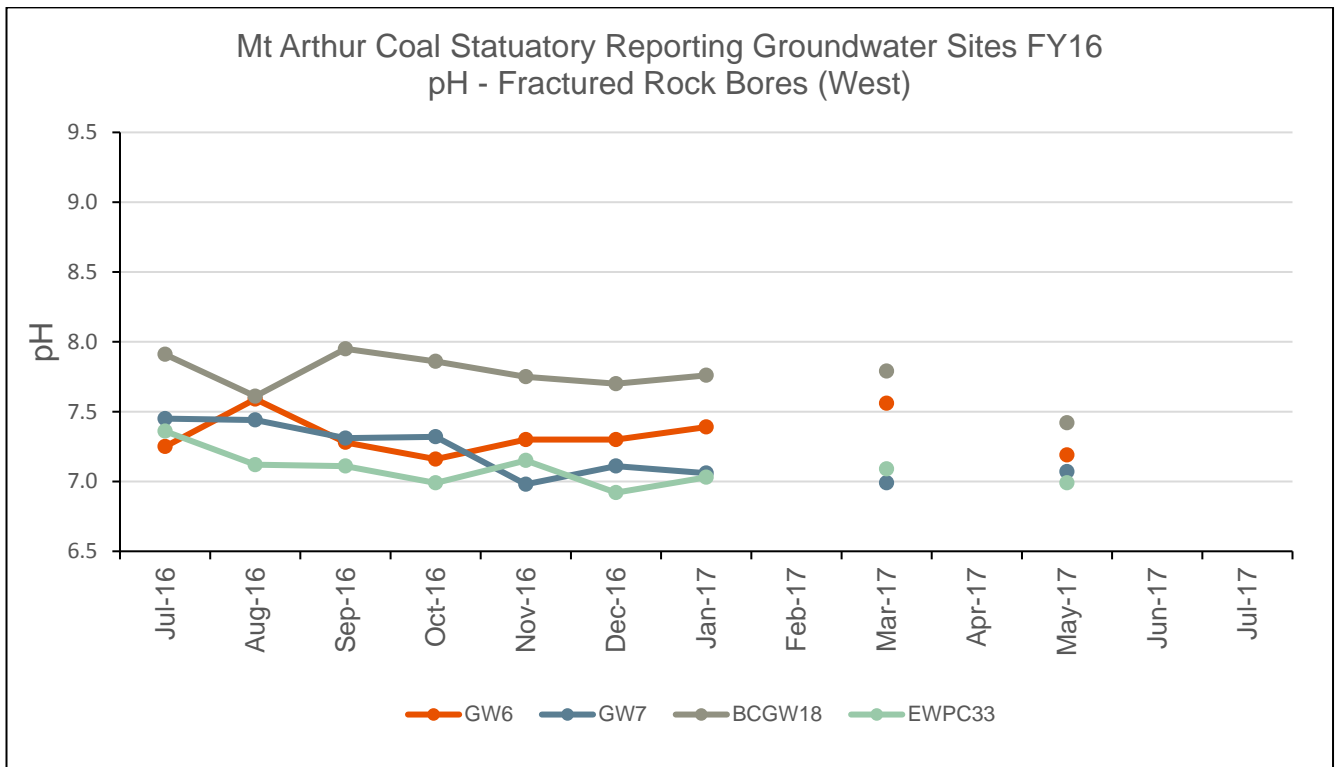
Groundwater quality plots (pH)
