Cultural Heritage

## 15 Cultural Heritage

This section addresses non-indigenous cultural heritage issues in relation to the project and is summarised from the Non-Indigenous Cultural Heritage Survey of Caval Ridge, Central Queensland (Archaeo 2008). The non-indigenous cultural heritage survey was conducted under permitting arrangements with the EPA (EPA permit number CHST00240207).

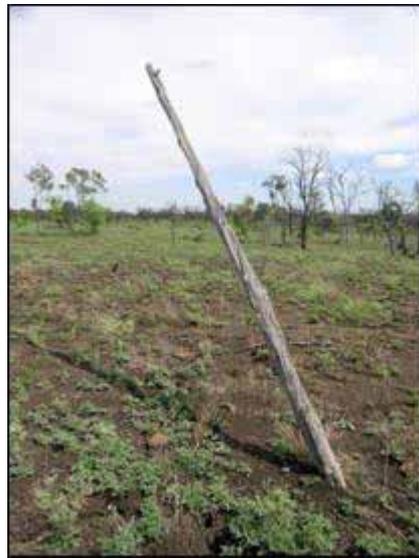
**Figure 15.2 North View - Telegraph post**

An old telegraph line is located approximately 500 m south of the Peak Downs Highway, in the centre of the project site (Figure 15.1). The remains of the telegraph line are shown in Figure 15.2. The line of timber posts extends for at least 1.5 km in a north-east to south-west alignment. There are at least 15 thin timber posts, positioned approximately 100 m apart, each with a ceramic conductor attached. Most of the posts are on a fairly steep inclination (approximately 45°) with some having completely collapsed. Otherwise, all are in relatively good condition. Original telegraph wire was only sited on one telegraph post.

The telegraph line is located outside the projects area of disturbance and will not be impacted by the project.

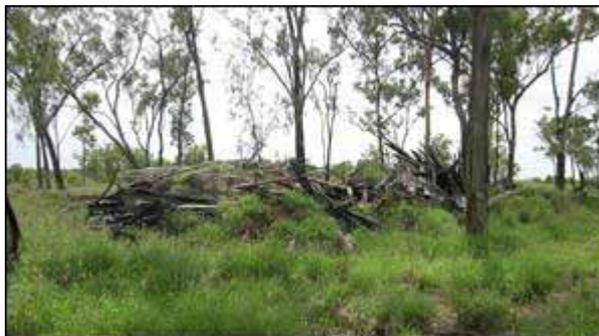
**Figure 15.3 South east view - Piles of sawn timber.**

Saw mill remnants consisting of three piles of sawn timber are located in the central / southern section of the project site (Figure 15.1), the remains of the saw mill are shown in Figure 15.3. These are the only remnants of a saw mill that apparently once existed in the area. Leaseholder consultation indicates this small mill was built during the 1970s by a local landowner in response to the large amount of timber being cleared in preparation for the Peak Downs mining operation. Immediately east of the piles of sawn timber are stock piles of lumber.

The saw mill remnants are located outside the project's area of disturbance will not be impacted by the project. If required, back access roads will be aligned so that they do not disturb the site.

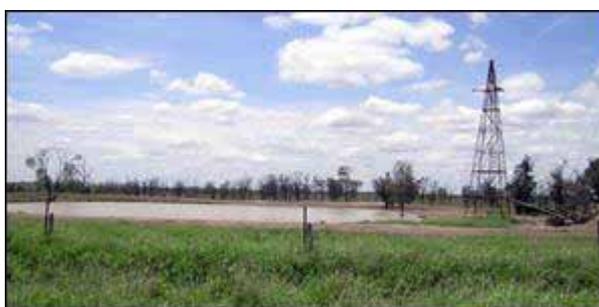
**Figure 15.4 South-east view - Damaged windmill and one of two nearby dams.**

Two dams and a water pumping windmill are located on the north western boundary of the project (Figure 15.1), the remains of the dams and windmill are shown in Figure 15.4. The windmill is damaged with the rotating blades lying on the ground at the base of the steel lattice tower. Evidence of the water pipeline used to feed the water from the dam can be seen emerging from one of the dam walls.

The two dams and a water pumping windmill are located outside the project's area of disturbance and will not be impacted by the project.

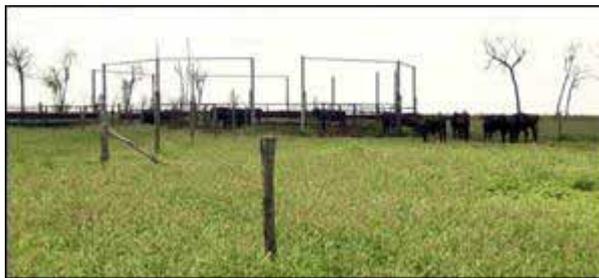
**Figure 15.5 Southern view - Timber and steel cattle yards and trough.**

Timber and steel cattle yards, trough and timber fence lines are located in the northern section of the project site (Figure 15.1). The site is shown in Figure 15.5. The yards are the central structure at this location with a number of timber fence lines extending out from the yards. With gates in working order and cattle in and around this site, it is apparent the yards are still in use. This site is in good condition.

The cattle trough, yards and fence lines are within the Horse Pit area of disturbance, this site will be removed during the clearing activities. This site does not contain suitable levels of cultural heritage significance to warrant specific mitigation strategies and should be decommissioned in the same manner as similar sites within the project site.
