# SARAJI EAST MINING LEASE PROJECT

Environmental Impact Statement

## Chapter 7 Aquatic Ecology

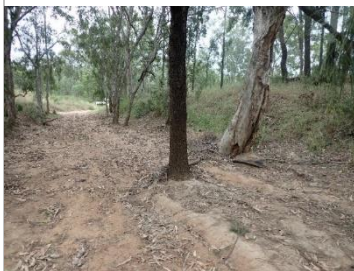
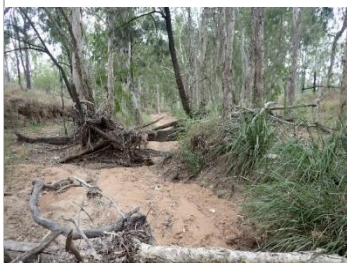
| Site | Feature | Upstream/Downstream |
|---|---|---|
| <b>BCO2</b><br><b>Late-wet</b> | <p><b>Watercourse:</b> Boomerang Creek</p> <p><b>Local landuse:</b> native bushland with cleared areas</p> <p><b>Bed erosion and sedimentation:</b> scours at constrictions and where grades steepen, some sand deposits, bed packed but not armoured</p> <p><b>Banks:</b> convex banks 10 m with low-moderate side slopes (10-60°). Banks moderately stable with small and infrequent areas of erosion, mostly healed. Bank cover &gt;80%</p> <p><b>Bed substrate:</b> predominately sand with silt/clay present</p> <p><b>Macrohabitat:</b> completely dry</p> <p><b>Microhabitat:</b> LWD, SWD, detritus, macrophytes</p> <p><b>Riparian vegetation:</b> semi-contiguous cover of mature trees, grasses dominate understorey with shrubbery and some bare areas present</p> <p><b>Habitat bioassessment score:</b> 69, good condition</p> | <p>Upstream:</p> <p>Downstream:</p> |

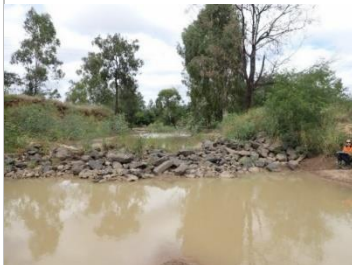
| Site | Feature | Upstream/Downstream |
|---|---|---|
| HCO2<br>Late-wet | <p><b>Watercourse:</b> Hughes Creek</p> <p><b>Local landuse:</b> highly cleared, road crossing</p> <p><b>Bed erosion and sedimentation:</b> scours at constrictions and bends, thin surface clay deposits in pools. Channelisation at old road crossing.</p> <p><b>Banks:</b> left bank flat (&lt;10° slope) and convex. Right bank shows fresh erosion and sign of bank collapse, currently has vertical slopes (80-90°) banks with wide lower bench. Both banks 10 m wide, and are unstable, with raw areas along straight sections and bends. Bank cover 25-49%</p> <p><b>Bed substrate:</b> largely silt/clay with equal presence of gravel and sand</p> <p><b>Macrohabitat:</b> dry with series of sandy/silt pools</p> <p><b>Microhabitat:</b> SWD, detritus, periphyton, blanketing silt, undercut banks, macrophytes</p> | <p>Upstream:</p> |

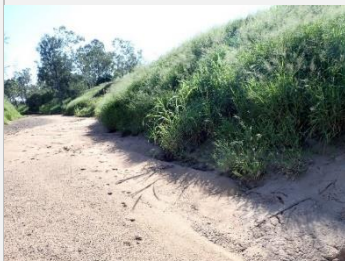
| Site | Feature | Upstream/Downstream |
|---|---|---|
| PCO2<br>Early-wet | <p><b>Watercourse:</b> Phillips Creek</p> <p><b>Local landuse:</b> riparian clearing for road crossing backed by native vegetation</p> <p><b>Bed erosion and sedimentation:</b> sand and silt deposits</p> <p><b>Banks:</b> 10 m wide convex banks, right bank moderately sloped 30-60°, left bank steeply sloped (60-80°), banks stable with no evidence of bank failure</p> <p><b>Bed substrate:</b> dominated by sand with equal cover from bedrock, cobble and silt/clay, low compaction. Bed sloped towards left bank to expose bedrock.</p> <p><b>Macrohabitat:</b> nearly entirely dry, very small highly turbid silty/sand pool remains</p> <p><b>Microhabitat:</b> LWD, SWD, detritus</p> <p><b>Riparian vegetation:</b> occasional clumps of mature trees present, understory of grasses and shrubs with some bare patches, exotic species present</p> <p><b>Habitat bioassessment score:</b> 66, fair condition</p> | <p>Upstream:</p> <p>Downstream:</p> |
