REMEDIAL ACTION PLAN

Bayswater No. 2 Infrastructure, Mt Arthur Coal Complex,
Muswellbrook, NSW

14/05/2014

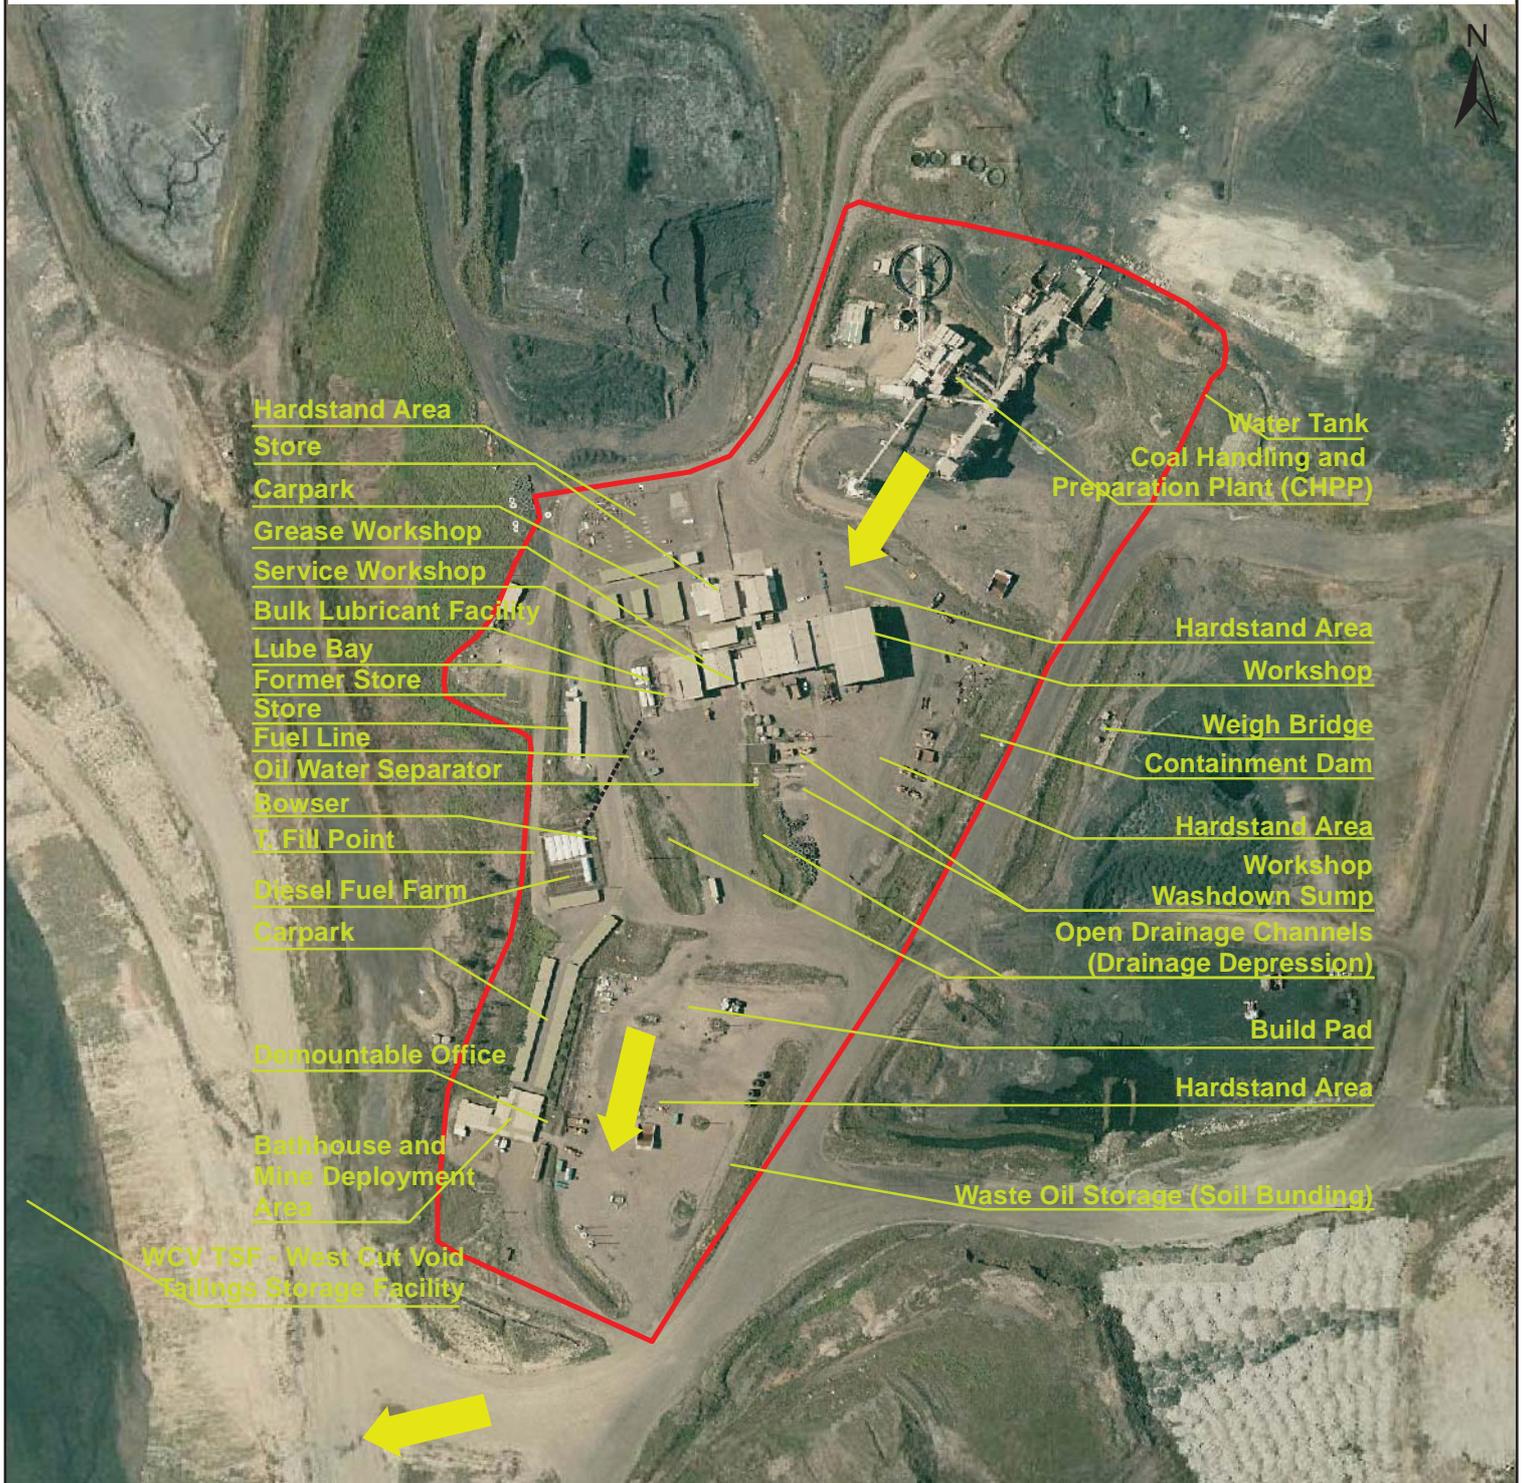
Background Aerial Photograph: SixViewer LPI NSW Government

The site layout is presented in Figure 2, **Appendix A**. Pertinent site details are summarised in Table 2.1 below:

The site comprised facilities to support open cut mining in the Bayswater No. 2 Area. Figure 2, Appendix A presents the infrastructure currently identified on site. Facilities and activities included:
