Mt Arthur Coal

Annual Environmental Management Review FY18

26 September 2018

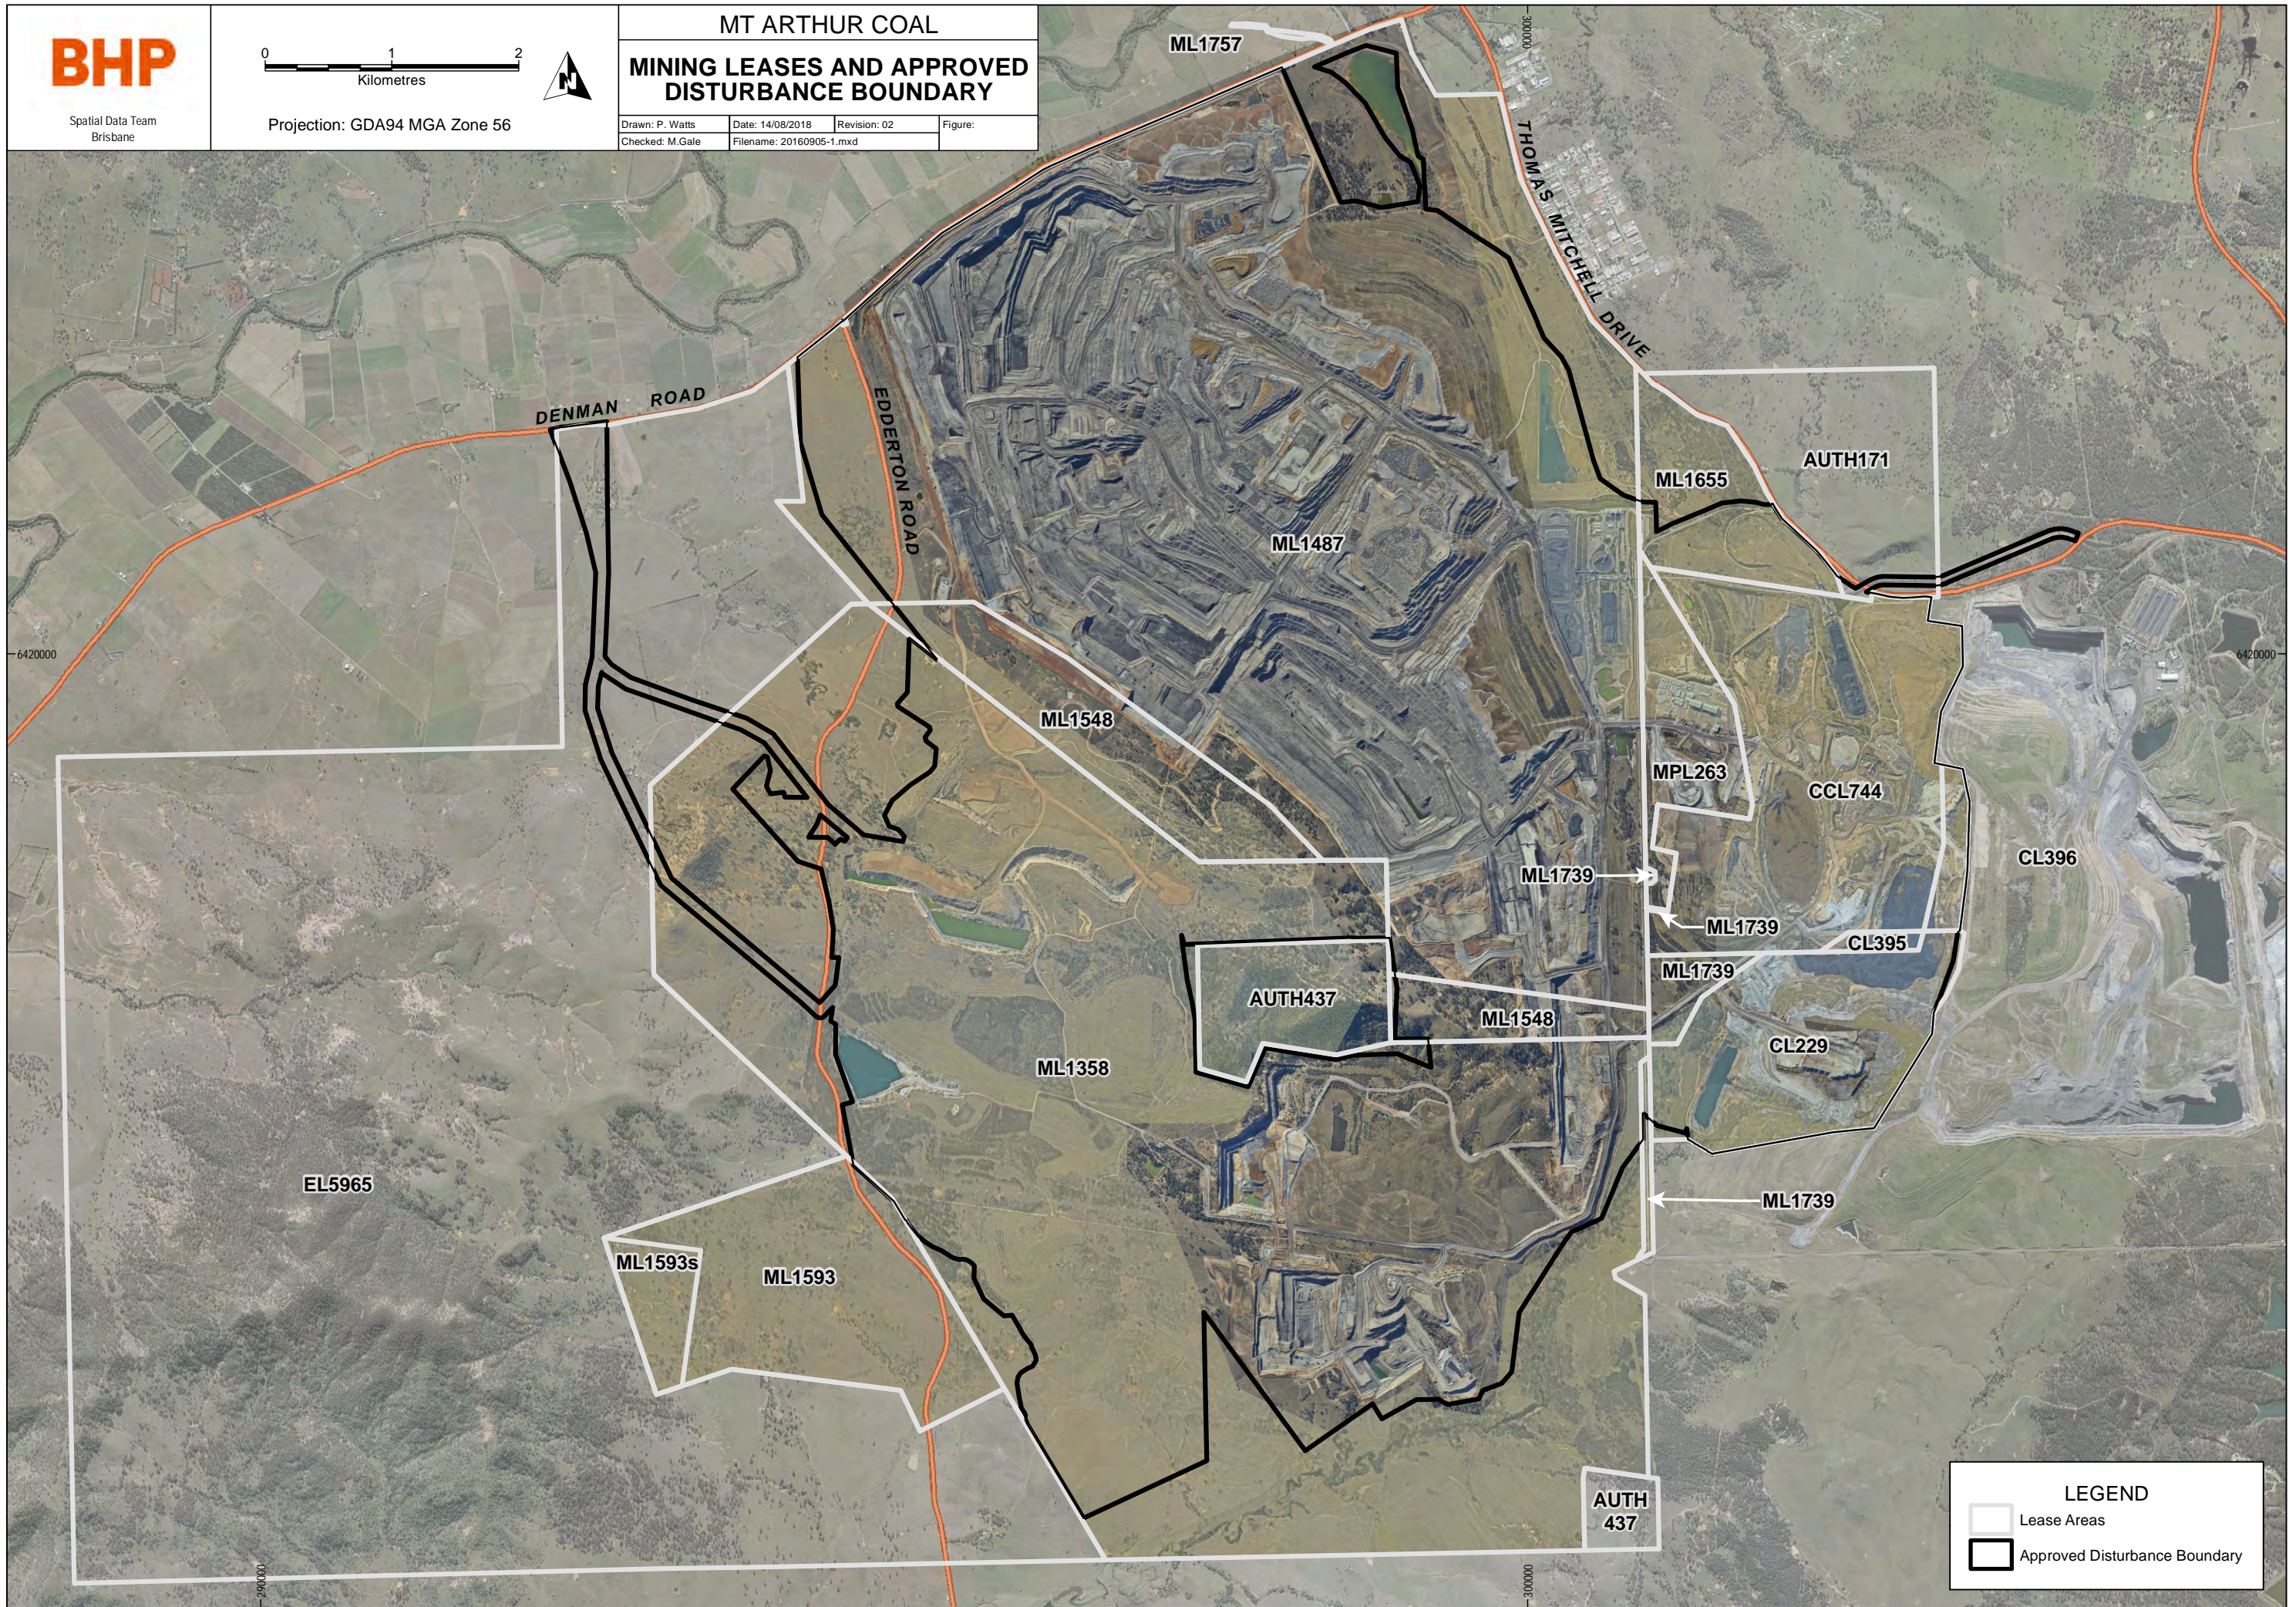
MINING LEASES AND APPROVED DISTURBANCE BOUNDARY

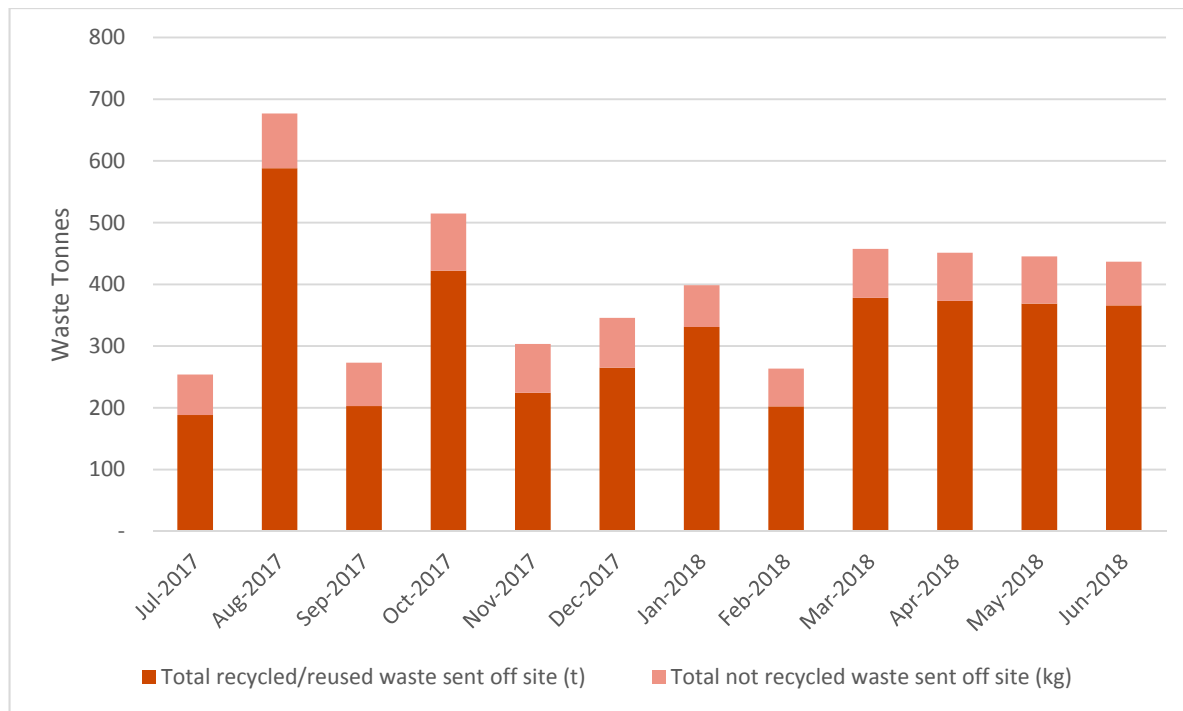
Figure 4: Waste disposal from Mt Arthur Coal

During the reporting period Mt Arthur Coal's activities, generated approximately 3,910 tonnes of waste sent off site for management, which was approximately a 4 per cent increase on the previous financial year's result of 3,758 tonnes. Approximately 81.1 per cent of the total waste produced and sent off site for management was recycled, as shown in Figure 4. This is a slightly lower result compared with FY17 (88.3 per cent).

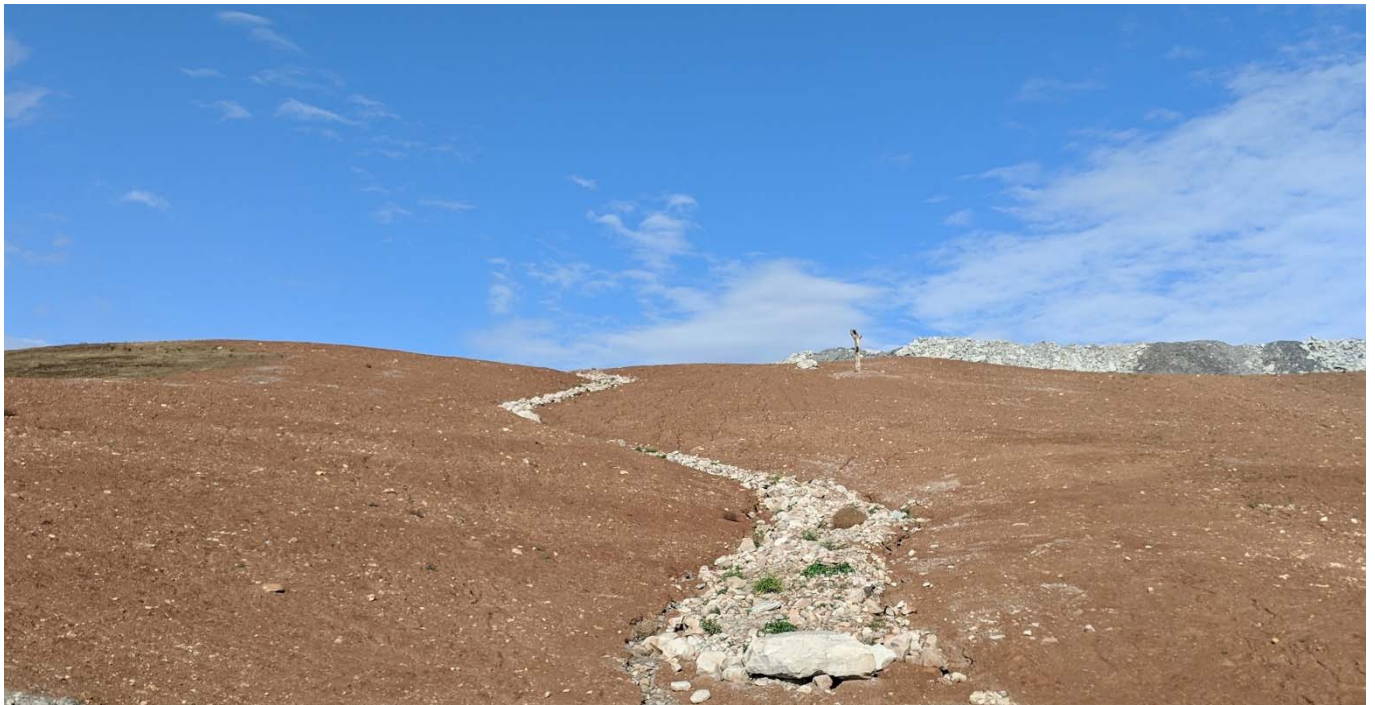
Figure 7: Rehabilitation at Macleans emplacement using natural landform design

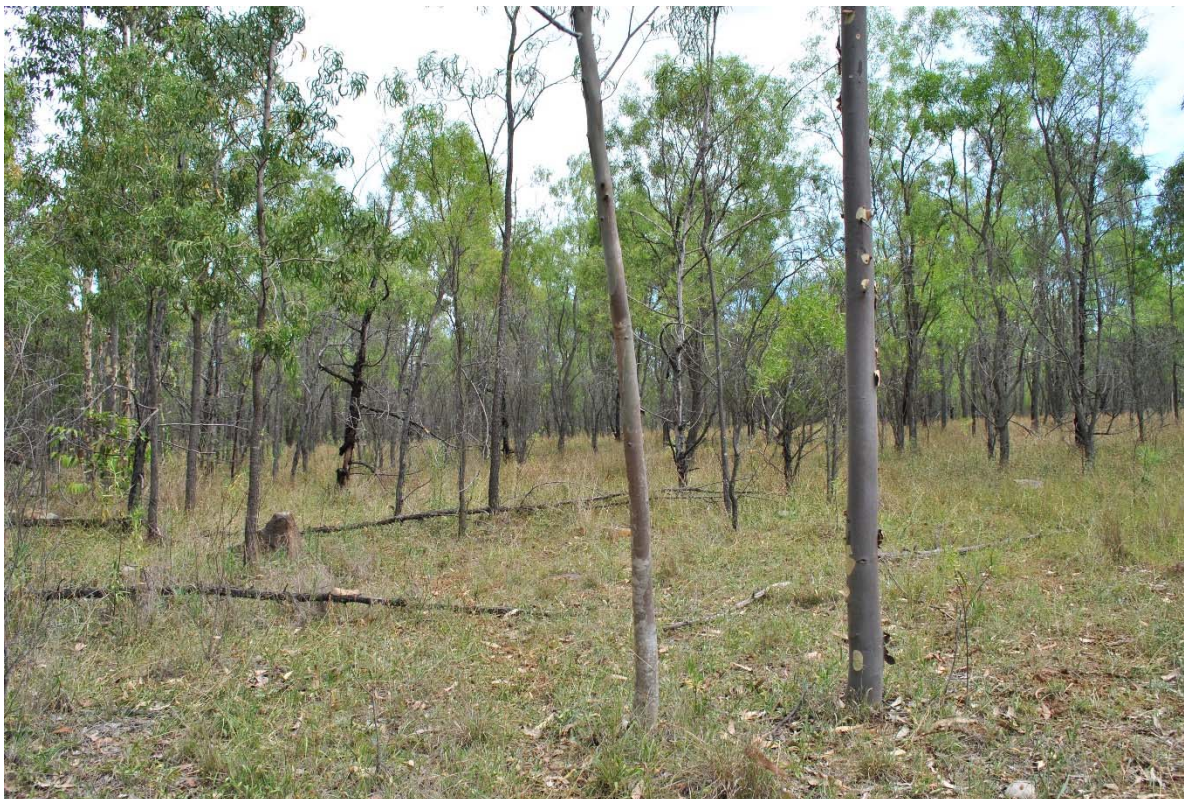
Figure 8: Open native woodland rehabilitation at McDonalds Pit which was rehabilitated in 2003

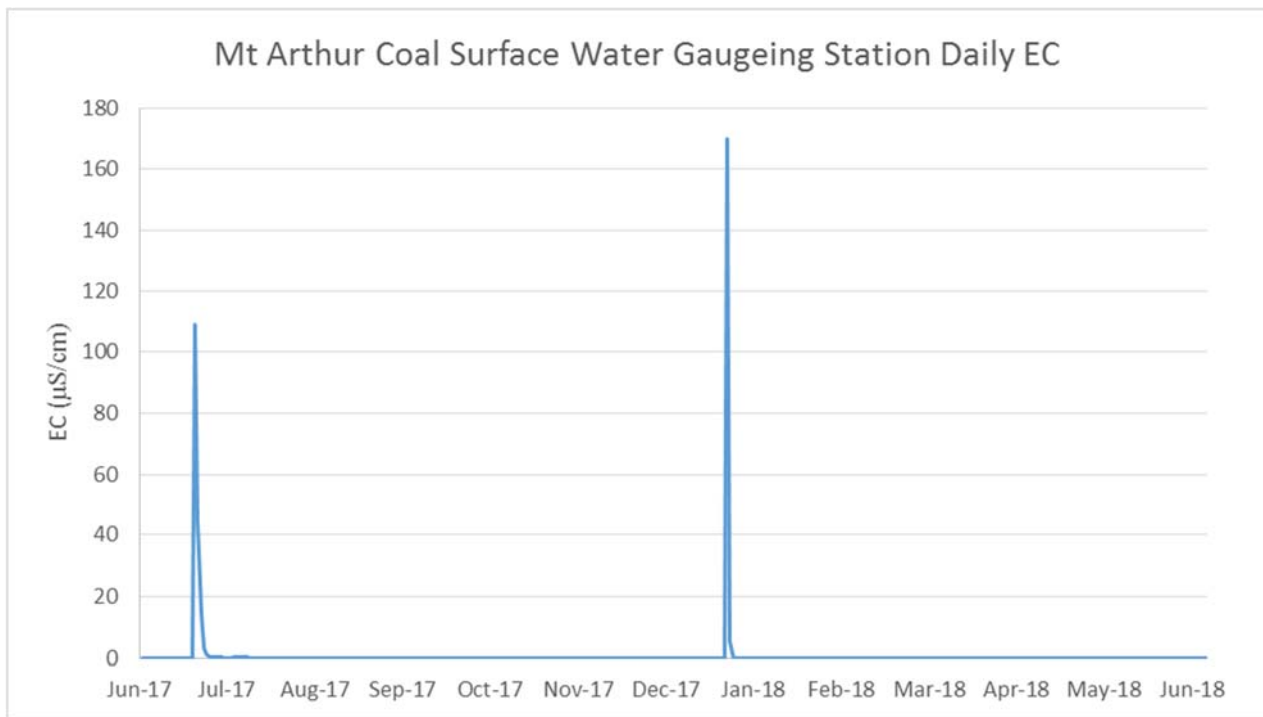
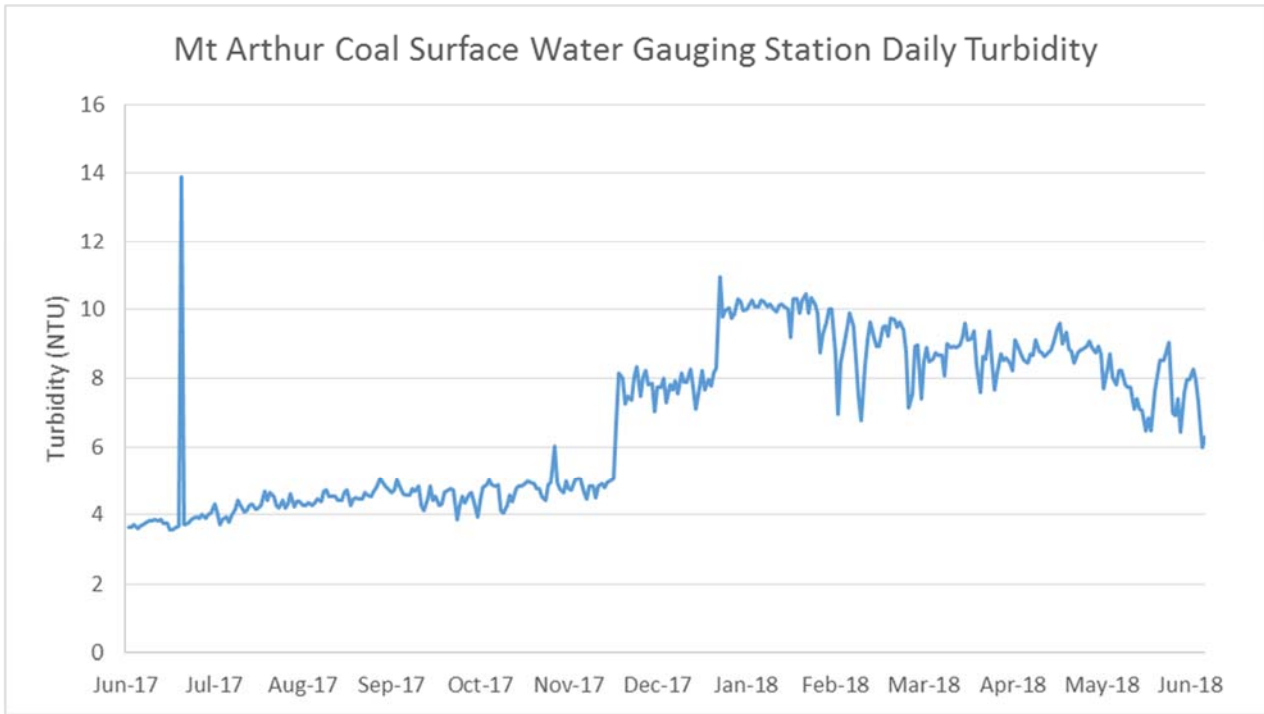
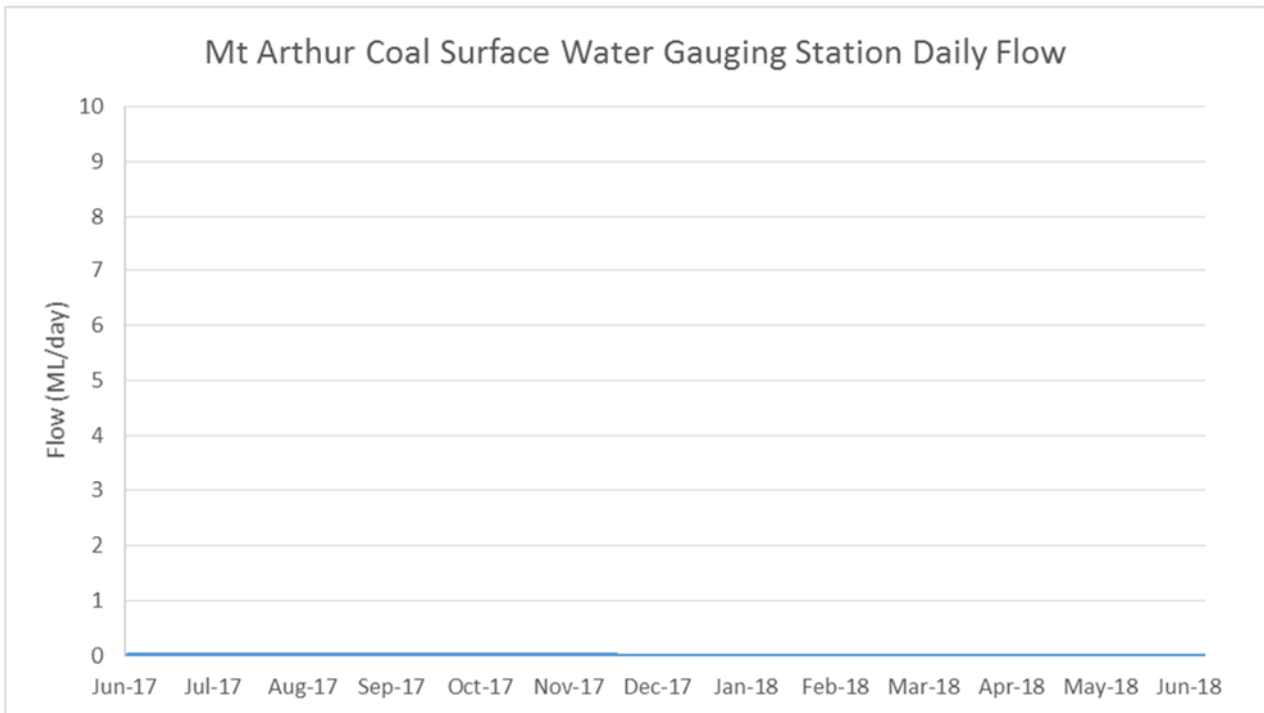
Saddlers Creek Surface Water Flow Plots

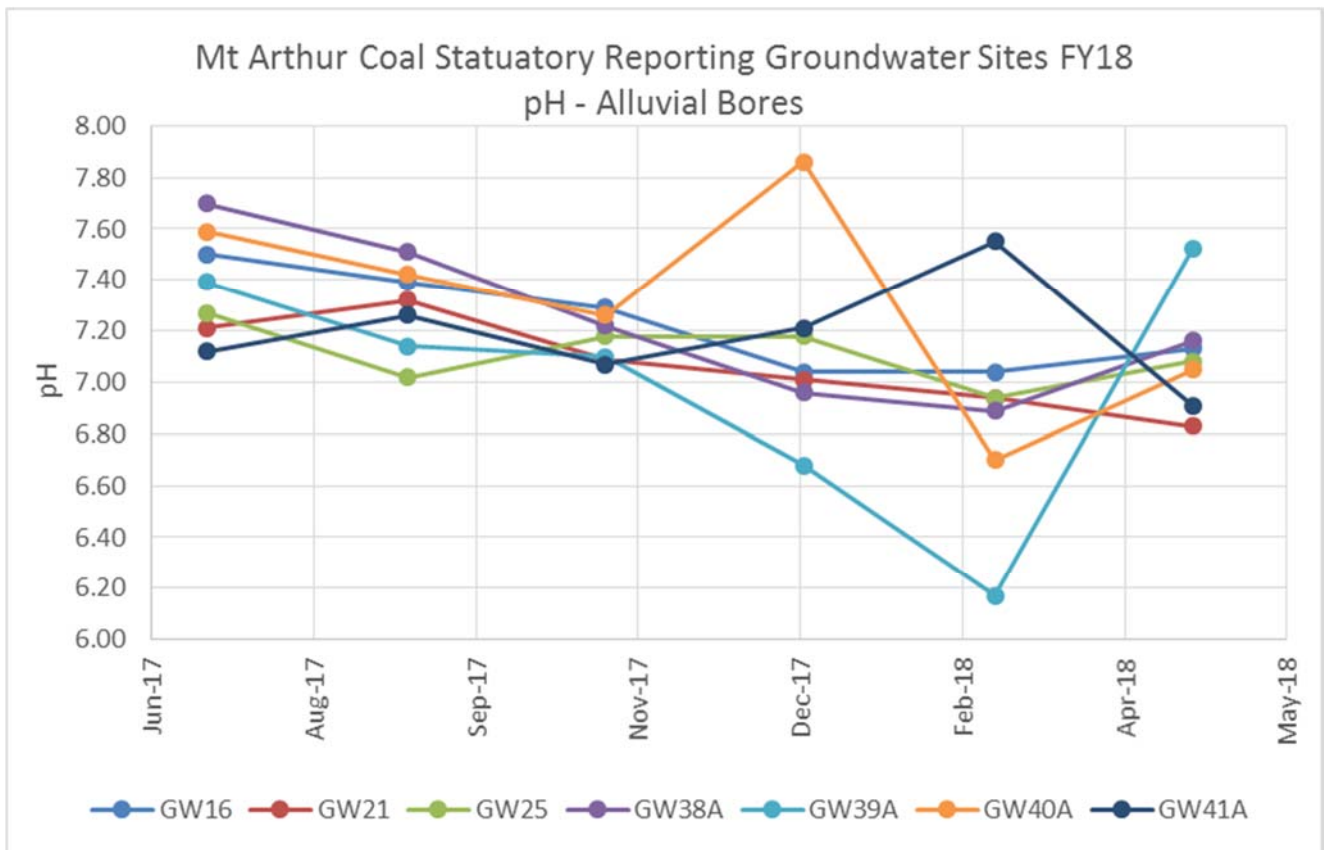
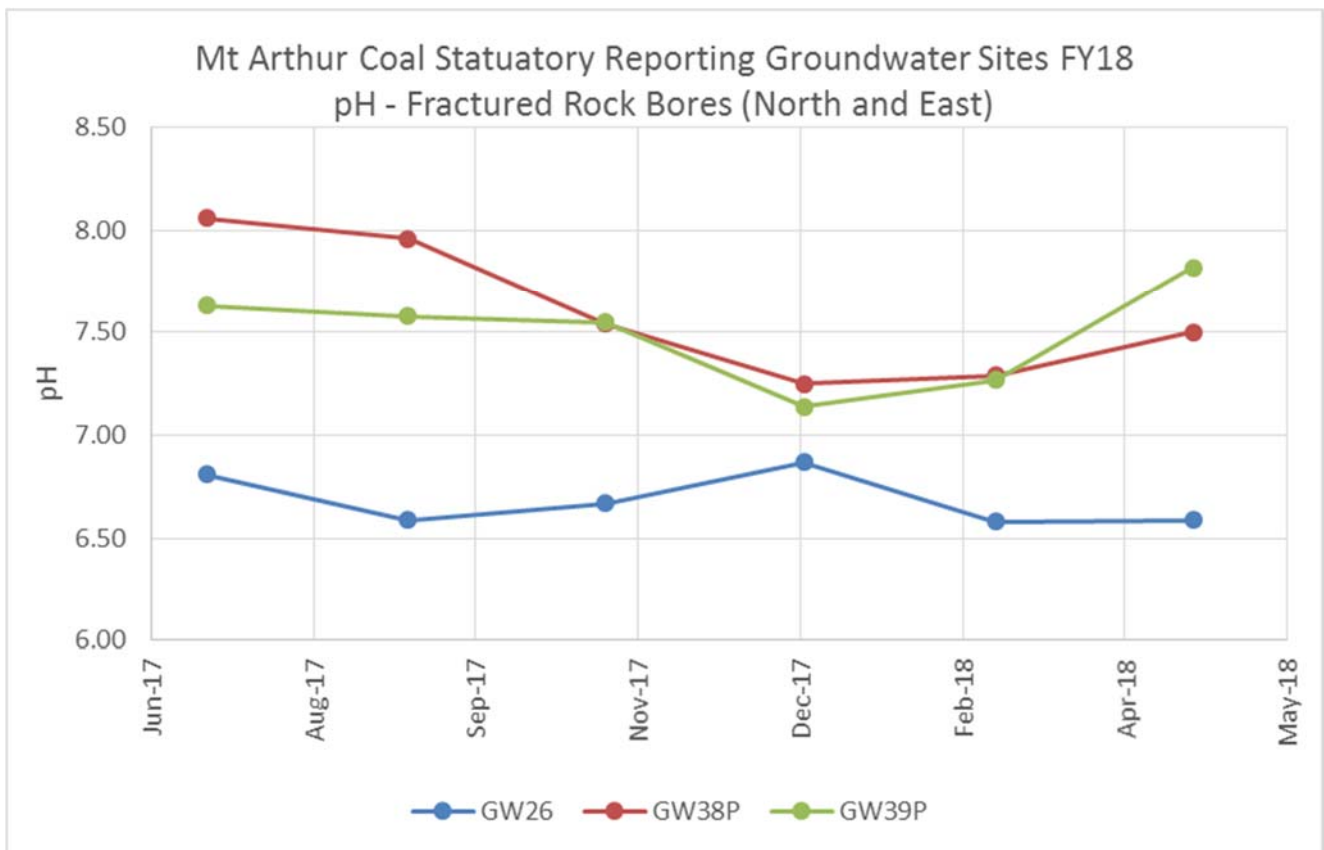
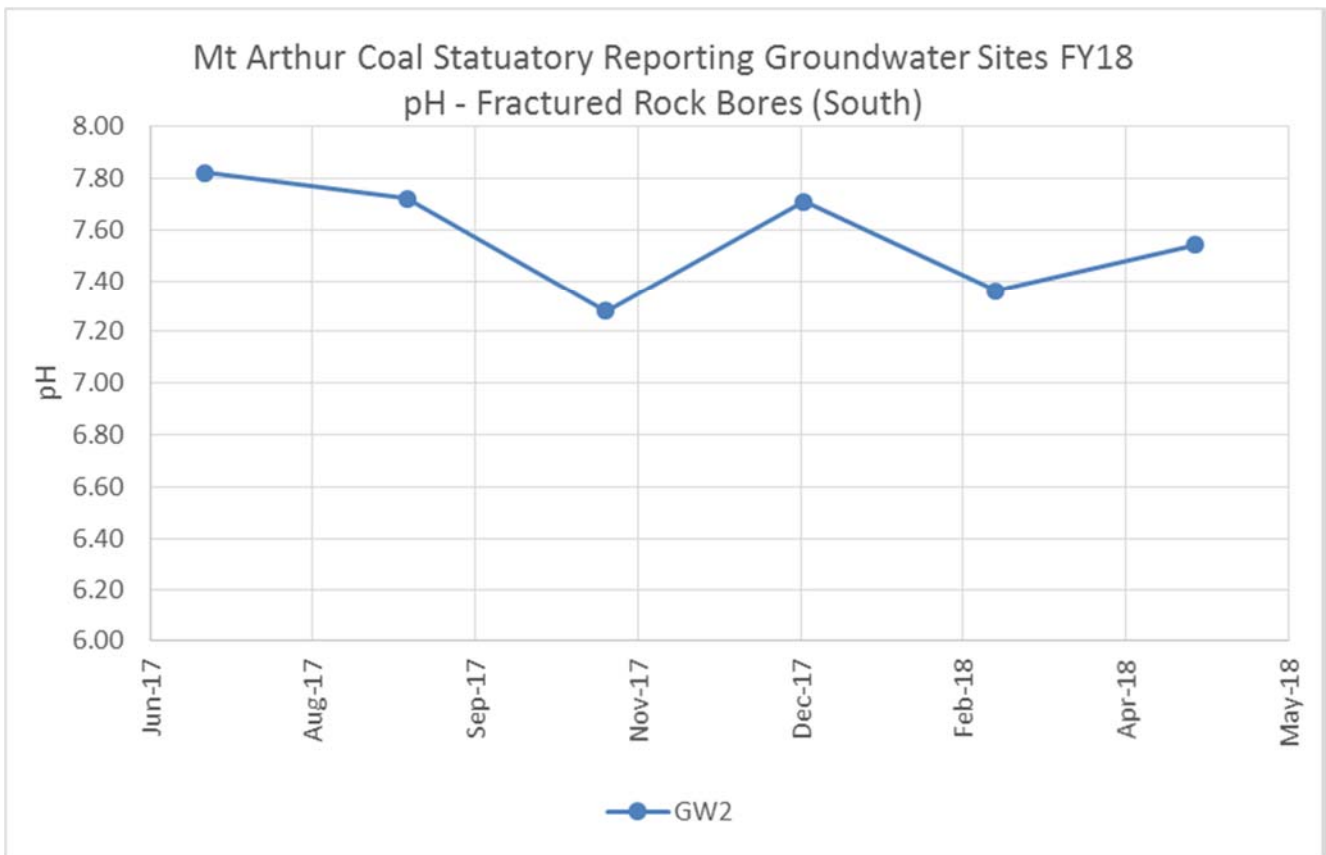
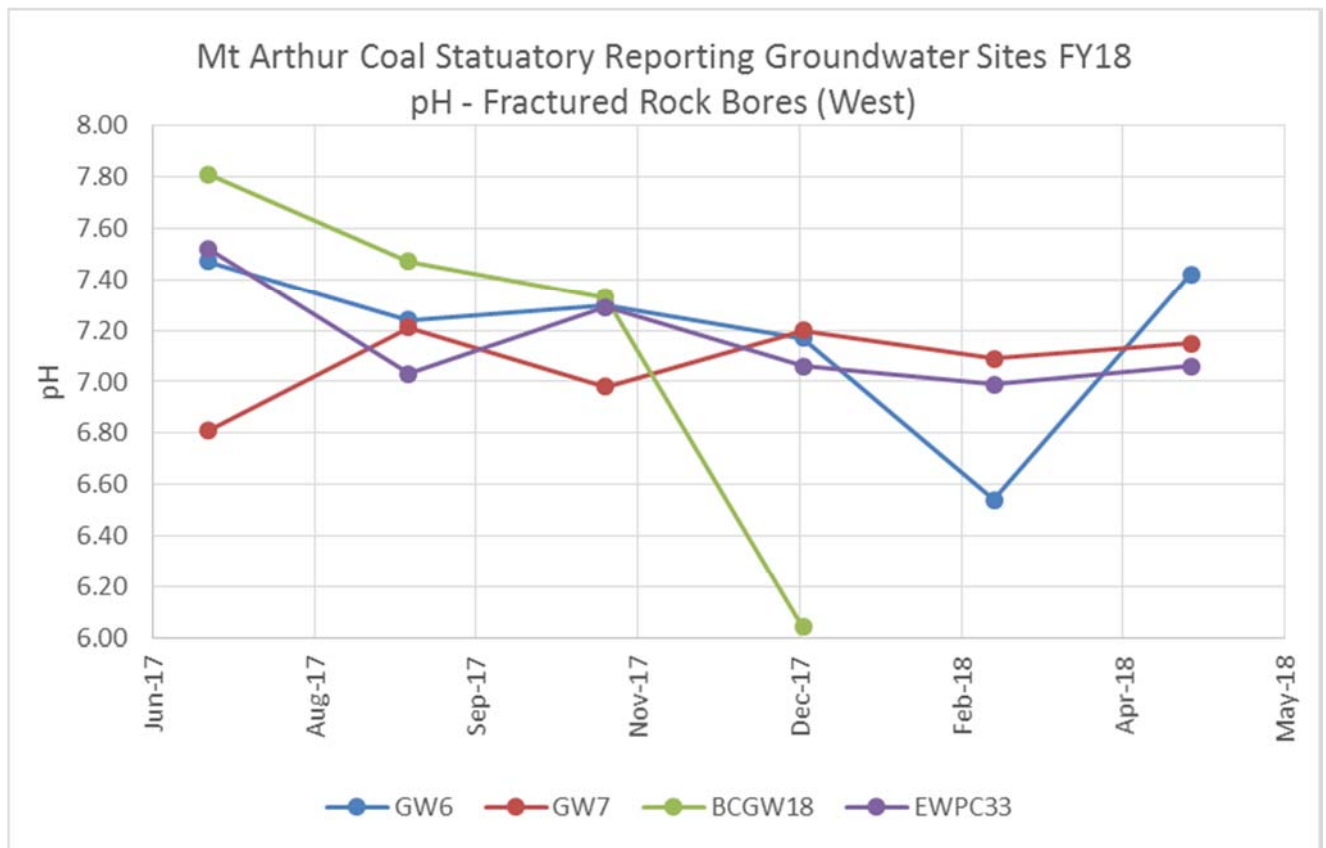
Groundwater quality plots (pH)

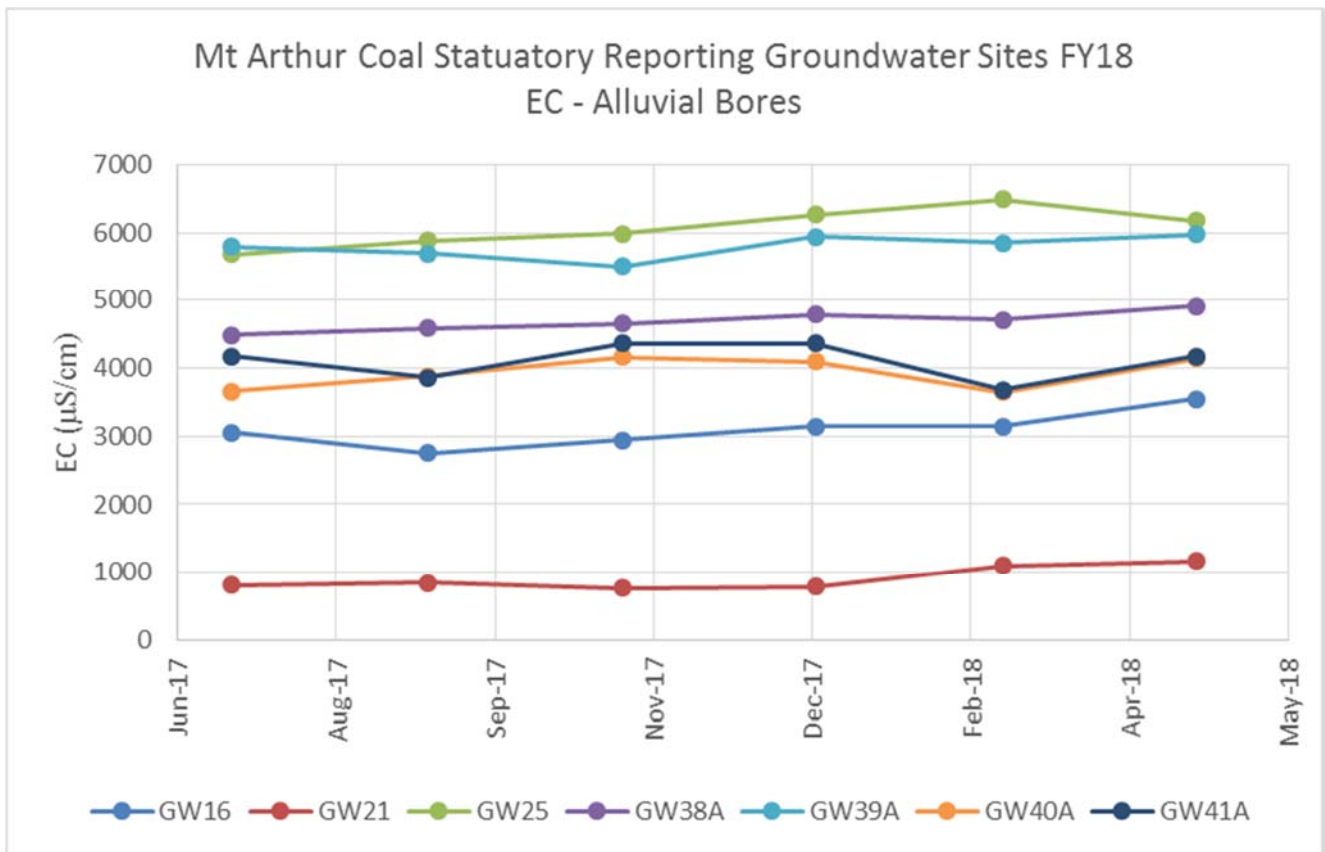
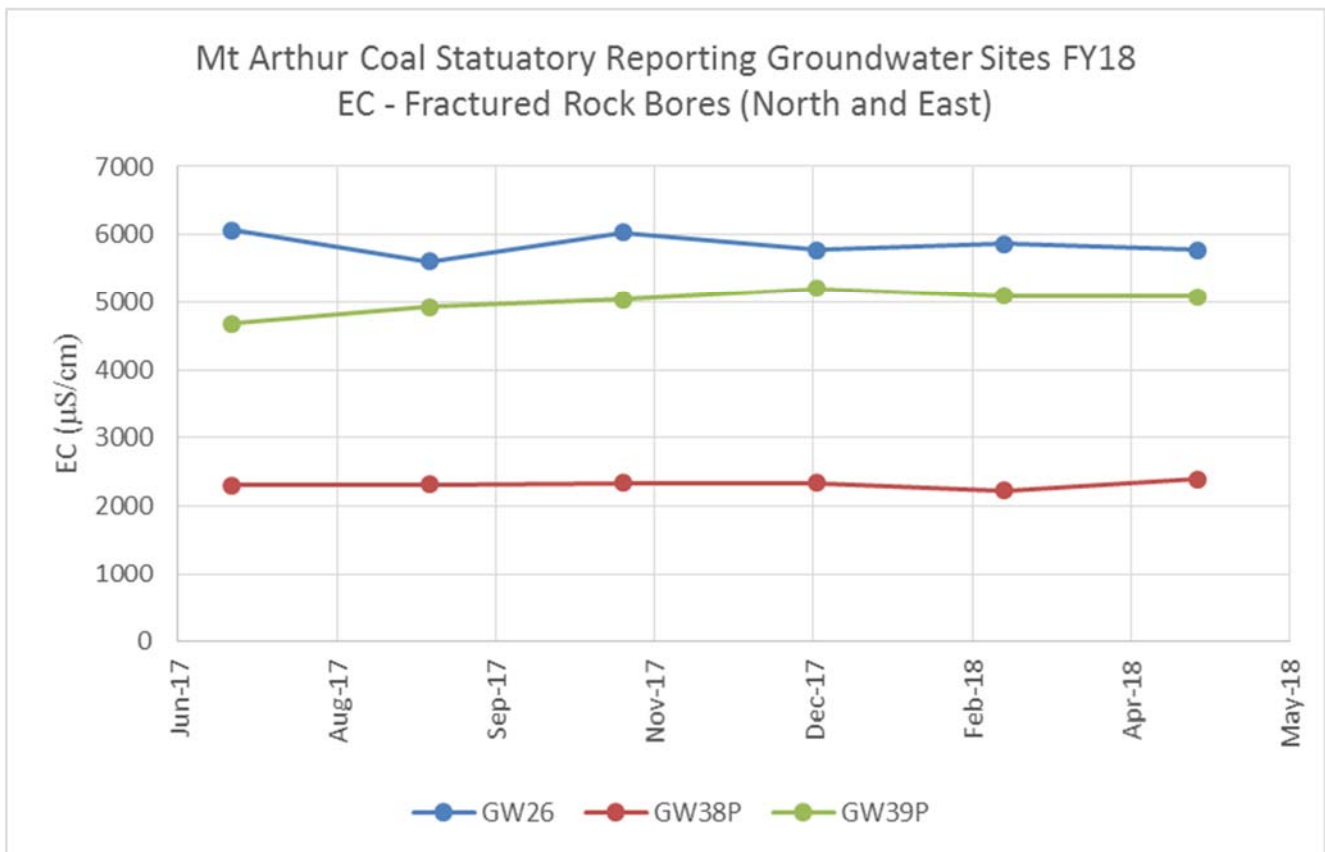
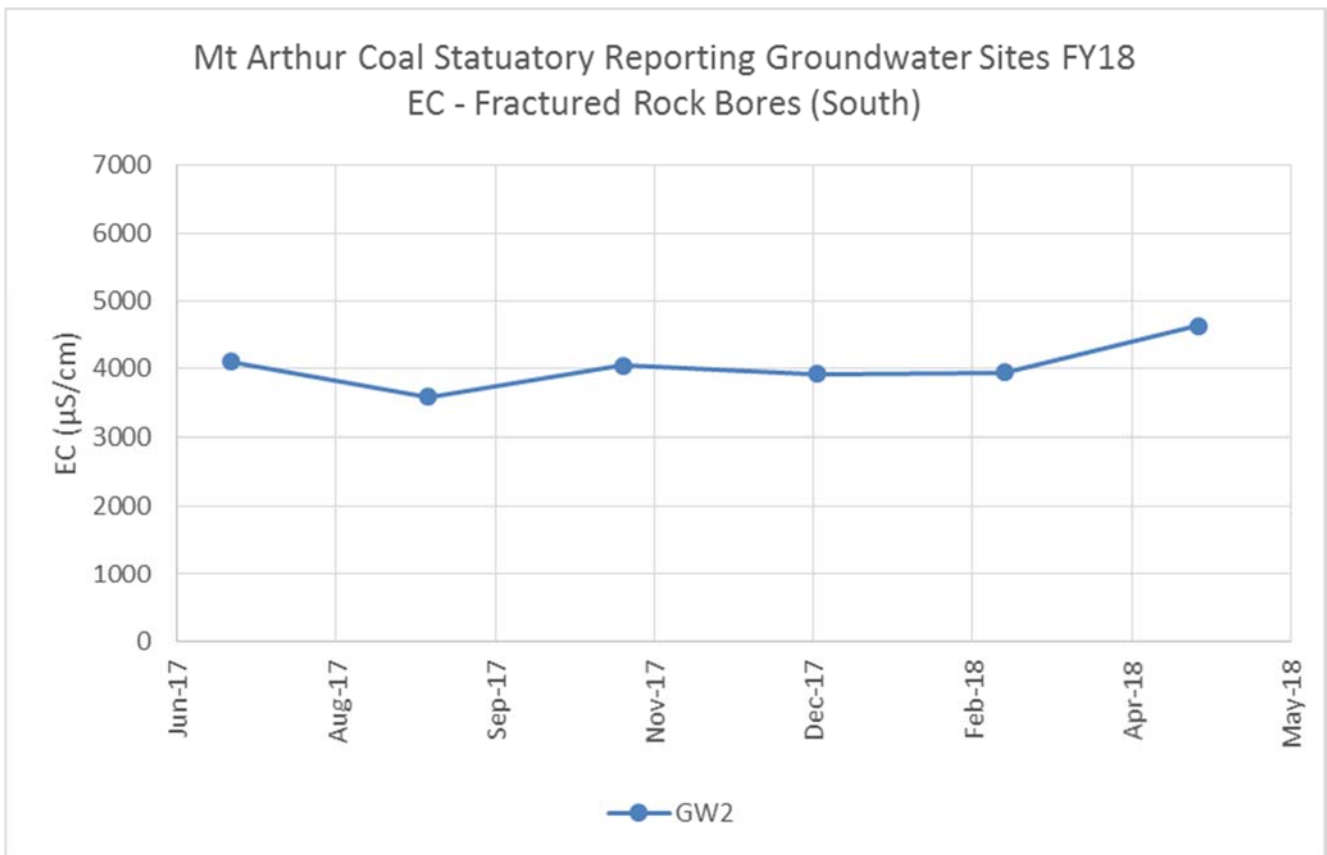
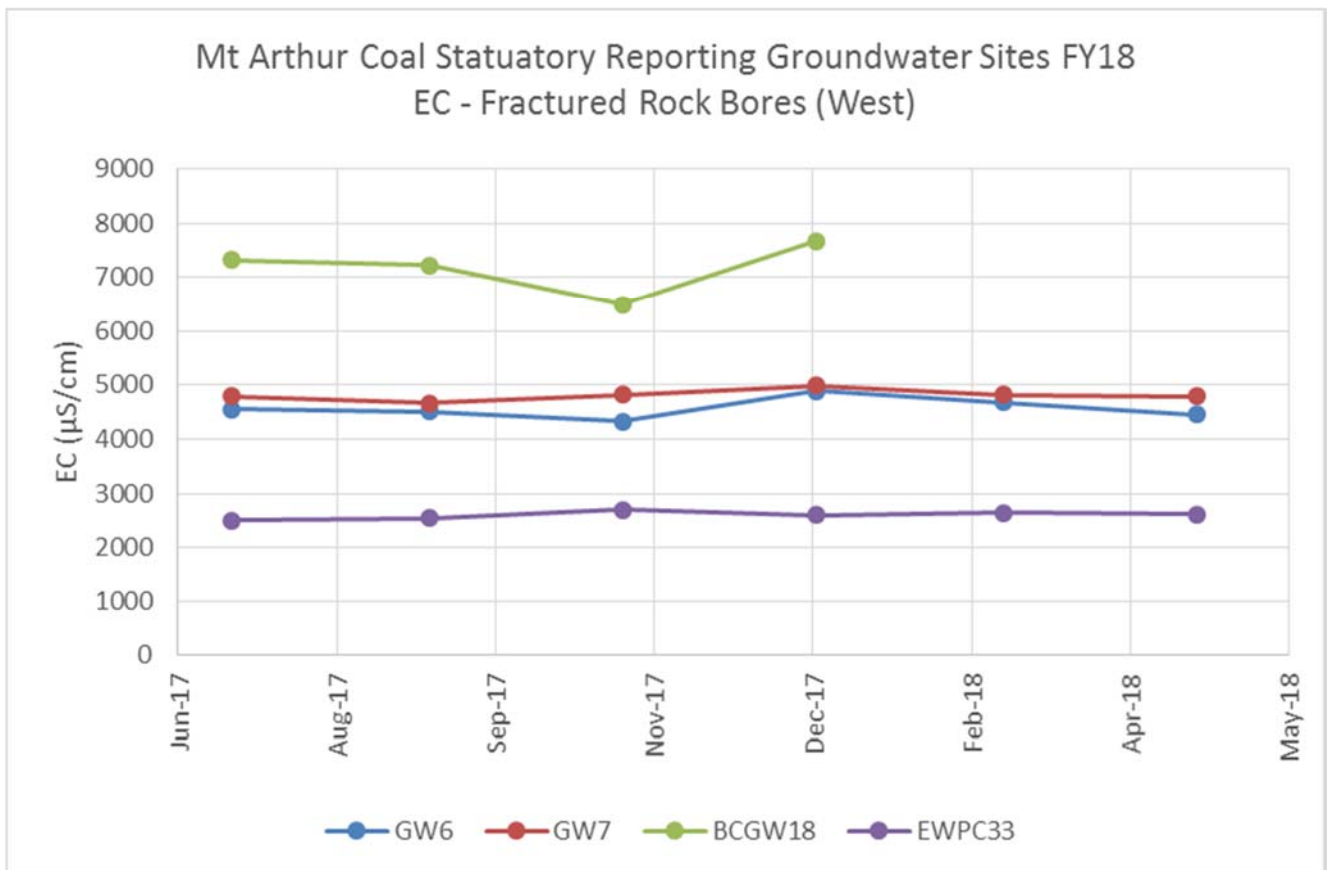
Groundwater quality plots (EC)
