# Mt Arthur Coal

Annual Review FY18

26 September 2018

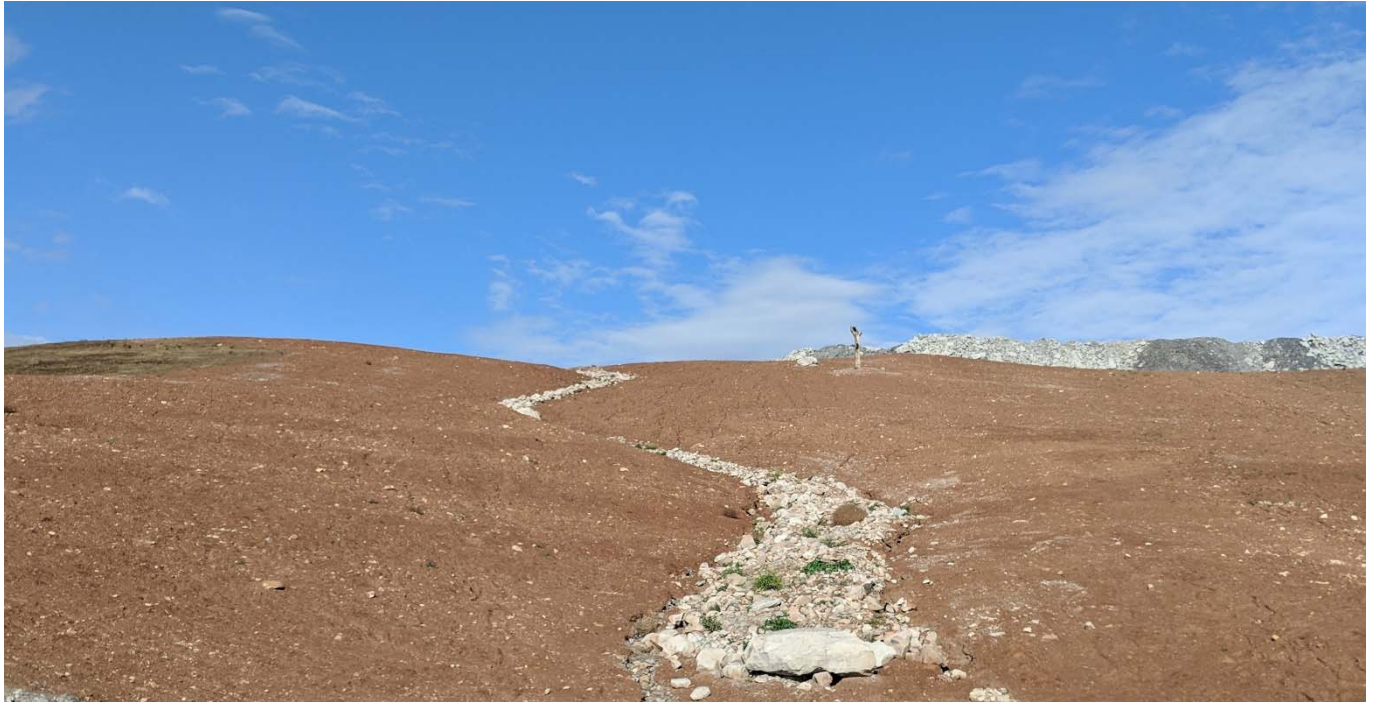
**Figure 8: Rehabilitation at Macleans emplacement using natural landform design**

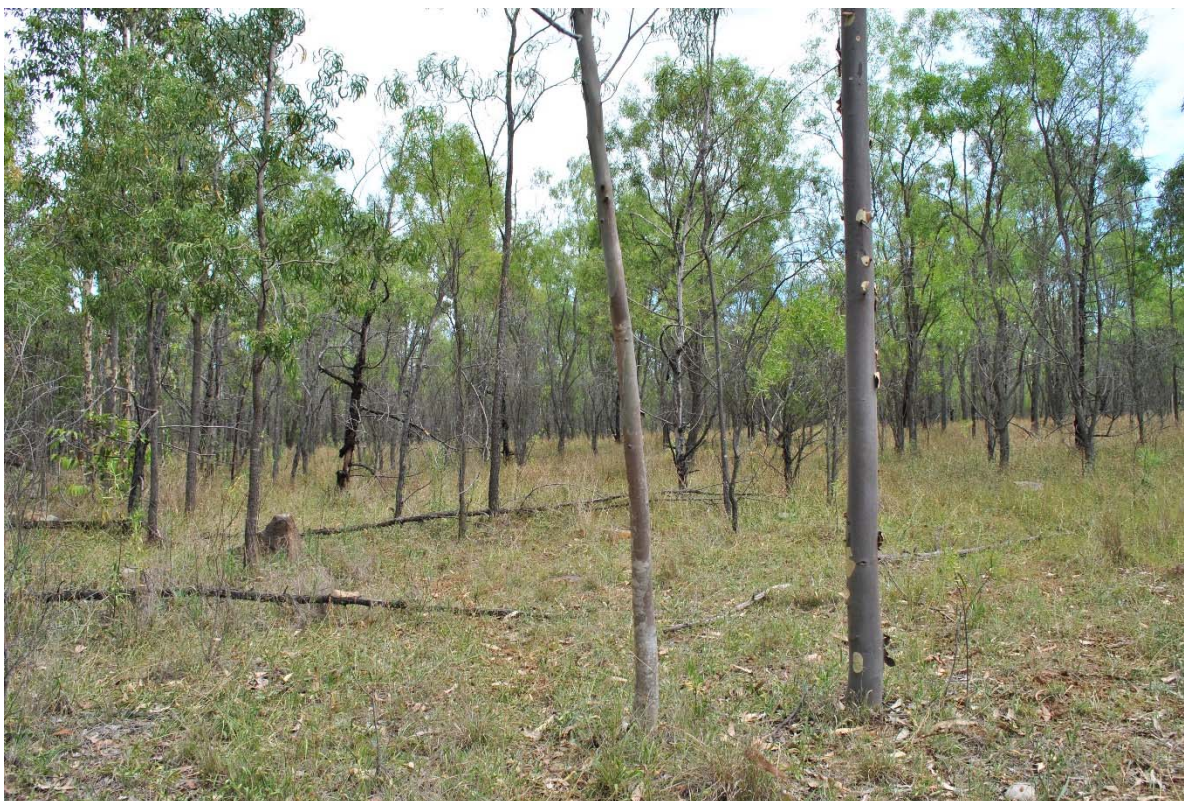
**Figure 9: Open native woodland rehabilitation at McDonalds Pit which was rehabilitated in 2003**

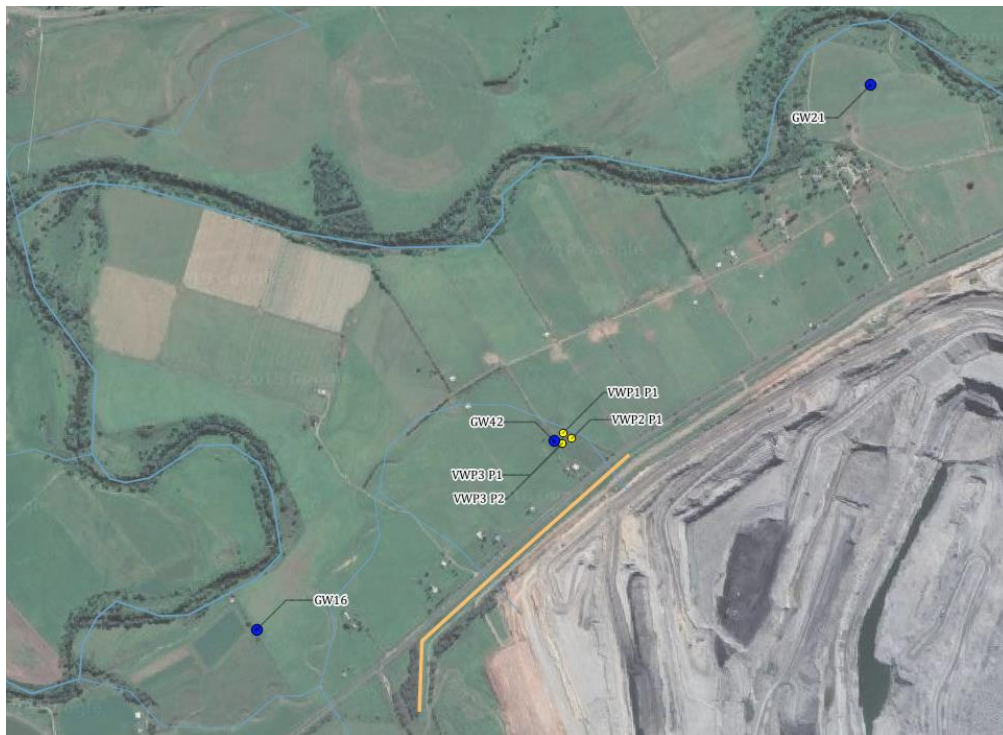
**Figure 3.3 Cut-off wall and HRA monitoring bore locations**
