Mt Arthur Coal

Annual Review FY20

25 September 2020

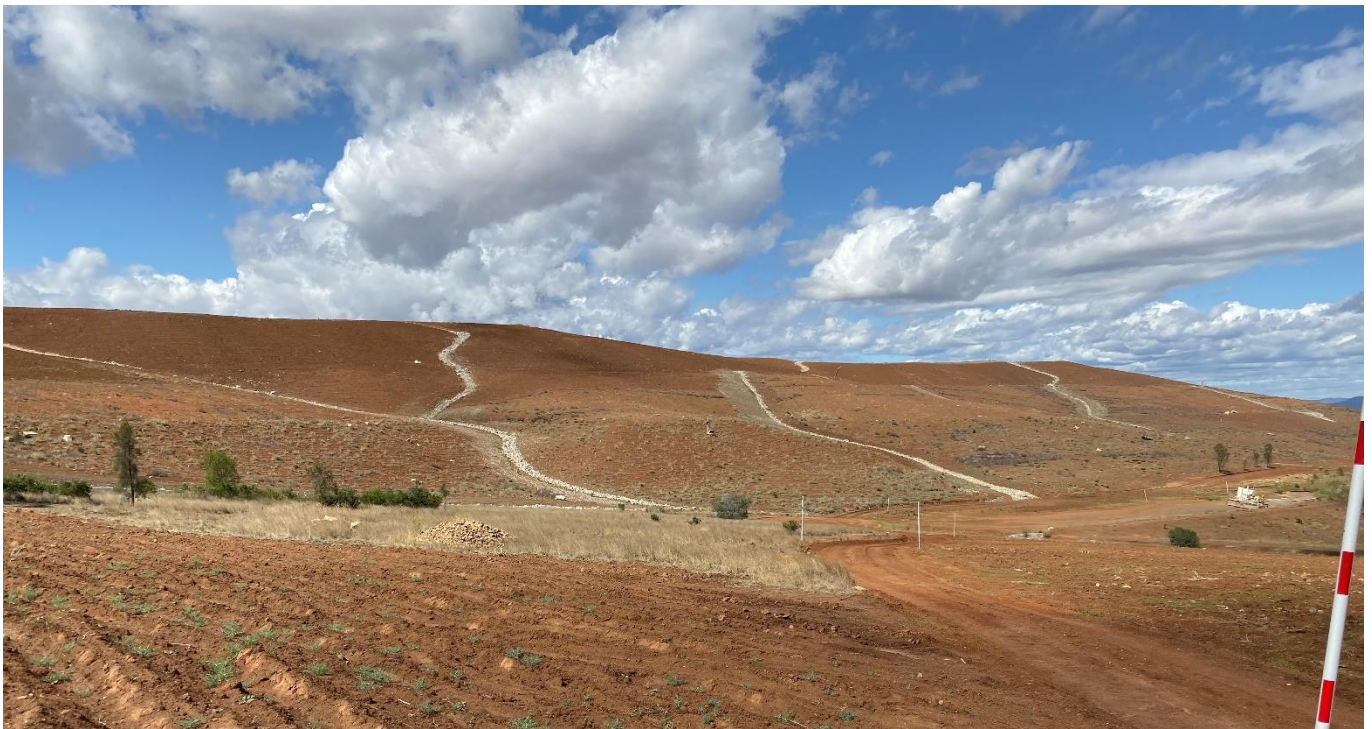
Figure 7: VD5 natural landform design showing FY18-FY20 rehabilitation. Image collected in November 2019 prior to rainfall.

Drought impacted the first half of the reporting period limiting revegetation efforts. Significant rainfall was received on site in the second half of the reporting period increasing vegetation cover (see Figure 7 and Figure 8 for comparison). This has helped to stabilise the landform but will need intense weed treatment in the short term to keep on track.

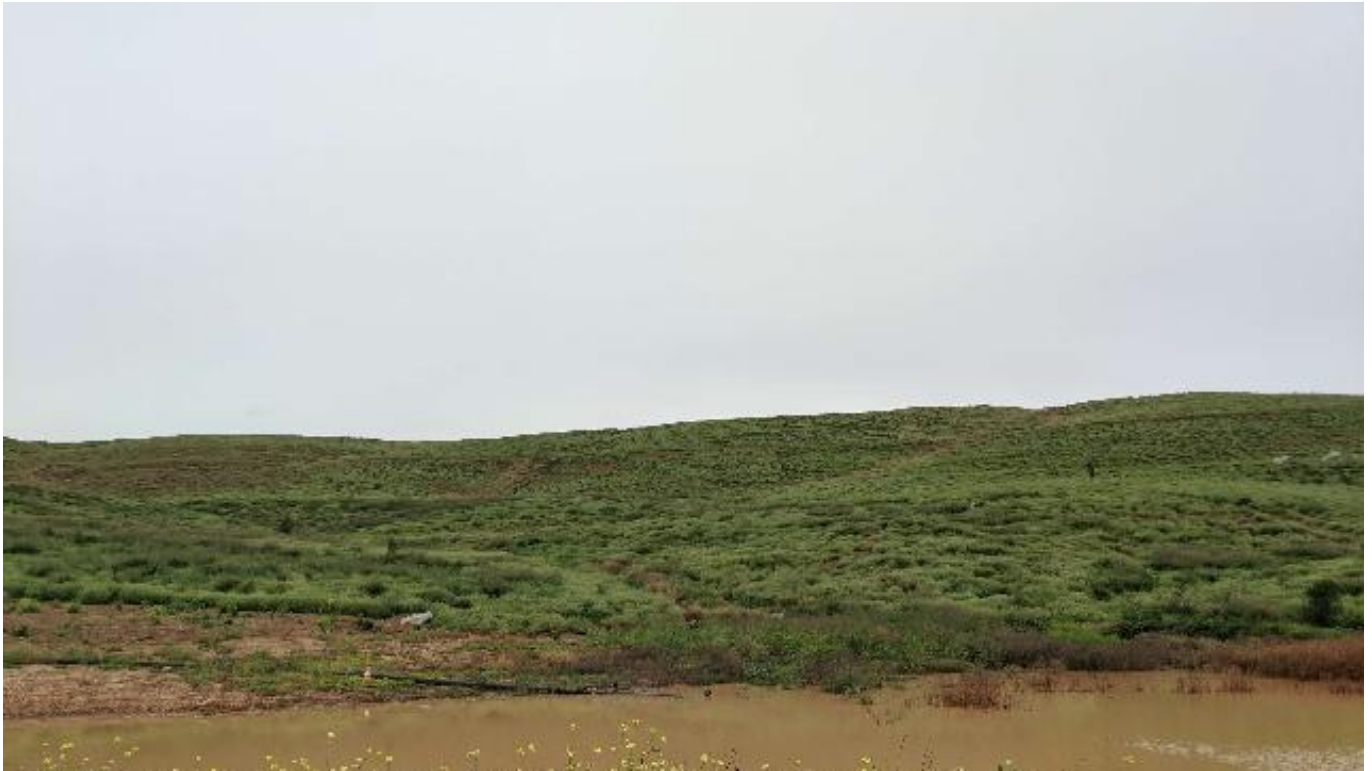
Figure 8: VD5 natural landform design showing FY18-FY20 rehabilitation. Image collected in April 2020 following rainfall.

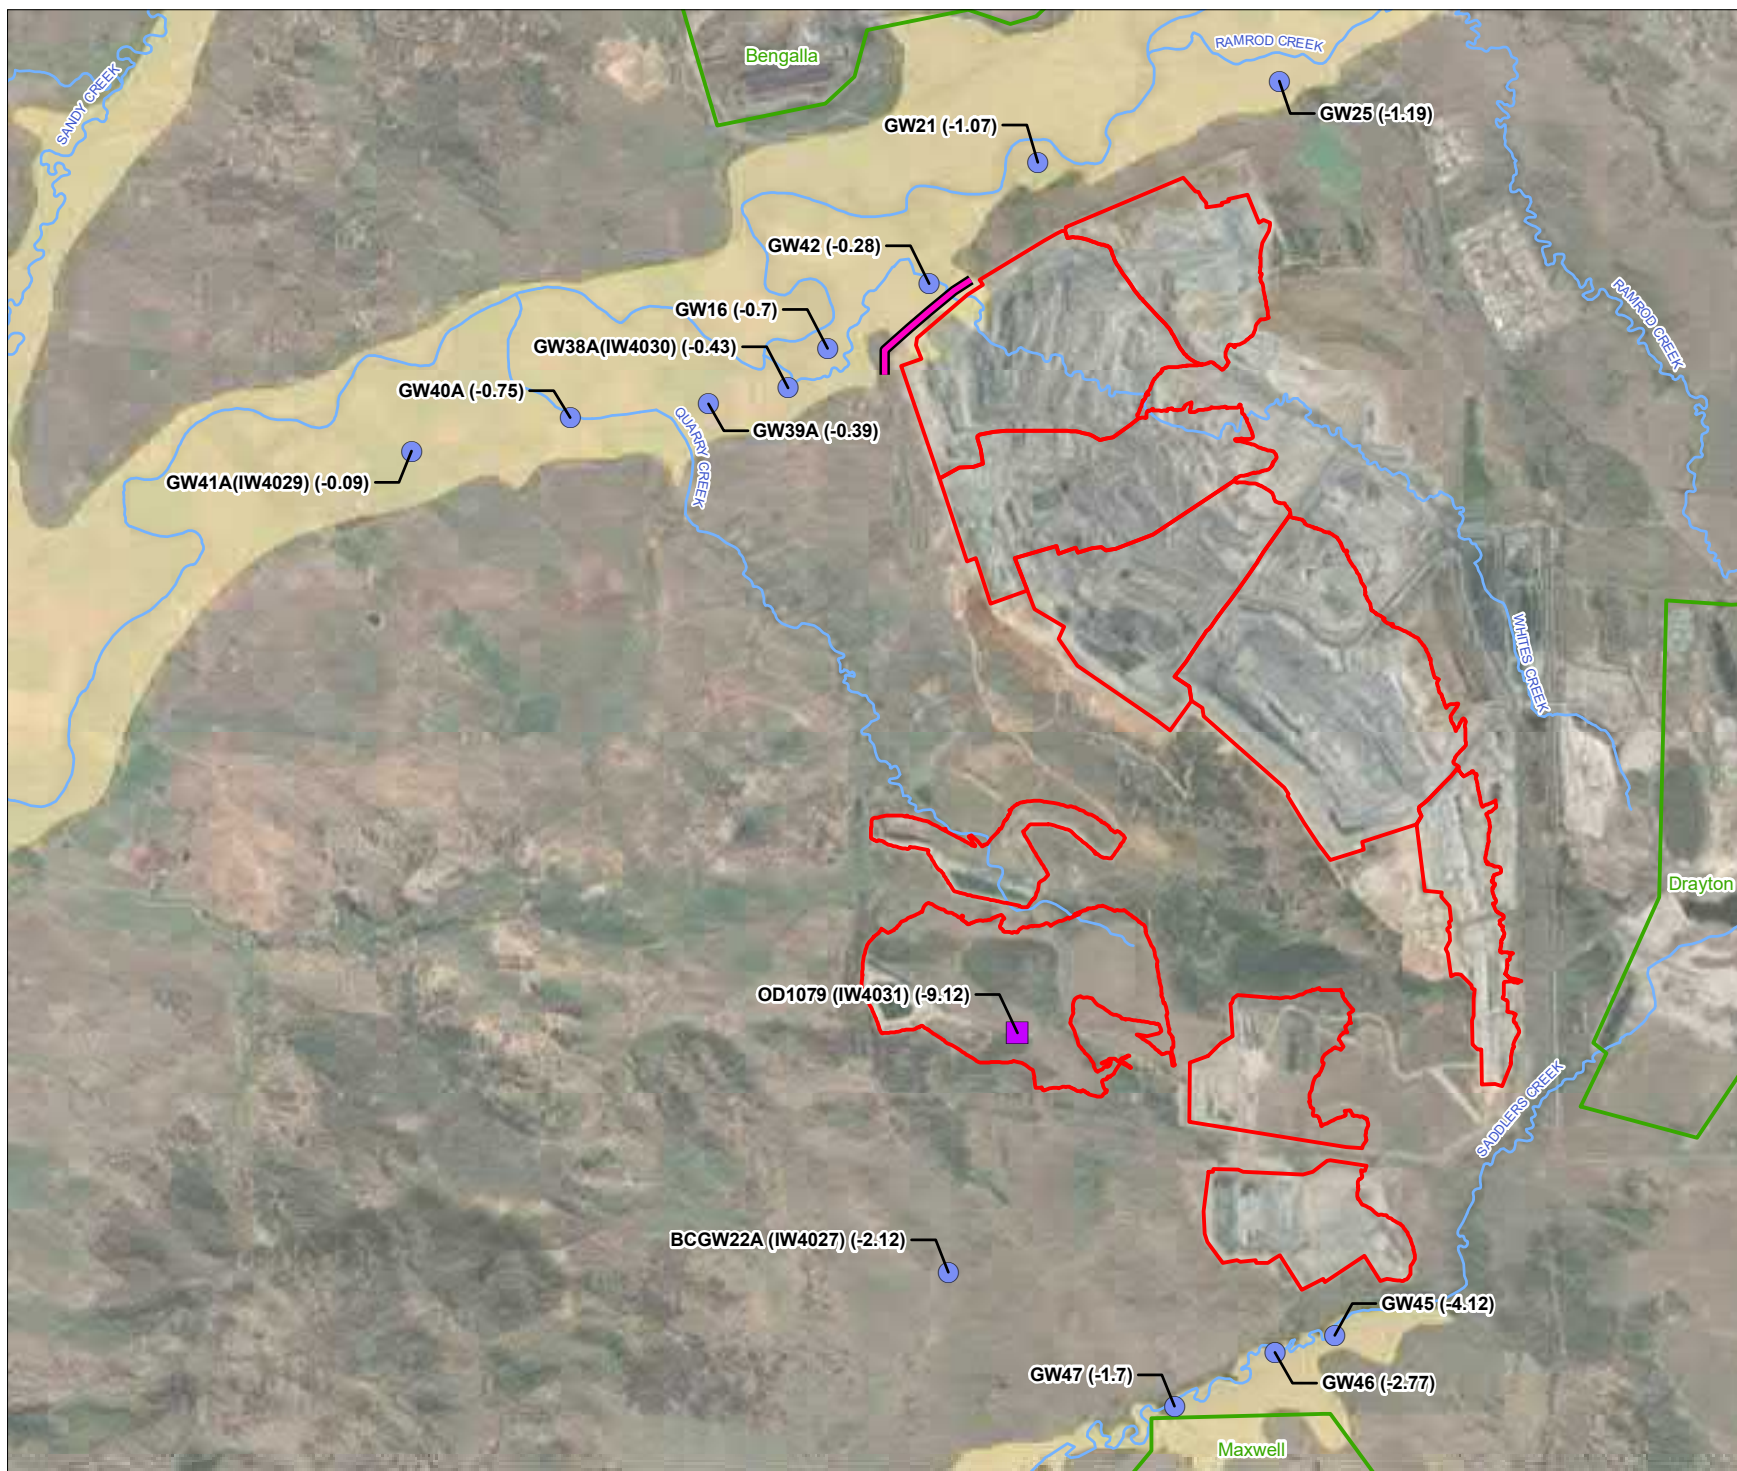
FIGURE 3

Groundwater Drawdown between Start of Monitoring and June 2020 Permian Coal Measures

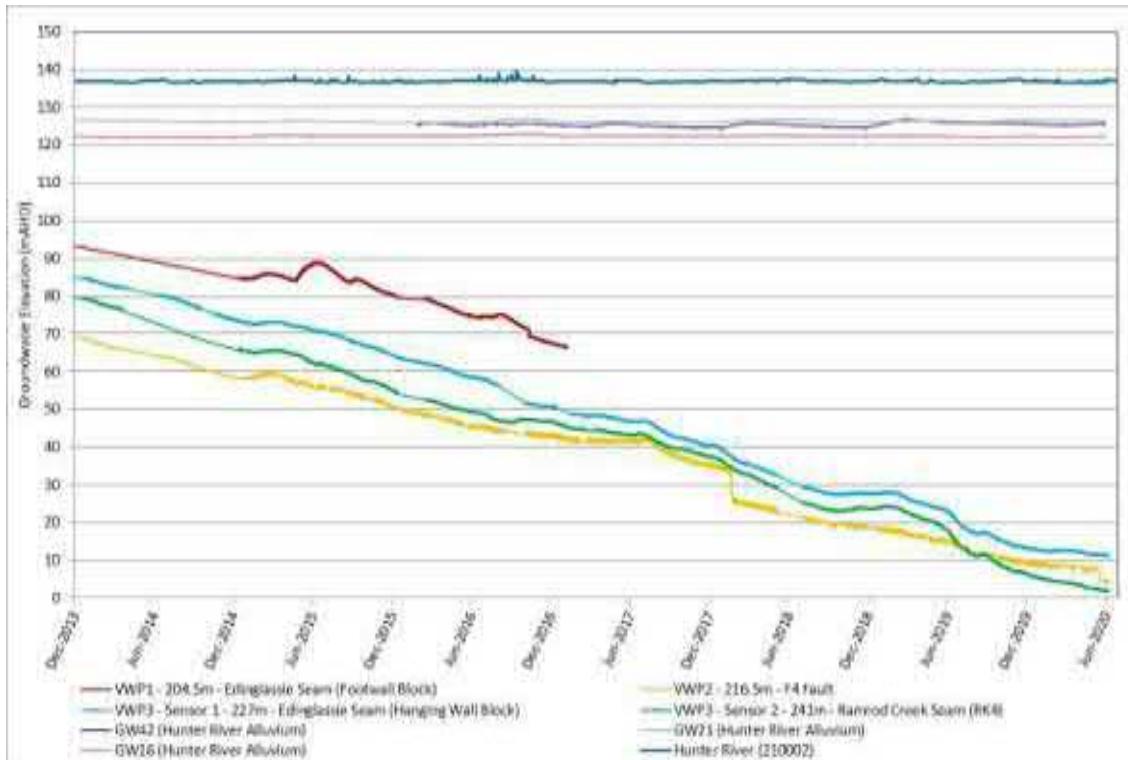
Figure 4 Permian Coal Measures Groundwater Levels Adjacent to Cut-off Wall

Depressurisation observed in the Permian coal measures also does not appear to have impacted on alluvium groundwater levels as shown by the relatively stable groundwater level trends shown by bores GW16 and GW21. However, as noted earlier these bores may also be influenced by local agricultural land use with enhanced recharge through irrigation. Regardless, the alluvial monitoring shows no adverse impact on the alluvial groundwater conditions and beneficial use of groundwater.

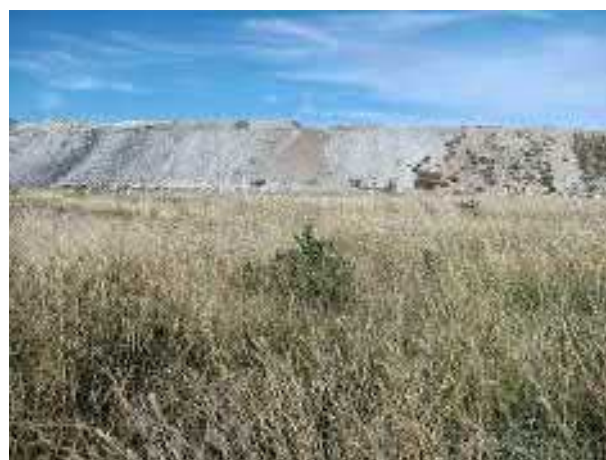
Drayton – Pasture

Revegetation Inspection Form-Additional Information					
Area	Drayton South	Date:	20-05-2020	Name:	A. Cavallaro & D. Martin
Domain:		Post Mining Land Use:	Pasture		
Revegetation Date:	<2017	Vegetation Type:	N/A		
Observations					
Drayton south rehabilitation area is a large area of exotic pasture with a northerly aspect.					
Site	Vegetation Establishment Notes				
Drayton South - Pasture	The pasture area is predominantly exotic grass consisting of <i>Chloris gayana</i> (Rhodes Grass), <i>C. virgata</i> (Feathertop Rhodes Grass), <i>Megathyrsus maximus</i> (Guinea Grass) with patches of <i>Galenia pubescens</i> , <i>Rapistrum rugosum</i> (Turnip Weed) and <i>Melinis repens</i> (Red Natal Grass) scattered throughout. The vegetation condition appears stable and is unlikely to change without a significant disturbance event.				
	Emergent community characteristics/ecosystem function:				
	Currently there is no distinct native vegetation community establishing in the area dominated by exotic pasture. This area may provide some refuge habitat for mobile fauna species or foraging opportunities for macropods and raptors.

Recommendations					
<ul style="list-style-type: none"> Targeted woody and herbaceous weed across the area focusing on weeds listed under the Biosecurity Act 2017 and high threat weeds Determine the target vegetation type species composition and develop a revegetation strategy.

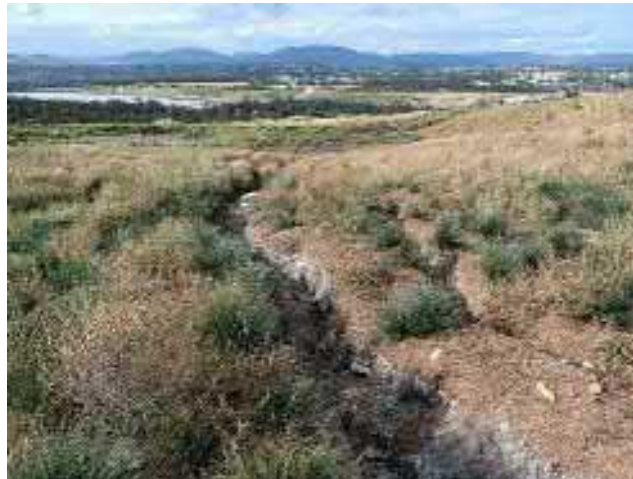
Visual Dump 1 – North-west

Revegetation Inspection Form-Additional Information					
Area:	Visual Dump 5 (VD5)	Date:	20/05-21/05 2020	Name:	A. Cavallaro & D. Martin
Domain:		Post Mining Land Use:	Woodland		
Revegetation Date:	2017-2019	Vegetation Type:	Box Woodland Establishment Area		
Observations					
<p>VD5 is located on the northern boundary of Mount Arthur Coal adjacent to Denman Rd. Three separate areas within VD5 (VD- A, VD -B & VD -C) were inspected as part of the Rehab site inspection.</p> <p>VD - A was within rehabilitation that was apparently undertaken during 2019 (MAC GIS file Layer 2020). The rehabilitation in this area has a persistent cover across the areas walked with small bare areas amongst dense <i>Sclerolaena muricata</i> (Black Roly Poly). The vegetation in this area is relatively young hence the low native species richness. It appears the rehabilitation works are relatively stable with a small number of channels establishing within low points in the landscape.</p> <p>VD - B and VD - C site inspections were primarily in the 2017 Rehab facing Denman Rd. These two sites were identical in structure. The vegetation is predominantly low growing Black Roly Poly with the occasional mid or canopy species emerging from the groundlayer vegetation. The sites in general are stable with most erosion concerns observed in the reshaped drainage channels within the rehab.</p>

Site	Vegetation Establishment Notes				
VD5 -A	<p>Vegetation within VD5 - A is predominantly a monoculture of <i>Sclerolaena muricata</i> (Black Roly Poly) with a very low presences of other native species. In amongst the dense Black Roly Poly there is the very occasional native groundcover establishing with species such as <i>Enchylaena tomentosa</i> (Ruby Saltbush) and <i>Einadia trigonos</i> (Fishweed) found in small gaps in the Black Roly Poly. On the lower slope there was a small cluster of two juvenile <i>Eucalyptus crebra</i> (Narrow-leaved Ironbark) approximately 1.5m in height. Weeds are present throughout the site with common species seen across the Mt Arthur Col site such as <i>Galenia pubescens</i>, <i>Rapistrum rugosum</i> (Turnip Weed), <i>Argemone mexicana</i> (Mexican Poppy) and juvenile African Boxthorn. The vegetation is young and has not had time to establish further them to initial pioneer species colonising the site.</p>
