# BHP

## Mt Arthur Coal

Annual Review FY21

29 September 2021

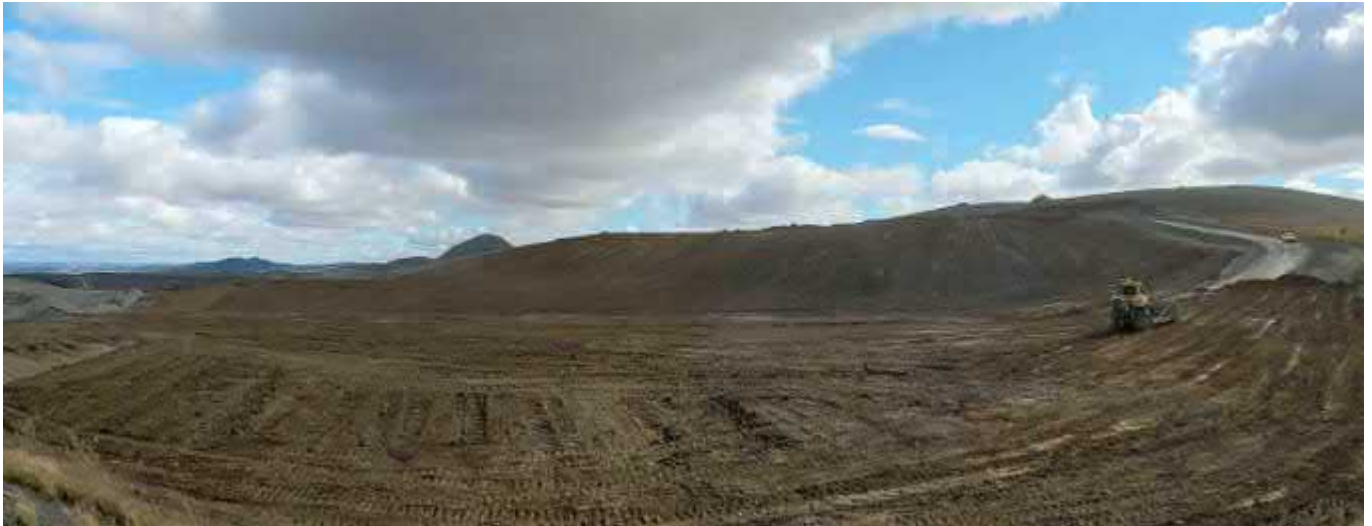
**Figure 6: Topsoil spreading at Drayton Void emplacement**

The final landform design can be seen in Figure 6 and Figure 7. Figure 6 and Figure 7 show the shaped waste rock with topsoil being placed. Although this geomorphic design has been implemented on other sites within NSW and also worldwide there are many defining characteristics that restrict its use such as space, waste characterisation, rainfall, availability of suitable rock, availability of mulch, final land use, landform height and steepness of the landform. Mt Arthur Coal has larger higher landforms than other sites in the Hunter Valley, and is also space constrained for emplacement area. The resultant design aligns with industry best practice but will be monitored over the coming years to ensure further natural landform design incorporates learnings and improvement from the current work.

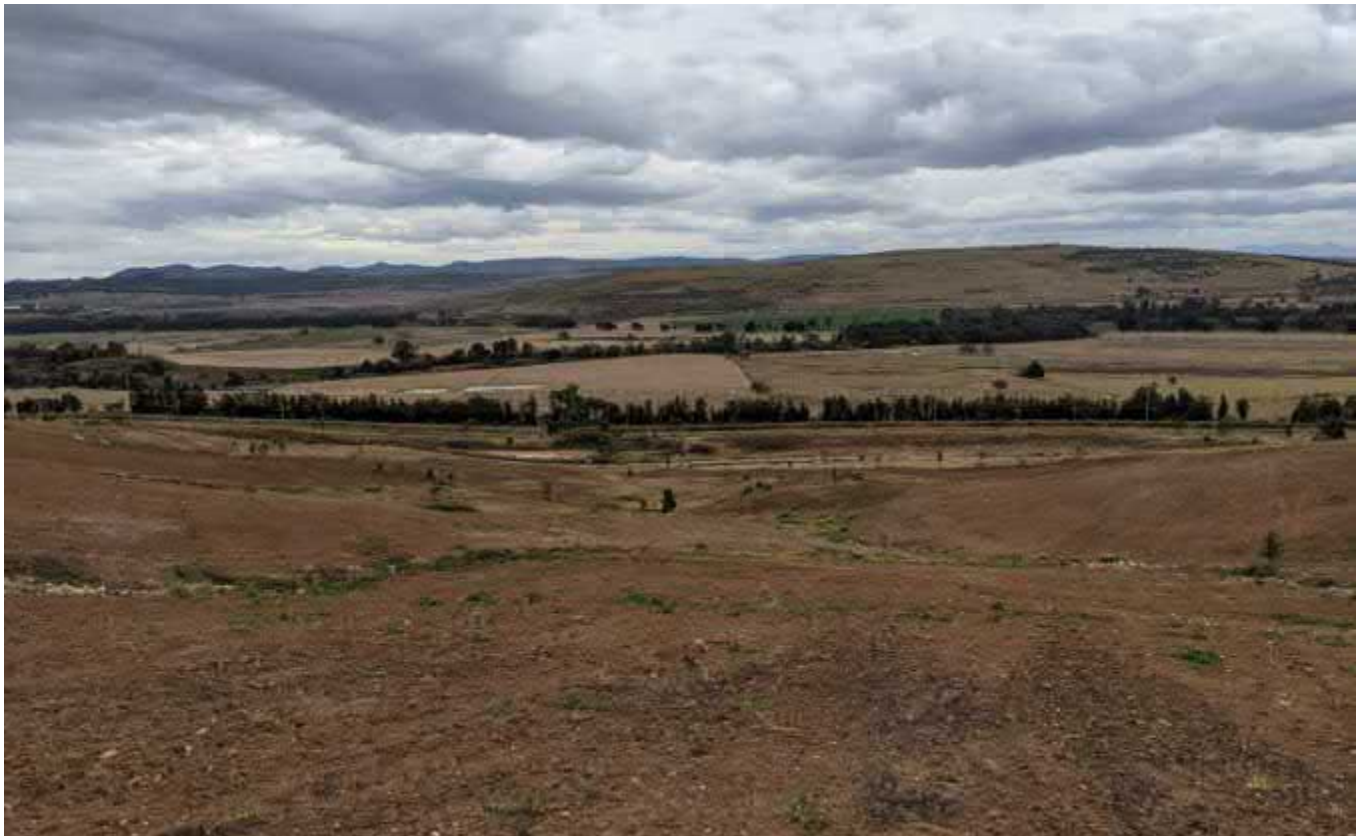
**Figure 8 VD5 following maintenance work looking north**

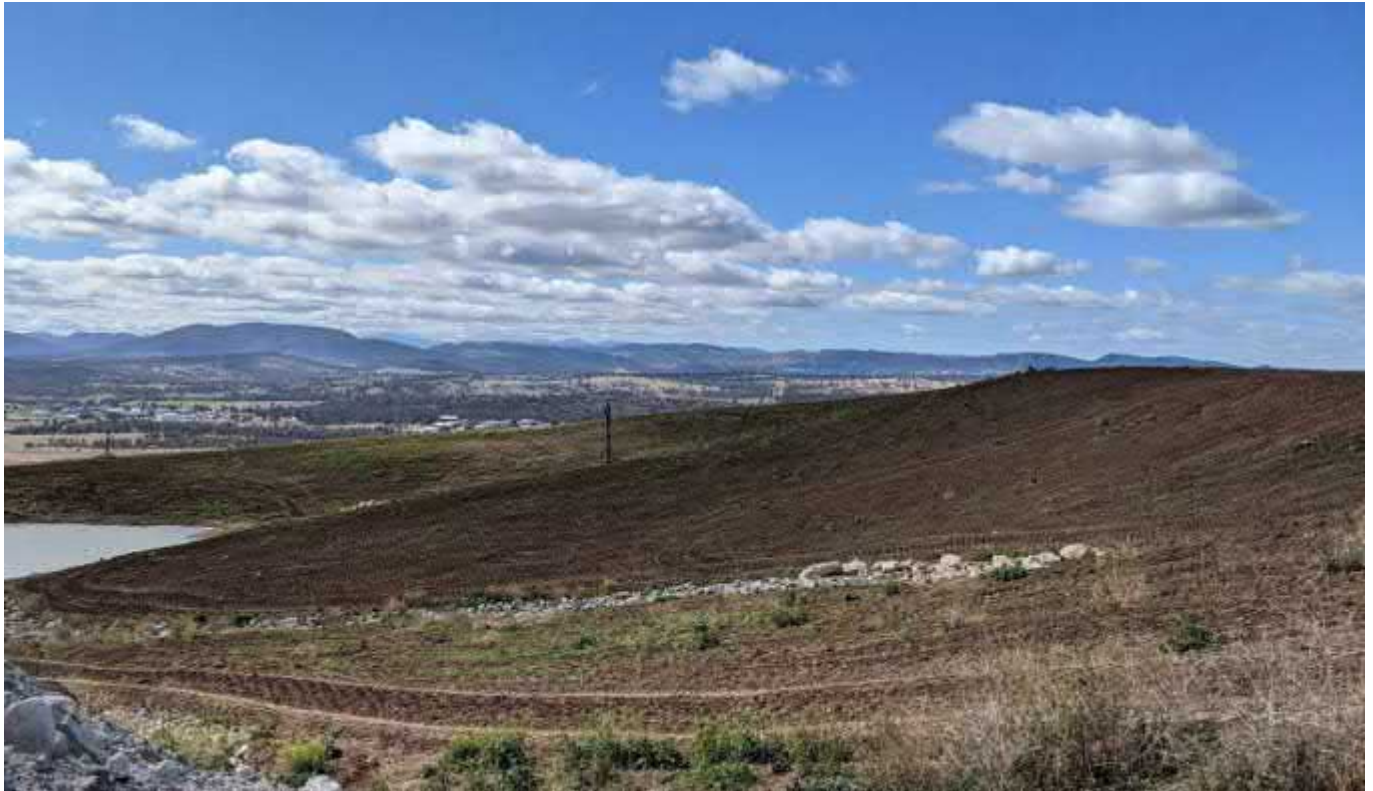
**Figure 9 VD4 following maintenance work looking east**

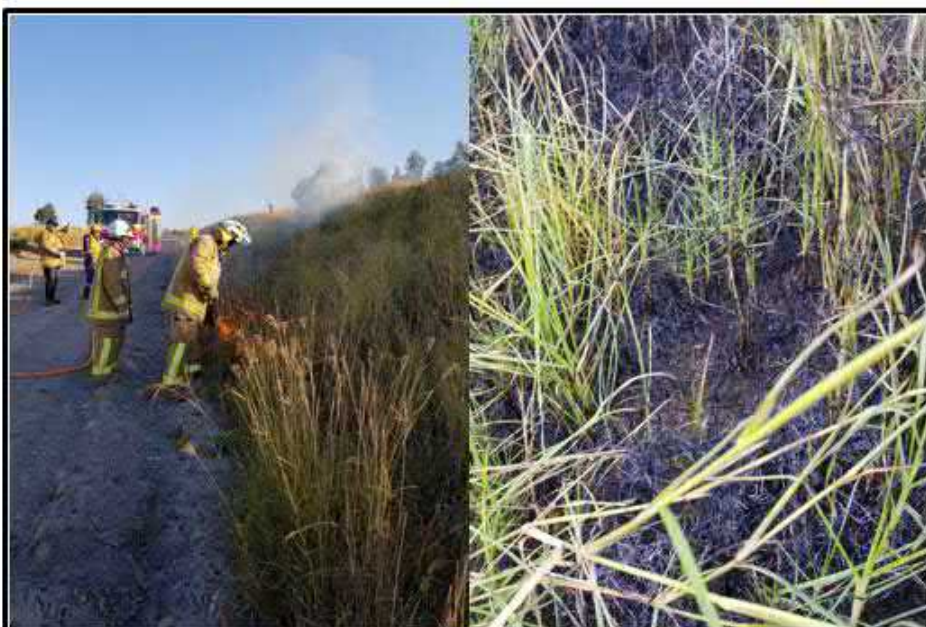
The results indicate that the grass in the area had not cured sufficiently to burn hot enough adequately treat exotic grasses. MAC plans follow up trials will take place in winter 2022 to determine potential of controlled burns in weed management. This will be in conjunction with other weed management practices to determine the most cost effective method for treatment of exotic grasses.

**Figure 10 Controlled burn on VD1 in exotic and depleted grasslands**

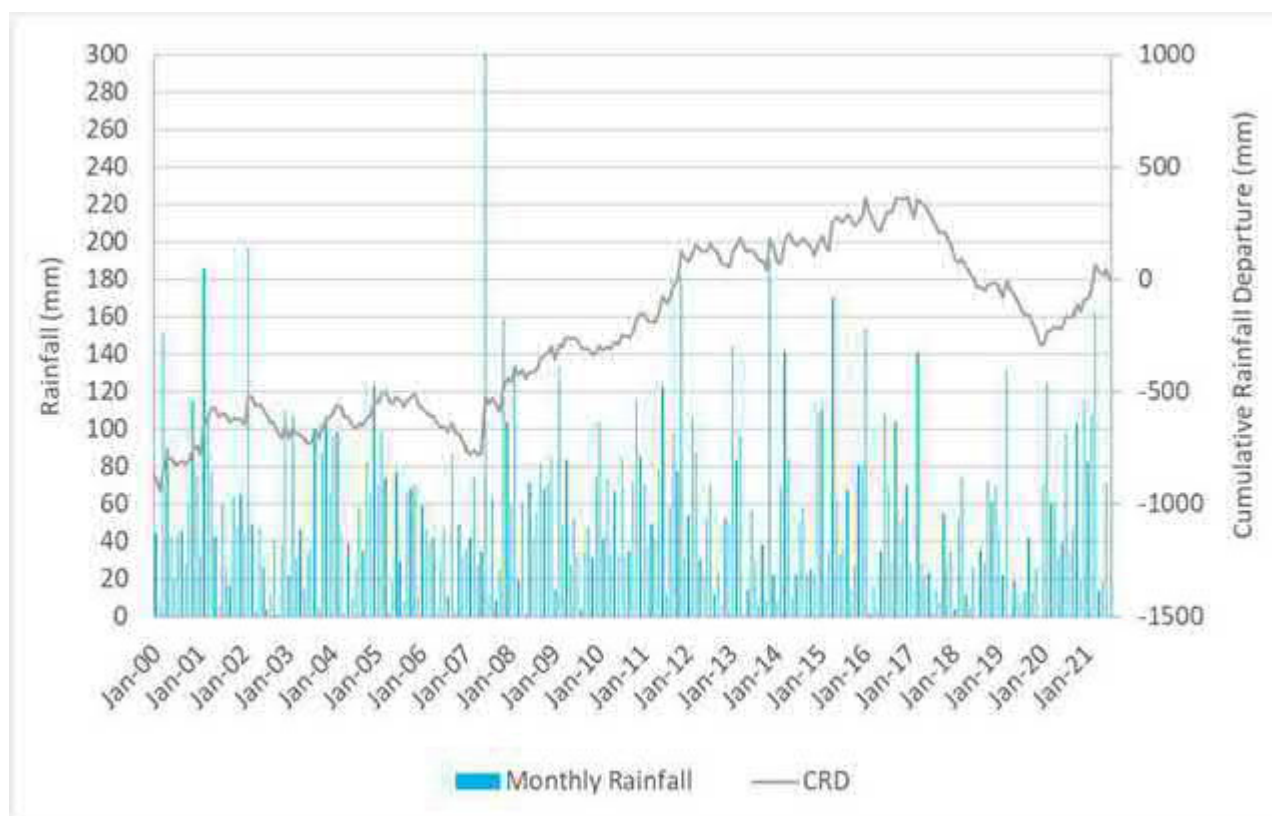
**Figure 2.1** shows the CRD and total monthly rainfall. The graph indicates the area has generally experienced a period of relatively average rainfall from 2000 to 2007. Above average rainfall was experienced from 2007 to 2017. From 2017 to 2020 the area experienced below average rainfall and since the start of 2020 the area has experienced above average rainfall.

**Figure 2.1** SILO Monthly Rainfall and CRD

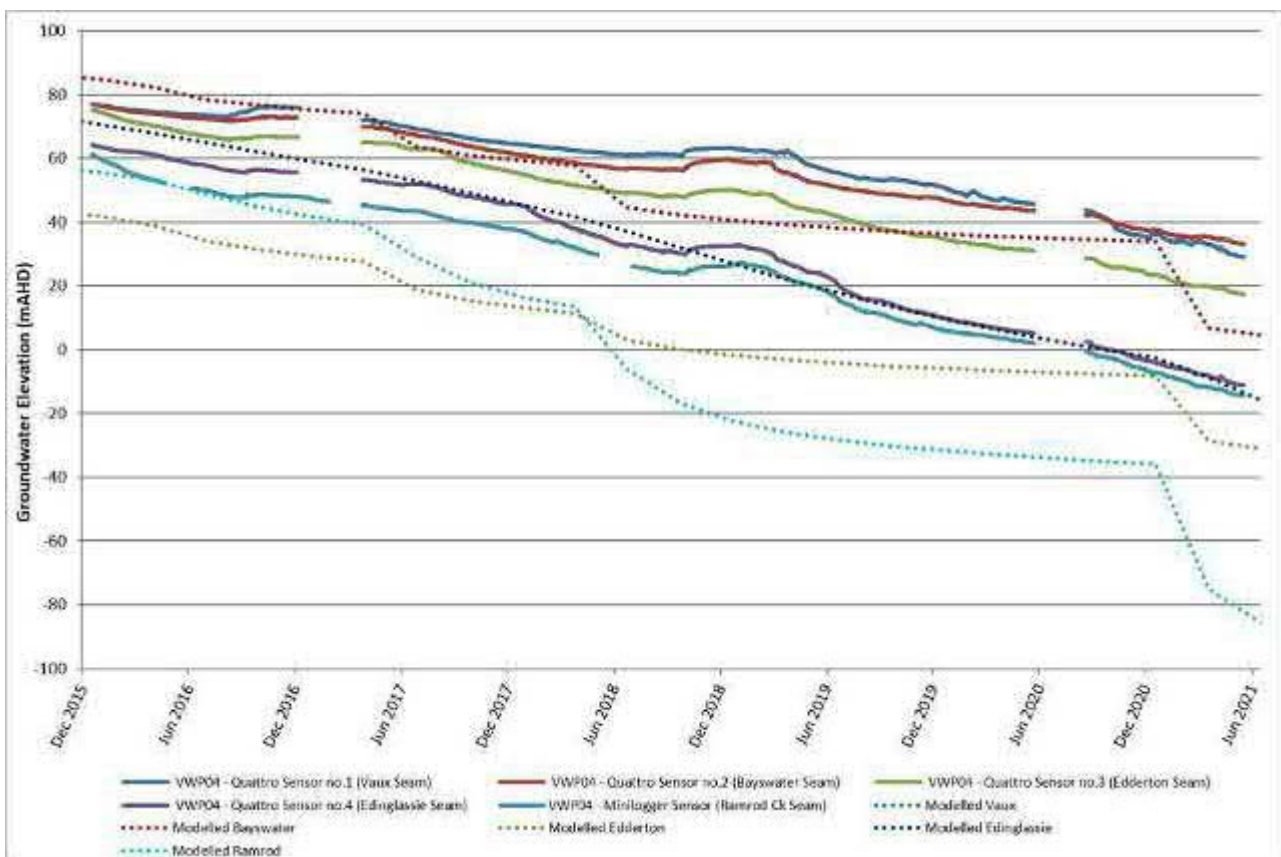
Figure 4.1 VWP04 Modelled versus Observed Levels

| Bore ID | Screened Lithology | Location | Comment |
|---|---|---|---|
| VWP04 | Vaux Seam<br>Bayswater Seam<br>Edderton Seam<br>Edinglassie Seam<br>Ramrod Creek Seam | On site - north of MAC open pit | <p>Levels in the Vaux, Bayswater, Edderton, Edinglassie, and Ramrod Creek Seams exceeded the 2020 trigger levels between October 2020 and June 2021.</p> <p>The continuing declining groundwater level trend represents mining induced depressurisation as predicted for the approved operations by SLR as shown in <b>Figure 4.1</b>.</p> <p>SLR (2020b) predicted continued drawdown in this area with simulated water levels ranging between 4.72 and -85.5 mAHD. The measured water levels ranged from 29 to -14.4 mAHD. The SLR (2020b) model predicted greater drawdown than observed and the trigger levels should be reviewed to align with levels in the latest model predictions.</p> |

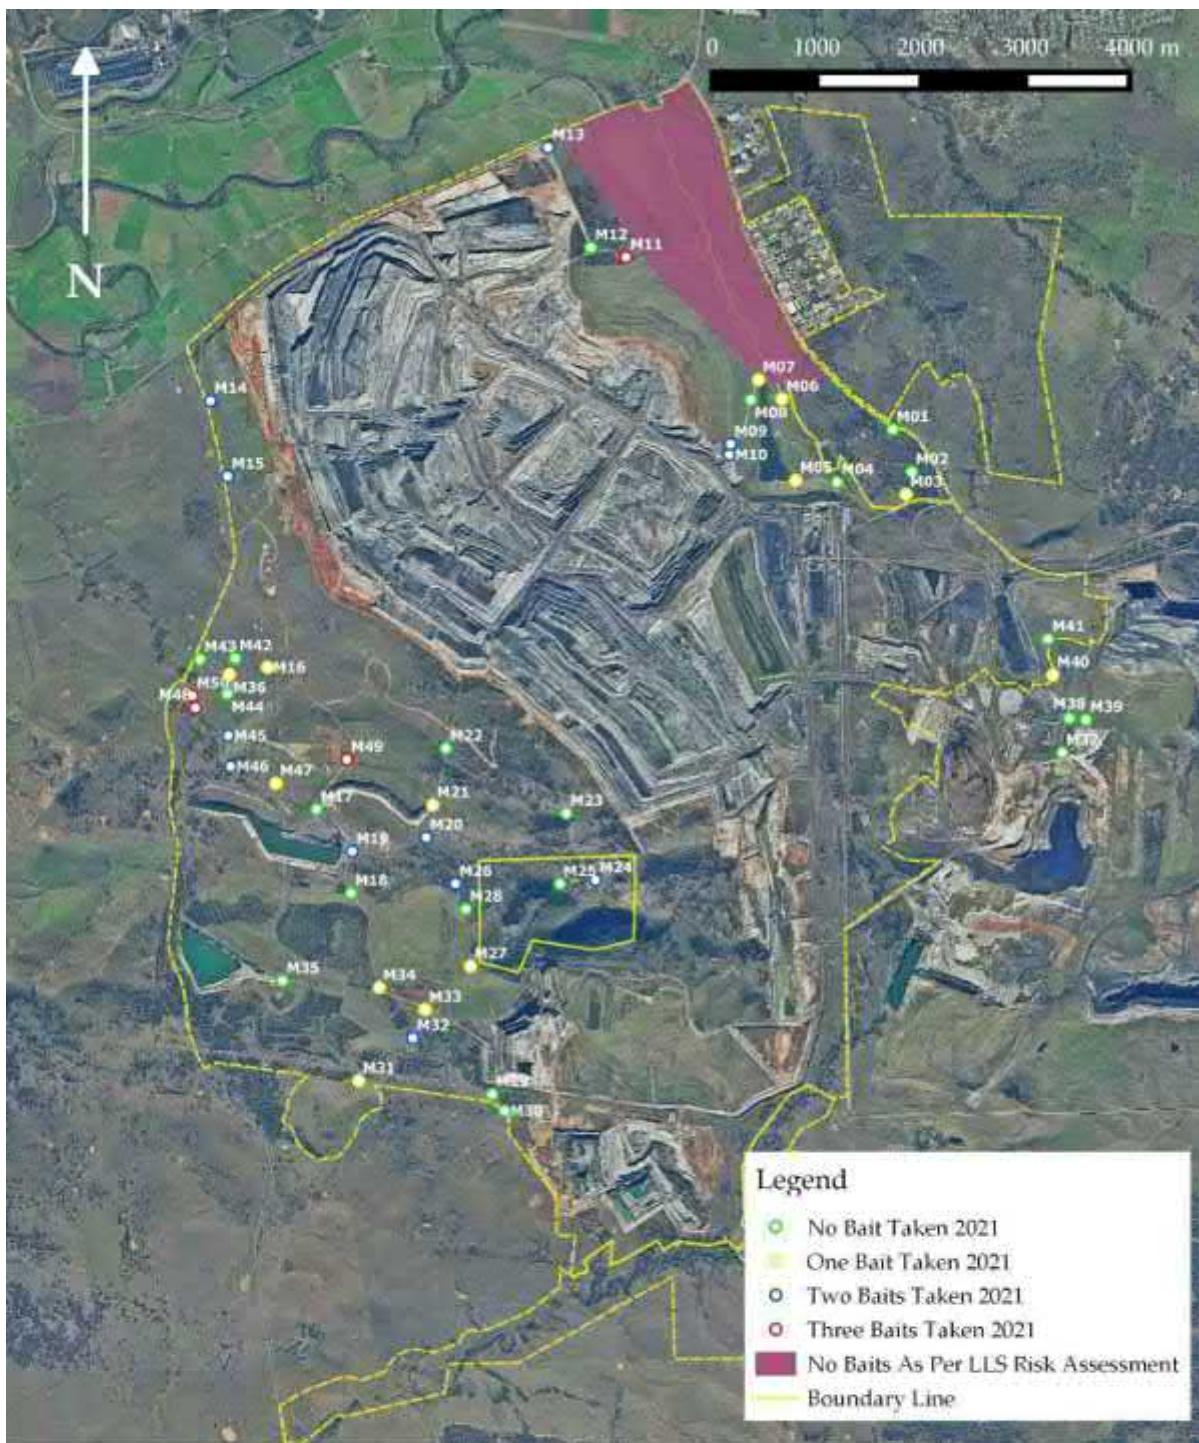
**BHP Billiton - Mt Arthur Coal Operations  
 VERTEBRATE PEST CONTROL  
 1080 BAITING AUTUMN 2021:  
 Wild Dog & Fox Bait Location Success Rate - Map 2**

The following GIS Map indicates the level of success at individual bait locations by indicating the number of baits taken by the Target Species. The success ratings range from 'No Baits Taken' up to 'Three Baits Taken' by Target Species

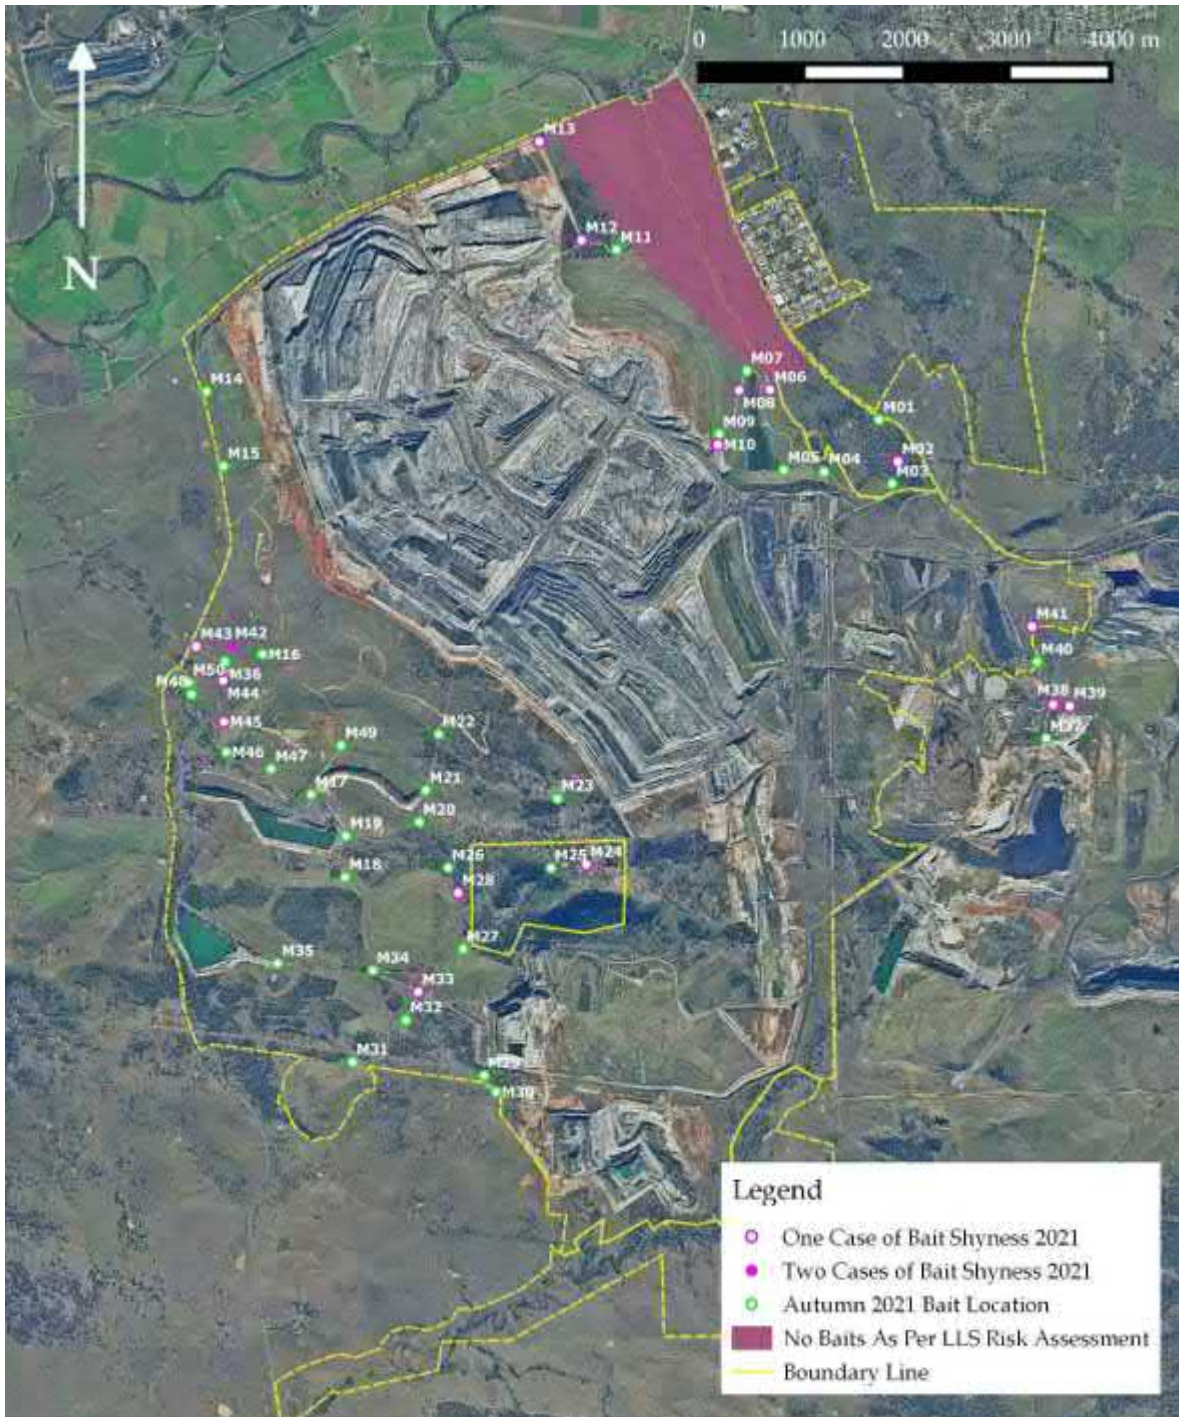
**BHP Billiton - Mt Arthur Coal Operations  
 VERTEBRATE PEST CONTROL  
 1080 BAITING AUTUMN 2021:  
 Wild Dog & Fox Bait Shyness - Map 3**

The following GIS Map depicts bait locations where evidence of bait shyness was observed during the 2021 Autumn baiting program. Bait shyness occurs when the target species have shown interest in the bait or dug at the bait mound and then left the bait and moved on. The level of bait shyness ranges from 'One Case of Bait Shyness' up to 'Two Cases of Bait Shyness' by Target Species.

*(Please note a white circle with a light green border indicates that no bait shyness was observed at that Bait Location).*
