# **EML 6488 Midway Quarry PEPR Compliance Report 2024/2025**

**September 2025**

CA-0000-ENV-REP-1051

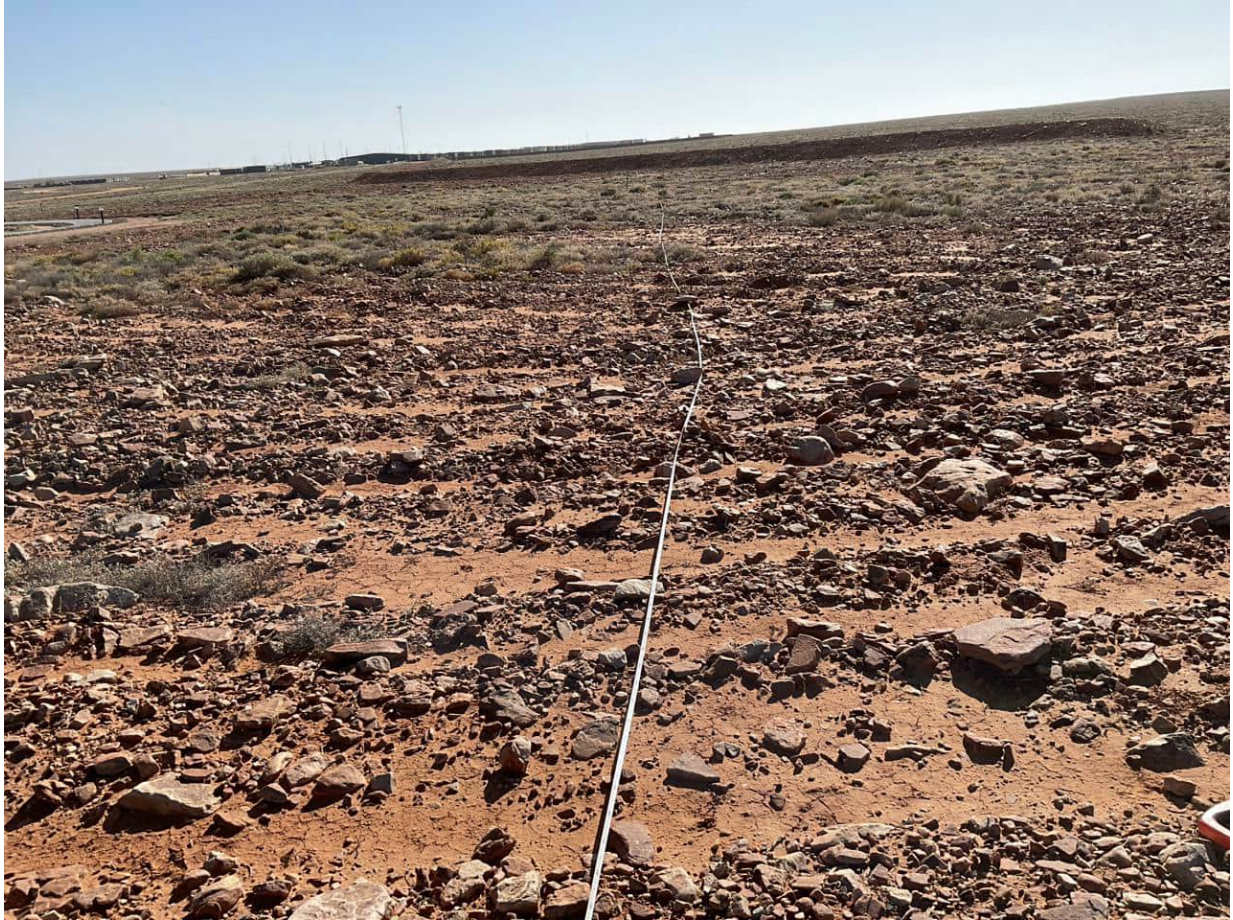
**Plate 3.1: Aerodrome transect 1A showing re-establishment of vegetation largely concentrated in the second half of the transect**

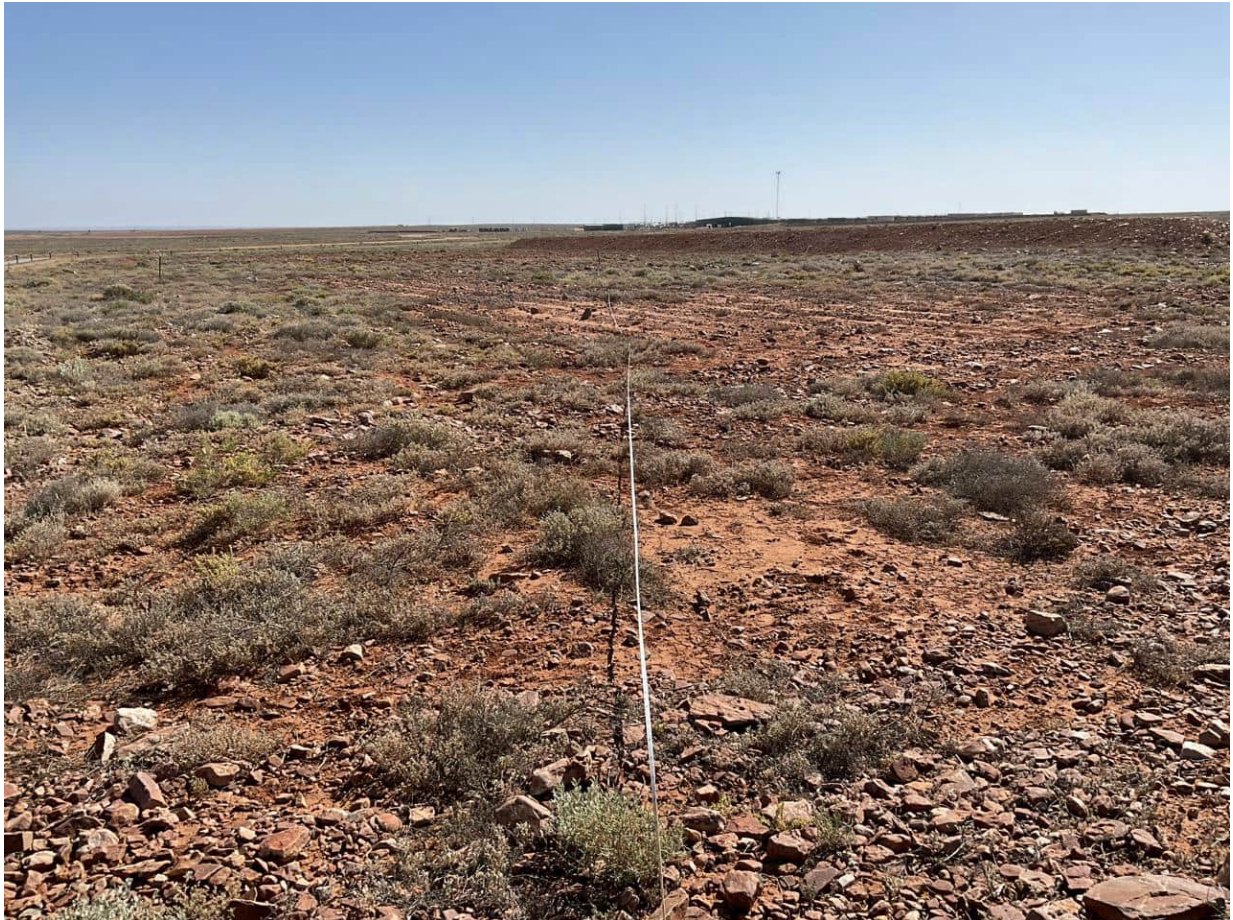
**Plate 3.2: Aerodrome transect 1B. From 0 m at start, facing the end. Moderately dense vegetation covers much of the first half of the transect**

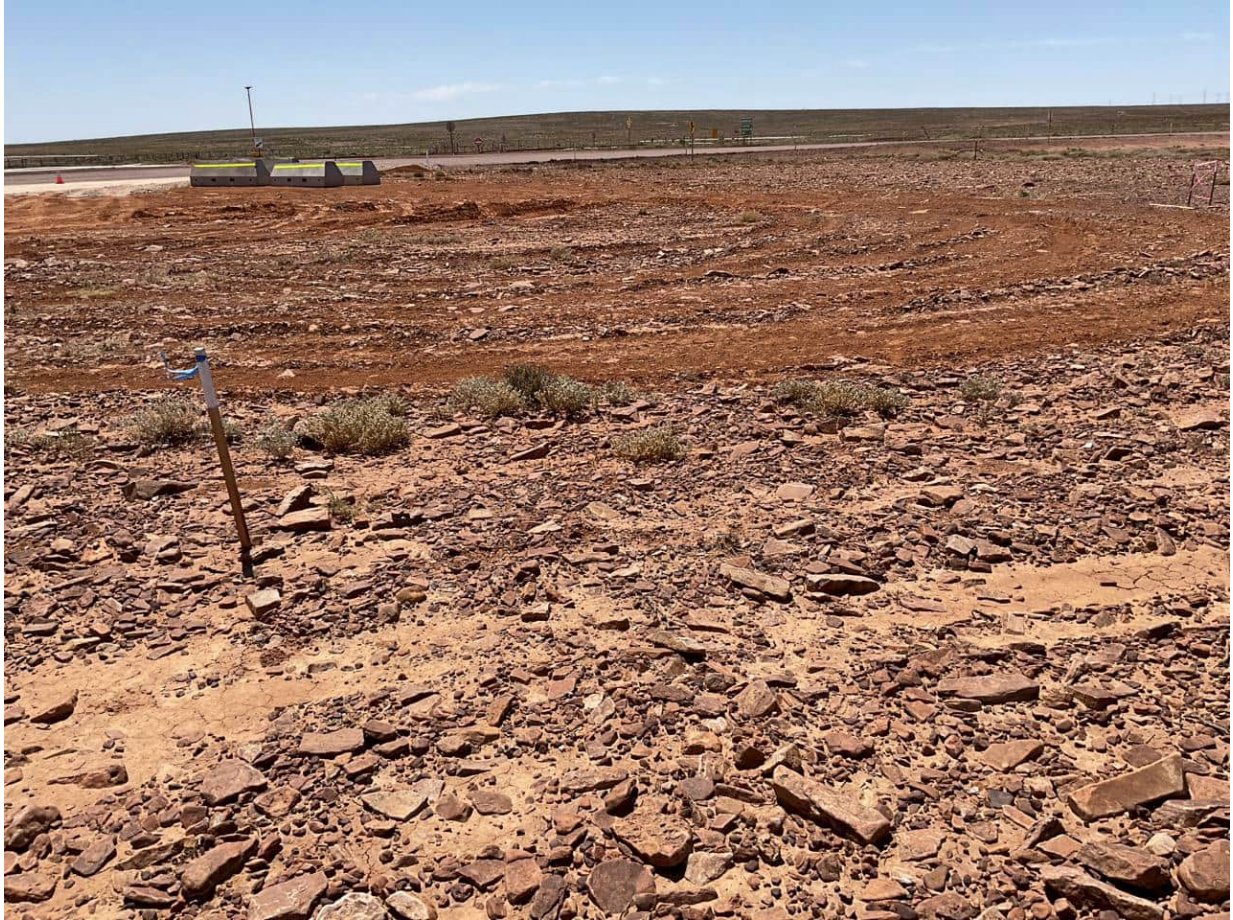
**Plate 3.3: Ventia transect 2A. The majority of the transect has been recently graded and no vegetation remains along the alignment**

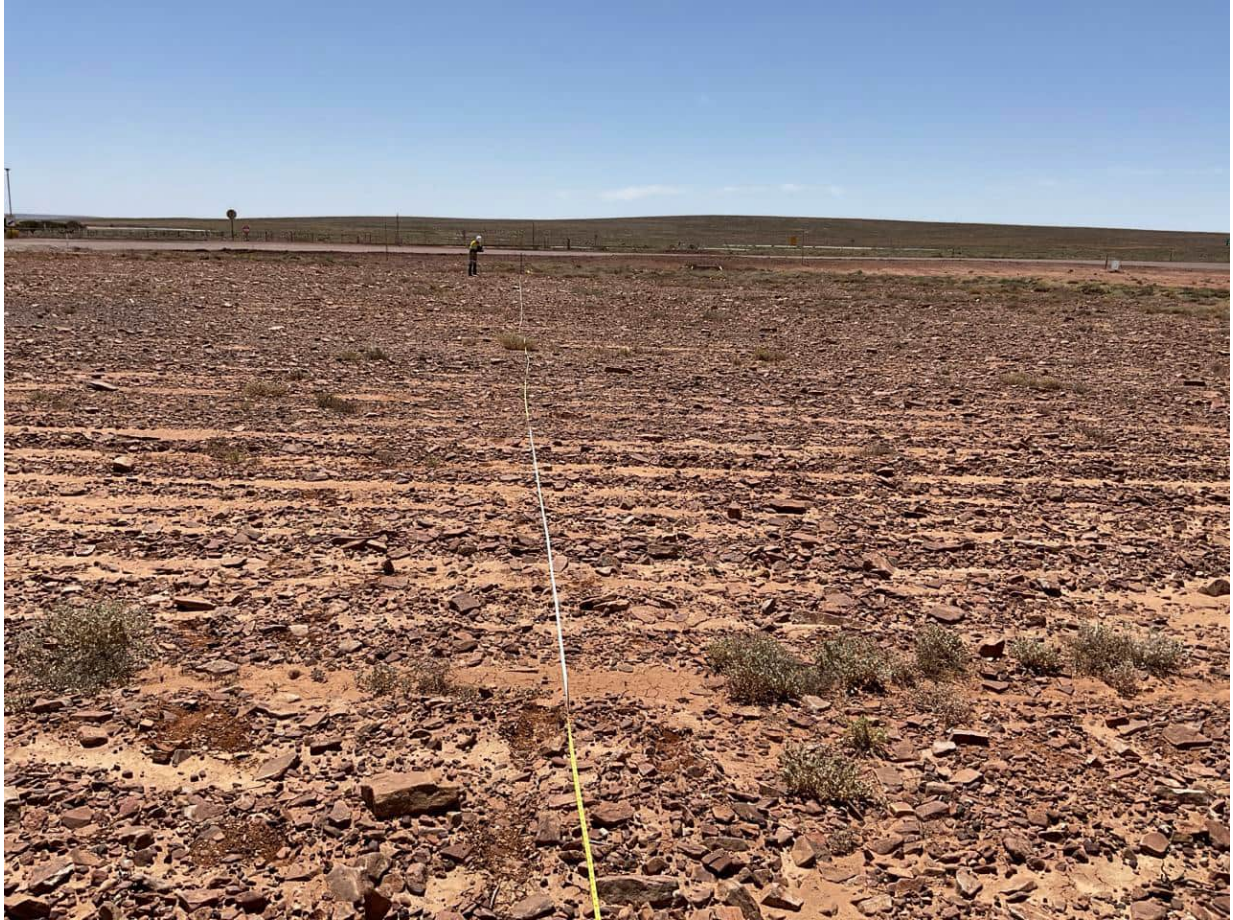
**Plate 3.4: Ventia transect 2B: Only one vegetation patch was intercepted along the transect**

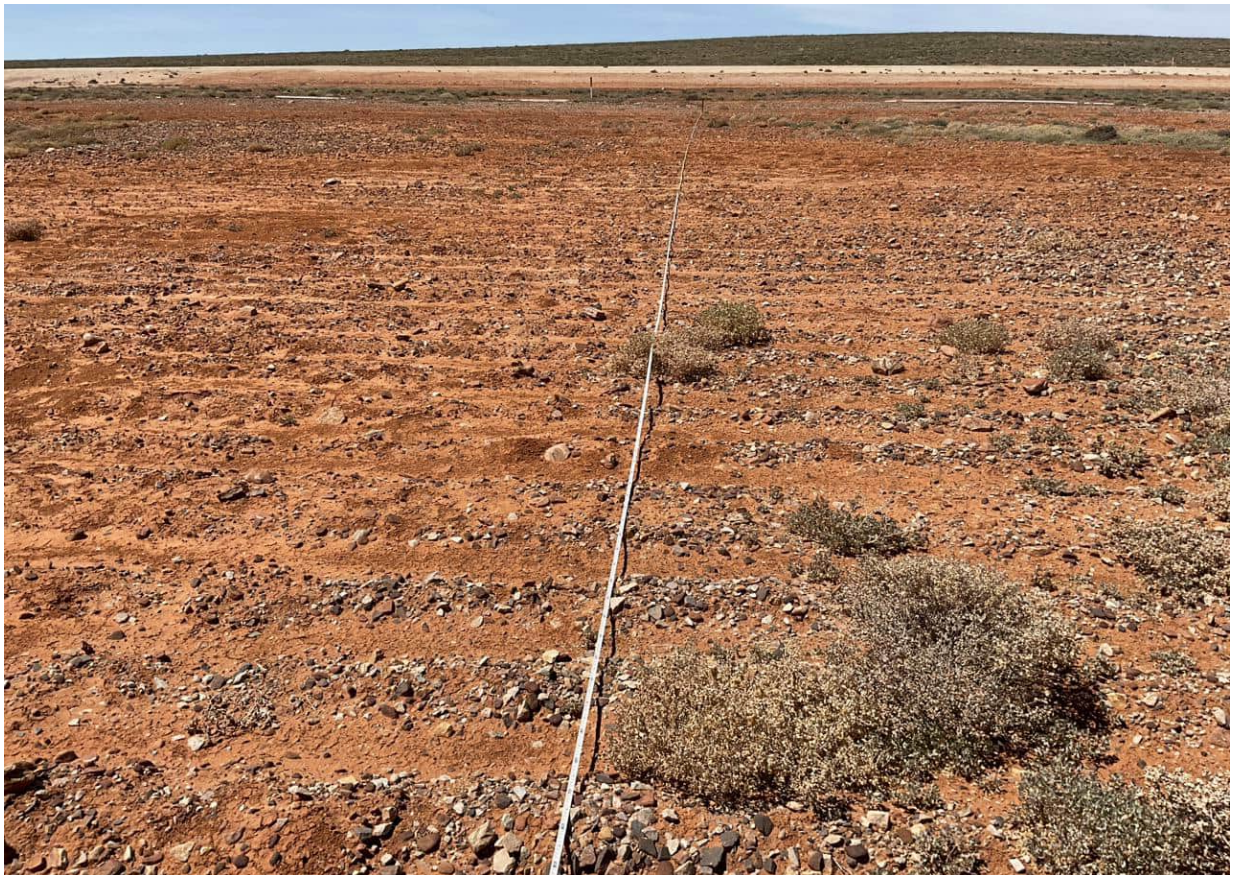
Plate 3.5: Midway Quarry transect 3A from start (0 m) facing end. Most re-establishment of short-lived perennials has occurred near the start of the transect.

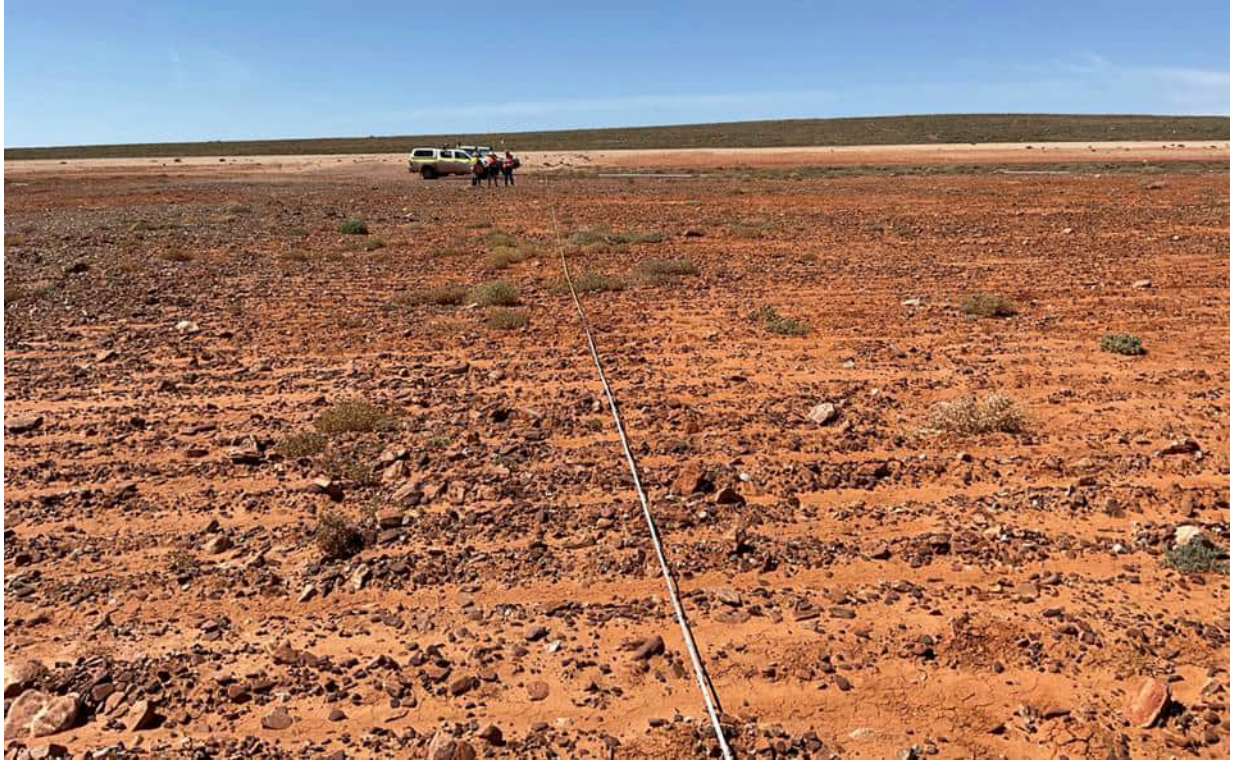
Plate 3.6: Midway quarry transect 3B, the contours have levelled out, now < 10 cm deep and plants have sparsely revegetated. Although still sparse, plant density is notably denser than in 2023

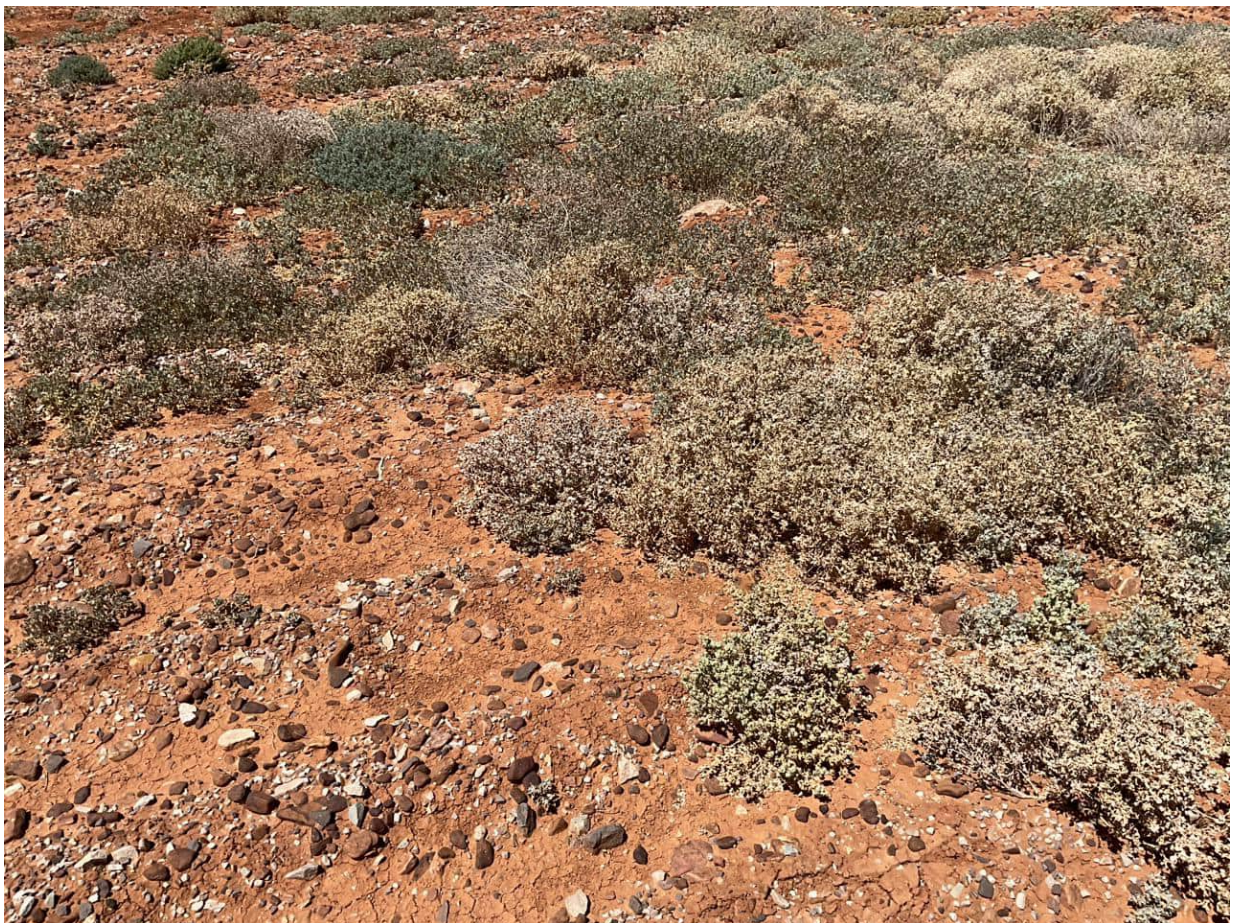
Plate 3.7: Dense patch of vegetation just off Midway Quarry transect 3A

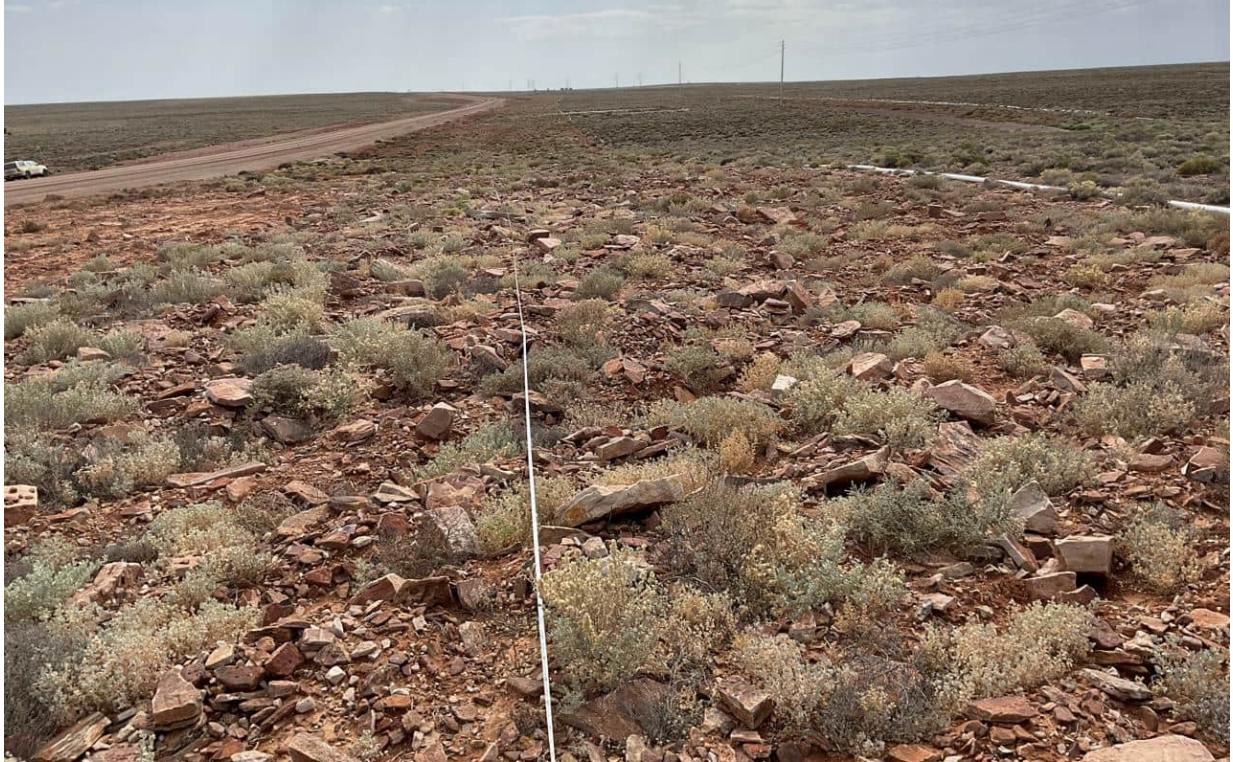
Plate 3.8: Tjungu transect 4A: From start at 0 m facing end. Large and abundant surface rock is present due to the deep ripping and vegetation is densely spaced

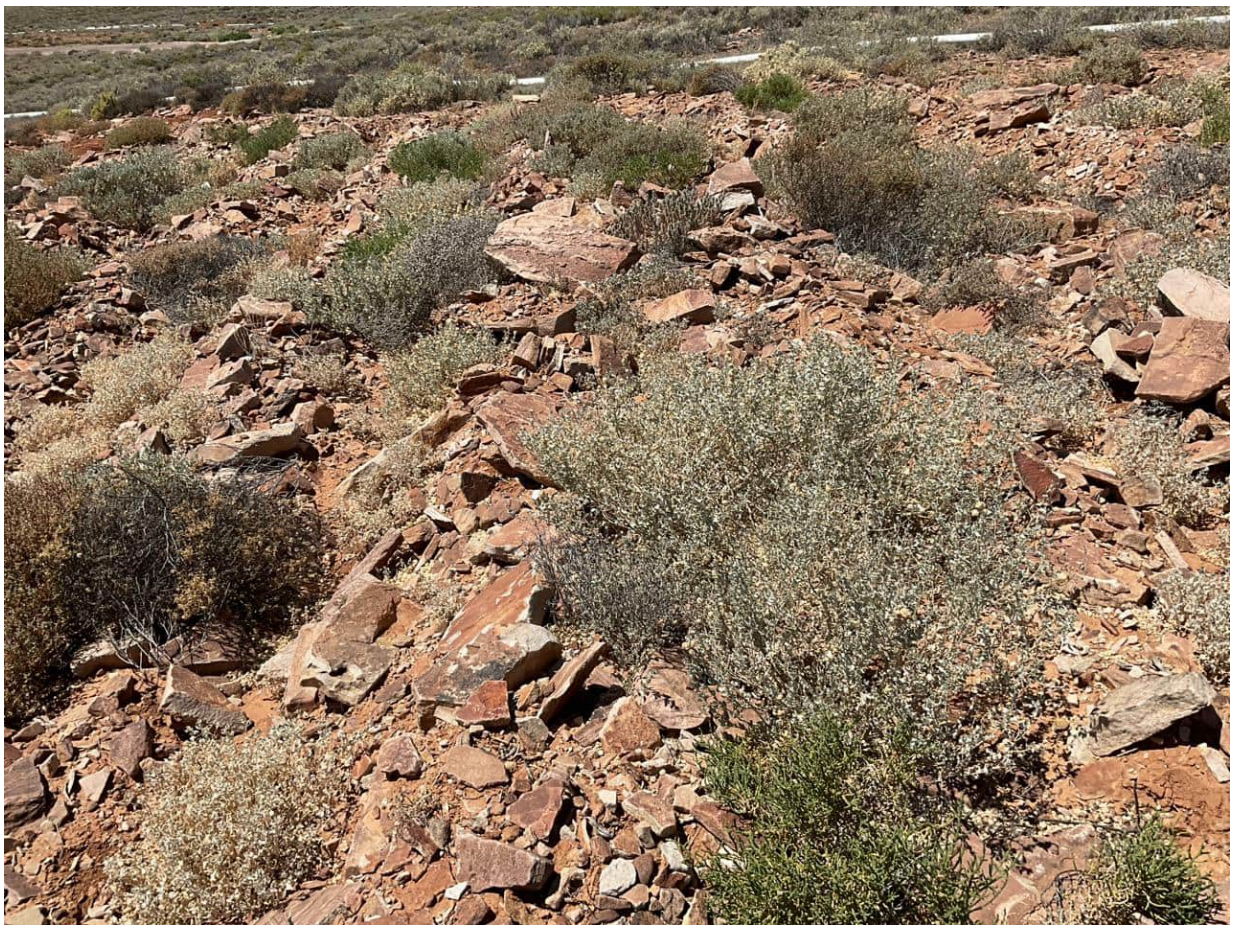
Plate 3.9: Transect 4A close up showing densely spaced vegetation in rip lines

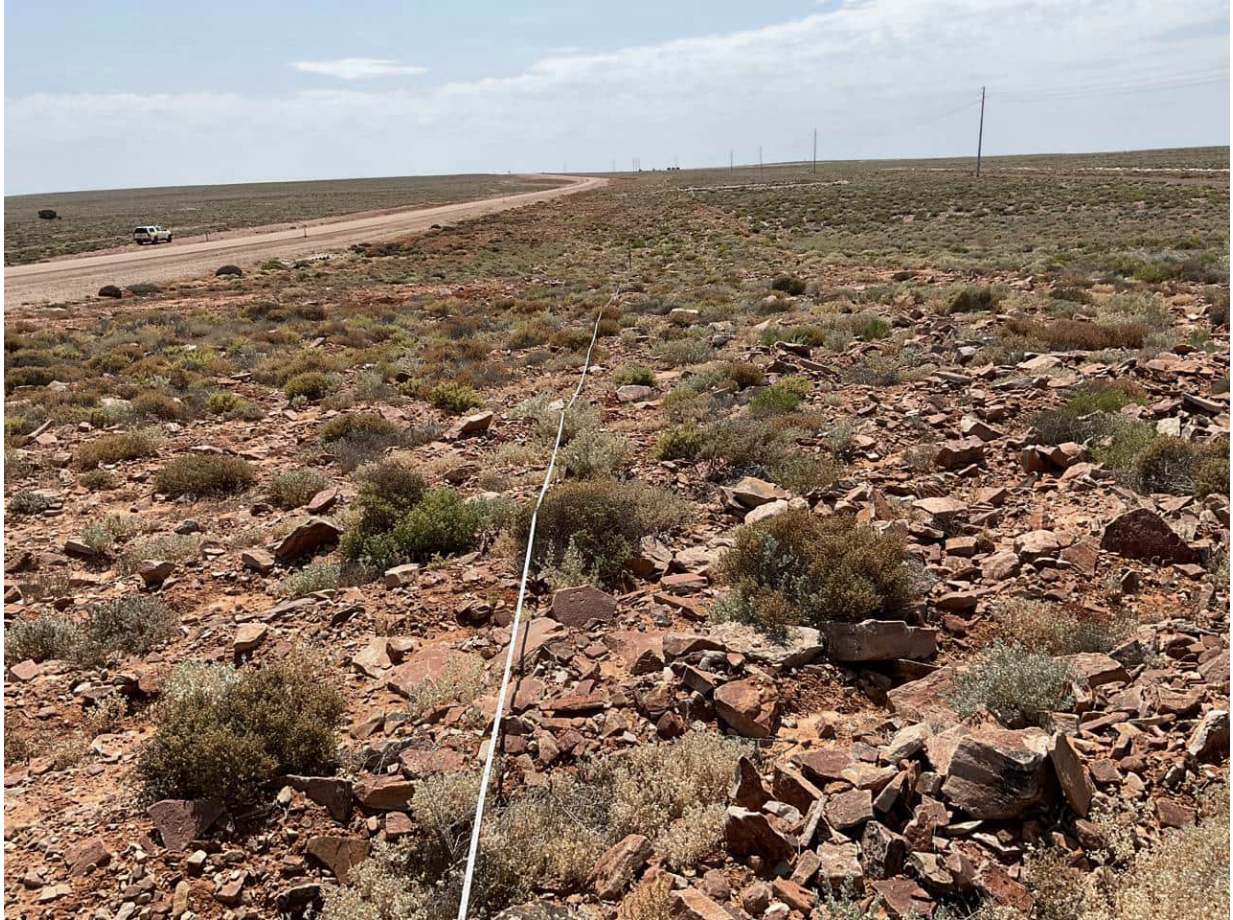
**Plate 3.10: Tjungu t transect 4B from start (0m). Densely spaced vegetation. Plant diversity comparable with adjoining non-cleared vegetation**
