# Annual Environmental Protection and Management Program Report Olympic Dam

1 July 2016 – 30 June 2017

**BHP Billiton Olympic Dam Annual EPMP Report**

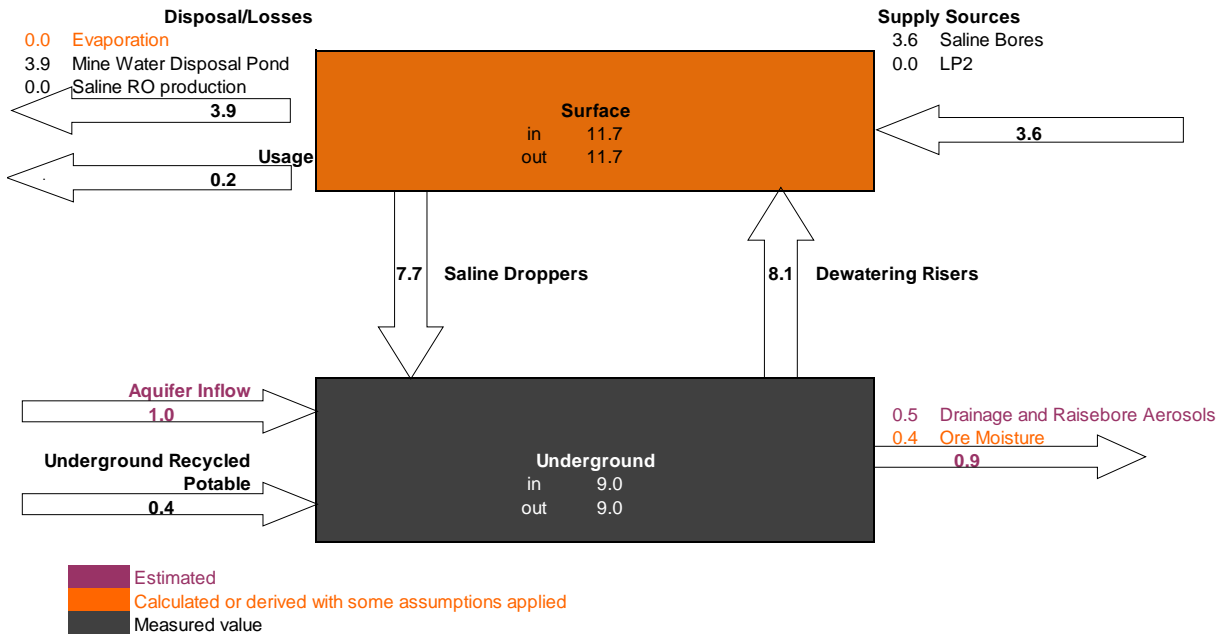
Groundwater inflow to the mine occurs at several intersections with the underground operations (Figure 1.2-3). Total natural inflow is estimated to be approximately 1.0 ML/d, the majority entering via upcast raise bores. Additional natural inflow comes into the mine via other entry points, including downcast raise bores, exploration drill holes and shafts. Much of the total inflow to the mine is transported to the surface as ore content or exhausted to the atmosphere as saline aerosols or moisture-laden air via upcast raise bores, estimated at around 0.9 ML/d.

**Figure 1.2-3: FY17 Saline (Mine) water balance summary (ML/d).**

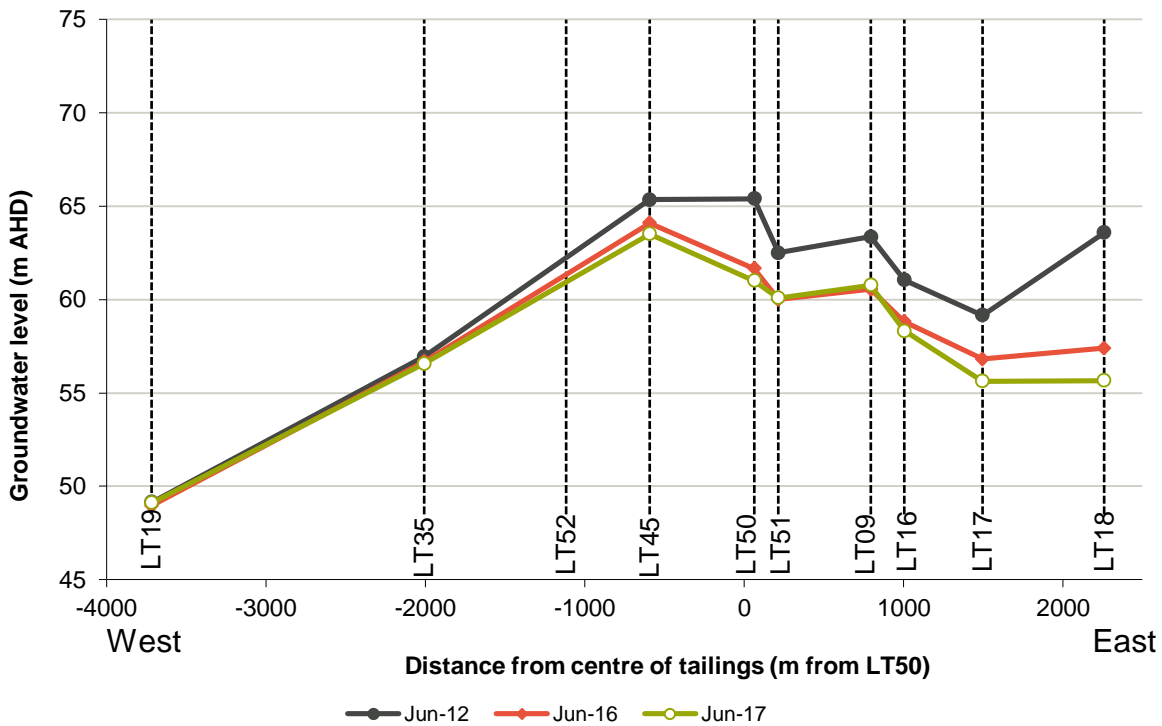
Figure 1.2-5: Change in groundwater elevation along an east-west cross-section from LT19 to LT18, through the centre of the TSF.

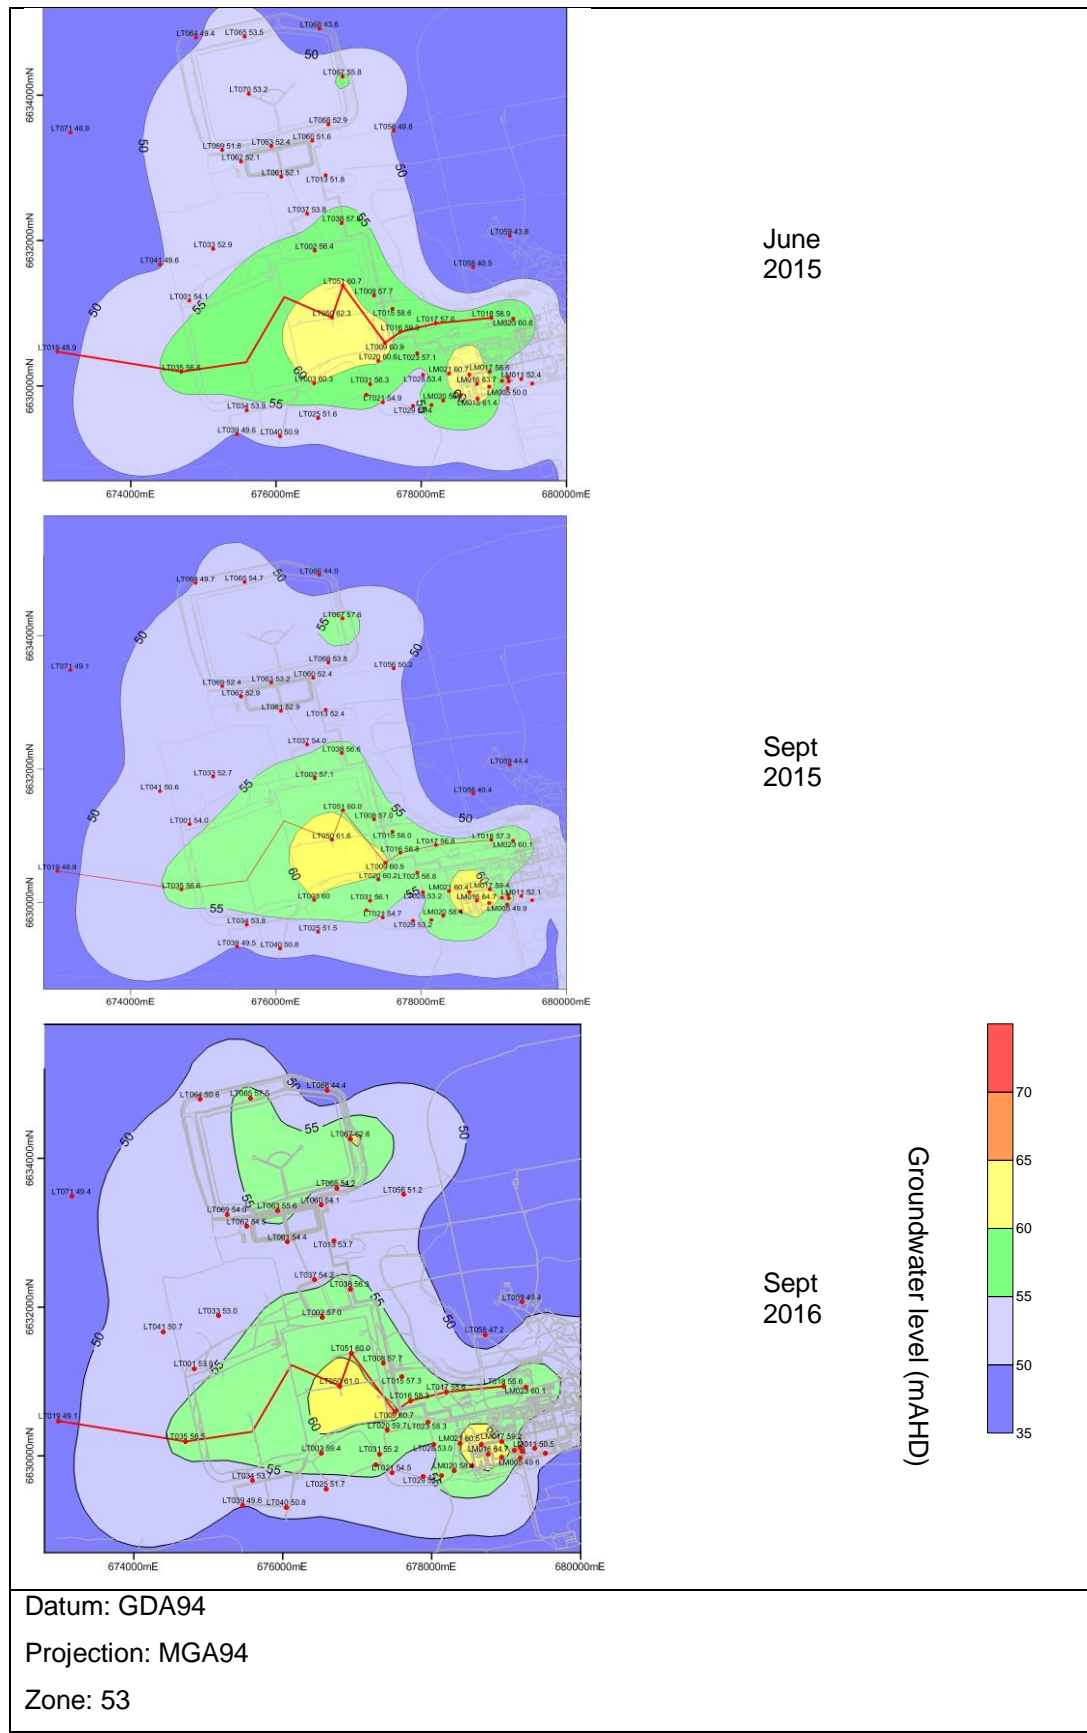
**Figure 1.2-7: TRS area groundwater levels (mAHD) Andamooka Limestone Aquifer.**

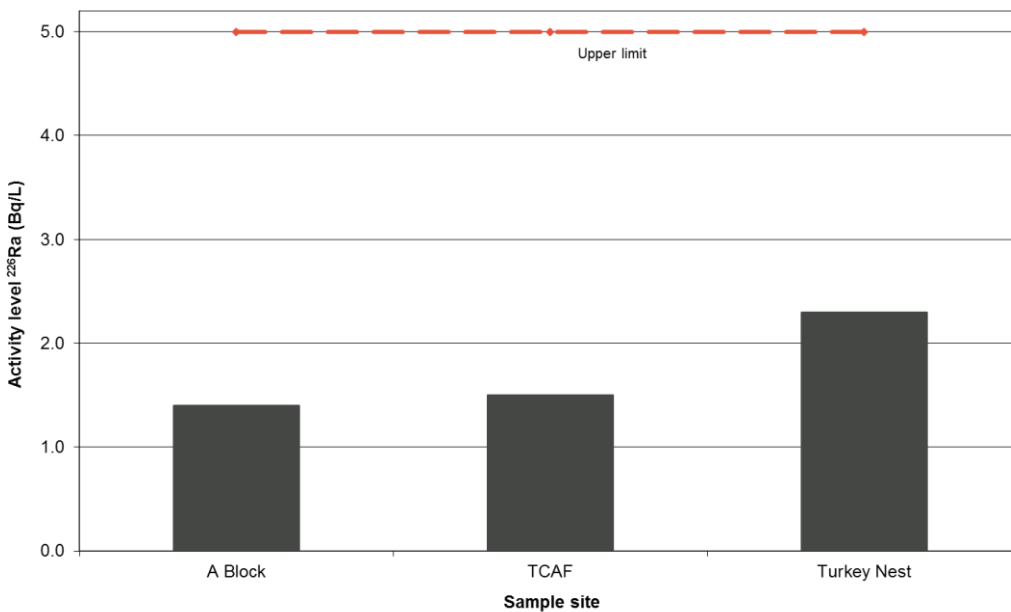
Figure 1.2-14: Mine water sample  $^{226}\text{R}$  levels and upper limit FY17.

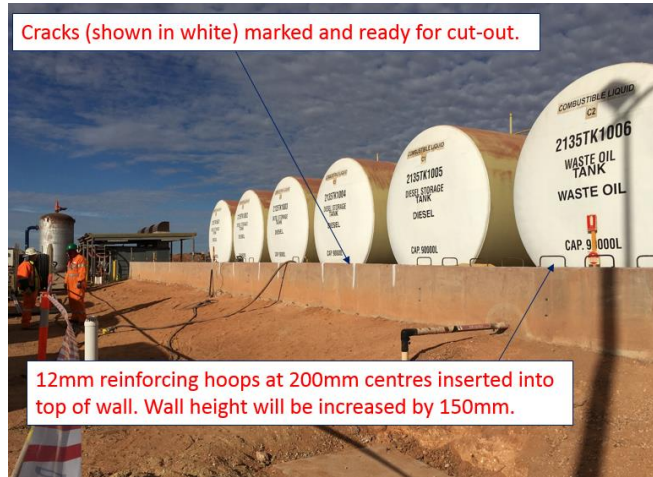
An environmental improvement plan was identified as part of the aspect and impact review process for the mine end fuel bay. Improvements and upgrades include the installation of tank overfill protection; an automated fuel shut off system and a local overfill alarm and gauge at the fill point. Bund crack repairs, increase in bund capacity and replacement of valves are currently in progress with the remainder of the works to be completed over the course of the next few months (Figure 2.1-2).

**Figure 2.1-2: Upgrade and repairs to the mine end fuel bay.**

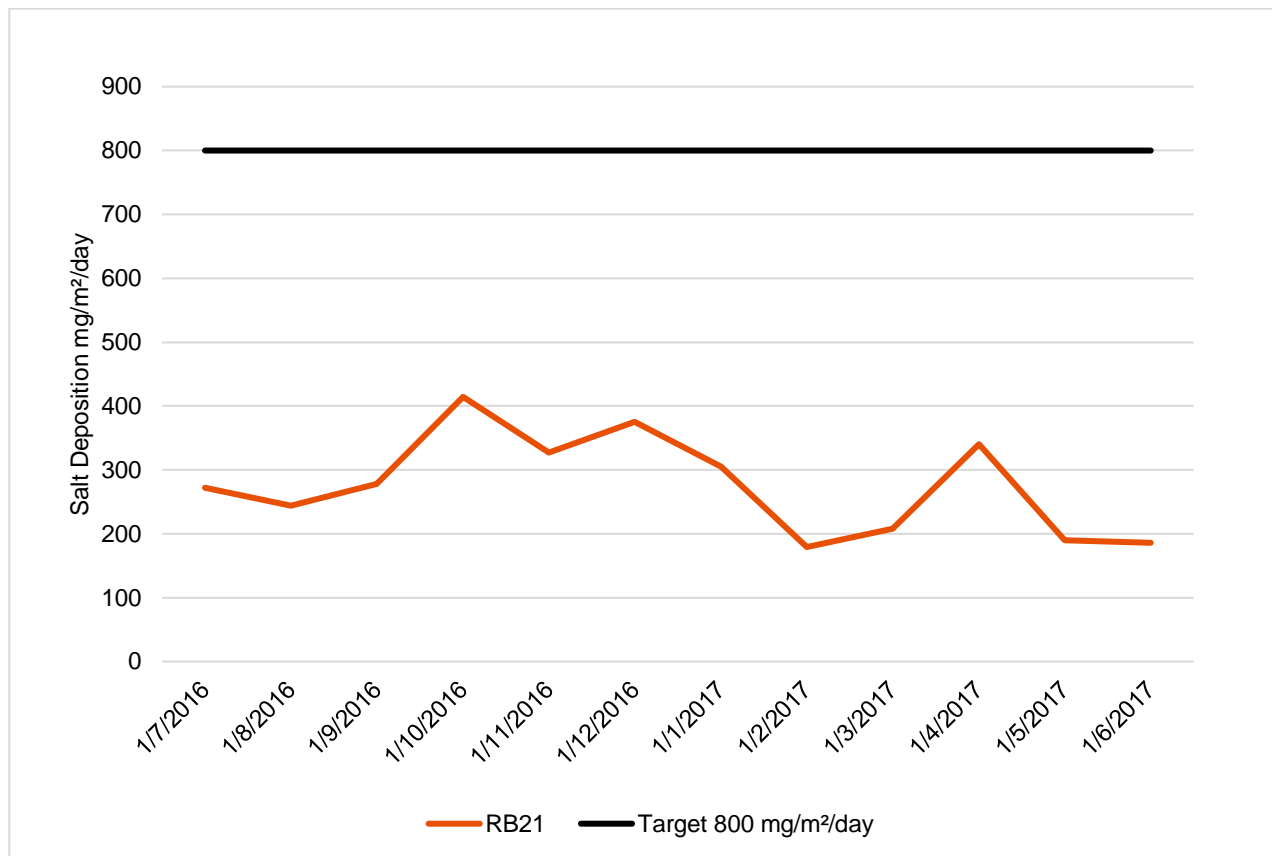
RB 21 has salt interception devices installed and remained below the salt deposition target of 800 mg/m²/day for all of FY17 (Figure 3.3-3).

**Figure 3.3-3: Saline deposition from RB21 FY17.**
