Annual Environmental Protection and Management Program Report

Olympic Dam

1 July 2019 – 30 June 2020

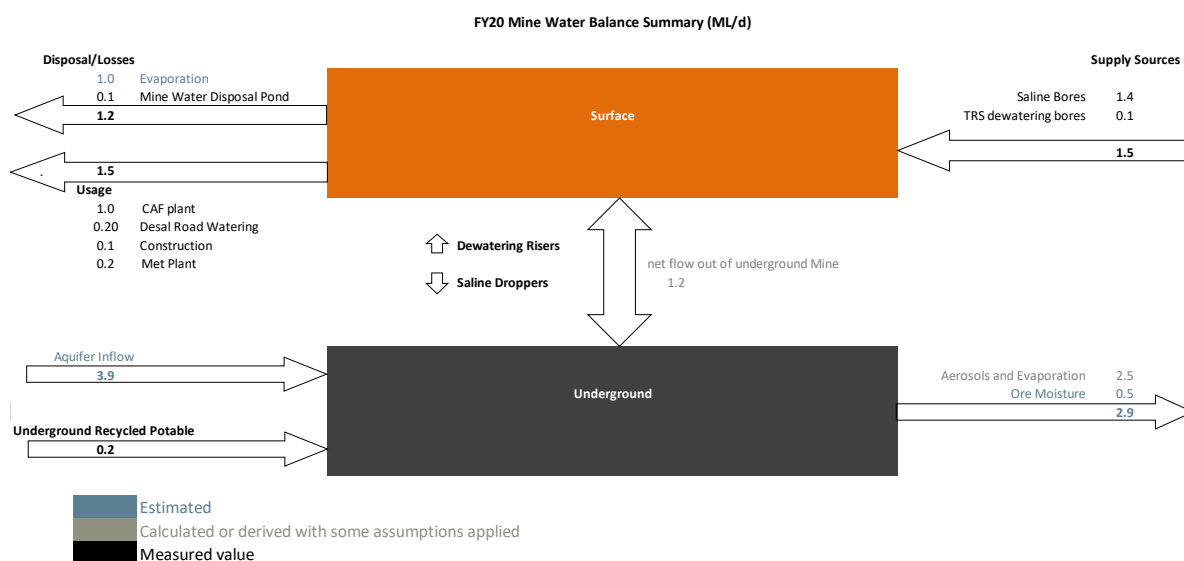
Figure 19: FY20 Saline (Mine) water balance summary (ML/d) (totals may differ from individual values due to rounding).

Groundwater inflow to the mine occurs at several intersections with the underground operations (Figure 19). Total natural inflow is estimated to be approximately 3.9 ML/d, the majority entering via upcast raise bores. Additional natural inflow comes into the mine via other entry points, including downcast raise bores, exploration drill holes and shafts. Much of the total inflow to the mine is transported to the surface as ore content or exhausted to the atmosphere as saline aerosols or moisture-laden air via upcast raise bores, estimated at around 2.5 ML/d.

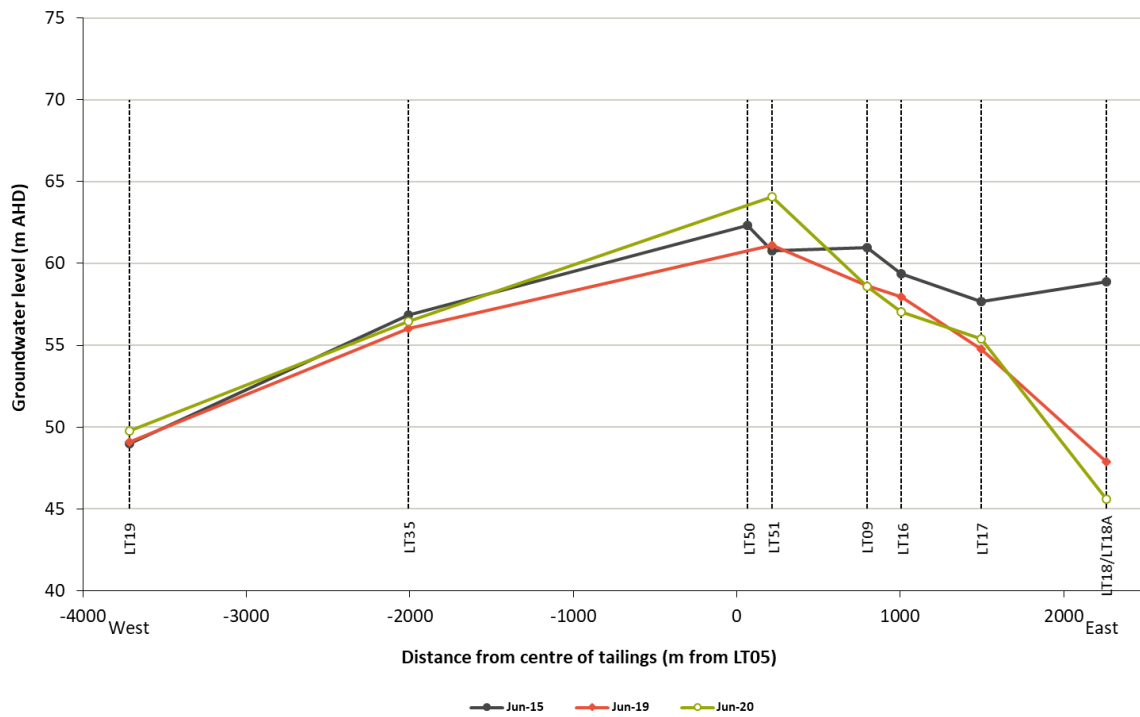
Figure 21: Change in groundwater elevation along an east-west cross-section from LT19 to LT18A, through the centre of the TSF.

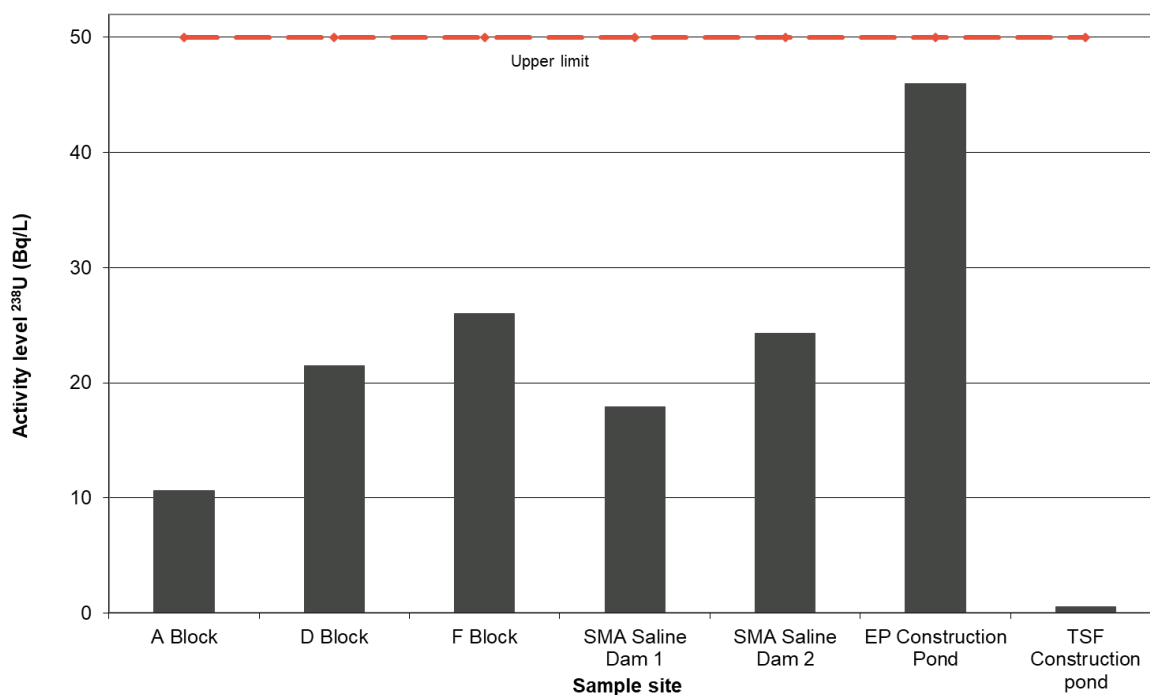
Figure 29: Mine water sample ²³⁸U levels and upper limit FY20

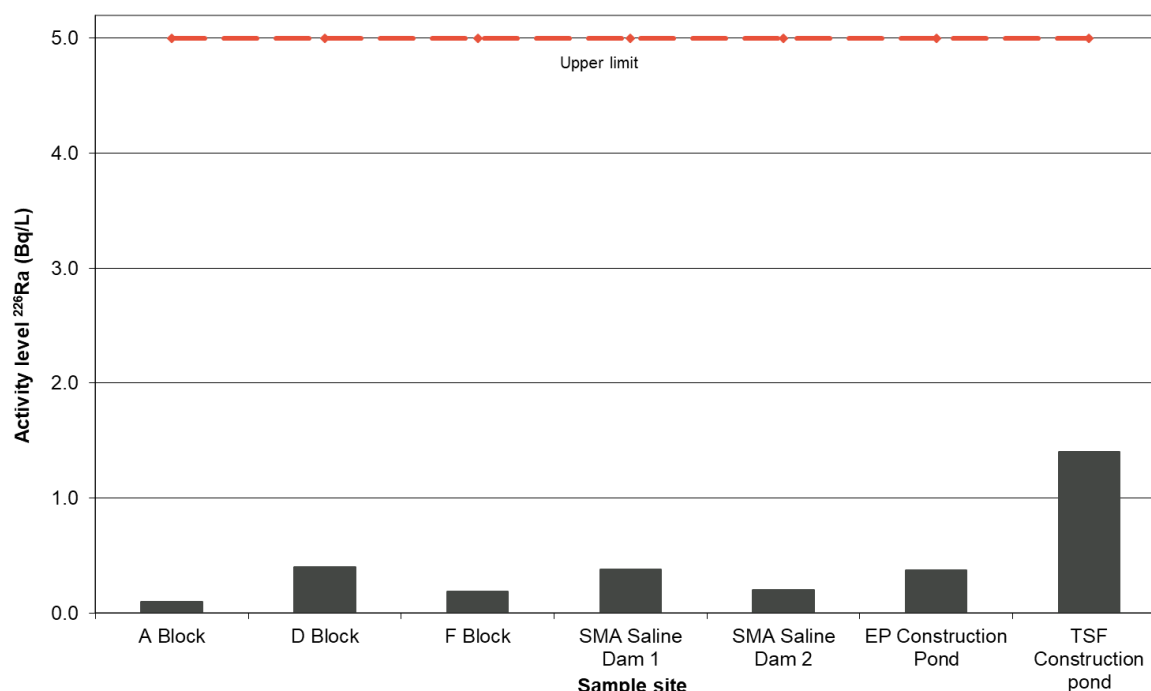
Figure 30: Mine water sample ²²⁶R levels and upper limit FY20

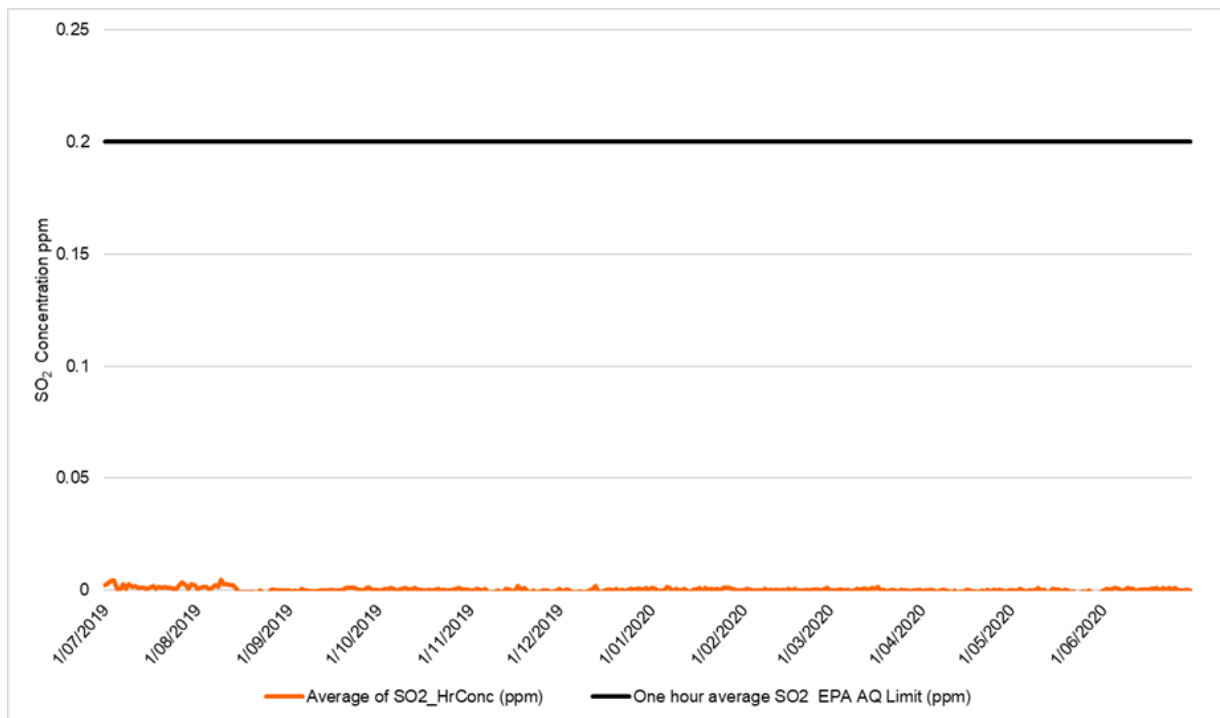
Figure 41: Measured hourly mean SO₂ concentration at sensitive receptor, Roxby Downs.

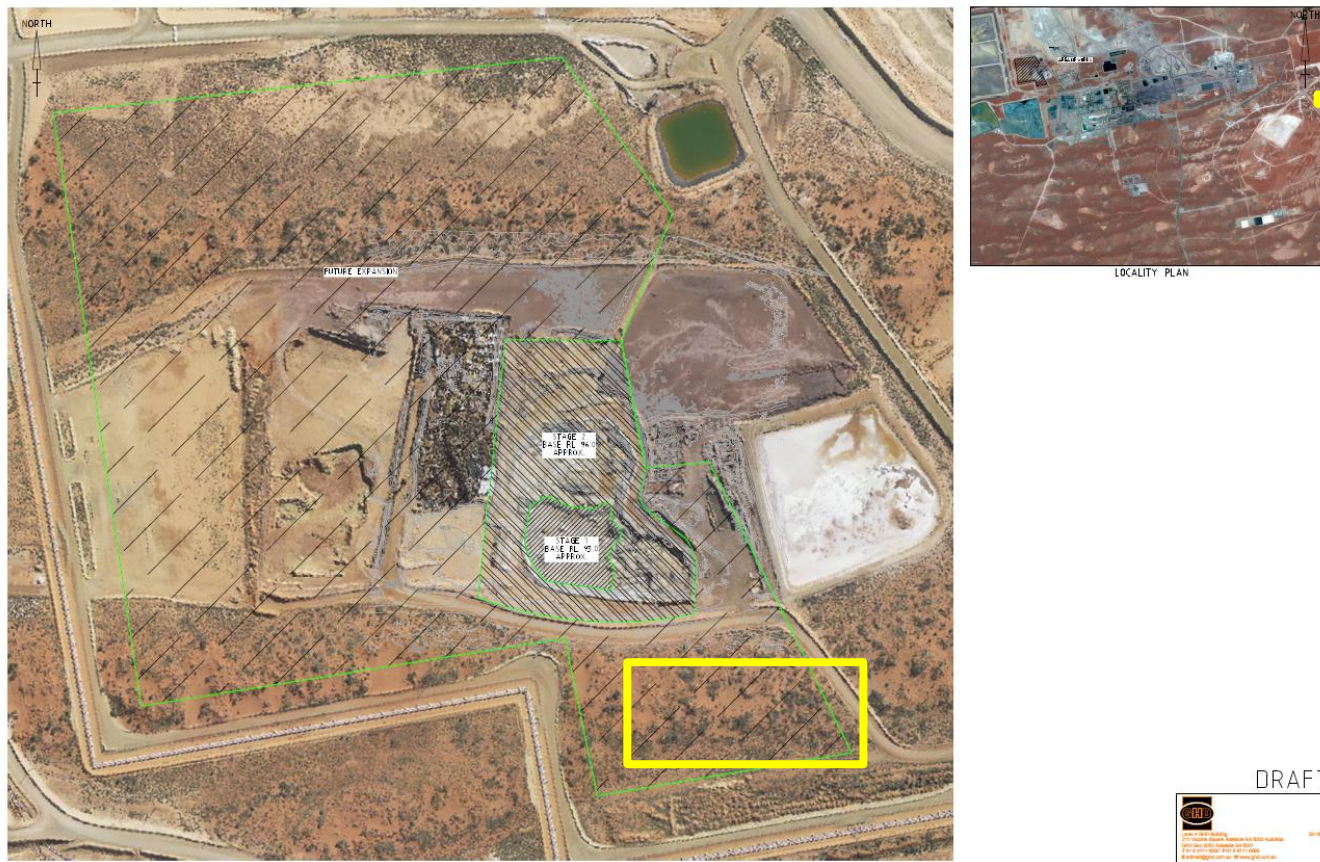
Figure 82: Currently active disposal area within CWDF Cell 1 Stage 2
