Prominent Hill Operation PEPR Compliance Report 2025

September 2025

PH-999-SEC-REP-5044

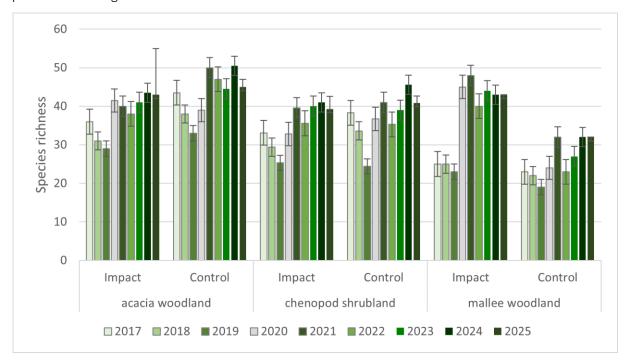
The average total species diversity in 2025 decreased for all vegetation-condition type combinations except mallee woodland impact sites compared to the 2024 monitoring data (Figure 3). The largest decrease was observed in the acacia woodland and chenopod shrubland control sites with a decrease of 5 species per site on average. However, the control and impact site in mallee woodland did not differ from 2024. Both impact sites for chenopod shrubland and acacia woodland decreased by 1 to 2 species per site on average from 2024 to 2025.

Figure 3: Total mean species richness (± SE) across the 2017-2025 monitoring period

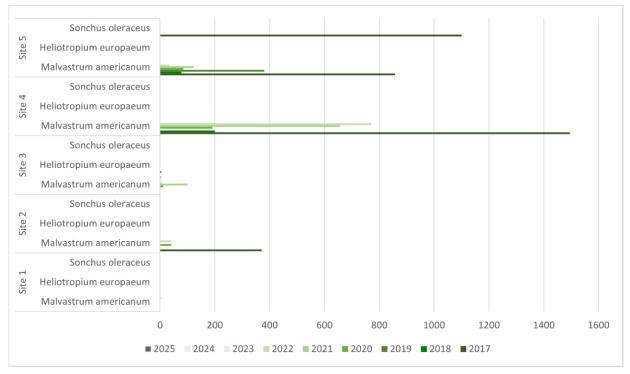
Malvastrum americanum var americanum is the most common weed species across the study area, occurring in all except one of the monitoring sites. Figure 14 shows cover for both the control and impact sites across the study area. Both the control and impact sites show variation in cover that is consistent with some seasonal variation and do not indicate and increase in this particular weed species as a result of disturbance from the mine.

Figure 13: Weed abundance across the five weed monitoring locations 2017-2025 surveys

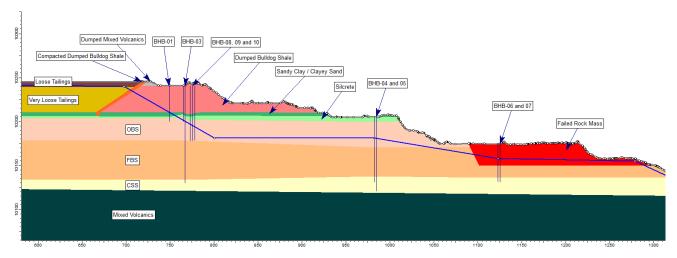
Figure 2.3 Stage 6 TSF layout at Section B (pit alignment)

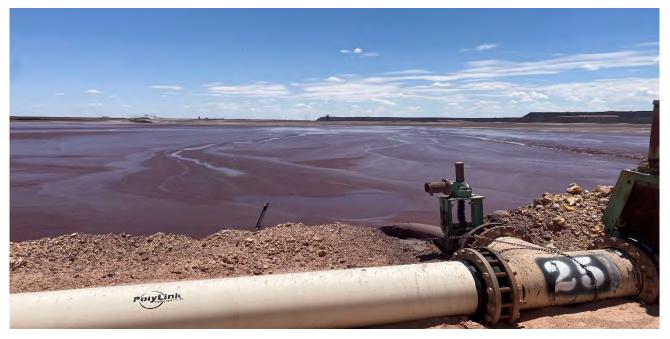
During the inspection, we stopped at a few spigots around the TSF to observe the discharge system. There had been recent deposition at Spigot 25 (refer Figure 3.1) and at the time of inspection there was discharge of tailings through spigot 15 on the southern embankment, shown in Figure 3.2. Delivery pipelines appeared in good condition, with no signs of leakage, corrosion or damage observed, as shown in Figure 3.3.

Figure 3.1 Recent tailings discharge from Spigot 25 at the southern embankment, facing north-west

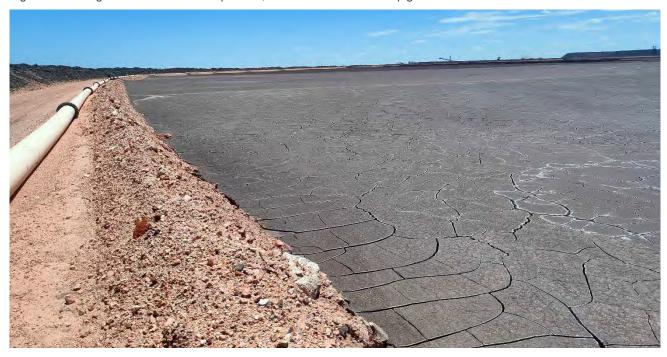
Figure 3.3 Discharge pipeline, southern embankment

No deformation of the TSF embankment was observed at the time of the site visit, with a photograph of the southern TSF embankment shown in Figure 3.3. Infrequent cracking was observed near the upstream edge of the TSF embankment. It was discussed that these cracks would be remediated during Stage 6 TSF construction, which commenced in March 2025. No damp spots suggesting seepage were observed. No erosion was observed on the downstream slope of the IWL.

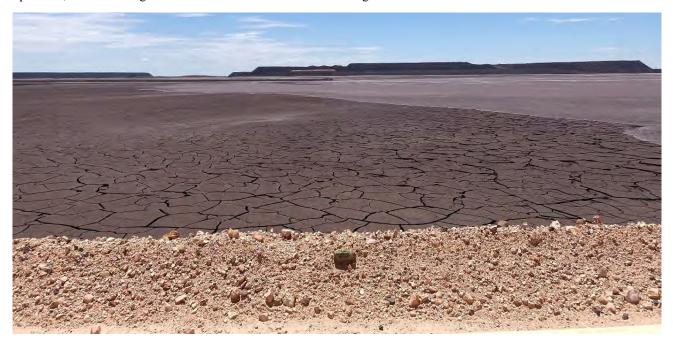
Figure 3.4 Tailings beach showing desiccation cracks, southern embankment

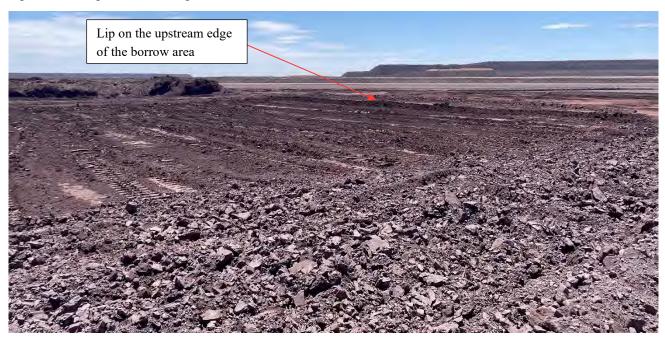
The tailings remining project had progressed on the southern portion of the tailings beach, as shown in Figure 3.5. Generally, the base of the excavation appeared to grade towards the decant pond, with a lip present at the upstream extent as shown in Figure 3.5. It is envisaged that temporary ponding may occur at this location during early stages of Stage 6 operation, unless drainage channels are excavated for water management.

Figure 3.5 Tailings near to the southern embankment being tilled and piled up

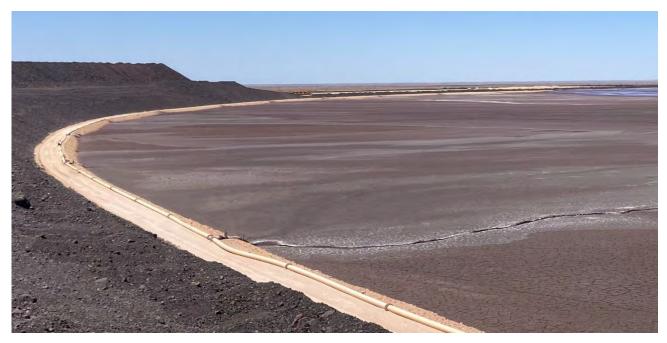
Figure 3.6 Freeboard capacity observation, northern embankment

At the time of the site visit, the Stage 5 operating freeboard was assessed to be consistently less than 1 m, with isolated instances where the tailings beach was approaching the limit of 0.3 m. Observations of the freeboard available for the southern and northern embankments are shown in Figure 3.3 and Figure 3.6 respectively. Stage 6 construction commenced on the southern embankment in March 2025.

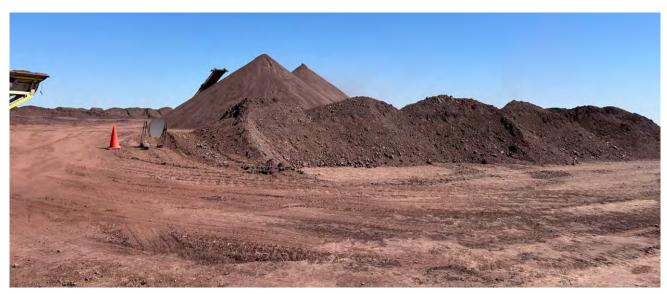
Figure 3.7 Tailings stockpiles on the southern waste rock dump crest (photo taken 2 April)

Tailings won from the deposit during the remining works described in Section 3.2.3, were hauled to the southern portion of the waste rock dump crest and stockpiled for reuse as underground backfill, as shown in Figure 3.7. The stockpiled tailings remained at these locations longer than expected due to limitations surrounding the reuse of this material. WSP suggest that a plan to exhaust stockpiled material should be developed as soon as practicable to manage risks associated with dust.

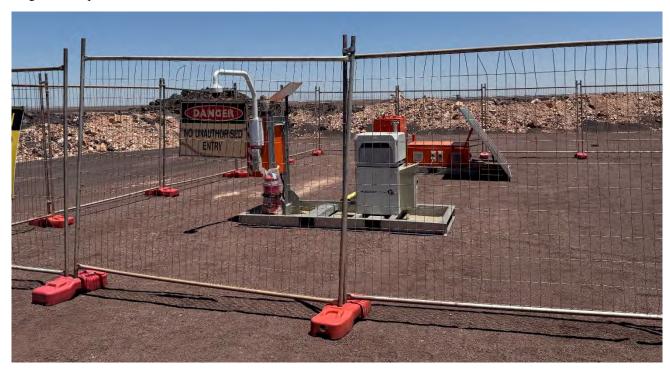
Figure 3.8 Rocket DNA drone home location

The Rocket DNA drone was being commissioned on the crest of the WRD downstream of the southern embankment at the time of the site visit, as shown in Figure 3.8. The drone will be used to provide survey and aerial imagery throughout Stage 6 TSF operations.

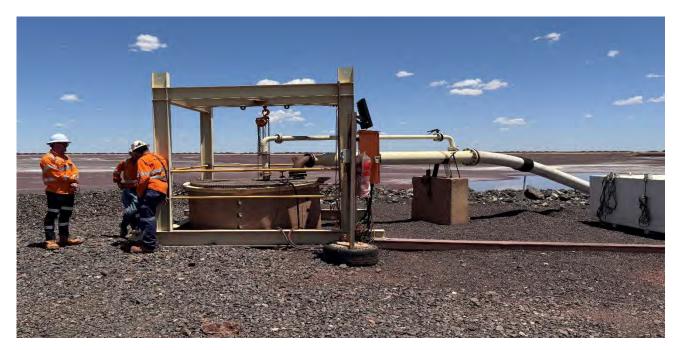
Cracking was observed at the surface of bulk fill placed to form the Stage 5 Decant Causeway. This cracking has previously been attributed to differential settlement due to consolidation of the tailings and is not considered an instability risk for the TSF. Nevertheless, WSP recommends that BHP continue to monitor the cracking development on the decant causeway.

Figure 3.9 Decant causeway tower

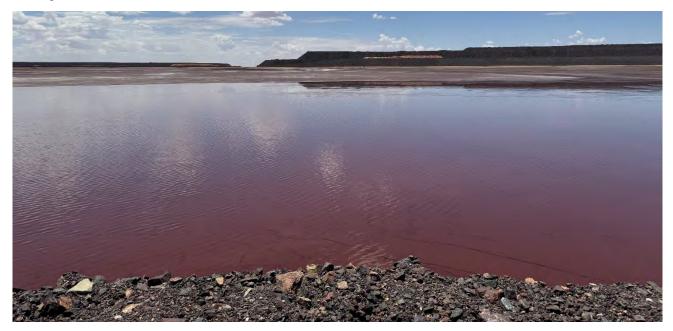
The decant pond was observed at the end of the causeway during the site visit, as shown in Figure 3.10. The pond was considered to be relatively circular in nature, with a radius of less than 100 m. Our calculations indicate a surface area of less than 3 ha based on these observations, which is comfortably within the normal operating zone based on the trigger values presented in Section 6.

Figure 3.10 Extent of decant ponding observed during the site visit

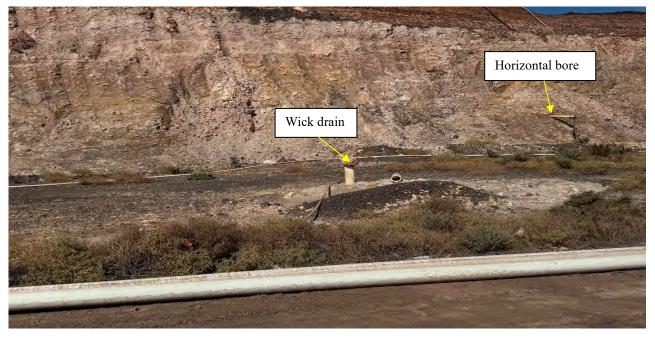
Based on our technical studies in 2024 during development of the Stage 6 embankment raise, it is clear that the performance of horizontal bores key to managing risks associated with the stability of the TSF embankment. We recommend that BHP continues to monitor damp spots and vegetation growth on the face of the southern pit wall and review flow data collected by the horizontal bores. More information on flows collected at the horizontal bores is described in Section 4.1.2.

Figure 3.11 Example of a horizontal bore at the first bench of the open pit

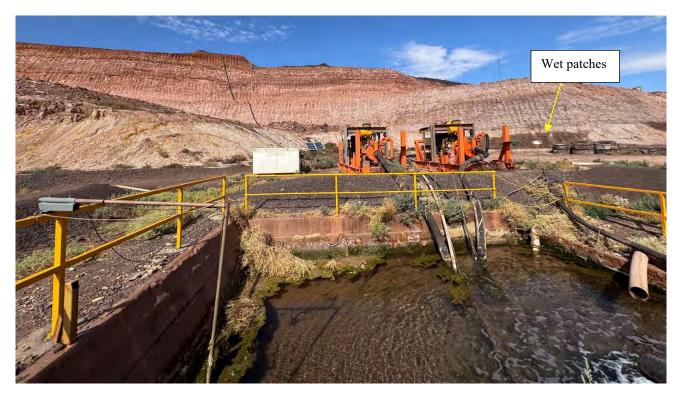
Figure 3.12 Damp spots on the face of the open pit, near the seepage collection sump

The horizontal bores and the collection sump located at the first bench of the southern pit wall were observed during the site visit. The bores extending from the pit wall and water pipelines appeared to be in reasonable condition at surface, as shown in Figure 3.11. Some damp spots and vegetation were observed on the face of the open pit, as shown in Figure 3.12.

Seepage collected by the horizontal bores is redirected to two sumps inside the open pit, one of which is shown in Figure 3.12. Seepage was observed to be flowing freely into both sumps at the time of the site visit, with no solids observed in flows collected. WSP is aware that BHP is installing flow meters on the horizontal bores, and installing additional bores to improve the seepage collection system.

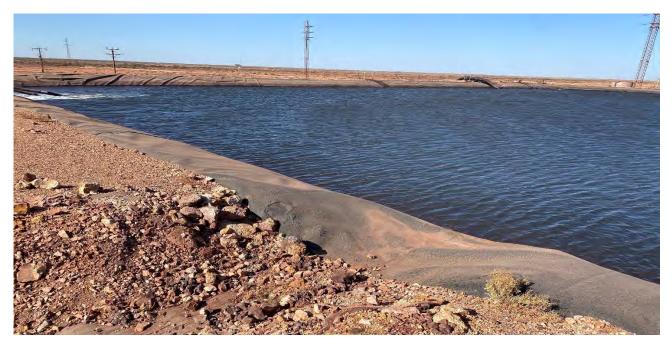
These ponds are important appurtenant structures to the TSF. Recommendations have been included in Section 7 to improve the understanding of these ponds within the water management system at site. The initial task is to use the survey drone (refer Section 3.3) to take monthly survey of the ponds for measurement of the water level, for use in an updated water balance, and to use as the basis of calculations for management of storm events.

Figure 3.13 Raw Water Dam spillway invert

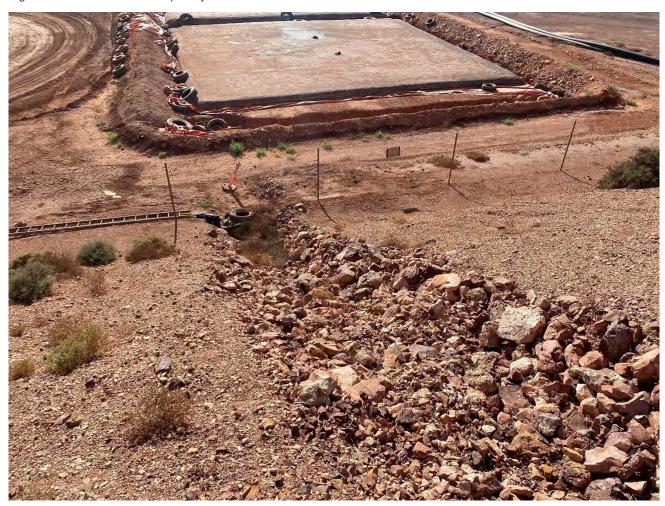
Figure 3.14 Raw Water dam spillway chute

- The Raw Water Dam is quite full, and based on our discussions with BHP, is generally operated this way.
- The spillway on the Raw Water Dam is shown in Figure 3.13 and Figure 3.14. It is uncertain whether the spillway meets the design requirements of current ANCOLD guidelines and we recommend this should be checked. The recommendations in Section 7 suggest a staged approach to this check.
- A pipe was discharging water onto the crest of the Raw Water Dam, as shown in Figure 3.15. BHP indicated that the pipe was to be extended further into the pond.

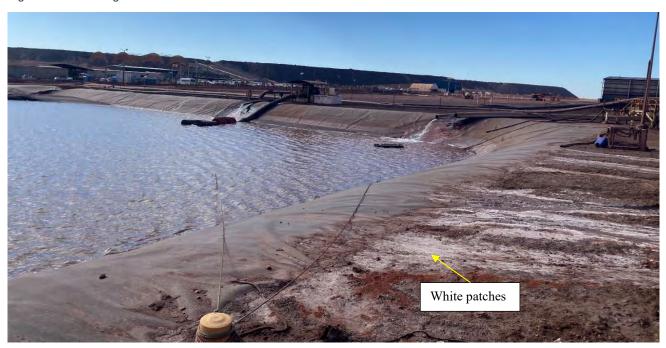
Figure 3.16 Condition of the Enviro Dam

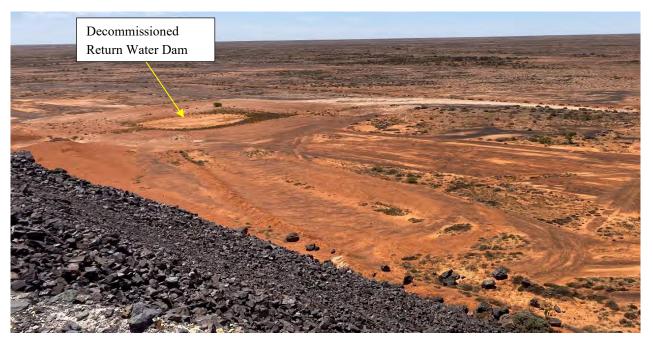
Figure 3.17 Former return water dam area

Notwithstanding, we recommend continuing to observe the valve pit and the depression in the footprint of the decommissioned return water dam during future annual inspections.

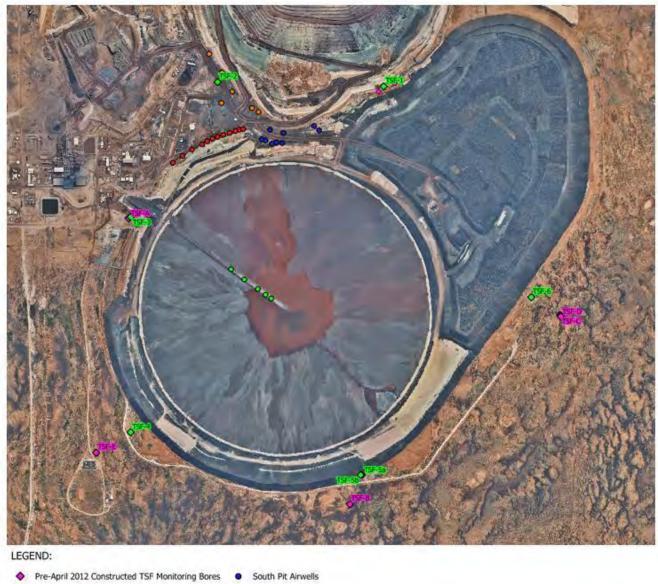
Figure 4.4 Locations of monitoring bores and dewatering wells at Prominent Hill TSF

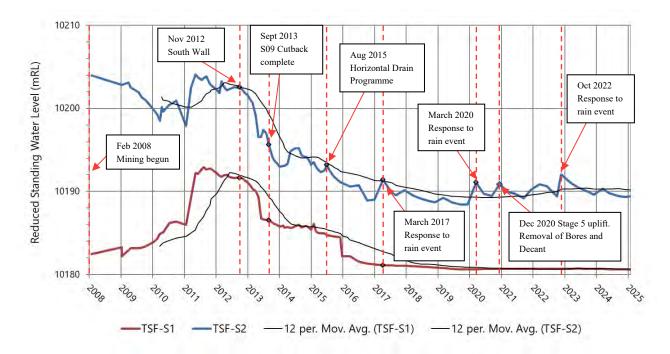
- 3 Similar trends of groundwater level development can be observed during 2024 across the monitoring data. A slight decrease is shown in TSF-S2 and TSF-A groundwater level, with less than 0.2 m decrease. Groundwater level at TSF-D has kept increasing with a similar trend since 2013 to approximately RL 10,119 m.

Figure 4.5 Historical water levels in groundwater monitoring bores TSF-1 & TSF-2 (Source BHP)

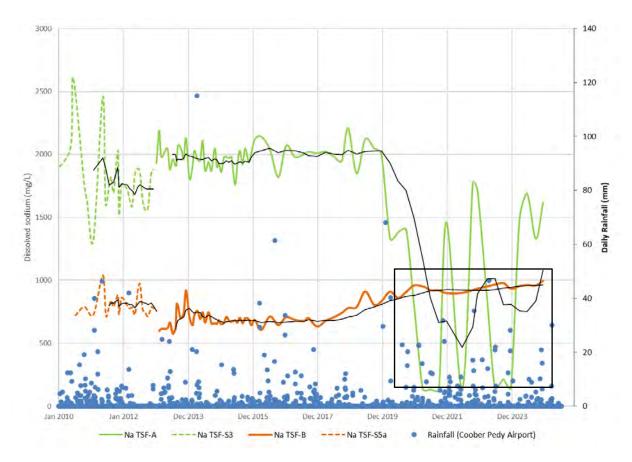
Data is still being collected irrespective of these findings. Groundwater samples could be used to improve confidence in TSF stability due to changes in the salinity of surficial soil units.

Figure 4.8 Historical levels of dissolved sodium in TSF-A & B (Source BHP)

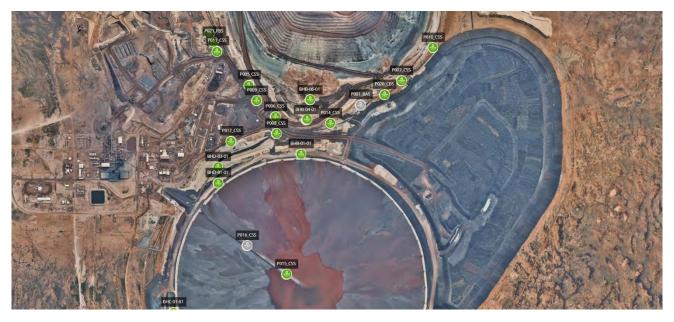
Figure 4.13 VWP borehole locations

Pore pressure data from instruments installed during the Stage 6 Geotechnical Investigation is now available in BHP's Beyond Monitoring system, with test locations shown in Figure 4.13. Data available up to 7 February 2025 has been exported based on the geological unit the instrumentation was installed in and is available in Appendix C-1.

The current pore pressure and maximum pressure measured by each instrument has been documented in Appendix C-2 and reviewed against trigger values developed for the Stage 6 TSF embankment. This data indicates that only the instrument installed in the Oxide Bulldog Shale at P008 triggered a level outside of the normal operating zone based in October 2024, which is in the troubleshooting zone in the Trigger Action Response Plam (TARP). BHP is following the action and response plan in the OMS manual.

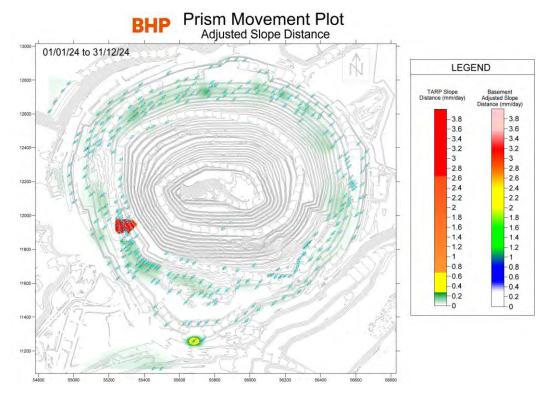
- 1 Movement of less than 0.5 mm per day is considered negligible by BHP.
- 2 The majority of prisms have moved between 0 mm to 15 mm over the year, which is less than the limit described above.
- 3 Two zones of relatively high movement are visible in Figure 4.14, near the access road at the top of the pit (south of the pit) and the red zone on the western face of the pit. Both have been attributed to loose instruments that may have been knocked during the period. BHP advised that the zone to the south of the red coloured area is anomalous movement and will be a target area for future horizontal drainage bores.
- 4 The trend of inwards movement at the pit is described as consistent with historic observations.

Figure 4.14 Average open pit movement between 1 January and 31 December 2024 (Source BHP)

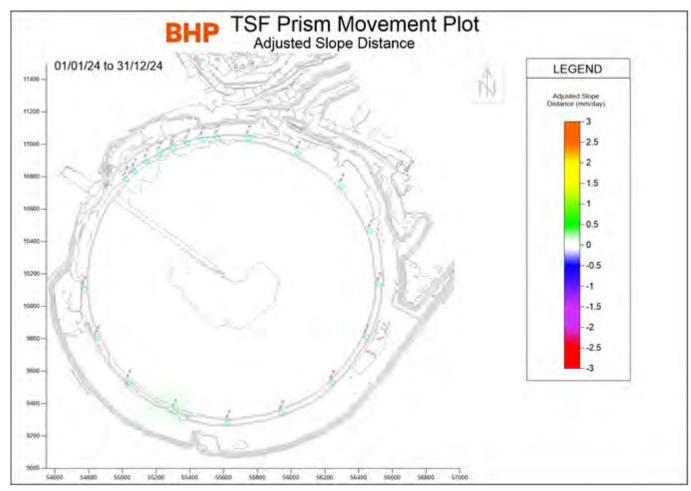
BHP set the trigger values presented in Stage 5 operating TARPs based on half of the pit wall movement triggers. The movements for 2024 are within the normal operating conditions. WSP has recommended a deformation model is developed to justify these values.

Figure 4.16 Prism movement in the TSF in Q4 2023 (Source BHP)

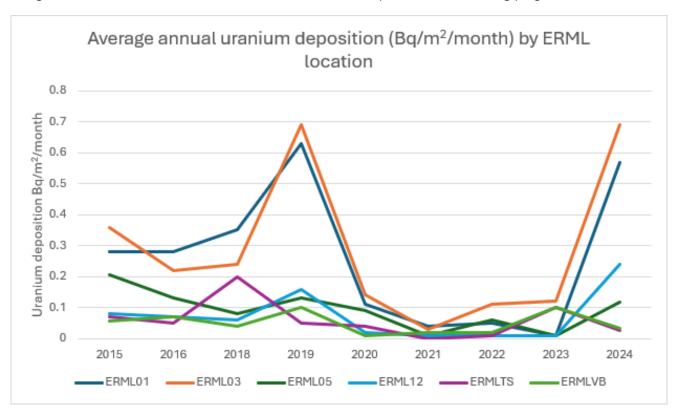
Average gamma dose rates remained comparable. Average dust deposition was greater for all sites, indicating that the amount of dust deposition was likely due to regional weather conditions, rather than dependant on site activities. Radon concentrations remain below detectable limits for half of all measurements. Concentrations often being below detectable limits has been the case since the inception of the monitoring program.

Figure 3: Average U²³⁸ deposition (g/m²/month) at each ERML results comparison
