Mt Keith Satellite Statement 1087 Compliance Assessment Report BHP Nickel West

29 March 2022

Condition 4-6 of the Statement 1087 approval requires BHP Nickel West to submit an annual Compliance Assessment Report which outlines the status of implementation of the Project and compliance with the approval conditions. This Report outlines the implementation status and compliance for the Project covering the period of 28 December 2020 to 31 December 2021. BHP Nickel West was in compliance with all conditions of the Statement 1087 approval during the reporting period.

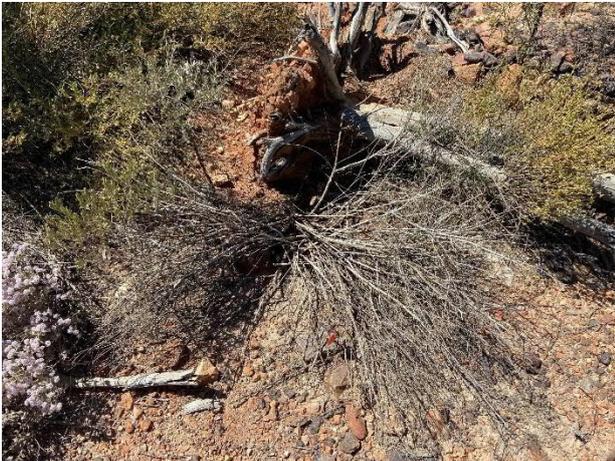
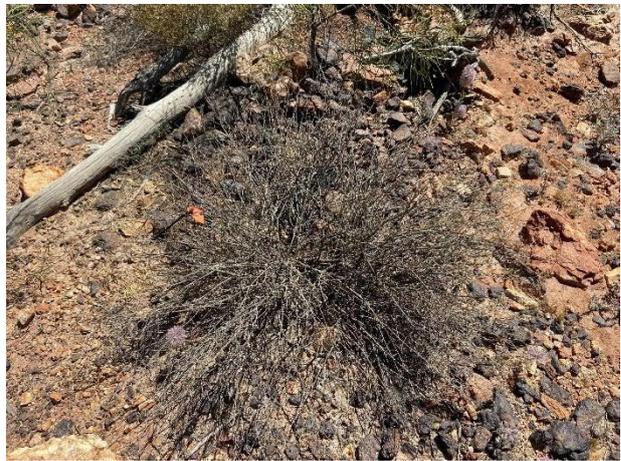
Figure 4-3: *Hybanthus floribundus* subsp. *chloroxanthus* dead individuals at the south-west impact site. HFC_70 located on the left and HFC_71 located on the right.

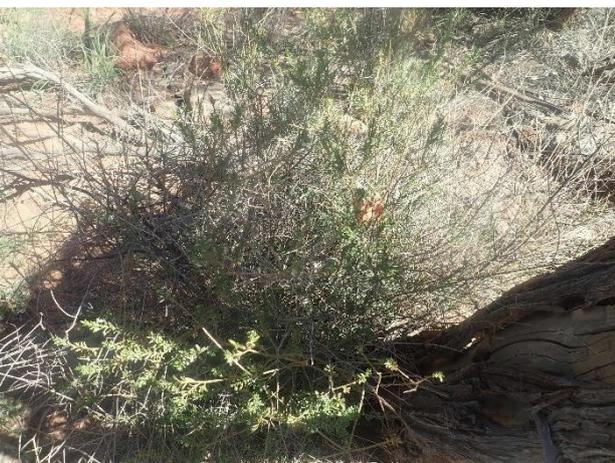
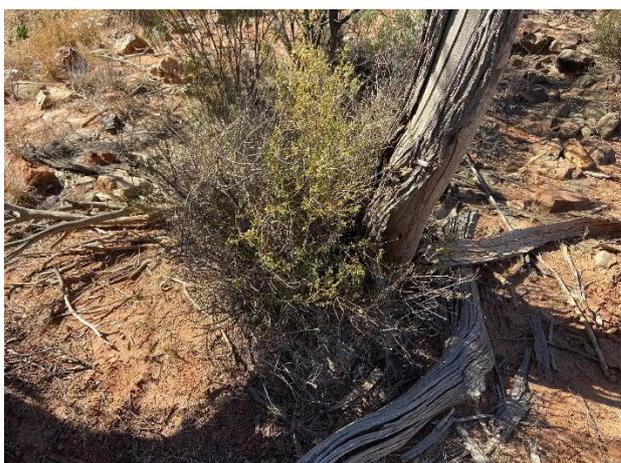
Figure 4-4: *Hybanthus floribundus* subsp. *chloroxanthus* individuals HFC_54 at the south-west impact site in March 2021 (left) and showing signs of yellowing in October 2021 (right).

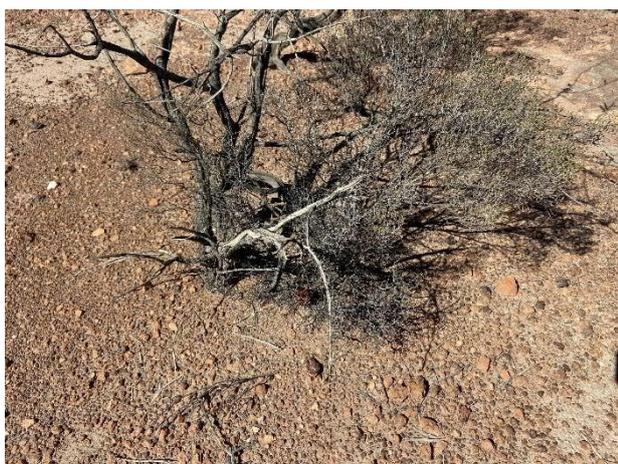
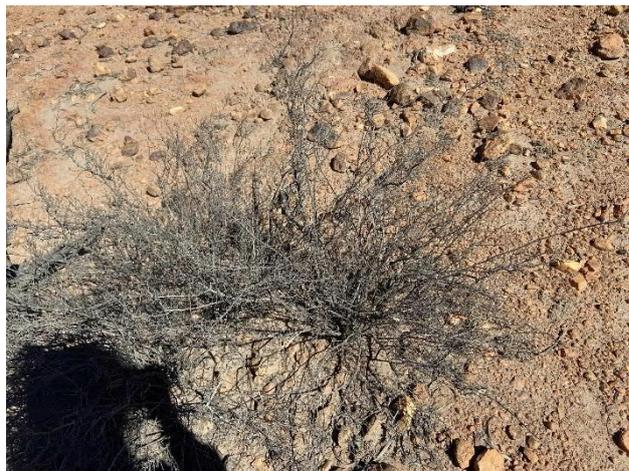
Figure 4-6 Both *Hibbertia* sp. Sherwood Breakaways (R.J. Cranfield 6771) individuals, HSPSB_141 and HSPSB_157, assessed as dead in October 2021.

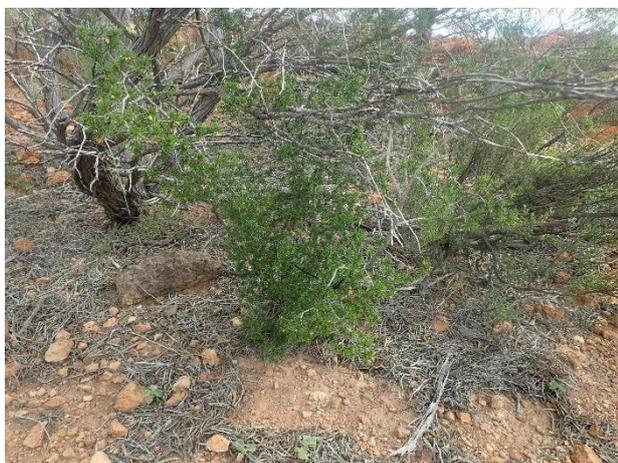
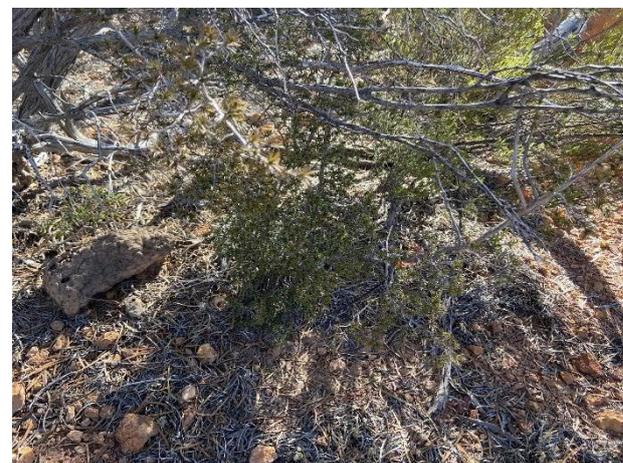
Figure 4-7: *Hibbertia* sp. Sherwood Breakaways (R.J. Cranfield 6771) individual, HSPSB_98 displaying the influence of rainfall on foliage after the March (left) and October assessments (right).

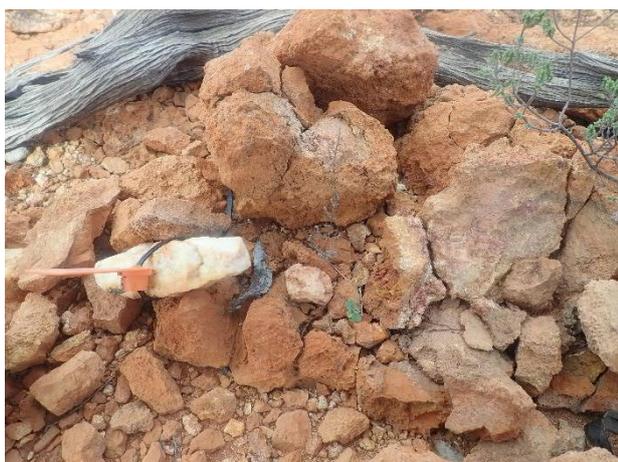
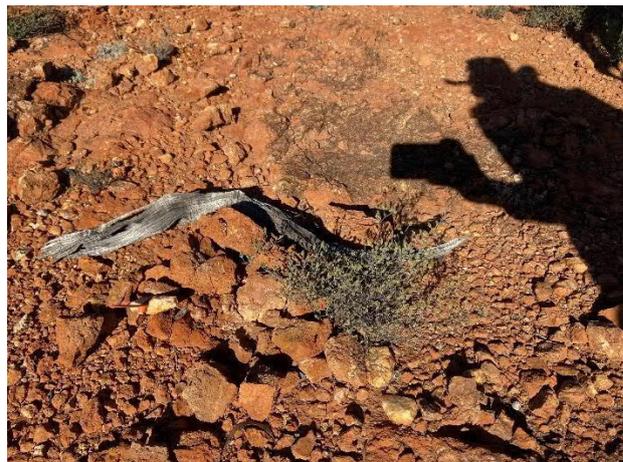
Figure 4-9: *Verticordia jamiesonii* individual VJ_140, assessed in March 2021 and replaced in October 2021, (left, with a score of 1 and right, with a score of 7a).

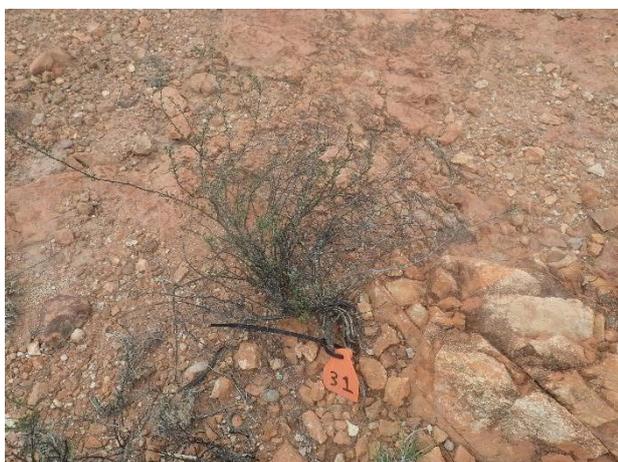
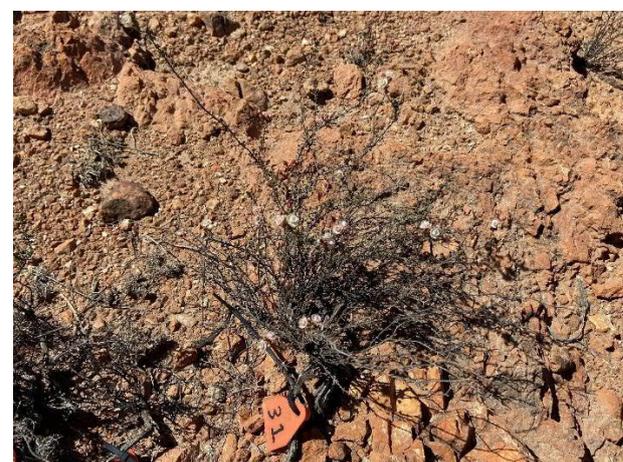
Figure 4-10: East of haul road *Verticordia jamiesonii* individual VJ_31, assessed in March 2021 as declining (left) and in October 2021, having lost a large proportion of foliage but displaying reproductive morphology.

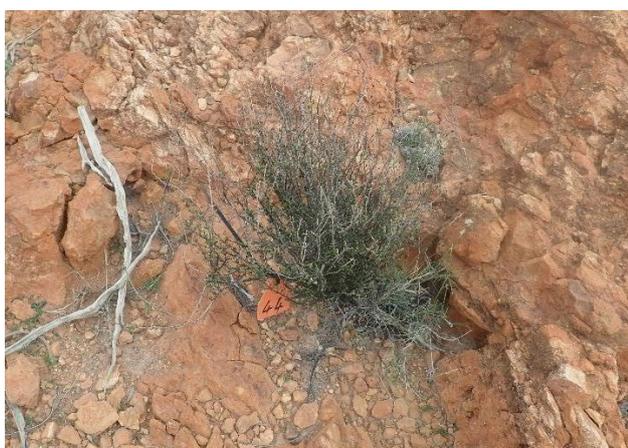
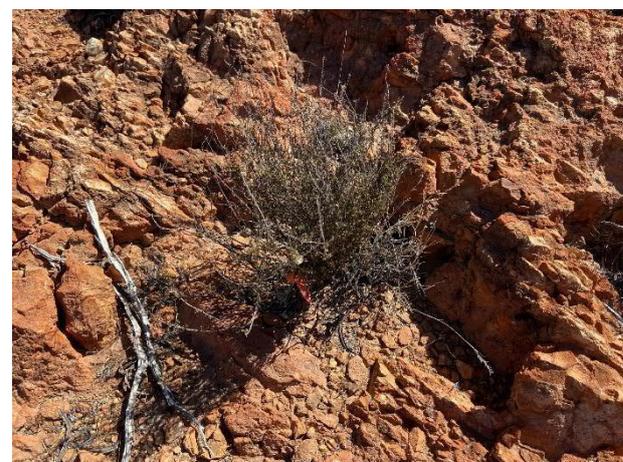
Figure 4-11: *Verticordia jamiesonii* individual VJ_44, showing greener foliage following high rainfall events in March 2021 compared to October 2021, where the individual experienced below average rainfall for the four months prior.

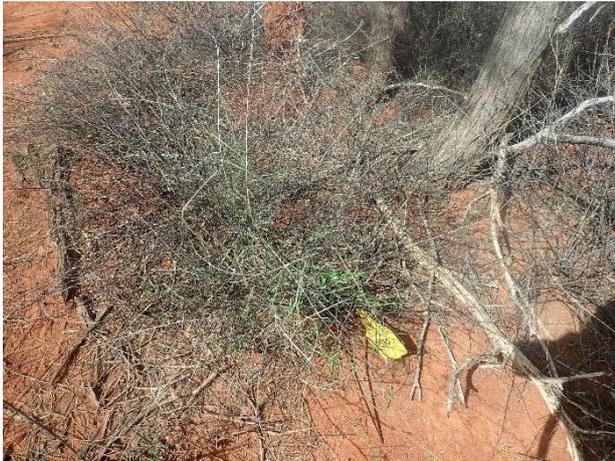
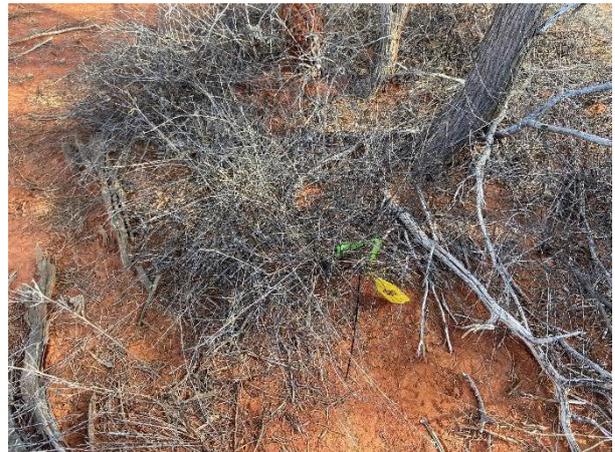
Figure 4-13: Individual ESPLP_230, was previously assessed with a score of 2 in December 2020. In March 2021 (left) the foliage began to recover and improved with a score of 3. In October 2021 (right), the individual declined back to a score of 2.

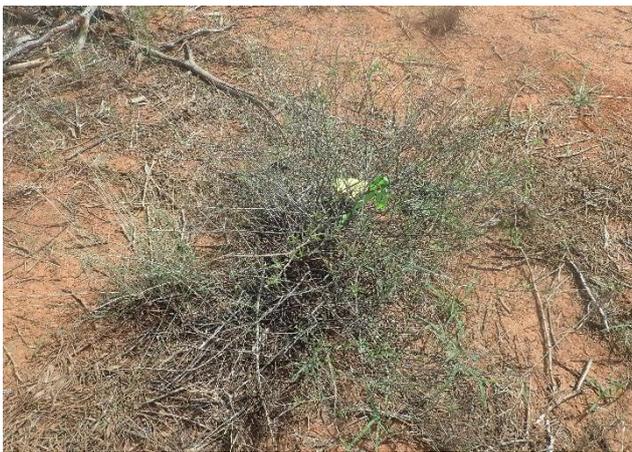
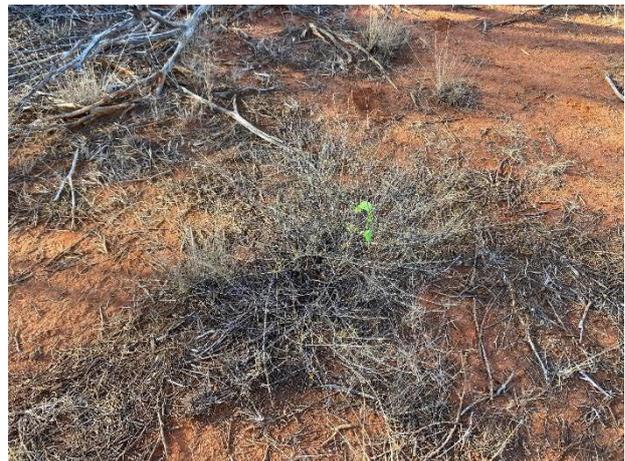
Figure 4-14: *Eremophila* sp. long pedicels individual ESPLP_225, in March 2021 and dead in October 2021.

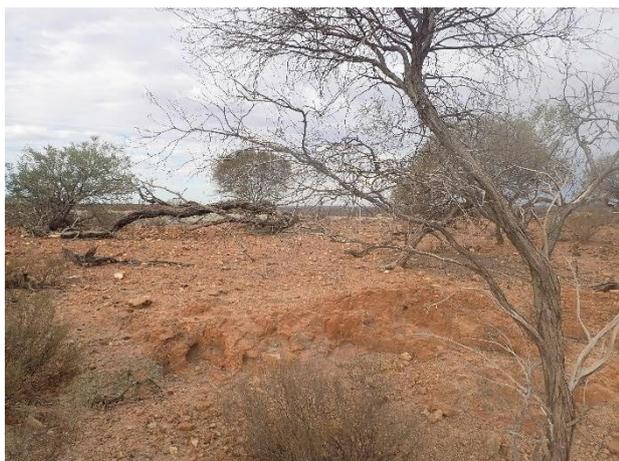
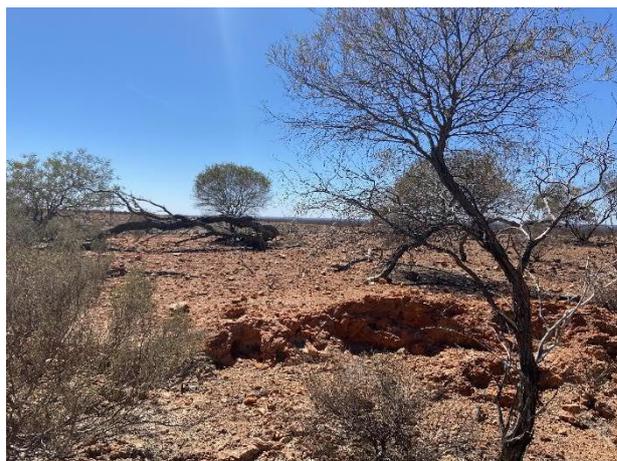
Figure 4-17: MKS EIA 37 increased from 'good' in 2020 (left) to 'very good' in 2021 (right). The increase in vegetation condition rating shown in the increases in plant cover and health.

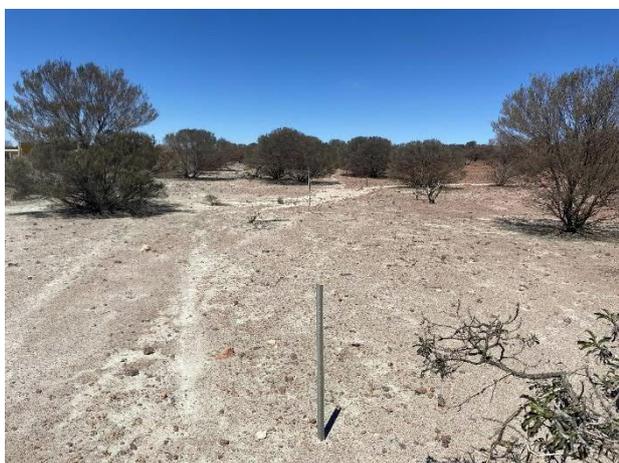
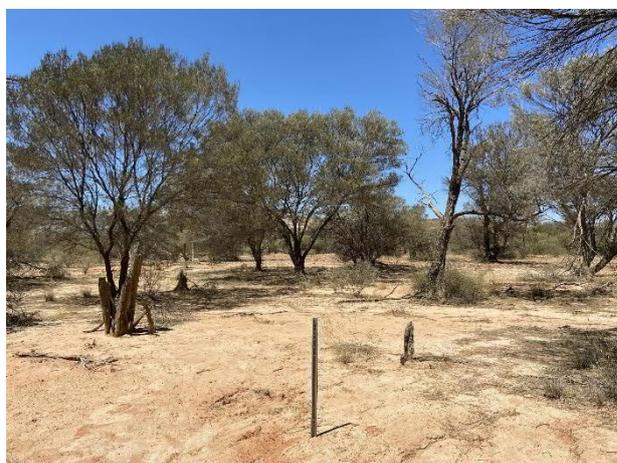
Figure 4-18 Examples of heavy dust deposition at infrastructure impact quadrats MKS EIA 4 (left) and MKS EIA 18 (right)

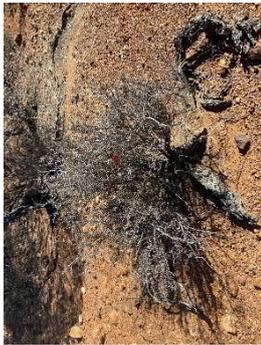
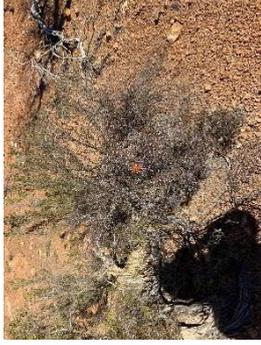
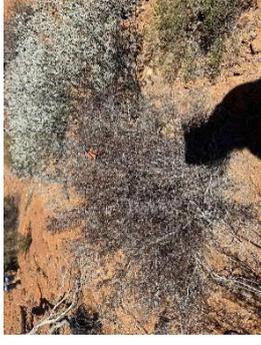
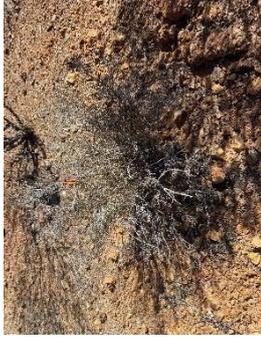
Site: Impact, Far West of Haul Road (Tag ID 166 to 190)					
Tag ID	HSPSB_166	HSPSB_167	HSPSB_168	HSPSB_169	HSPSB_170
Photo

Category (score)	Declining (3)	Reproductive (6)	Vegetative (7d)	Vegetative (7d)	Vegetative (7d)
Tag ID	HSPSB_171	HSPSB_172	HSPSB_173	HSPSB_174	HSPSB_175
Photo

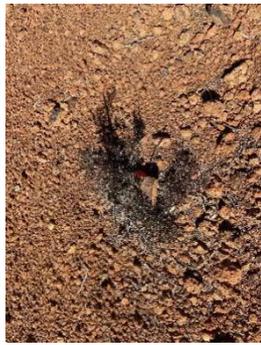
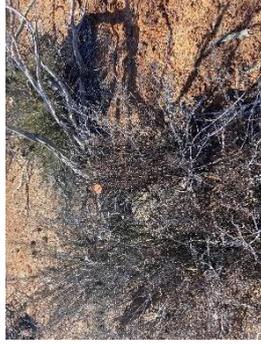
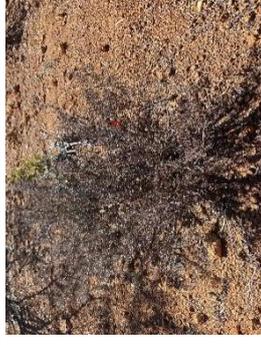
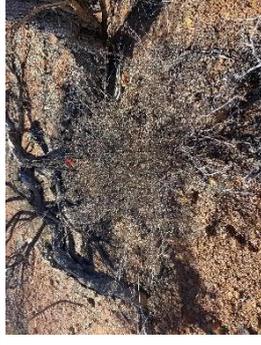
Category (score)	Vegetative (7a)	Vegetative (7d)	Declining (3)	Vegetative (7d)	Declining (3)
Tag ID	HSPSB_176	HSPSB_177	HSPSB_178	HSPSB_179	HSPSB_180
Photo

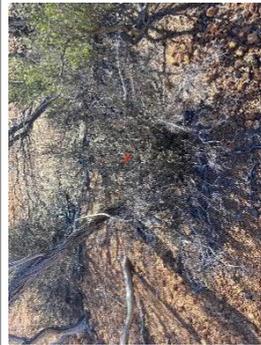
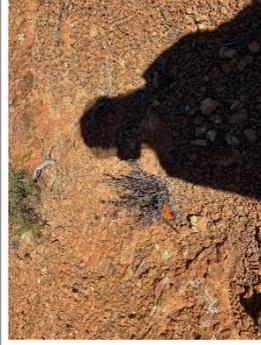
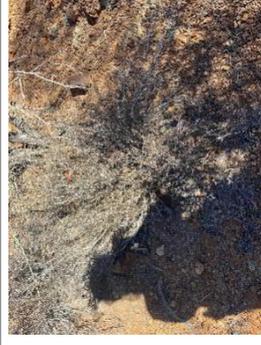
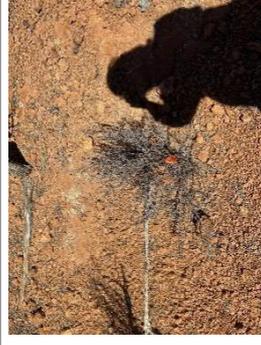
Category (score)	Vegetative (7d)	Declining (2)	Declining (3)	Vegetative (7d)	Declining (2)

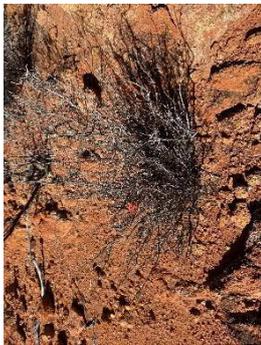
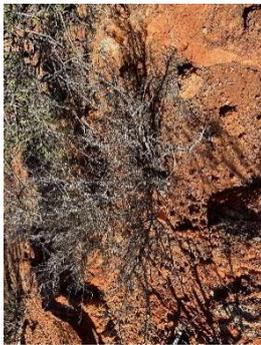
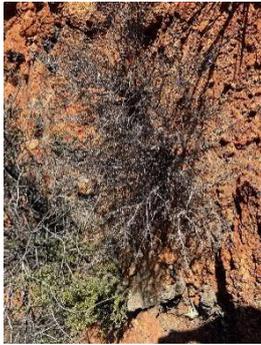
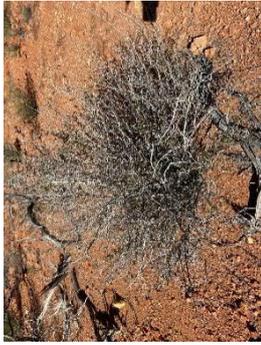
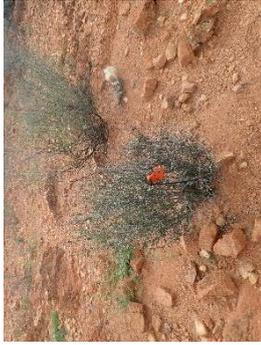
Site: Control, Wanjarri Nature Reserve (Tag ID 91 to 115)					
Tag ID	HSPSB_91	HSPSB_92	HSPSB_93	HSPSB_94	HSPSB_95
Photo

Category (score)	Declining (2)	Declining (2)	Declining (2)	Declining (2)	Declining (3)
Tag ID	HSPSB_96	HSPSB_97	HSPSB_98	HSPSB_99	HSPSB_100
Photo

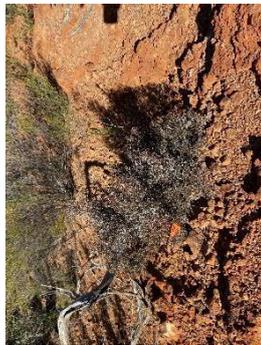
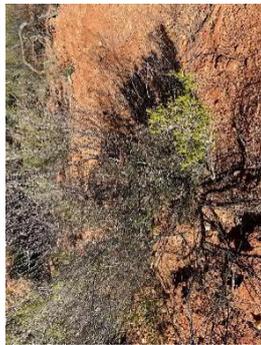
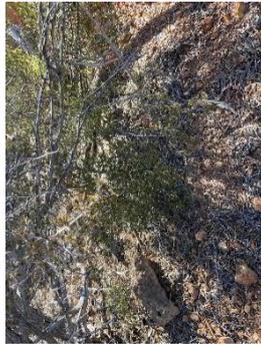
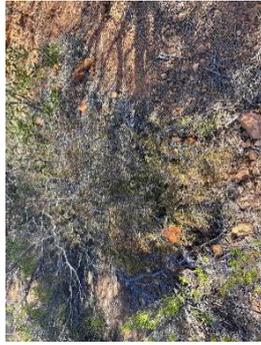
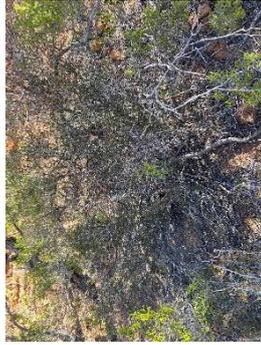
Category (score)	Reproductive (6)	Vegetative (7b)	Vegetative (7b)	Vegetative (7d)	Vegetative (7d)
Tag ID	HSPSB_101	HSPSB_102	HSPSB_103	HSPSB_104	HSPSB_105
Photo

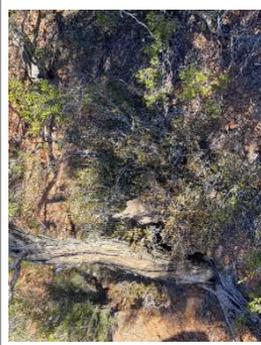
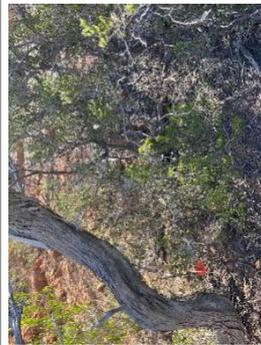
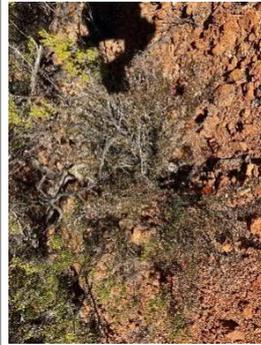
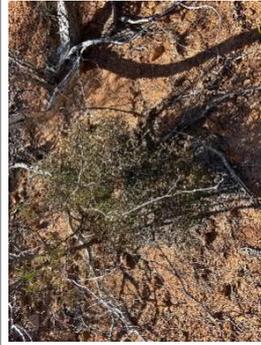
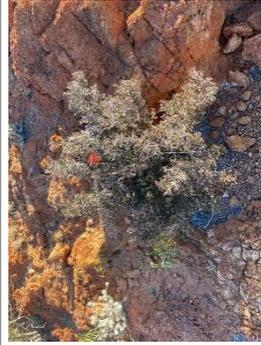
Category (score)	Vegetative (7c)	Vegetative (7b)	Vegetative (7c)	Reproductive (6)	Reproductive (4)

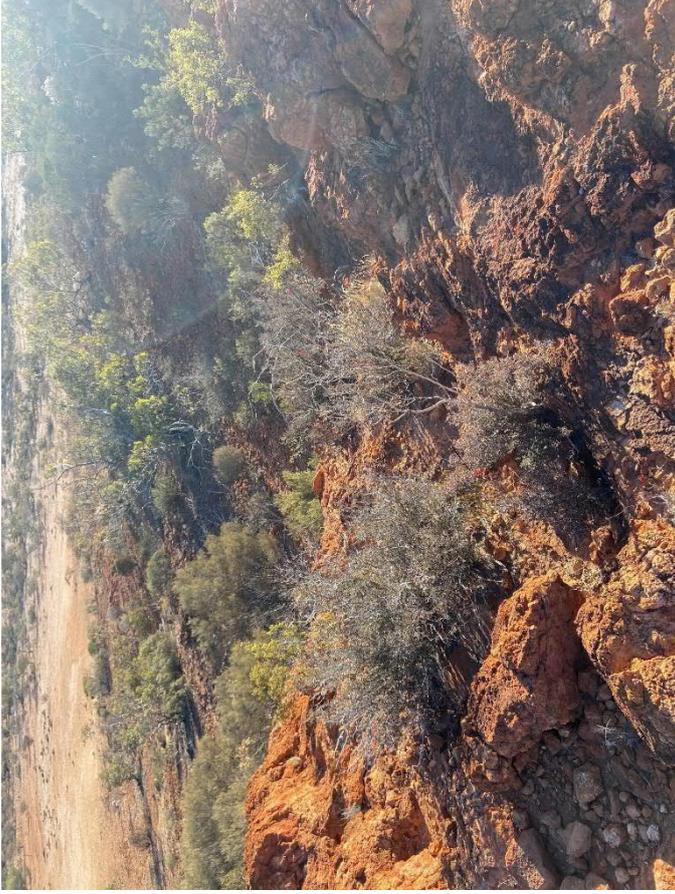
*Photo point established in September 2020 due to plant location on edge of breakaway

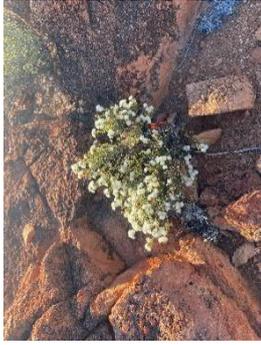
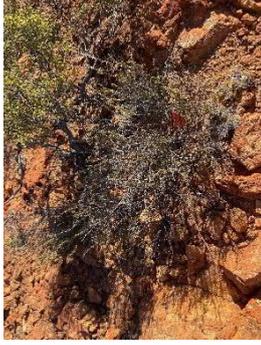
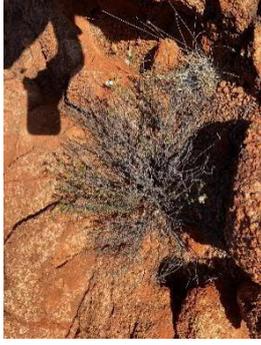
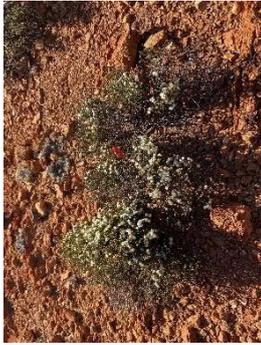
Tag ID	VJ_126	VJ_127	VJ_128	VJ_129	VJ_130
Photo	Photo not taken

Category (score)	Dead (1)	Reproductive (5)	Declining (2)	Reproductive (5)	Reproductive (5)
Tag ID	VJ_131	VJ_132	VJ_133	VJ_134	VJ_135
Photo

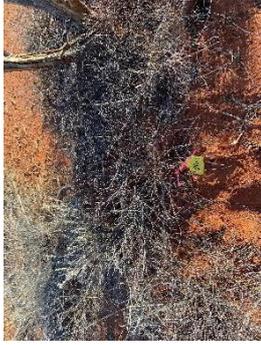
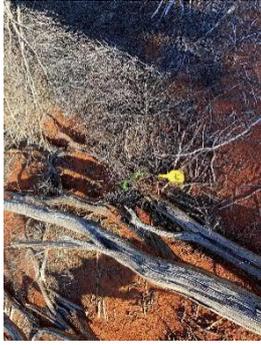
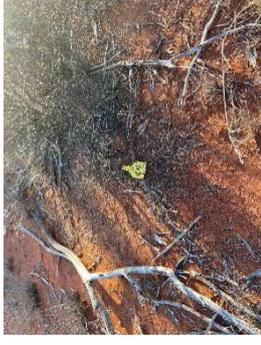
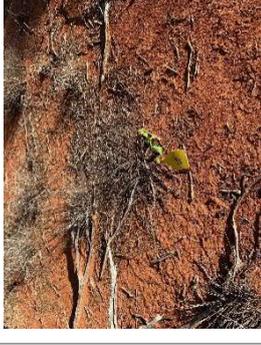
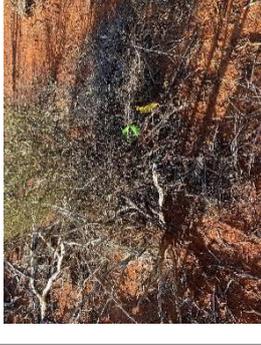
Site: Control, Northern edge of Wanjarri Nature Reserve (Tag ID 216 to 240; 258)					
Tag ID	ESPLP_216	ESPLP_217	ESPLP_218	ESPLP_219	ESPLP_220
Photo

Category (score)	Dead (1)	Vegetative (7b)	Vegetative (7b)	Declining (2)	Vegetative (7b)
Tag ID	ESPLP_221	ESPLP_222	ESPLP_223	ESPLP_224	ESPLP_225
Photo

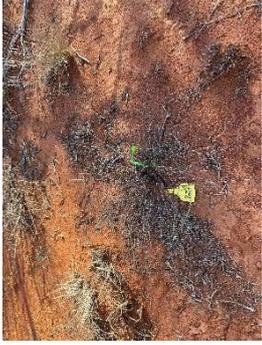
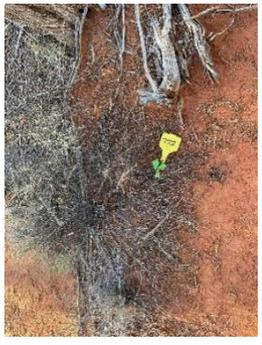
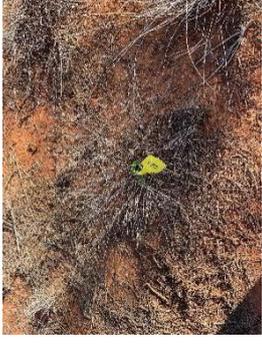
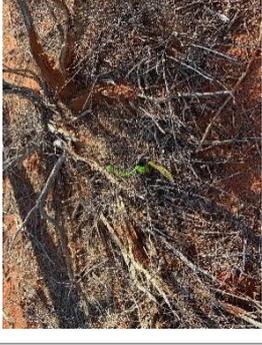
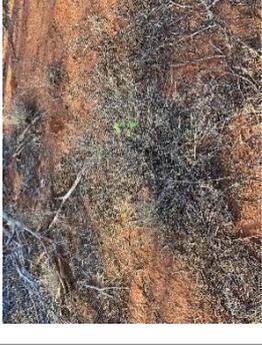
Category (score)	Declining (3)	Declining (2)	Vegetative (7c)	Vegetative (7b)	Vegetative (7a)
Tag ID	ESPLP_226	ESPLP_227	ESPLP_228	ESPLP_229	ESPLP_230
Photo

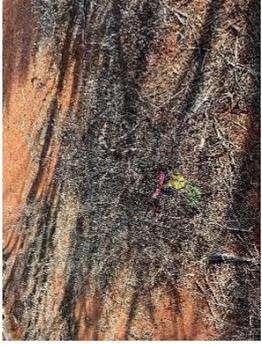
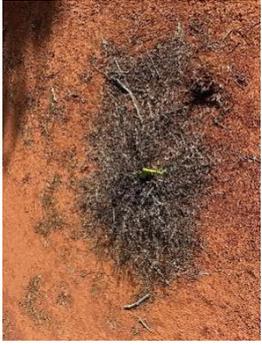
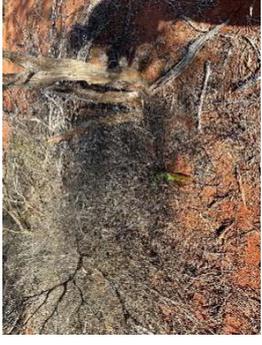
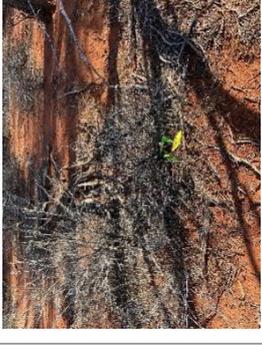
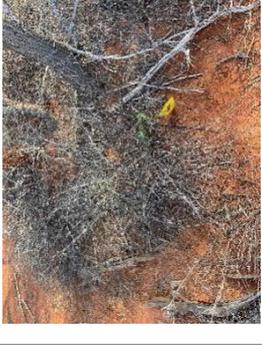
Category (score)	Dead (1)	Declining (2)	Declining (3)	Declining (3)	Declining (2)

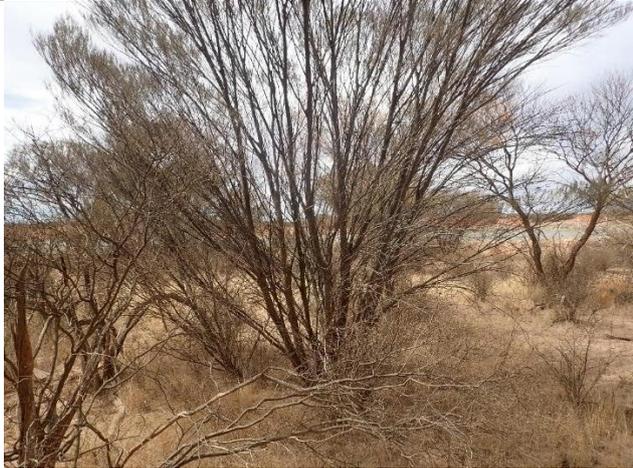
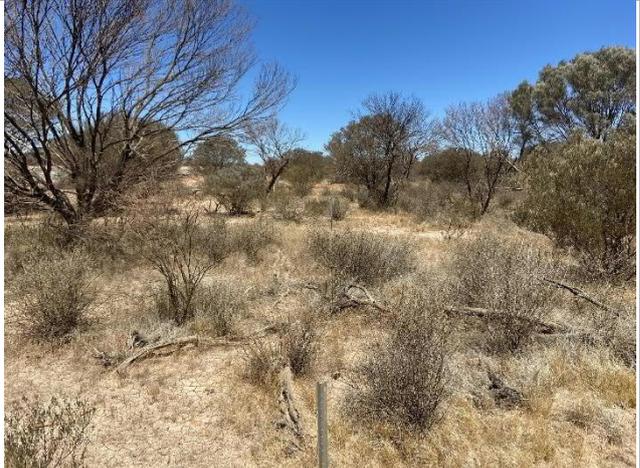
2020		2021 Photo shifted to northern most post.

Site ID: MKS EIA 1		Co-ordinates: 51 J 261082 6973489	
Location: ~ 40 m west of haul road		Comments: Drainage at this site is from south-east to north-west. Previous plant deaths. Heavily impacted by dust due to proximity to haul road. Loss of foliage on Acacia trees. Stressed vegetation, particularly <i>S. ectogama</i> which has lost most of its foliage. Ants present. Cryptograms present but covered in dust. Rabbit warrens observed. Subject peg had to be reinstated, removed in grading of fence line track.	
Veg. Type: Drainage line Mulga shrubland			
Veg. Condition: Good			
Grazing: Light			
Weed cover: Nil			
Photo direction: N			
Species	Cover (%)	Plant Health Score	Comments
<i>Aristida jerichoensis</i>	60	3	Dry. Good cover.
<i>Sida ectogama</i>	12	7d	Covered in dust. Loss of foliage.
<i>Acacia aneura</i>	30	7b	Covered in dust. Loss of foliage.
<i>Eremophila latrobei</i>	2	4	Dusty. Stressed.
<i>Eremophila galeata</i>	2	5	Dusty. Stressed.

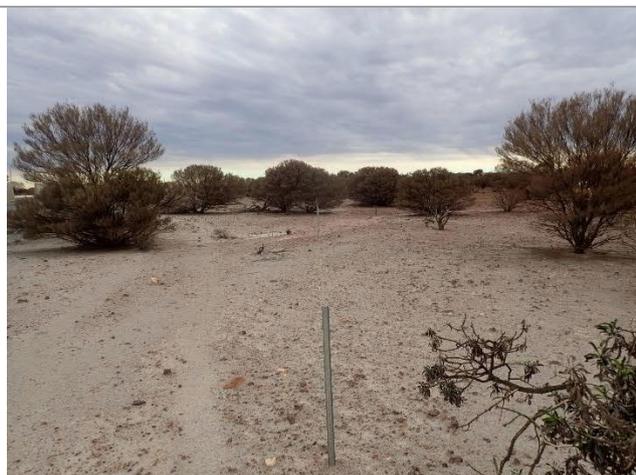
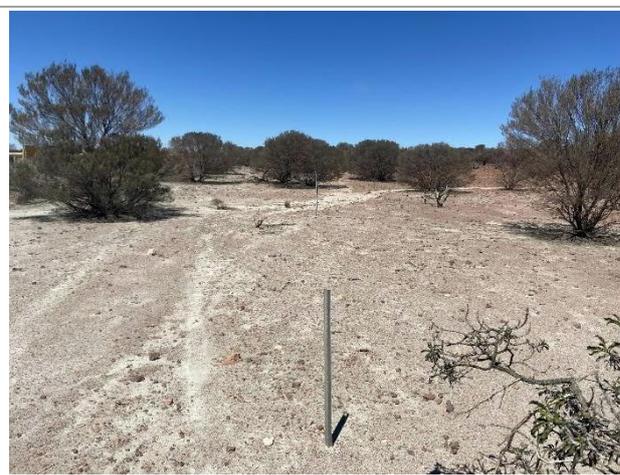
Site ID: MKS EIA 4		Co-ordinates: 51 J 261049 6971565	
Location: ~ 75 m west of haul road	Comments: Cleared road and soil bund. This area gets a lot of dust from vehicular traffic and this is clearly visible on <i>Mulga</i> , <i>Senna</i> and <i>Eremophila</i> species. Drainage is west to south west so it is expected that the haul road may have minimal impact on sheet flow. No cryptograms. Historical Acacia deaths. Directly adjacent to haul road. Soil surface has high dust coverage.		
Veg. Type: Groved Mulga shrubland/ Stony ironstone Mulga shrubland			
Veg. Condition: Good			
Grazing: Nil			
Weed cover: Nil			
Photo direction: NW			
Species	Cover (%)	Plant Health Score	Comments
<i>Acacia aneura</i>	15	5	Dust affected.
<i>Eremophila galeata</i>	2	2	Very stressed.
<i>Ptilotus obovatus</i>	0	1	Dead
<i>Eremophila latrobei</i>	<2	2	Very stressed.
<i>Senna glaucifolia</i>	<2	2	Replaces <i>Ptilotus obovatus</i>

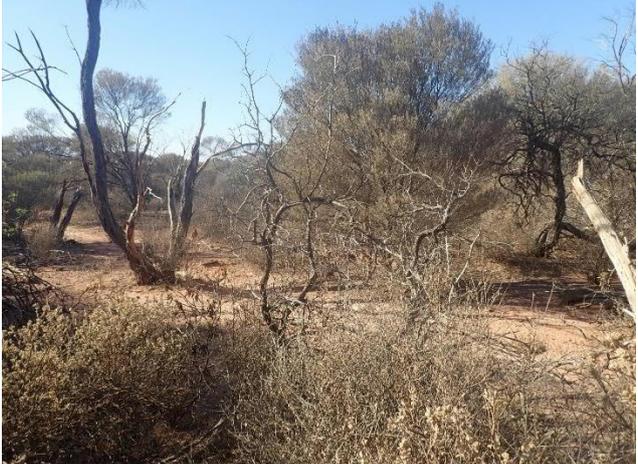
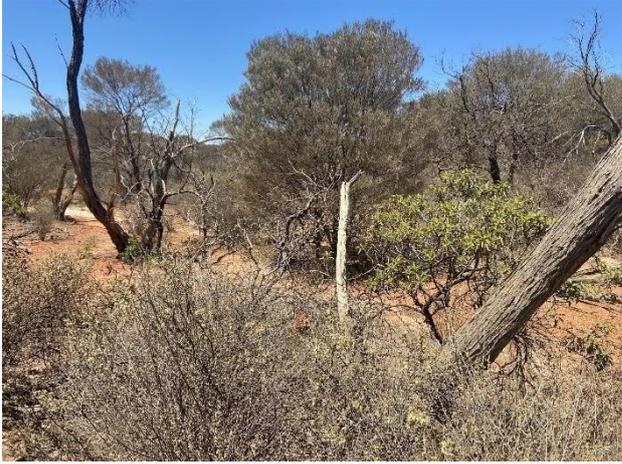
2020		2021

Site ID: MKS EIA 5		Co-ordinates: 51 J 261204 6970774	
Location: ~ 80 m east of haul road	Comments: Site lies 100m downstream from the MKS haul road and about 15m west of the WNR track. Minor drainage line drains from southern end of the breakaway in a south-east direct into the Wanjarri Nature Reserve. The haul road interrupts that drainage path. Cryptograms on soil surface. Litter present under trees. Pedestalling erosion present. Vegetation is water stressed and dust affected. Historical <i>Acacia</i> deaths recorded. Termite mounds and kangaroo scats observed.		
Veg. Type: Drainage line Mulga shrubland			
Veg. Condition: Very good			
Grazing: Light, historic			
Weed cover: Nil			
Photo direction: N			
Species	Cover (%)	Plant Health Score	Comments
<i>Acacia aneura</i>	15	7b	Good condition.
<i>Acacia tetragonophylla</i>	10	4	Old flowers still attached to plant.
<i>Sida ectogama</i>	20	3	Dry, foliage loss observed.

<i>Eremophila pungens</i> (P4)	3	7c	Good condition.
<i>Eremophila forrestii</i>	2	3	Dry, foliage loss observed.
Other species: <i>Acacia craspedocarpa</i> , <i>Eremophila galeata</i> , <i>Eremophila jucunda</i> subsp. <i>jucunda</i> , <i>Psyrax latifolia</i> , <i>Enneapogon avenaceus</i> , <i>Eremophila compacta</i> , <i>Ptilotus exaltatus</i> , <i>Sclerolaena eurotioides</i> , <i>Eremophila latrobei</i> , <i>Dodonaea petiolaris</i> , <i>Ptilotus obovatus</i> , <i>Ptilotus helipteroides</i> , <i>Aristida jerichoensis</i> , <i>Senna</i> sp. Meekatharra

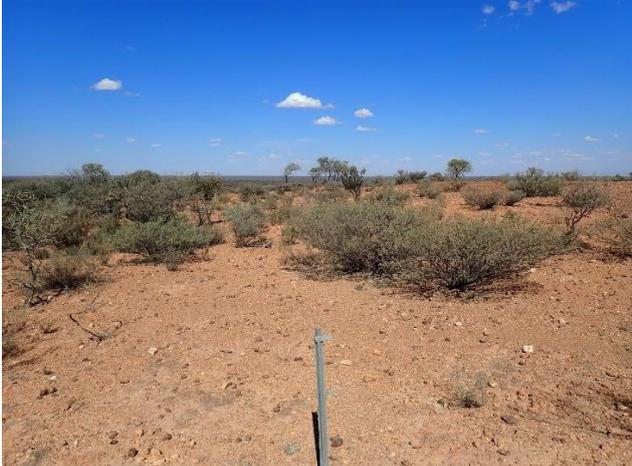
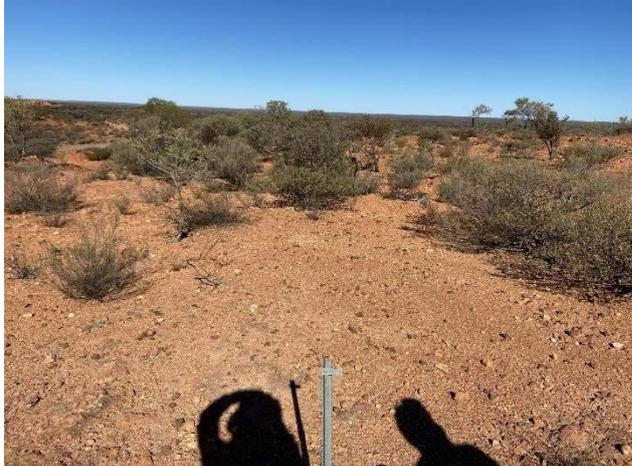
2020		2021

Site ID: MKS EIA 6		Co-ordinates: 51 J 261139 6971172	
Location: ~13 m east of haul road	Comments: Post has WB 30 on it and all four posts are installed. All vegetation is in good condition considering dry seasonal conditions. Minimal dust impact. Area protected by large bund along the edge of the haul road, in previous assessment but was not observed in 2021.		
Veg. Type: Archaean granite geology			
Veg. Condition: Excellent			
Grazing: Light			
Weed cover: Nil			
Photo direction: NW			
Species	Cover (%)	Plant Health Score	Comments
<i>Callitris columellaris</i>	10	7d	Good condition.
<i>Thryptomene</i> sp. Leinster (P3)	15	7d	Good condition.
<i>Acacia pruinoarpa</i>	2	7b	Good condition.
<i>Acacia quadrimarginea</i>	10	7b	Good condition.
<i>Eriachne mucronata</i>	2	3	Dry, with dead patches.
Other species: <i>Acacia rhodophloia</i> , <i>Acacia aneura</i> , <i>Hibbertia</i> sp. <i>Sherwood Breakaways</i> (R.J. Cranfield 6771), <i>Hakea leucoptera</i> subsp. <i>sericipes</i> , <i>Acacia tetragonophylla</i> , <i>Dodonaea petiolaris</i> , <i>Verticordia jamiesonii</i> , <i>Poaceae</i> sp., <i>Calytrix uncinata</i>

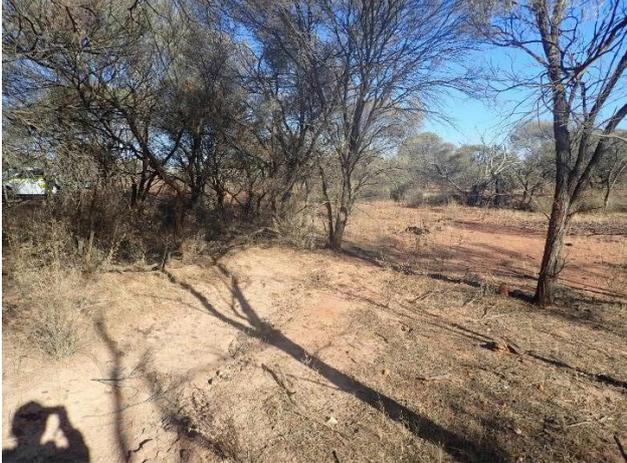
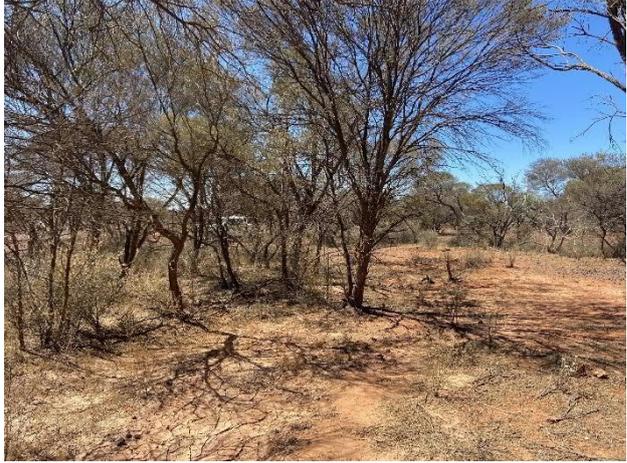
2020		2021

Site ID: MKS EIA 7		Co-ordinates: 51 J 261216 6970204	
Location: ~ 90 m east of haul road		Comments: Drainage from the west, interrupted by haul road. Two posts installed. Kangaroo scats and termite mounds were present. Litter present under large <i>Acacia</i> shrubs. Half of quadrat dominated by vegetation, but other half is almost bare. Historic shrub deaths to the west of the quadrat. Upper storey healthy while lower storey was water stressed. Dust affected.	
Veg. Type: Drainage line Mulga shrubland			
Veg. Condition: Very good			
Grazing: Light, historic			
Weed cover: Nil			
Photo direction: N			
Species	Cover (%)	Plant Health Score	Comments
<i>Acacia aneura</i>	30	7b	Lower branches have reduced foliage. Previously grazed.
<i>Eremophila compacta</i>	<2	3	Stressed adult beneath Mulgas.
<i>Sida ectogama</i>	20	3	Dusty and stressed. Some foliage loss.
<i>Eremophila granitica</i>	<2	3	Dusty and stressed. Some foliage loss.

<i>Acacia thoma</i>	20	7b	Good condition.
Other species: <i>Enneapogon caeruleus</i> , <i>Ptilotus obovatus</i> , <i>Ptilotus exaltatus</i> , <i>Eremophila galeata</i> , <i>Eremophila forrestii</i> , <i>Ptilotus helipteroides</i> , <i>Senna</i> sp. Meekatharra, <i>Aristida</i> sp.

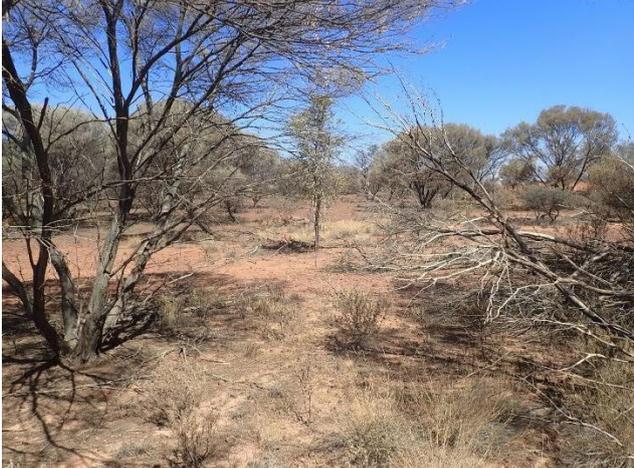
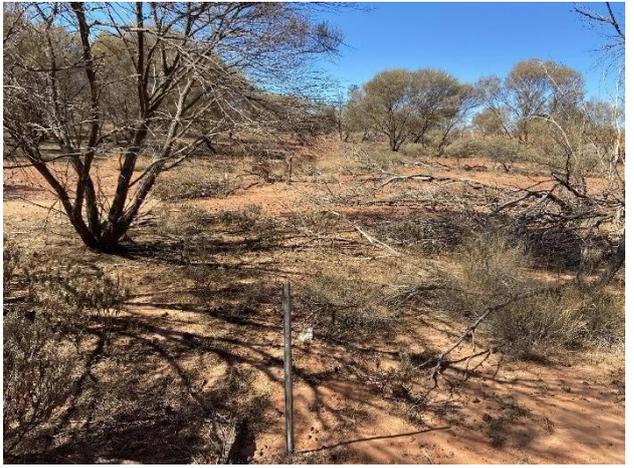
2020		2021

Site ID: MKS EIA 8		Co-ordinates: 51 J 261231 6969060	
Location: ~ 60 m east of haul road	Comments: This site may dependent on sheet flow from the west. Site is covered in stony ferruginous rocks and boulders. No annuals at time of assessment. Evidence of grazing, possibly historic. Dust present on vegetation. Termite mounds and rabbit warrens present. Dead grasses and shrubs observed. Litter present under Acacias.		
Veg. Type: Stony ironstone Mulga shrubland			
Veg. Condition: Very good			
Grazing: Light			
Weed cover: Nil			
Photo direction: N			
Species	Cover (%)	Plant Health Score	Comments
<i>Acacia aneura</i>	20	7b	Healthy adult individuals.
<i>Psydrax suaveolens</i>	<2	3	
<i>Eremophila spectabilis</i>	10	6	Dry, but full canopy.
<i>Eremophila latrobei</i>	<2	6	Stressed individuals under <i>Acacias</i> .
<i>Senna glaucifolia</i>	<2	7c	
Other species: <i>Ptilotus schwartzii</i> , <i>Eriachne helmsii</i> , <i>Eremophila jucunda subsp. jucunda</i> , <i>Eragrostis eriopoda</i> , <i>Sida sp. Golden calyces glabrous</i> (H.N. Foote 32)

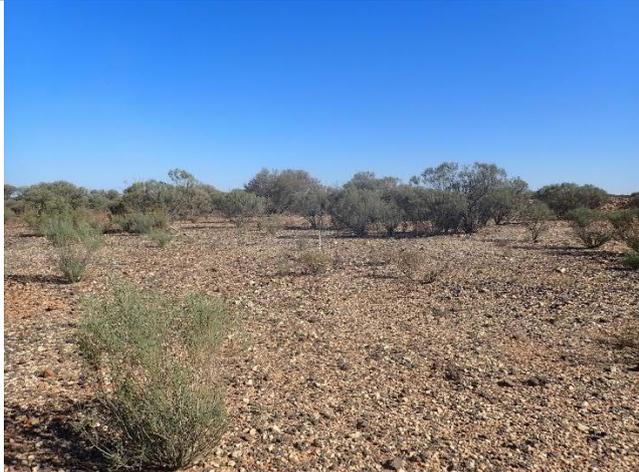
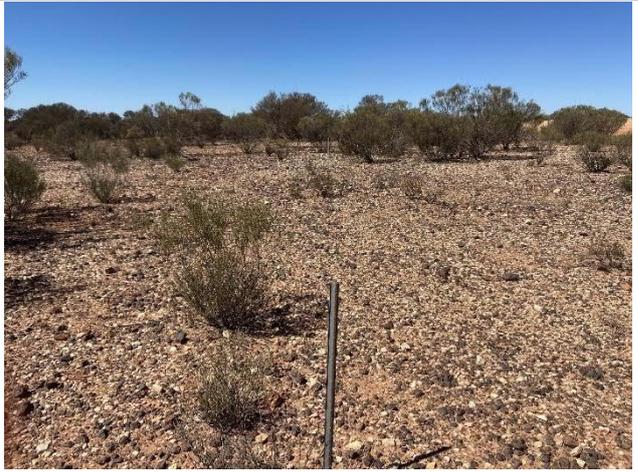
2020		2021

Site ID: MKS EIA 9		Co-ordinates: 51 J 261218 6969942		
Location: ~95 m east of haul road		Comments: Soil surface is 95% quartz, ironstone rocks and gravel with 5% silty sand. No cryptogams observed. Site is on a low rise, higher than surrounding landscape and unlikely to be affected by interruption to drainage due to the haul road. Many young <i>Hakea leucoptera</i> observed. Many Maireanas stressed. No annuals. Less impacted by dust than other quadrats observed despite being closer to the haul road.		
Veg. Type: Weathered basalt, <i>Hakea leucoptera</i> subsp. <i>sericipes</i> / <i>Eremophila pantonii</i> shrubland				
Veg. Condition: Excellent				
Grazing: Nil				
Weed cover: Nil				
Photo direction: N				
Species	Cover (%)	Plant Health Score	Comments	
<i>Hakea leucoptera</i> subsp. <i>sericipes</i>	10	4	Healthy. Old seed pods present. Many juveniles.	
<i>Maireana triptera</i>	<2	3	Stressed. Loss of foliage.

<i>Senna</i> sp. <i>Meekatharra</i>	<2	7b	Dusty, but healthy. Juveniles present.	
<i>Eremophila pantonii</i>	<2	5	Healthy. Flowering.	
-	-	-	-	
Other species: <i>Atriplex semilunaris</i> , <i>Ptilotus obovatus</i> , <i>Maireana georgei</i>

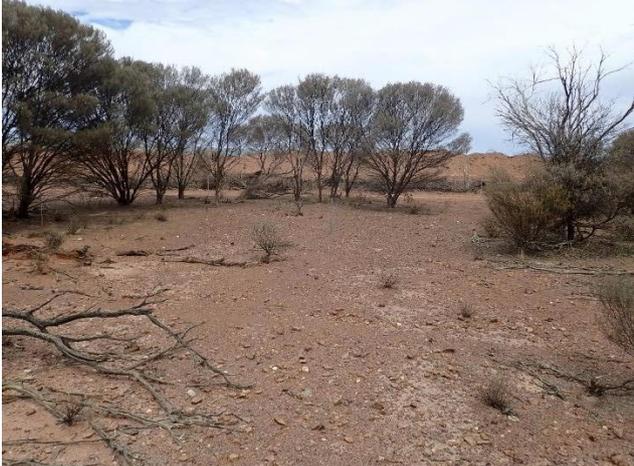
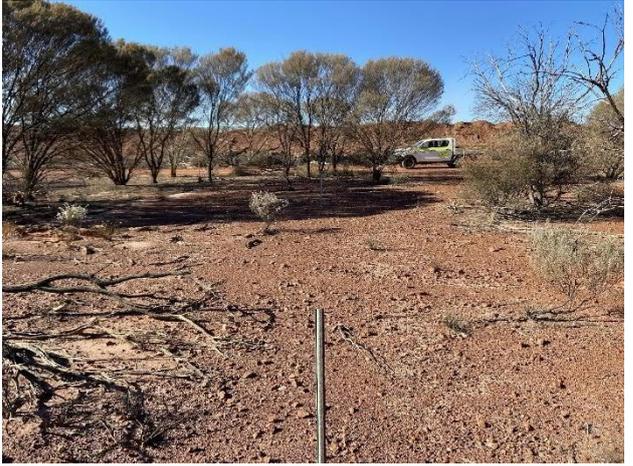
2020		2021

Site ID: MKS EIA 10		Co-ordinates: 51 J 260553 6966093	
Location: ~ 320 m north of Run-of-mine		Comments: Topsoil stockpile in the background of photo. Note east peg is 8m from center peg (closer than standard 10m distance). Drainage comes from the west, the Run-of-mine is north of the quadrat so drainage may not be interrupted. Very bare quadrat. Low cover of cryptogams present. Some understorey shrub death. No annuals. Litter present under Acacias. Dust present on vegetation. Vegetation is dry, reflecting extended dry seasonal conditions. Old rabbit warrens present.	
Veg. Type: Stony ironstone Mulga shrubland			
Veg. Condition: Good			
Grazing: Light			
Weed cover: Nil			
Photo direction: NW			
Species	Cover (%)	Plant Health Score	Comments
<i>Acacia aneura</i>	5	7b	Some dust, full canopy.
<i>Ptilotus schwartzii</i>	<2	5	Actively flowering.
<i>Eremophila forrestii</i>	<2	3	Some loss of foliage. Lots of dust present.

<i>Eremophila spectabilis</i>	<2	7d	Very dry. Yellowing leaves. Dusty.
<i>Ptilotus obovatus</i>	<2	5	Very dry, foliage loss. Flowering.
Other species: <i>Eremophila latrobei</i> , <i>Psydrax suaveolens</i> , <i>Eriachne helmsii</i> , <i>Enneapogon caeruleus</i> , <i>Acacia pruinocarpa</i>

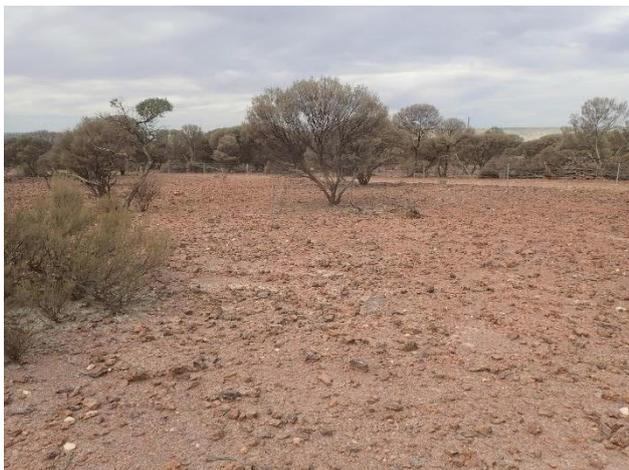
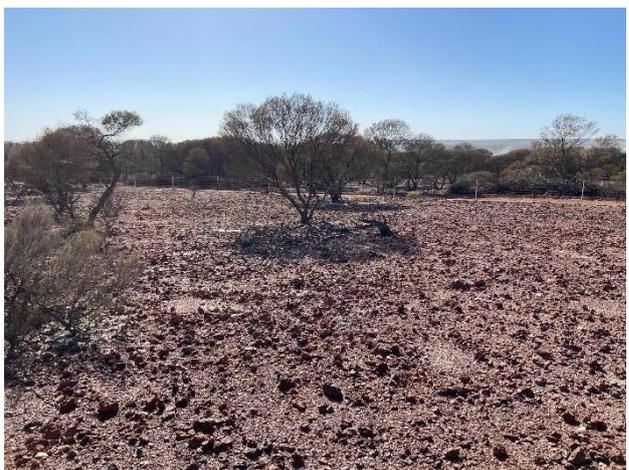
2020		2021

Site ID: MKS EIA 11		Co-ordinates: 51 J 260029 6965525	
Location: ~ 250 m east of Run-of-mine	Comments: Six mile well pit and run-of-mine in background. 100% rocky laterite with quartz stones and gravel. Lichens present on rocks. Light dust layer visible on rocks.		
Veg. Type: Stony ironstone low/Mulga shrubland	Dry vegetation, with sparse cover. Many dead understorey plants, particularly <i>P. schwartzii</i> . Likely affected by extended dry seasonal conditions. Note: This site is positioned perpendicular to the MKS clearing edge and transversely across the slope.		
Veg. Condition: Good			
Grazing: Light, historic			
Weed cover: Nil			
Photo direction: NW			
Species	Cover (%)	Plant Health Score	Comments
<i>Acacia aneura</i>	2	7c	Healthy. Previously grazed, with browse line observed.
<i>Acacia quadrimarginea</i>	<2	2	Loss of 70% foliage.
<i>Thryptomene</i> sp. Leinster (P3) (EIA_11_001)	<2	3	Stressed individuals.

<i>Eremophila latrobei</i>	<2	2	Stressed and dry.
<i>Ptilotus obovatus</i>	<2	3	Dry. Some foliage loss.
Other species: <i>Hamieria kempeana</i> , <i>Senna glaucifolia</i> , <i>Ptilotus schwartzii</i>

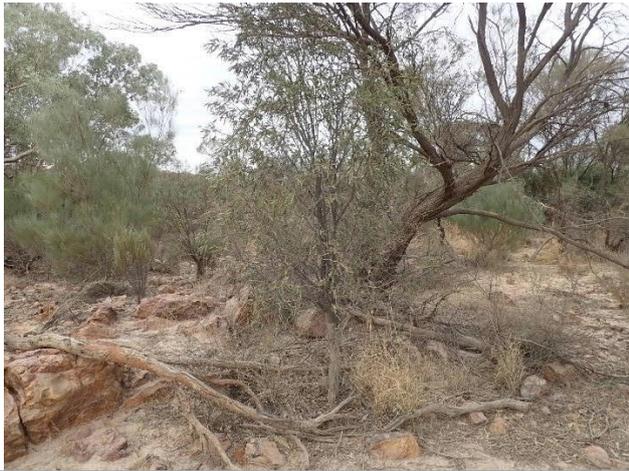
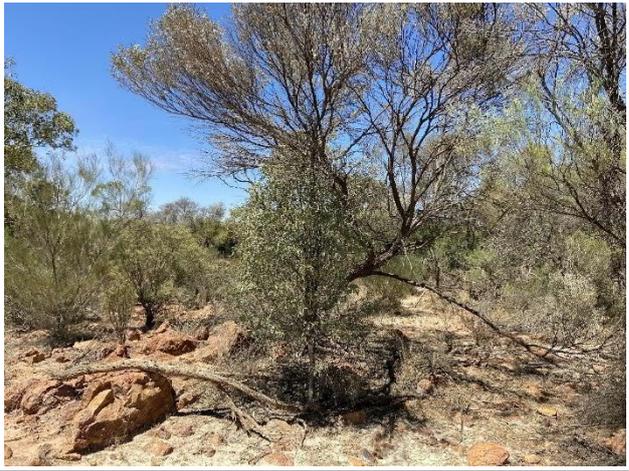
2020		2021

Site ID: MKS EIA 13		Co-ordinates: 51 J 260866 6964098	
Location: ~ 80 m from Six Mile Well pit		Comments: Creek bed at the site is normal with healthy fringing grasses and a sandy creek bed. On western bank of Jones Creek. Creek banks composed of silty sand overlaying polymictic rocks including weather sandstone and concreted Wiluna hardpan. All vegetation in good condition, most are vegetative. <i>Eucalyptus camaldulensis</i> in healthy condition. Some historic shrub death. Heavy dust deposition on vegetation and soil surface. Ants present. Only middle post present.	
Veg. Type: Drainage line Mulga shrubland			
Veg. Condition: Very good			
Grazing: Light			
Weed cover: Nil			
Photo direction: NW			
Species	Cover (%)	Plant Health Score	Comments
<i>Acacia caesaneura</i>	10	5	Seeding. Vegetative.
<i>Acacia burtikii</i>	15	4	Budding. Vegetative.
<i>Themeda triandra</i>	15	4	Budding. Declining.
<i>Dodonaea viscosa</i>	5	4	Budding. Vegetative.

<i>Dodonaea rigida</i> (EIA_13_012)	5	4	Budding. Vegetative.
Other species: <i>Ptilotus exaltatus</i> , <i>Ptilotus obovatus</i> , <i>Duperreya sericea</i> , <i>Grevillea inconspicua</i> , <i>Santalum spicatum</i> , <i>Eucalyptus camaldulensis</i> subsp. <i>obtusa</i> , <i>Eremophila granitica</i> , <i>Hemigenia exilis</i> , <i>Eremophila pantonii</i> , <i>Eremophila oldfieldii</i> subsp. <i>angustifolia</i> , <i>Hybanthus floribundus</i> subsp. <i>chloroxanthus</i>

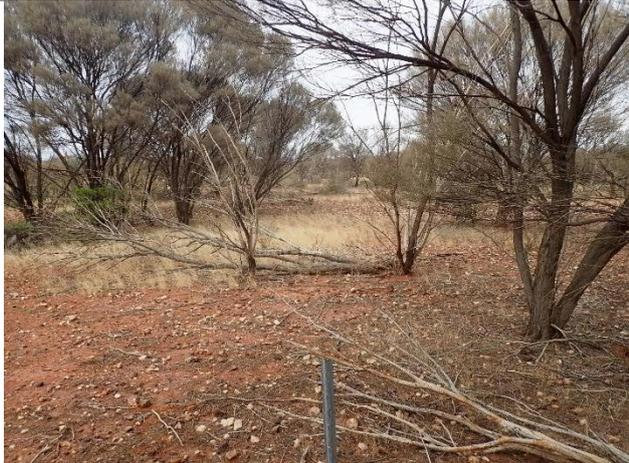
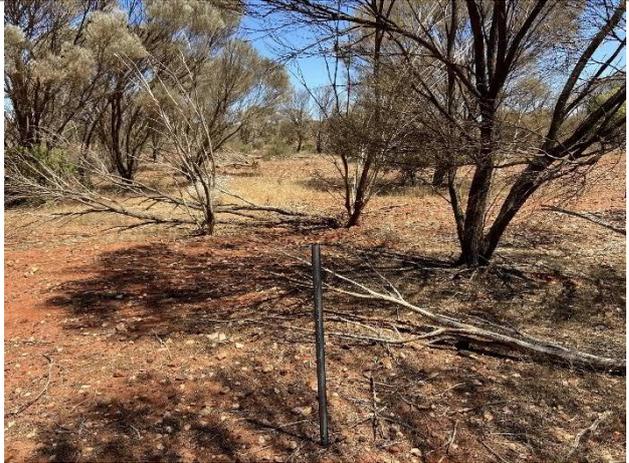
2020		2021

Site ID: MKS EIA 15		Co-ordinates: 51 J 260412 6961163	
Location: ~ 2.2 km south west of WRL, ~ 450 m from Jones Creek track		Comments: Historical Acacia deaths. Kangaroo scats present. Several dead <i>Maireana</i> individuals. Annual grass cover. Dust affected Acacias. This site is a minor drainage line within a stony plain. Drainage here is from the east, from the south-western corner of the MKS development envelope.	
Veg. Type: Mulga over <i>Maireana triptera</i> shrubland/ Drainage line Mulga shrubland			
Veg. Condition: Very good			
Grazing: Light			
Weed cover: Nil			
Photo direction: NW			
Species	Cover (%)	Plant Health Score	Comments
<i>Ptilotus obovatus</i>	5	5	Some foliage loss but flowering.
<i>Acacia aneura</i>	40	5	Historic browsing lines. Vegetative. Flowering.
<i>Eremophila galeata</i>	5	5	Green foliage on end of stems, browning at base. Vegetative. Flowering.
<i>Aristida jerichoensis</i>	40	7d	High cover.

<i>Senna artemisioides</i> subsp. <i>helmsii</i>	2	2	Little foliage remaining.
Other species: <i>Solanum lasiophyllum</i> , <i>Ptilotus schwartzii</i> , <i>Maireana georgei</i> , <i>Ptilotus helipteroides</i>
