Mt Keith Satellite Statement 1087 Compliance Assessment Report BHP Nickel West

29 March 2022

Condition 4-6 of the Statement 1087 approval requires BHP Nickel West to submit an annual Compliance Assessment Report which outlines the status of implementation of the Project and compliance with the approval conditions. This Report outlines the implementation status and compliance for the Project covering the period of 28 December 2020 to 31 December 2021. BHP Nickel West was in compliance with all conditions of the Statement 1087 approval during the reporting period.

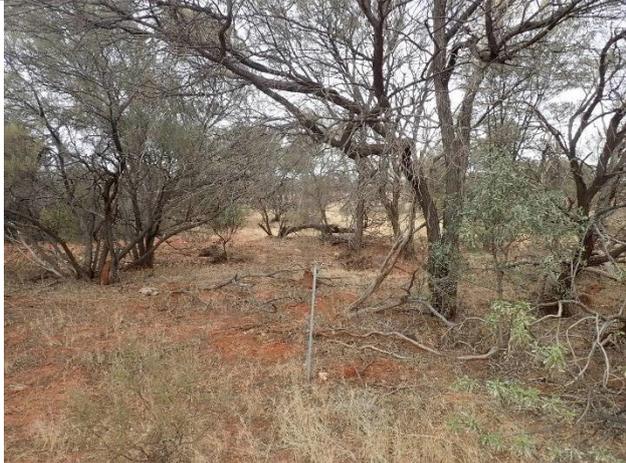
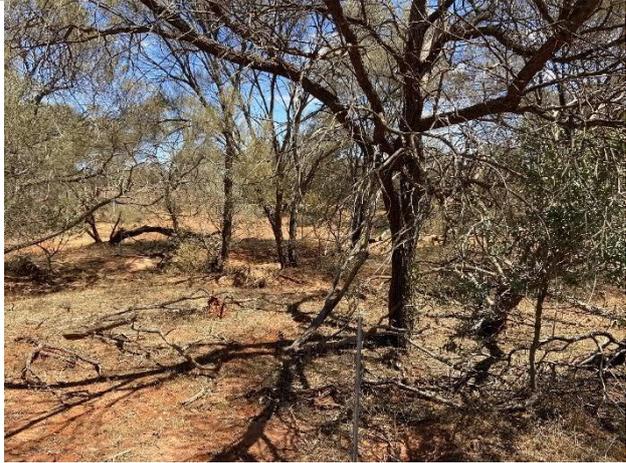
2020		2021

Site ID: MKS EIA 16		Co-ordinates: 51 J 260261 6961683	
Location: ~ 1.8 km south west of WRL, ~ 250 m from Jones Creek track	Comments: All vegetation in good condition for dry extended seasonal conditions. Cryptograms are present but dry. High grass cover. Dead <i>Acacia tetragonophylla</i> present and annual species. Dust on foliage of most species. Stream channel showing clayey sand on banks and stony stream bed. This site lies downslope of the MKS development with a large proportion of its catchment interrupted by MKS. Dust on foliage. Risk of water starvation or increased sedimentation from adjacent mining operations.		
Veg. Type: Drainage line Mulga shrubland			
Veg. Condition: Very good			
Grazing: Light, historic			
Weed cover: Nil			
Photo direction: NW			
Species	Cover (%)	Plant Health Score	Comments
<i>Sida ectogama</i>	5	5	Dusty. Vegetative.
<i>Eremophila granitica</i>	5	5	Browning of stem ends. Vegetative.

<i>Eremophila galeata</i>	5	7d	Browning foliage and foliage loss.
<i>Acacia ?craspedocarpa (hybrid) (EIA_16_001)</i>	25	7c	
<i>Acacia aptaneura (EIA_16_002)</i>	60	7c	
Other species: <i>Eriachne helmsii</i> , <i>Psydrax suaveolens</i> , <i>Solanum lasiophyllum</i> , <i>Ptilotus obovatus</i> , <i>Eremophila latrobei</i> , <i>Ptilotus exaltatus</i> , <i>Senna artemisioides subsp. filifolia</i> , <i>Aristida jerichoensis</i> , <i>Santalum ?lanceolatum</i> , <i>Ptilotus helipteroides</i>

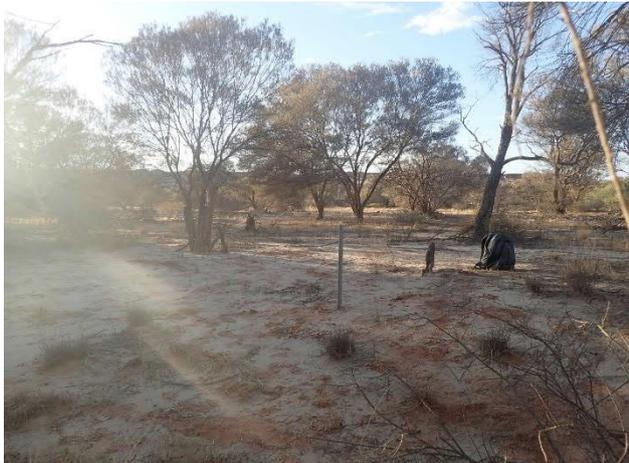
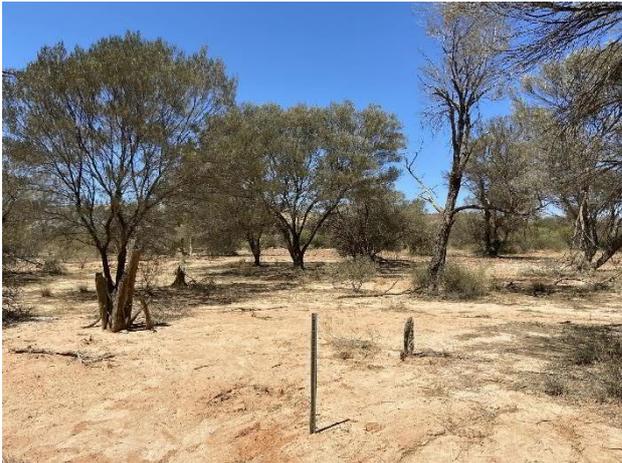
F.17 MKS EIA 18 - Infrastructure Impact

Site ID: MKS EIA 18		Co-ordinates: 51 J 261285 6964460	
Location: ~ 195 m south east of Run-of-Mine/ Six Mile Well	Comments: Jones Creek, upstream of bridge crossing on the eastern bank. Grasses on edge of the creek are stressed, dusty and grazed. <i>Eucalyptus camaldulensis</i> are healthy. Heavy dust load on most shrubs and grasses. Soil surface also covered in dust. Ants present.		
Veg. Type: Drainage line Mulga shrubland			
Veg. Condition: Very Good			
Grazing: Light, historic			
Weed cover: Nil			
Photo direction: NW			
Species	Cover (%)	Plant Health Score	Comments
<i>Acacia aneura</i>	25	5	Flowering and vegetative.
<i>Santalum spicatum</i>	20	5	Flowering and declining.
<i>Aristida jerichoensis</i>	10	7b	
<i>Acacia burkittii</i>	10	5	Pods on plants.
<i>Themeda triandra</i>	5	7d	
Other species: <i>Santalum lanceolatum</i> , <i>Acacia aneura</i> , <i>Eucalyptus camaldulensis</i> subsp. <i>obtusa</i> , <i>Eragrostis eriopoda</i> , <i>Eremophila gilesii</i> , <i>Sida ectogama</i> , <i>Maireana tomentosa</i> , <i>Ptilotus obovatus</i> , <i>Eremophila latrobei</i> , <i>Teucrium teucriiflorum</i> , <i>Rhagodia drummondii</i> , <i>Ptilotus exaltatus</i>

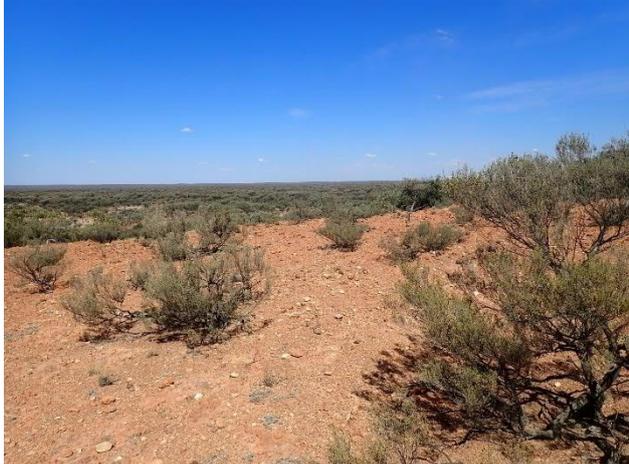
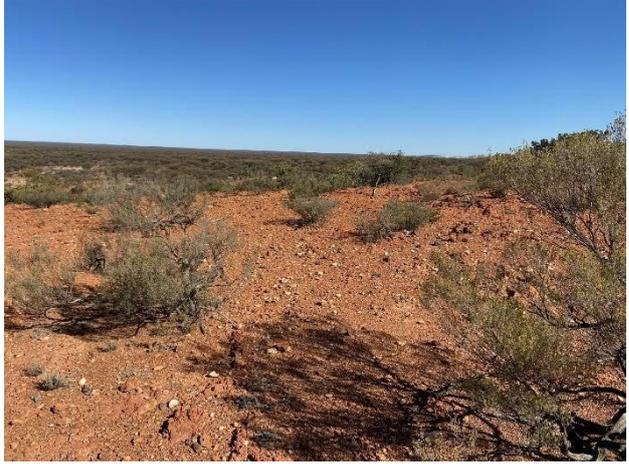
F.19 MKS EIA 24 - Haul Road Impact

Site ID: MKS EIA 24		Co-ordinates: 51 J 261187 6971273	
Location: ~ 10 m west from haul road		Comments: Looking southwards parallel to the haul road. No annuals. Most shrubs are vegetative, but dry. Recent foliage loss on <i>Thryptomene</i> sp. Leinster and <i>Calytrix uncinata</i> shrubs. Minimal dust load on vegetation. Quadrat re-established due to quadrat being too close to haul road.	
Veg. Type: Granitic Mulga shrubland on Archaean geology.			
Veg. Condition: Excellent			
Grazing: Light			
Weed cover: Nil			
Photo direction: NW			
Species	Cover (%)	Plant Health Score	Comments
<i>Thryptomene</i> sp. Leinster (P3)	15	7c	
<i>Dodonaea petiolaris</i>	<2	7d	Yellowing and foliage loss.
<i>Eriachne mucronata</i>	<2	2	
<i>Calytrix uncinata</i>	5	7d	-
<i>Verticordia jamiesonii</i>	2	7d	-
Other species: <i>Hibbertia</i> sp. <i>Sherwood Breakaways</i> (R.J. Cranfield 6771), <i>Poaceae</i> sp.

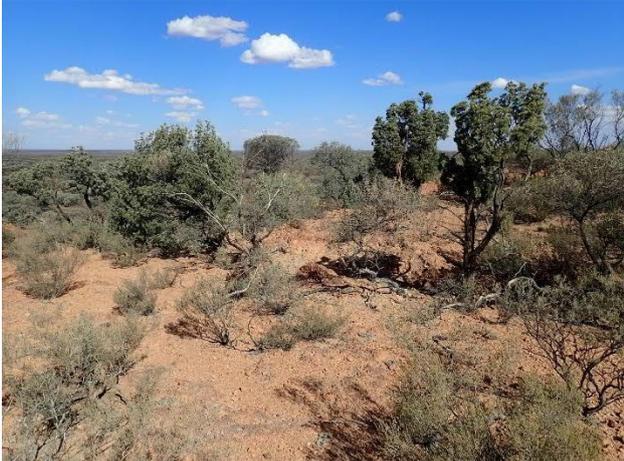
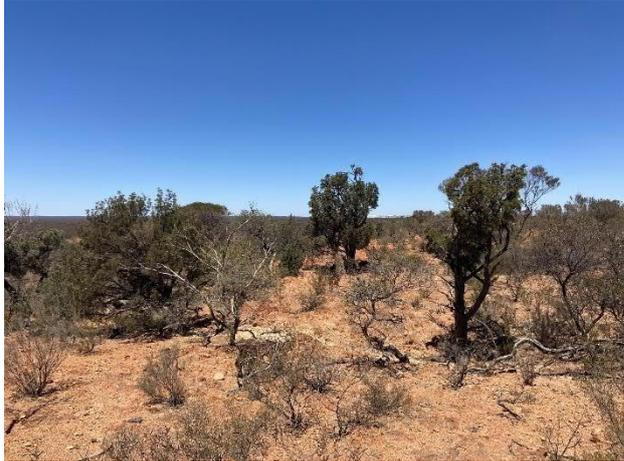
F.21 MKS EIA 26 - Haul Road Impact

Site ID: MKS EIA 26		Co-ordinates: 51 J 261162 6971094	
Location: ~ 7 m east of haul road	Comments: Moved quadrat away from haul road. Most plants are vegetative, but smaller lower storey shrubs are losing foliage. Small dust load.		
Veg. Type: Granitic Mulga shrubland on Archaean geology.			
Veg. Condition: Excellent			
Grazing: Nil			
Weed cover: Nil			
Photo direction: NW			
Species	Cover (%)	Plant Health Score	Comments
<i>Callitris columellaris</i>	15	7b	
<i>Thryptomene</i> sp. Leinster (P3)	15	7d	
<i>Dodonaea petiolaris</i>	5	3	
<i>Acacia pruinoarpa</i>	5	7b	
<i>Acacia rhodophloia</i>	2	7b	
Other species: <i>Acacia aneura</i> , <i>Hakea leucoptera</i> subsp. <i>sericipes</i> , <i>Verticordia jamiesonii</i> , <i>Hibbertia</i> sp. <i>Sherwood Breakaways</i> (R.J. Cranfield 6771), <i>Ptilotus obovatus</i> , <i>Eriachne mucronata</i> , <i>Calytrix uncinata</i>

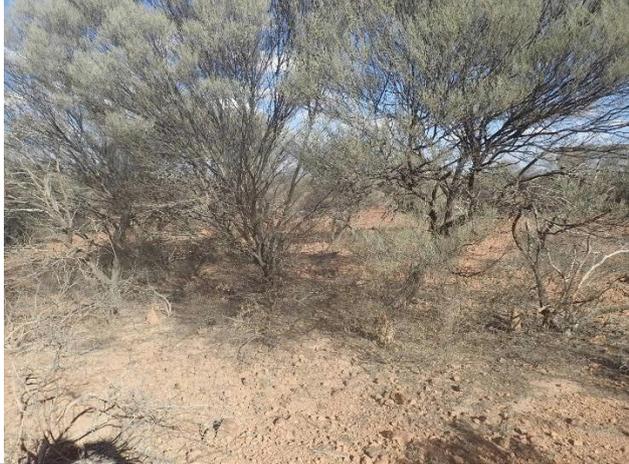
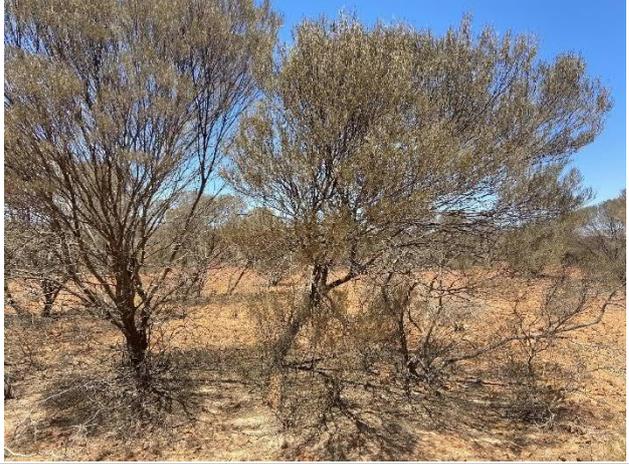
F.22 MKS EIA 27 - Haul Road Impact

Site ID: MKS EIA 27		Co-ordinates: 51 J 261177 6970972	
Location: ~ 4 m west of haul road	Comments: Southern edge of Breakaway landform. Haul interrupts surface drainage from west to east. Mid slope from MKS haul road. Lichens present. Little under trees. Light dust load. Dry but vegetative shrubs.		
Vegetation Type: Granitic Mulga shrubland on Archaean geology.			
Veg. Condition: Very good			
Grazing: Nil			
Weed cover: Nil			
Photo direction: NW			
Species	Cover (%)	Plant Health Score	Comments
<i>Acacia aneura</i>	40	7b	
<i>Dodonaea petiolaris</i>	<2	3	
<i>Scaevola spinescens</i>	2	7b	
<i>Sida ectogama</i>	<2	7d	
<i>Eremophila pungens</i> (P4)	2	7a	
Other species: <i>Psydrax suaveolens</i> , <i>Ptilotus schwartzii</i> , <i>Thryptomene</i> sp. <i>Leinster</i> , <i>Eremophila shonae</i> subsp. <i>shonae</i> , <i>Poaceae</i> sp.

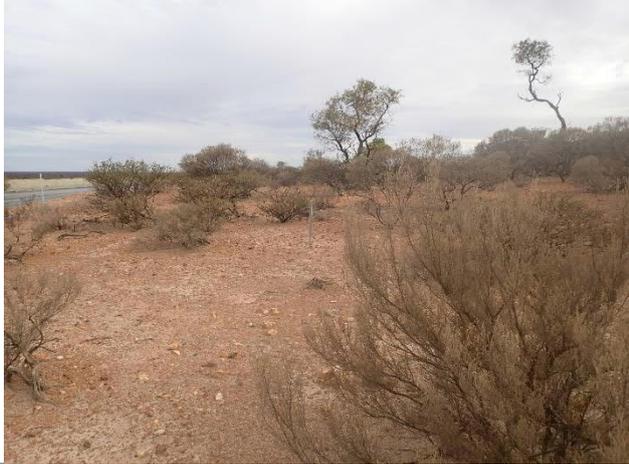
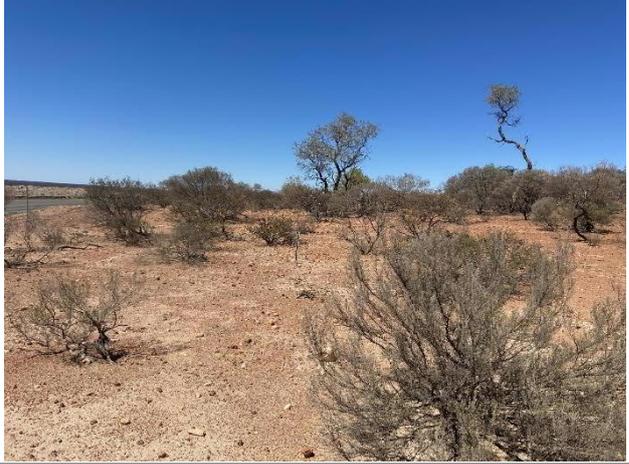
Site ID: MKS EIA 36		Co-ordinates: 51 J 261071 6971159	
Location: ~ 52 m west of haul road	Comments: Dust impacts on flora and vegetation. Soil is firm silty with abundant discontinuous lag gravel of angular quartz and subangular ironstone. Site slope towards the new haul road, which intercepts drainage from the easterly direction. Shrubs in good condition, except for some <i>Thryptomene</i> sp. Leinster (P3) deaths. Light browsing present. Some cryptogams and ants present.		
Veg. Type: Stony ironstone Mulga shrubland			
Veg. Condition: Very good			
Grazing: Light			
Weed cover: Nil			
Photo direction: N			
Species	Cover (%)	Plant Health Score	Comments
<i>Acacia aneura</i>	<2	5	Grazing lines, flowering.
<i>Acacia rhodophloia</i>	10	7b	Grazing line,
<i>Thryptomene</i> sp. Leinster (P3)	5	6	Declining.
<i>Acacia pruinocarpa</i>	<2	7c	Large adult outside quadrat, but juvenile within.
<i>Dodonaea petiolaris</i>	<2	3	Dry.

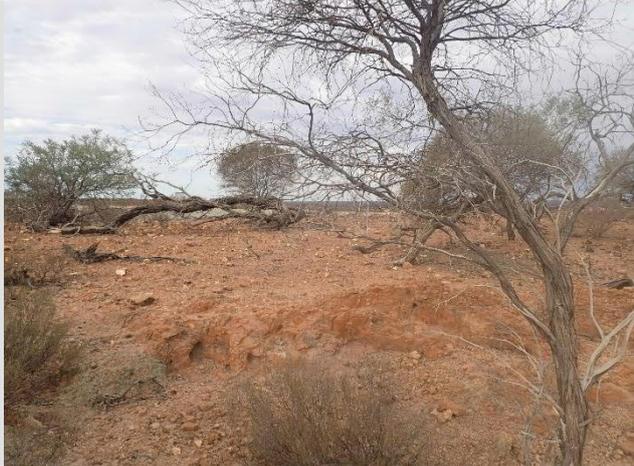
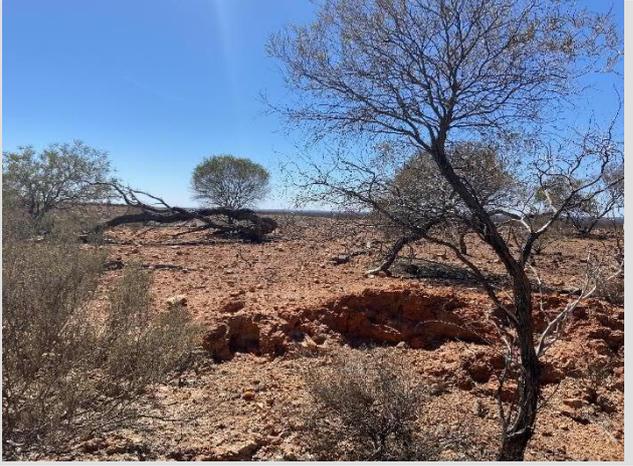
F.25 MKS EIA 37 - Haul Road Impact

Site ID: MKS EIA 37		Co-ordinates: 51 J 261077 6971050	
Location: ~ 48 m west of the haul road	Comments: Dust impacts likely on flora and vegetation, with dust covering soil surface. Site has shallow silty sand over extensive outcropping and sub cropping weather granite. Area subject to dust from vehicular movement on MKS haul road. Historic shrubs death observed. Acacia in good condition considering extended dry seasonal conditions and proximity to haul road. Scats, termite mounds and lichen present.		
Vegetation Type: Stony ironstone low shrubland			
Veg. Condition: Very Good			
Grazing: Light, historic			
Weed cover: Nil			
Photo direction: N			
Species	Cover (%)	Plant Health Score	Comments
<i>Acacia pruinocarpa</i>	8	7b	
<i>Acacia quadrimarginea</i>	8	7b	
<i>Dodonaea petiolaris</i>	<2	7b	Dust present.
<i>Thryptomene</i> sp. Leinster (P3)	0	1	Dead and replaced.
<i>Eremophila jucunda</i> subsp. <i>jucunda</i>	<2	3	Dust present.

<i>Calytrix uncinata</i>	<2	5	Replaces <i>Thryptomene</i> sp. Leinster. Flowering.
Other species: <i>Acacia aneura</i> , <i>Acacia rhodophloia</i> , <i>Hibbertia</i> sp. <i>Sherwood Breakaways</i> (R.J. Cranfield 6771), <i>Hakea leucoptera</i> subsp. <i>sericipes</i>

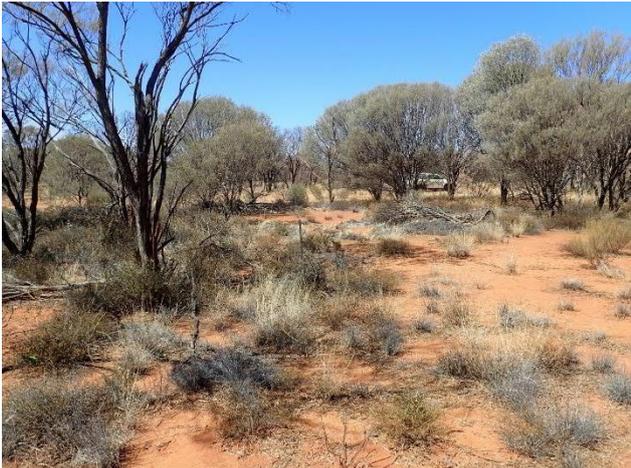
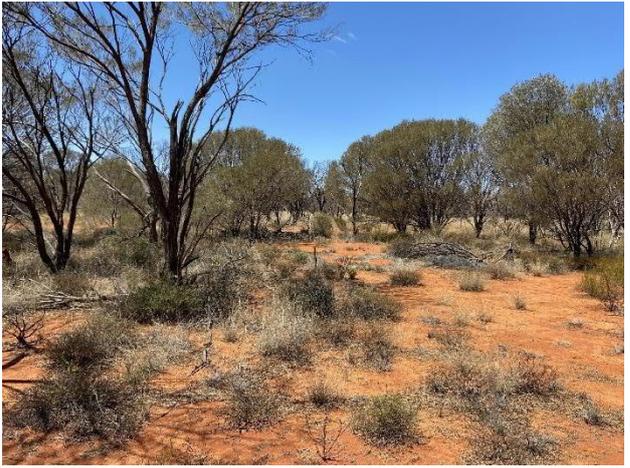
F.26 MKS EIA 19 - Control

Site ID: MKS EIA 19		Co-ordinates: 51 J 270893 6981469	
Location: ~12 km from haul road in Wanjarri Nature Reserve		Comments: Along fence line of Wanjarri Nature Reserve. <i>Triodia</i> is stressed, likely from dry seasonal conditions. Grazing impacting individual species including <i>Eremophila</i> sp. long pedicels (P2). Cattle and kangaroo scats present.	
Veg. Type: Sandplain Mulga spinifex shrubland/ Hardpan Mulga shrubland			
Veg. Condition: Excellent			
Grazing: Light,			
Weed cover: Nil			
Photo direction: NW			
Species	Cover (%)	Plant Health Score	Comments
<i>Triodia basedowii</i>	10	3	
<i>Acacia aneura</i>	20	7b	
<i>Acacia burkittii</i>	5	7b	
<i>Eragrostis eriopoda</i>	2	4	Post flowering.
<i>Grevillea deflexa</i>	5	7c	
Other species: <i>Eremophila spectabilis</i> , <i>Psydrax suaveolens</i> , <i>Eremophila</i> sp. long pedicels (G. Cockerton 1975)

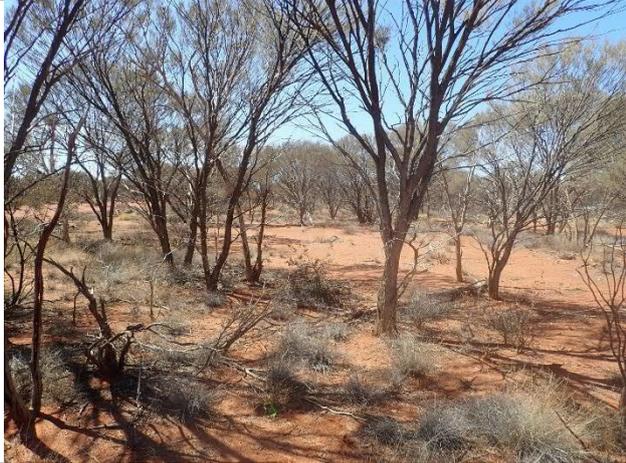
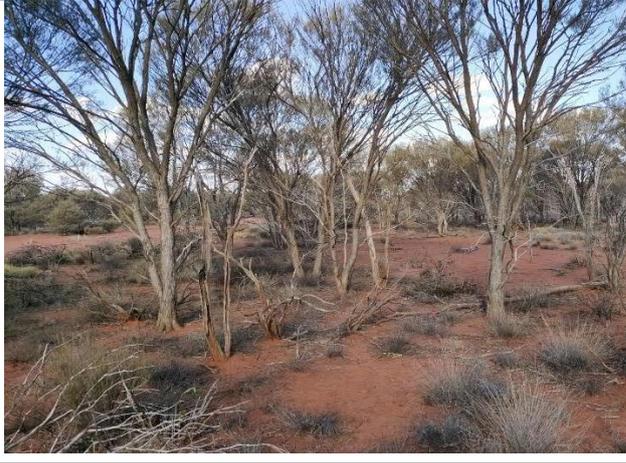
F.27 MKS EIA 20 - Control

Site ID: MKS EIA 20		Co-ordinates: 51 J 272524 6982988	
Location: ~15 km from haul road in Wanjarri Nature Reserve	Comments: <i>Eremophila</i> sp. long pedicels occurring in patches under Mulga with older seed pods present. Very dry vegetation. Cryptograms present but dry. Grasses are dry. No impacts from MKS, but nearby WNR track and grazing observed.		
Veg. Type: Sandplain Mulga spinifex shrubland/ Hardpan Mulga shrubland			
Veg. Condition: Very good			
Grazing: Light, historic			
Weed cover: Nil			
Photo direction: NW			
Species	Cover (%)	Plant Health Score	Comments
<i>Eragrostis eriopoda</i>	10	4	
<i>Triodia basedowii</i>	10	4	
<i>Acacia incurvaneura</i>	20	7c	
<i>Grevillea deflexa</i>	2	3	
<i>Eremophila spectabilis</i>	2	3	
Other species: <i>Acacia caesaneura</i> , <i>Ptilotus obovatus</i> , <i>Eremophila</i> sp. long pedicels

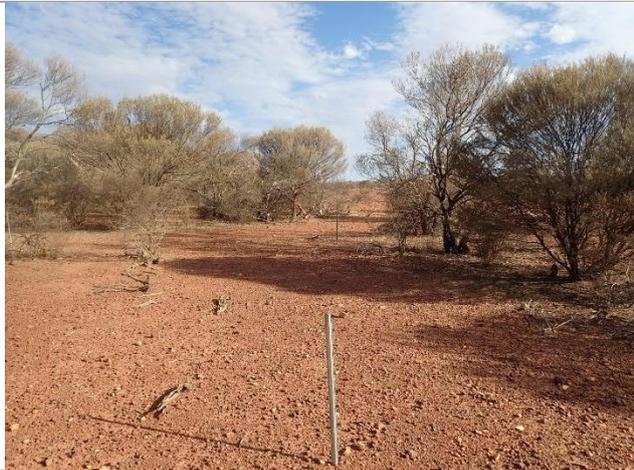
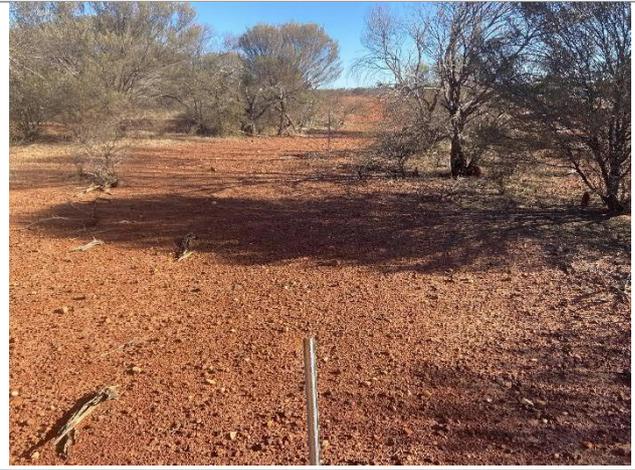
F.29 MKS EIA 22 - Control

Site ID: MKS EIA 22		Co-ordinates: 51 J 261218 6972404	
Location: ~ 87 m from haul road, within WNR	Comments: Almost all plants are water stressed. Control quadrat is close to MKS haul road and receives dust from the road. 10 m away from the WNR track. Historical <i>Acacia</i> deaths observed.		
Vegetation Type: Groved Mulga woodland			
Veg. Condition: Very good			
Grazing: Light, historic			
Weed cover: Nil			
Photo direction: N			
Species	Cover (%)	Plant Health Score	Comments
<i>Acacia aneura</i>	10	3	
<i>Sida ectogama</i>	5	7d	
<i>Aristida jerichoensis</i>	<2	2	
<i>Eremophila latrobei</i>	<2	2	
<i>Acacia tetragonophylla</i>	5	5	-
Other species: <i>Acacia thoma</i>

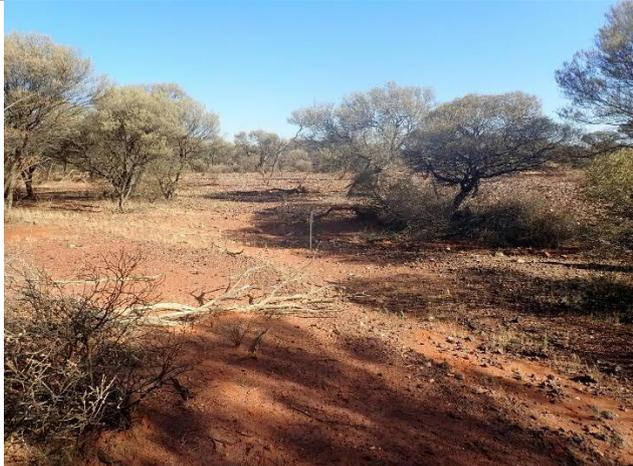
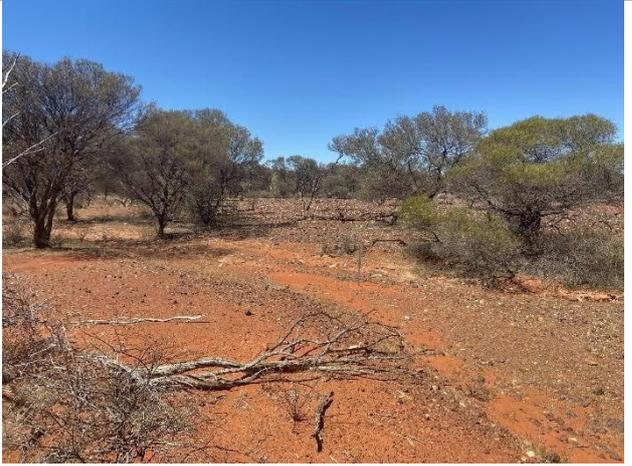
Site ID: MKS EIA 29		Co-ordinates: 51 J 261255 6970160	
Location: ~ 100 m east of haul road, within WNR	Comments: Monitoring peg is approximately 15 m east of the WNR track in a minor drainage. Vegetation in good condition, but dry. Centre post installed. Minor pedestalling western side of quadrat. Lower dust load than the other quadrats. Historic <i>Acacia</i> deaths. Ants present. Dead <i>Maireana</i> shrubs in center of quadrat.		
Veg. Type: Drainage line Mulga shrubland			
Veg. Condition: Very good			
Grazing: Light			
Weed cover: Nil			
Photo direction: NW			
Species	Cover (%)	Plant Health Score	Comments
<i>Acacia quadrimarginea</i>	20	7c	Browsing lines across lower branches.
<i>Sida ectogama</i>	5	7d	
<i>Acacia aneura</i>	15	7b	
<i>Eremophila jucunda</i> subsp. <i>jucunda</i>	<2	2	Dusty. Stressed.

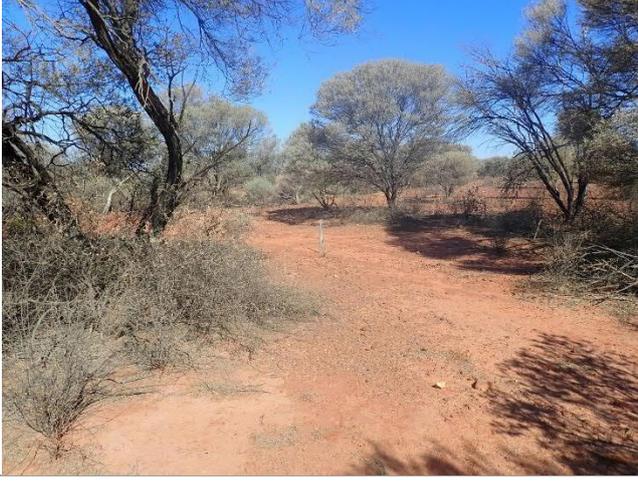
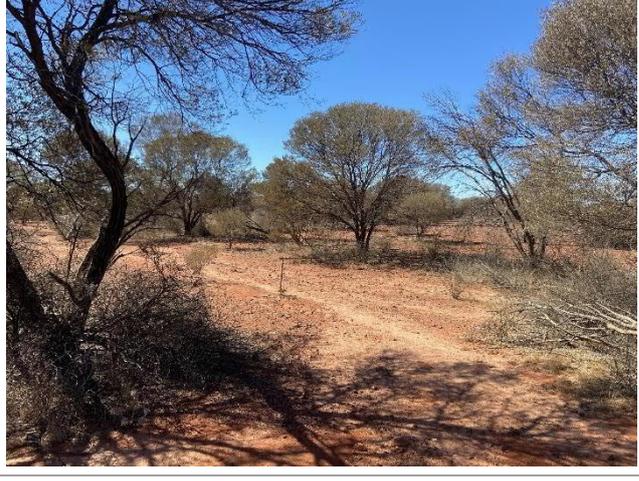
F.32 MKS EIA 30 - Control

Site ID: MKS EIA 30		Co-ordinates: 51 J 261261 6969699	
Location: ~ 125 m east of haul road, within WNR	Comments: Monitoring peg is approximately 15m east of the WNR track a minor drainage line. Dusty vegetation.		
Veg. Type: Drainage line Mulga shrubland			
Veg. Condition: Very good			
Grazing: Light			
Weed cover: Nil			
Photo direction: NW			
Species	Cover (%)	Plant Health Score	Comments
<i>Sida ectogama</i>	15	2	
<i>Acacia caesaneura</i>	30	7b	
<i>Dodonaea petiolaris</i>	0	1	Dead. Not Replaced.
<i>Eremophila galeata</i>	<2	3	
-	-	-	-
Other species: <i>Ptilotus exaltatus</i> , <i>Ptilotus obovatus</i> , <i>Eremophila compacta</i> , <i>Psydrax suaveolens</i> , <i>Enneapogon caeruleus</i> , <i>Lysiana sp</i>

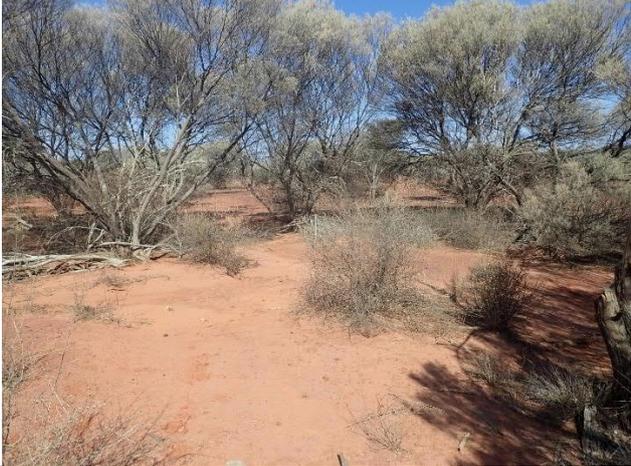
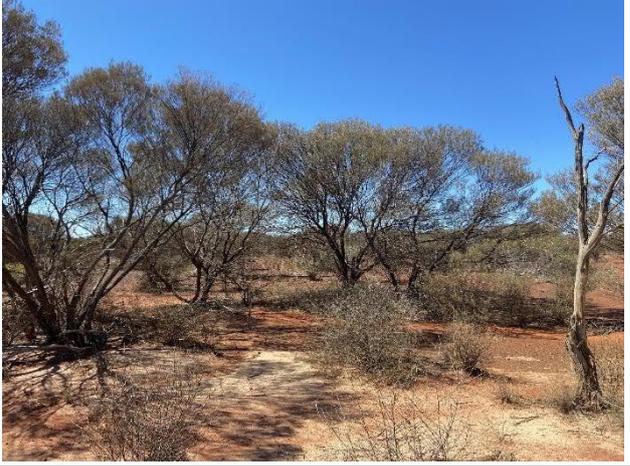
F.33 MKS EIA 31 - Control

Site ID: MKS EIA 31		Co-ordinates: 51 J 261263 6969421	
Location: ~ 114 m east of haul road, within WNR	Comments: Monitoring peg is approximately 10m east of the WNR track in a minor drainage line. Soil surface is intact with a clay and cryptogam crust. No annuals. All vegetation in good condition considering extended dry seasonal conditions. Insect galls on vegetation. Only middle post installed. Some dust present on vegetation. Grazing observed with browsing lines across Acacia shrubs/trees.		
Veg. Type: Drainage line Mulga shrubland			
Veg. Condition: Very good			
Grazing: Light, historic			
Weed cover: Nil			
Photo direction: NW			
Species	Cover (%)	Plant Health Score	Comments
<i>Sida ectogama</i>	10	2	Dusty. Stressed.
<i>Eremophila latrobei</i>	<2	3	
<i>Acacia caesaneura</i>	40	6	
<i>Eremophila spectabilis</i>	<2	2	Small individual under Mulgas.
<i>Eriachne helmsii</i>	<2	7c	
Other species: <i>Eremophila jucunda</i> subsp. <i>jucunda</i> .

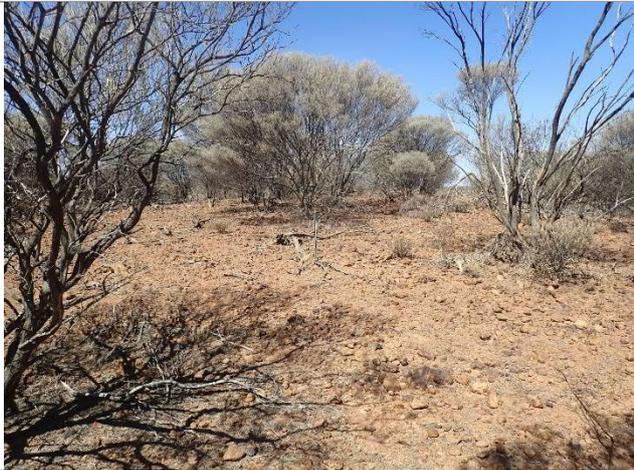
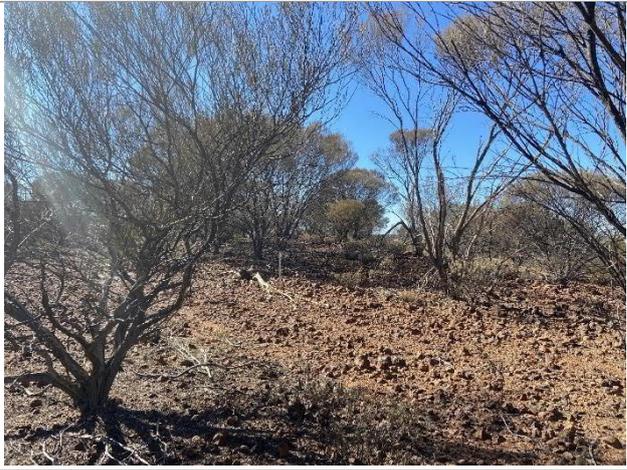
F.34 MKS EIA 32 - Control

Site ID: MKS EIA 32		Co-ordinates: 51 J 261277 6968983	
Location: ~ 110 m east of haul road, within WNR	Comments: Site is 100% covered in stony ferruginous rocks and boulders. No annuals at time of assessment. Only middle post installed. Grasses grazed to butts. Vegetation dry, likely due to extended dry seasonal conditions. Leaf litter present under Acacias.		
Veg. Type: Stony ironstone Mulga shrubland			
Veg. Condition: Excellent			
Grazing: Light			
Weed cover: Nil			
Photo direction: NW			
Species	Cover (%)	Plant Health Score	Comments
<i>Acacia aneura</i>	15	7b	
<i>Acacia thoma</i>	10	7b	
<i>Eremophila spectabilis</i>	<2	6	
<i>Eremophila latrobei</i>	<2	7c	Insect damage.
<i>Senna glaucifolia</i>	<2	7b	One healthy individual.
Other species: <i>Acacia aneura sens. lat.</i> , <i>Eriachne mucronata</i> , <i>Eremophila jucunda</i> subsp. <i>jucunda</i> , <i>Ptilotus schwartzii</i> , <i>Eragrostis eriopoda</i>

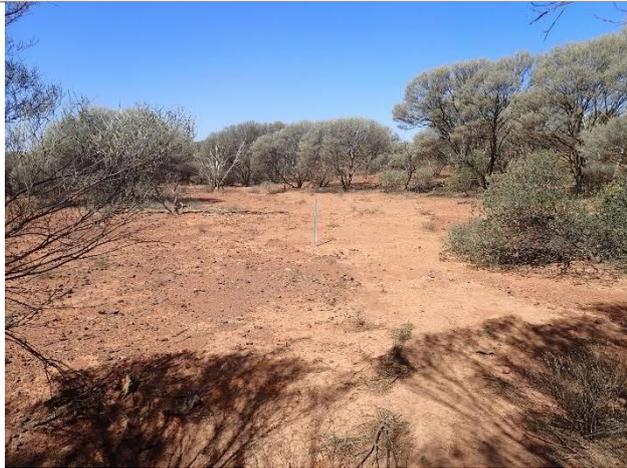
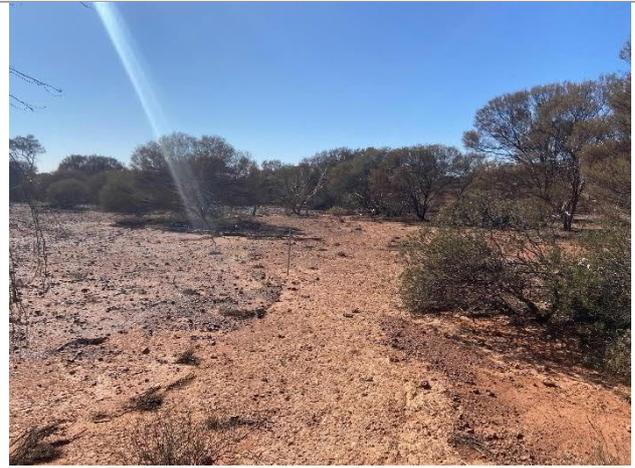
F.35 MKS EIA 33 - Control

Site ID: MKS EIA 33		Co-ordinates: 51 J 261280 6968863	
Location: ~ 114 m east of haul road, within WNR	Comments: Site is very bare. Multiple dead <i>Maireana</i> sp. individuals. Only middle post present. Cryptograms on soil surface. Some pedestalling erosion present. Dry vegetation with further lower storey shrub deaths.		
Veg. Type: Stony ironstone Mulga shrubland			
Veg. Condition: Good			
Grazing: Light			
Weed cover: Nil			
Photo direction: NW			
Species	Cover (%)	Plant Health Score	Comments
<i>Senna</i> sp. Meekatharra	10	7b	Fallen over tree, living and healthy.
<i>Acacia aneura</i> sens. lat.	15	7b	Some insect galls.
<i>Dodonaea petiolaris</i>	0	1	Dead, not replaced.
<i>Maireana</i> sp.	<2	2	Only few individuals remaining.
<i>Ptilotus obovatus</i>	<2	2	
Other species: <i>Acacia quadrimarginea</i> , <i>Hibiscus</i> sp., <i>Hakea preissii</i> , <i>Aristida</i> sp.

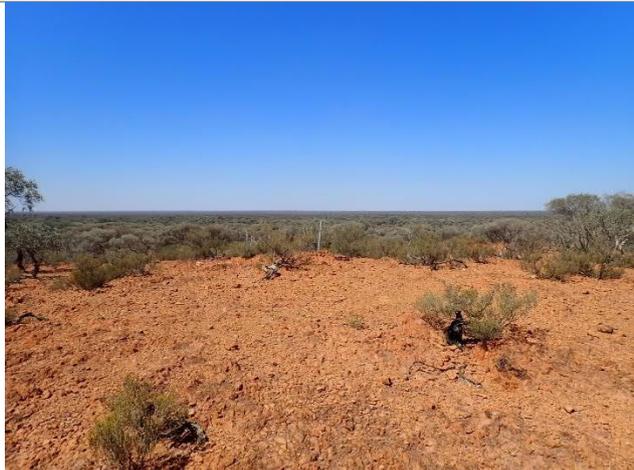
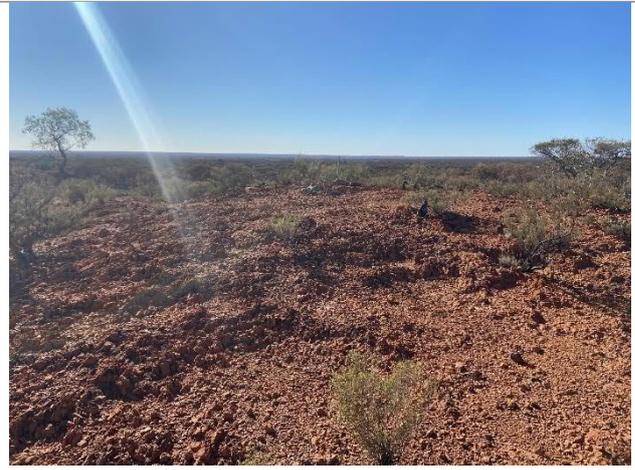
F.36 MKS EIA 34 - Control

Site ID: MKS EIA 34		Co-ordinates: 51 J 261298 6968771	
Location: ~ 114 m east of haul road, within WNR		Comments: Quadrat situated on a rocky outcrop next to WNR track. Dominated by <i>Thryptomene</i> sp. Leinster (P3). Lichens present on rocks. Some vegetation affected by extended dry seasonal conditions (<i>P. schwartzii</i> , <i>D. rigida</i>).	
Veg. Type: Stony ironstone low shrubland			
Veg. Condition: Excellent			
Grazing: Light			
Weed cover: Nil			
Photo direction: E			
Species	Cover (%)	Plant Health Score	Comments
<i>Thryptomene</i> sp. Leinster (P3)	20	4	Budding.
<i>Acacia pruinocarpa</i>	5	7b	Few adolescent trees.
<i>Dodonaea rigida</i> (EIA_13_012)	<2	6	Post flowering.
<i>Ptilotus schwartzii</i>	<2	2	
-	-	-	-

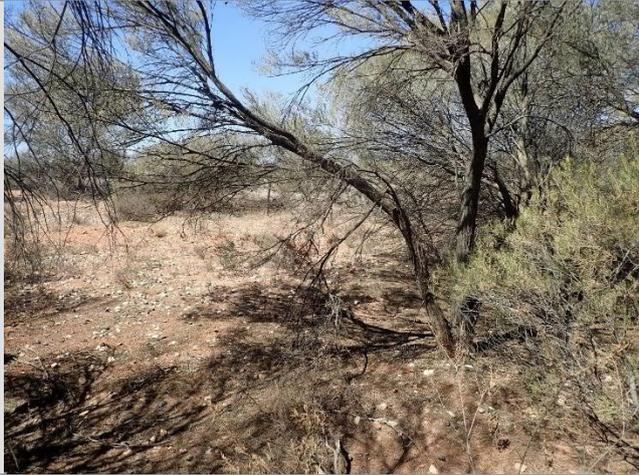
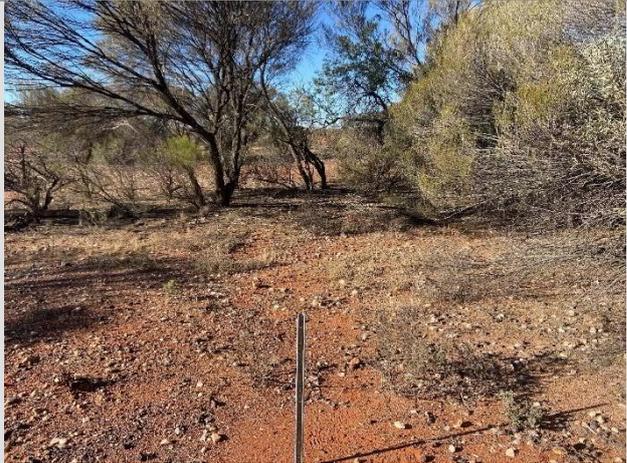
F.37 MKS EIA 38 - Control

Site ID: MKS EIA 38		Co-ordinates: 51 J 261304 6967527	
Location: ~ 130 m east of haul road	Comments: Dust impacts and flora and vegetation. Ants and multiple rabbit warrens. Litter under trees. <i>Maireana</i> sp. individuals very dry, likely due to extended dry seasonal conditions.		
Veg. Type: Stony ironstone low shrubland.			
Veg. Condition: Very good			
Grazing: Light, historic			
Weed cover: Nil			
Photo direction: NW			
Species	Cover (%)	Plant Health Score	Comments
<i>Maireana triptera</i>	15	2	Few dead individuals.
<i>Acacia burkittii</i>	15	7b	Insect galls.
<i>Acacia aptaneura</i>	10	7b	Browsing line.
<i>Eremophila oldfieldii</i>	5	7b	
<i>Eremophila ?compacta</i> (EIA_38_001)	0	1	Dead and replaced.
<i>Senna artemisioides</i> subsp. <i>?filifolia</i>	<2	6	Replaces <i>Eremophila ?compacta</i> .
Other species: <i>Acacia aneura</i> , <i>Eremophila granitica</i> , <i>Enneapogon caerulescens</i> , <i>Sclerolaena eurotioides</i> , <i>Ptilotus obovatus</i> , <i>Eremophila latrobei</i> , <i>Lysiana</i> sp.

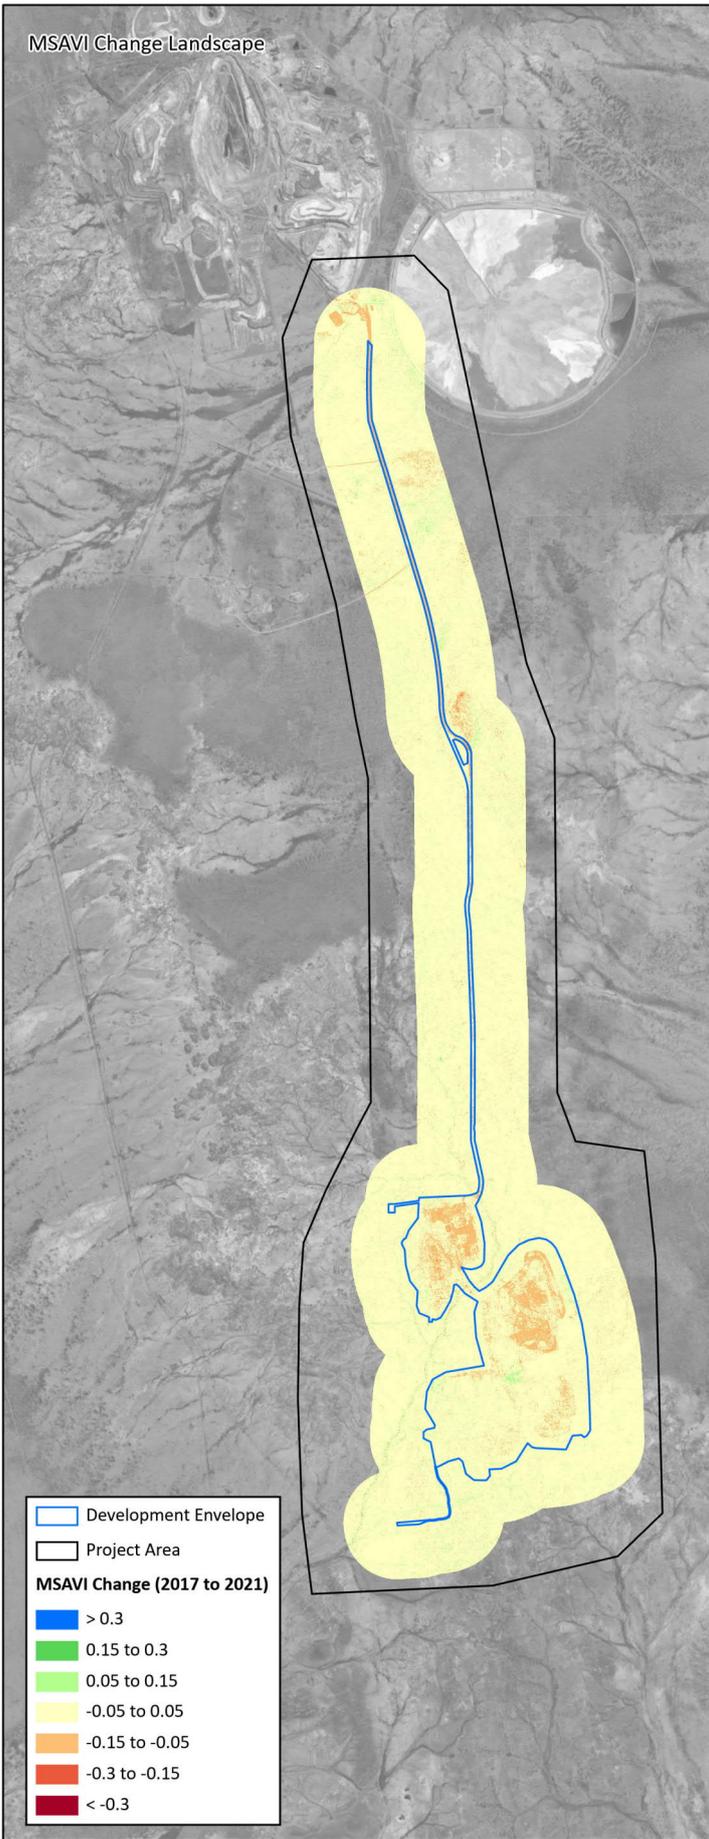
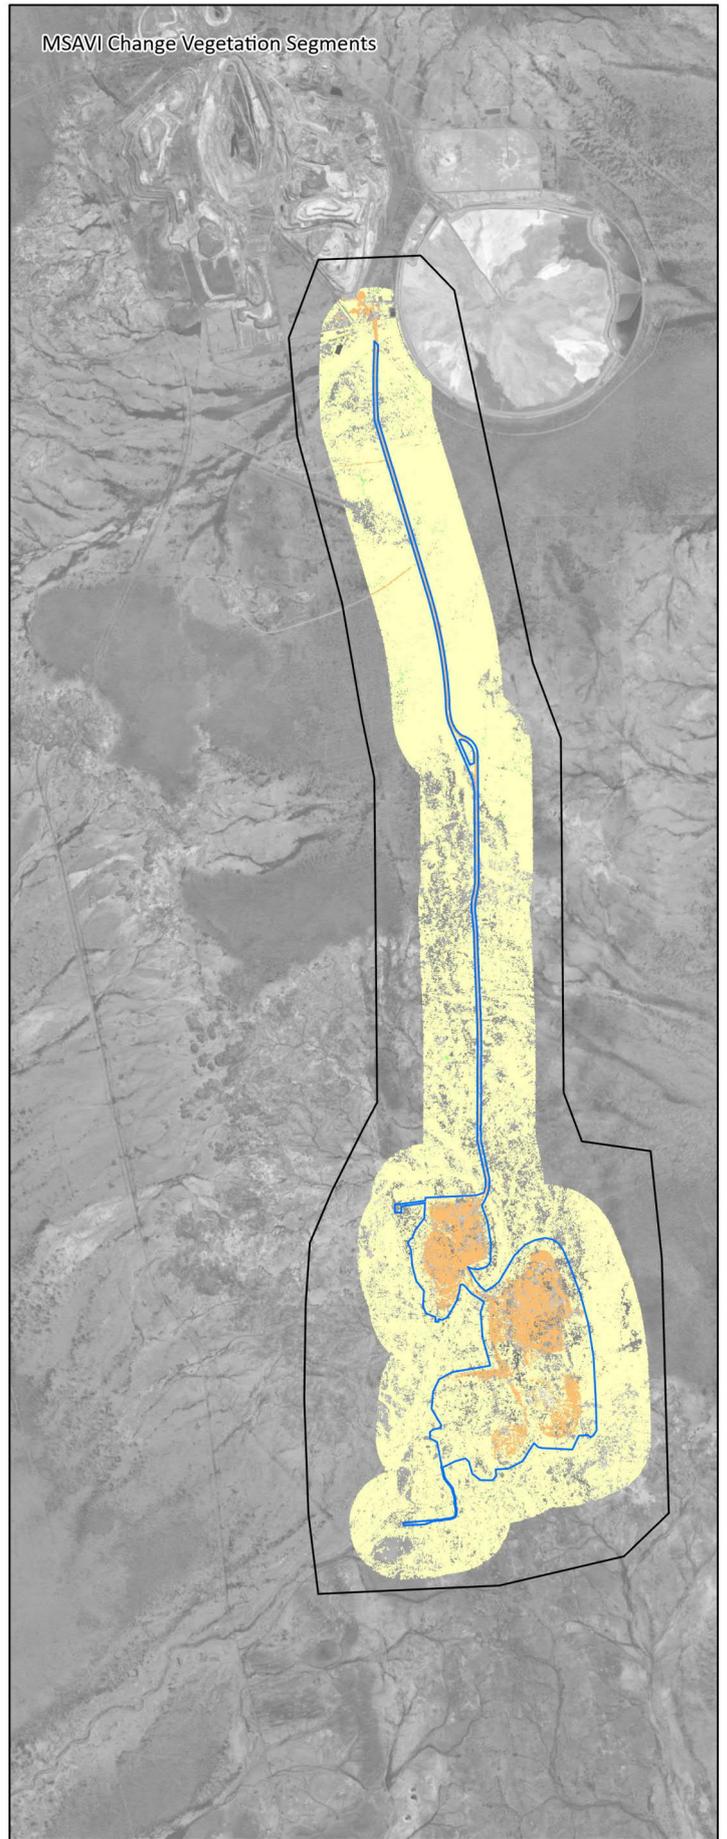
Figure 4: WorldView Modified Soil Adjusted Vegetation Index change September 2017 to October 2021

The MSAVI change statistics (Table 3) and change map (Figure 4) show a decrease in mean MSAVI in the case of vegetation segments, but no change in the case of the landscape. The majority of negative change in the study area appears to coincide with the mining footprint changes between 2017 and 2021, and this is particularly noticeable in the imagery and landscape MSAVI change layer. However, there are areas of decrease on the eastern side of the study area that appear to be related to a decline in vegetation condition. Some of this decrease in mean MSAVI may be partially attributed to the difference in annual rainfall between 2017 and 2021 (Figure 2). However, project impacts such as disruptions to surface flow could also be a factor in some areas.
