Land Resources

4 Land Resources

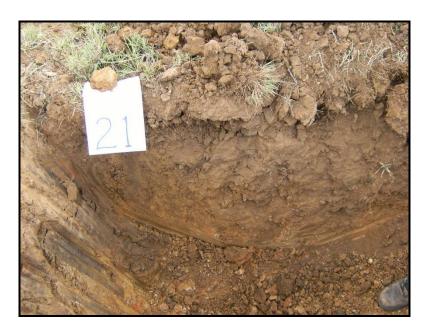
Figure 4.17 Uniform Clay Profile

The soil unit occurs on the undulating plains which include minor areas of linear gilgai. This soil unit generally consist of yellowish and reddish brown to light brownish and reddish yellow uniform clays. Uniform soils display little textural change down the profile. This soil unit is associated in the north western areas of the project site. This soil unit encompasses approximately 41% of the project site. A representative profile of this soil unit is presented in Table 4.9. Figure 4.17 shows typical Uniform Clay profile.

Soil Unit: Uniform Clay			
Layer Depth (m) Description			
1	0 – 0.15	Yellowish brown (10YR5/4) clay loam. Weak consistence, angular- blocky peds, 5-10 mm diameter. Many roots and nil stone content. The lower boundary is sharp and even to layer 2.	
2	0.15 – 0.69	Yellowish brown (10YR5/4) clay loam. Moderate consistence, sub- angular blocky peds, 20-50 mm diameter. Roots noted as common and stone content minor. The boundary is clear to layer 3.	
3	0.69 – 1.05+	Light yellowish brown (10YR6/4) clay loam. Strong consistence and massive. Stone and root content noted as nil.

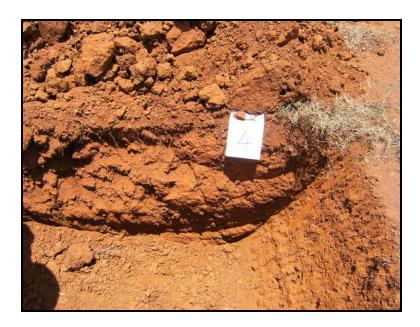
Figure 4.18 Uniform Clay (red variant) Profile

Table 4.10 and Figure 4.18 provide the red variant to the soil profile described above.

Soil Unit: Uniform Clay			
Layer	Depth (m)	Description	
1	0 – 0.20	Reddish brown (7.5YR4/6). Moderate consistency and pedality. Angular blocky, 10-20 mm peds. Roots noted as many and 10-20% sub-rounded weathered stones 2-6 mm in diameter. Boundary is clear to layer 2.	
2	0.20 – 1.05	Yellowish Red (5YR5/6) clay loam. Moderate consistence. Angluar blocky, 10-20 mm peds. Roots noted as many. Stone content 10-20%. Weathered stones 6-20 mm diameter. Boundary is clear to layer 3.	
3	1.05 – 1.25+	Reddish yellow (7.5YR6/6) clay loam. Strong consistence and Apedal massive. No roots stone content 2-10%, 2-6 mm in diameter.

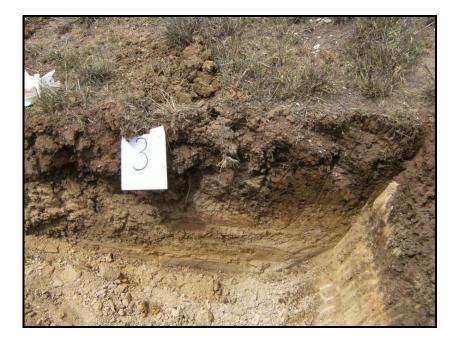
Figure 4.19 Yellow Duplex Soil Profile

This soil unit is associated with the floodplain areas, and encompasses some 10% of the project site. The soil is characterised by dark yellow sandy and clay loam of varying depths. A representative and typical profile of this soil unit is presented in Table 4.11 and Figure 4.19.

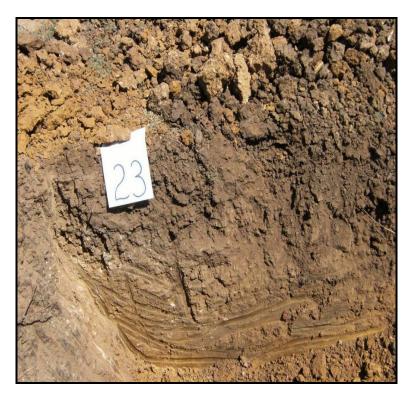
Figure 4.20 Brigalow Clay Profile

The soil unit occurs on the lowlands and plains (up to 1% slope). These areas contain melanholes and normal gilgai. The soil is characterised by brown light to medium clays throughout the profile. The unit encompasses some 6% of the project site. A representative profile of this soil unit is presented Table 4.12. A typical Brigalow Clay profile is shown in Figure 4.20.

Soil Unit: Brigalow Clay			
Layer	Depth (m)	Description	
1	0 – 0.15	Brown (10YR5/3) light clay. Weak consistency and pedality. Platy <2 mm primary peds. Roots are common. Stone content <2%, weakly weathered sub-rounded stones, 2-6 mm diameter. Boundary is clear and wavy to layer 2.	
2	0.15- 0.40	Brown (10YR4/3) light clay. Moderate consistency and pedality. Sub-angular blocky, 2-5 mm peds. Roots noted as few. Stone content 2-10%, weakly weathered sub-rounded stones, 2-6 mm diameter. Boundary is clear but uneven to layer 3.	
3	0.40 - 1.10+	Brownish yellow (10YR6/6) light clay. Strong consistency and apedal massive. No roots. Nil stone content.

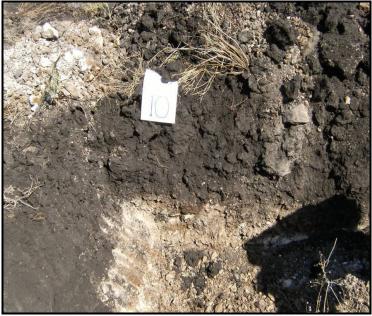
Figure 4.22 Shallow Heavy Clay Profile

Shallow dark cracking clays occur on undulating plains and low hills within the project site. Description of the soil unit was based on surface observations and no samples were collected. The soil unit encompasses some 9% of the project site. A representative profile of this soil unit is presented in Table 4.14. A typical Shallow Heavy Clay profile is presented in Figure 4.22.

Soil Unit: Shallow Heavy Clay			
Layer	Depth (m)	Description	
1	0 – 0.10	Dark greyish heavy clay. Weak consistence and weak pedality, with 2-5 mm crumby peds. Roots are common and 2-10% sub-rounded stones, 2-6 mm in diameter are present. The lower boundary is sharp and even to layer 2.	
2	0.10- 0.70	Black and heavy clay. Moderate consistence and moderate pedaility. Sub-angular blocky, rough faced, 50-100 mm, peds. Roots are common and 2-10% stones, 2-6 mm diameter are present. The boundary is clear and wavy to layer 3.	
3	0.70 - 1.20+	Grey white weathered sedimentary material.

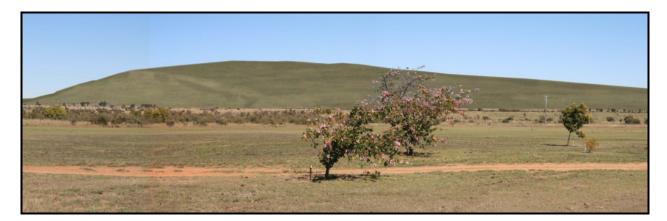
Figure 4.83 Visual Simulation of View from View Situation 11

The visual simulation presented in Figure 4.83 illustrates how the final landform would appear from View Situation 11 at the entrance to the Moranbah airport from the Moranbah Access Road. The slope on the left hand side of the landform is one side of a cutting that would extend through the new landform, which rises up again to the left of the photograph.

The visual simulation illustrates the high visual impact that would result at this location as a result of the new landform to be created by the proposed mining operations. It also demonstrates that vegetation located close to the viewer, such as the small flowering tree in the centre of the photograph, could effectively screen views of the new landform. Such planting would need to include tall-growing trees planted dense enough to create a continuous visual screen. The existing long distance view illustrated in Figure 4.84 extends well beyond the project site to the mountain range on the skyline.

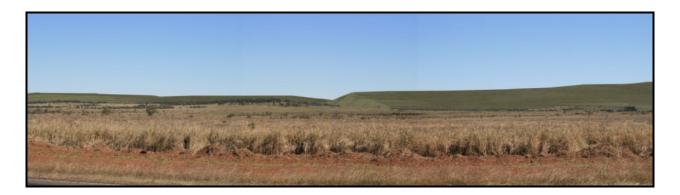
Figure 4.85 Visual Simulation of the final landform from View Situation 13

The visual simulation presented in Figure 4.85 shows the final landform viewed from View Situation 13 along the Moranbah Access Road north of the intersection with the Peak Downs Highway. The steep slope in the centre of the landform is associated with a cutting through the new landform.

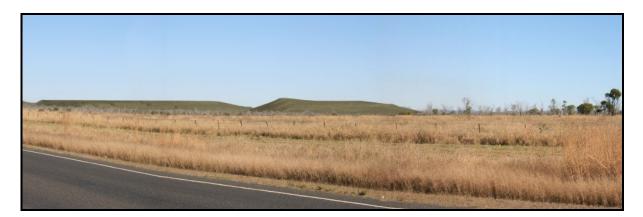
Figure 4.87 Visual Simulation of view of the final landform from View Situation 19

The visual simulation presented in Figure 4.87 shows the final landform viewed from View Situation 19 along the section of Dysart-Moranbah Road south of the intersection with the Peak Downs Highway. The steep slopes in the centre of the landform are associated with a cutting through the new landform.
