BHP BILLITON IRON ORE NEWMAN TOWNSHIP ELECTRICITY SUPPLY

ANNUAL AUDIT REPORT ON COMPLIANCE MONITORING SYSTEMS 2014/2015 FINANCIAL YEAR

REVISION A

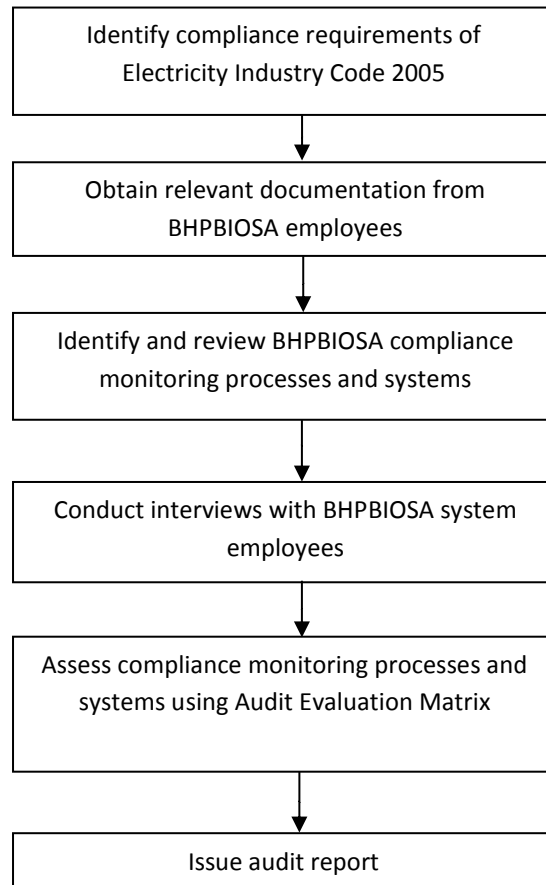
3.1. Audit Flowchart

The methodology applied to perform the audit is as per the following flowchart:
