BHP BILLITON IRON ORE NEWMAN TOWNSHIP ELECTRICITY SUPPLY

ANNUAL AUDIT REPORT ON COMPLIANCE MONITORING SYSTEMS 2015/2016 FINANCIAL YEAR

REVISION A

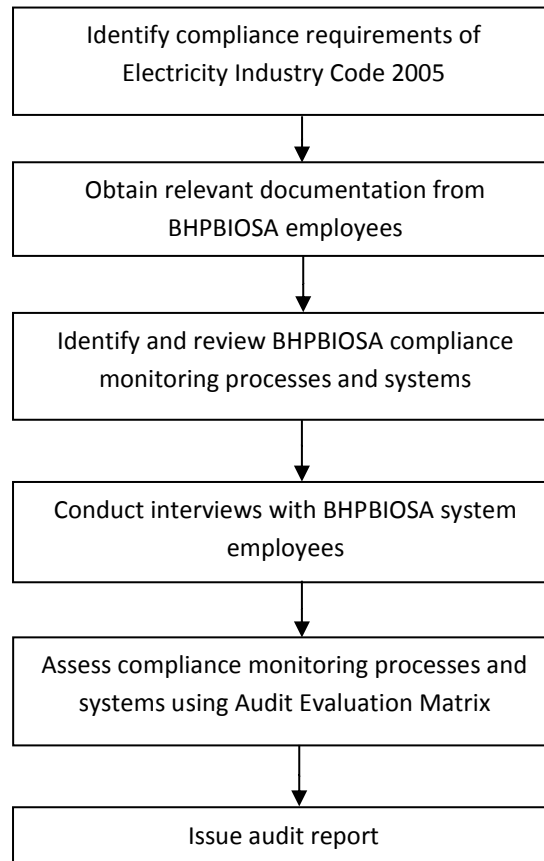
3.1. Audit Flowchart

The methodology applied to perform the audit is as per the following flowchart:
