BHP

Mt Arthur Coal

Annual Review FY19

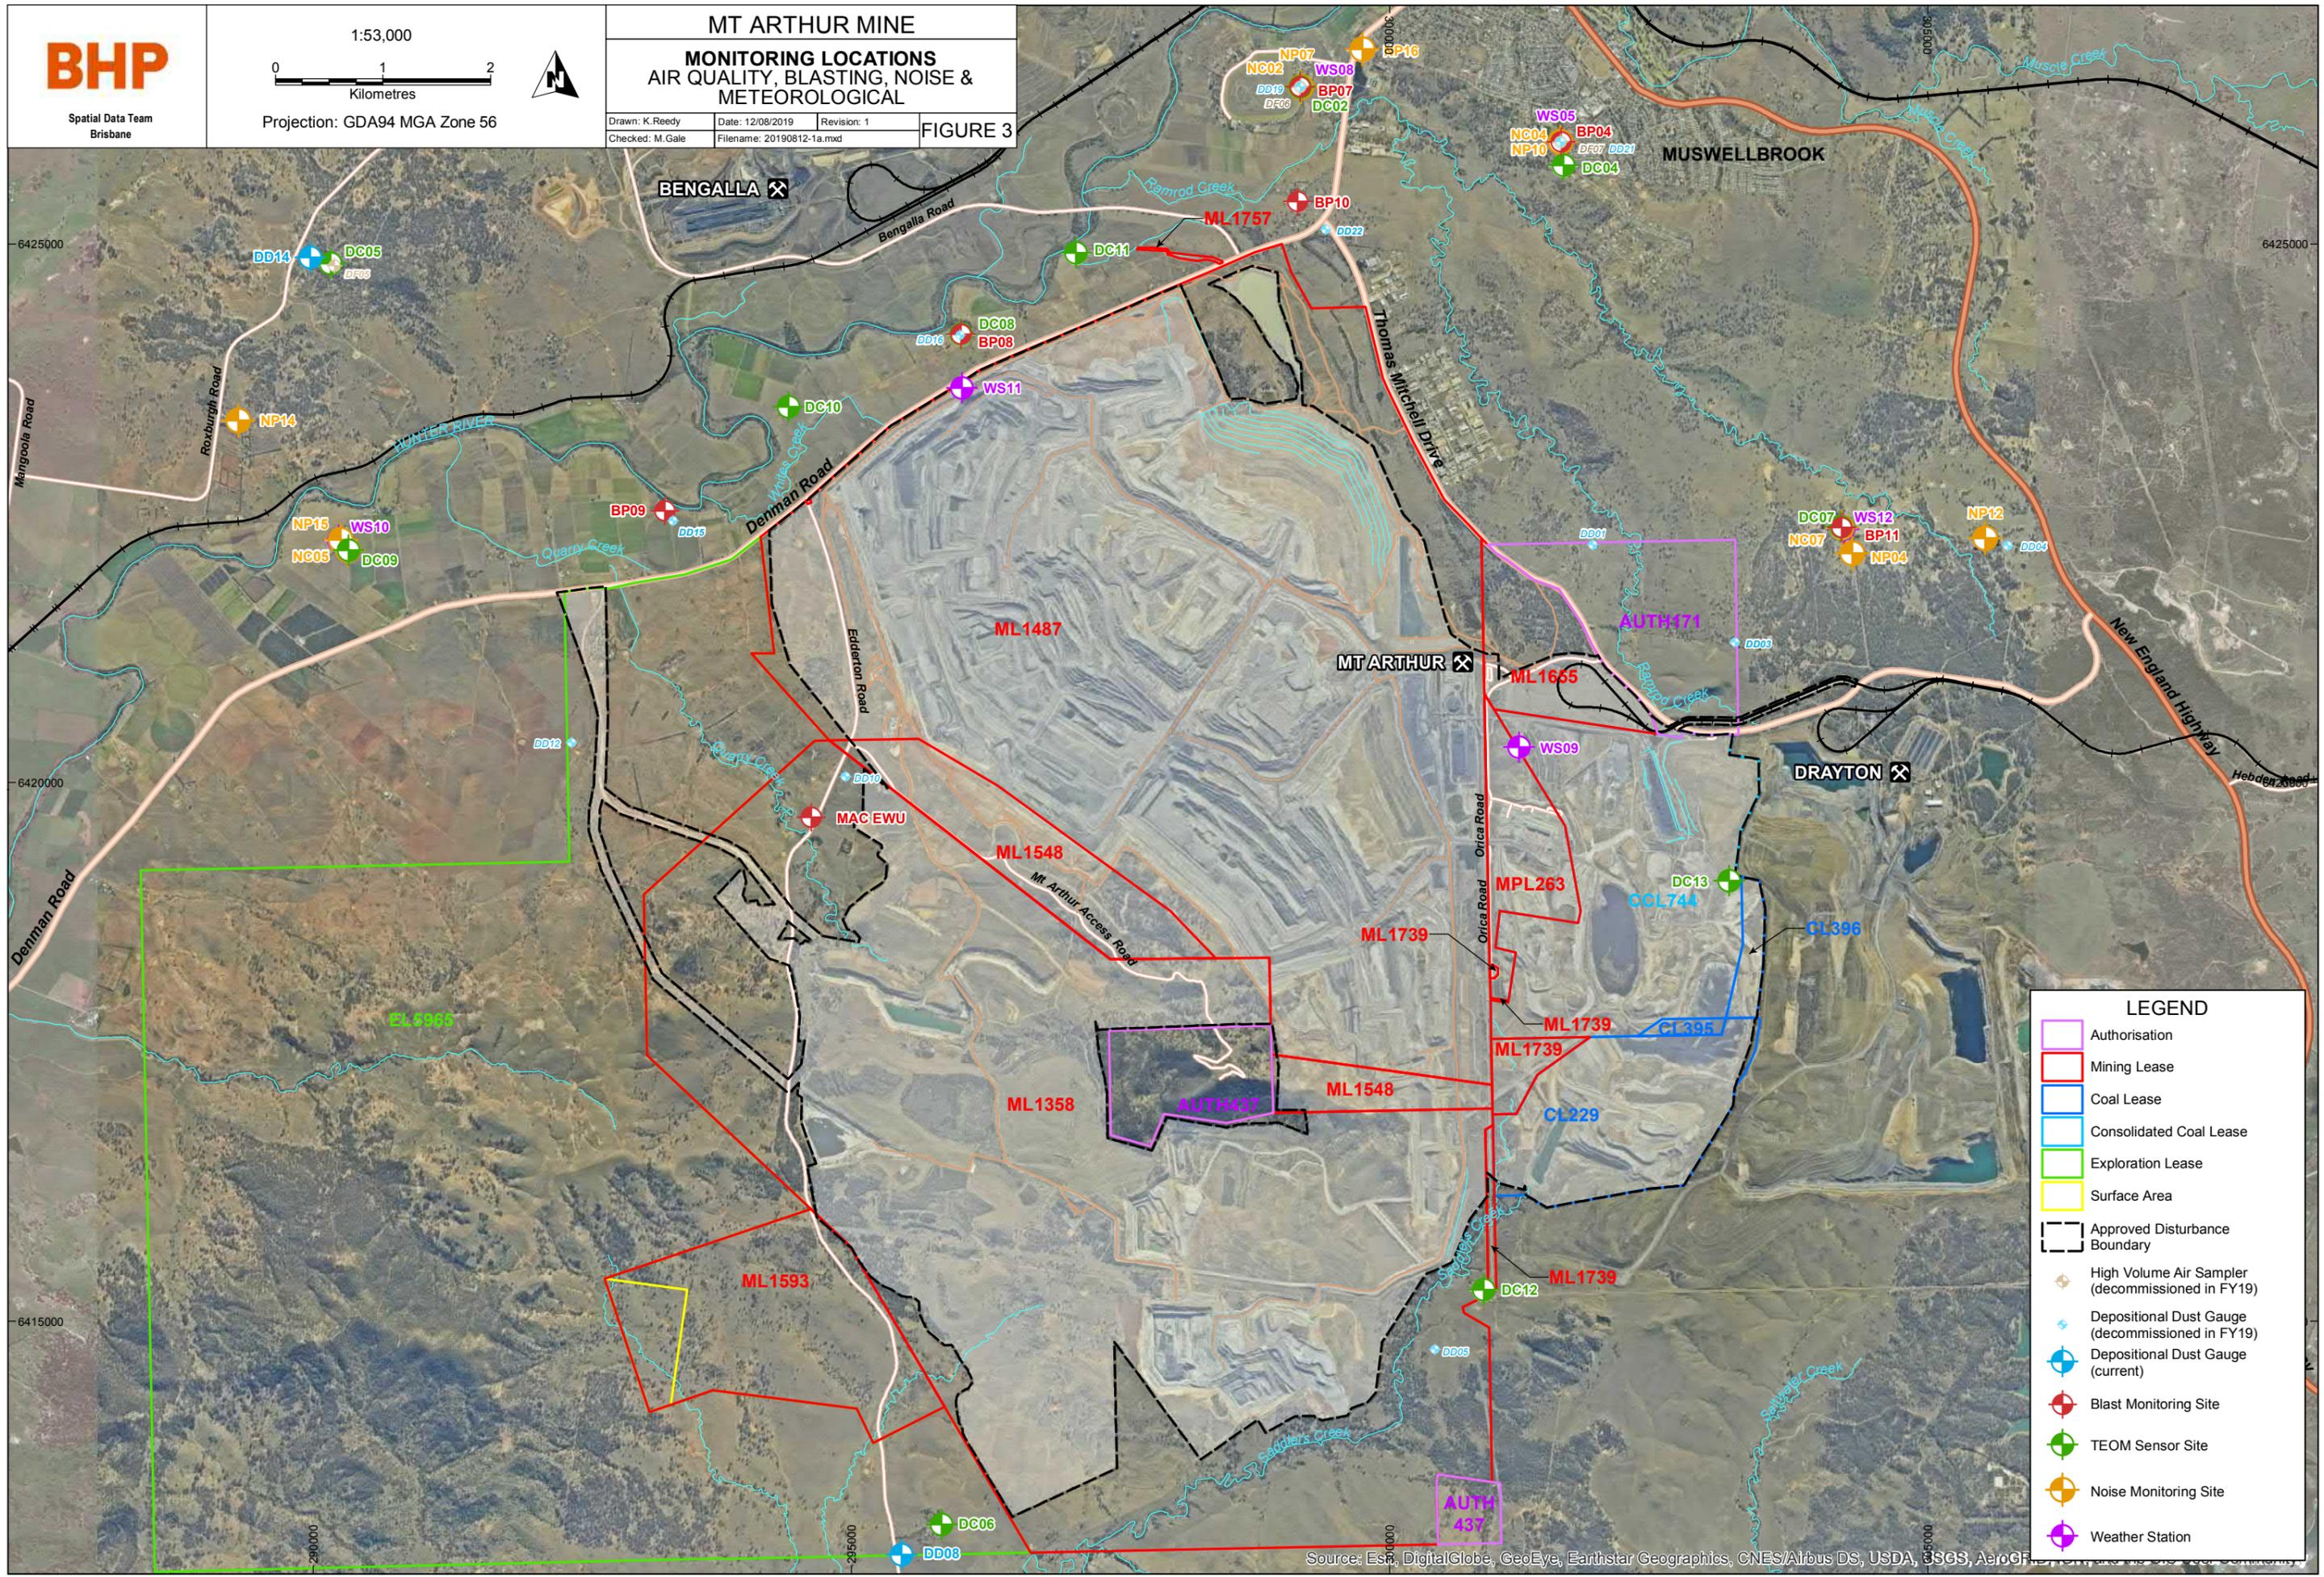
FIGURE 3

- Authorisation
- Mining Lease
- Coal Lease
- Consolidated Coal Lease
- Exploration Lease
- Surface Area
- Approved Disturbance Boundary
- High Volume Air Sampler (decommissioned in FY19)
- Depositional Dust Gauge (decommissioned in FY19)
- Depositional Dust Gauge (current)
- Blast Monitoring Site
- TEOM Sensor Site
- Noise Monitoring Site
- Weather Station

Mt Arthur Coal has eight statutory monitoring locations as detailed in the Noise Monitoring Program and four real-time monitoring locations utilised for internal use. Noise monitoring locations are shown in Figure 3.

Blast monitoring locations are shown in Figure 3.

A secondary statutory real-time meteorological station, located off site to the north west of the mine at Wellbrook (WS10), also provides representative weather data for the mine site, including prevailing wind conditions, and is used in conjunction with WS09 to determine the presence and strength of temperature inversions in the local atmosphere as part of the pre-blast environmental assessment. These meteorological stations are shown on Figure 3.

Air Quality monitoring locations are shown in Figure 3.

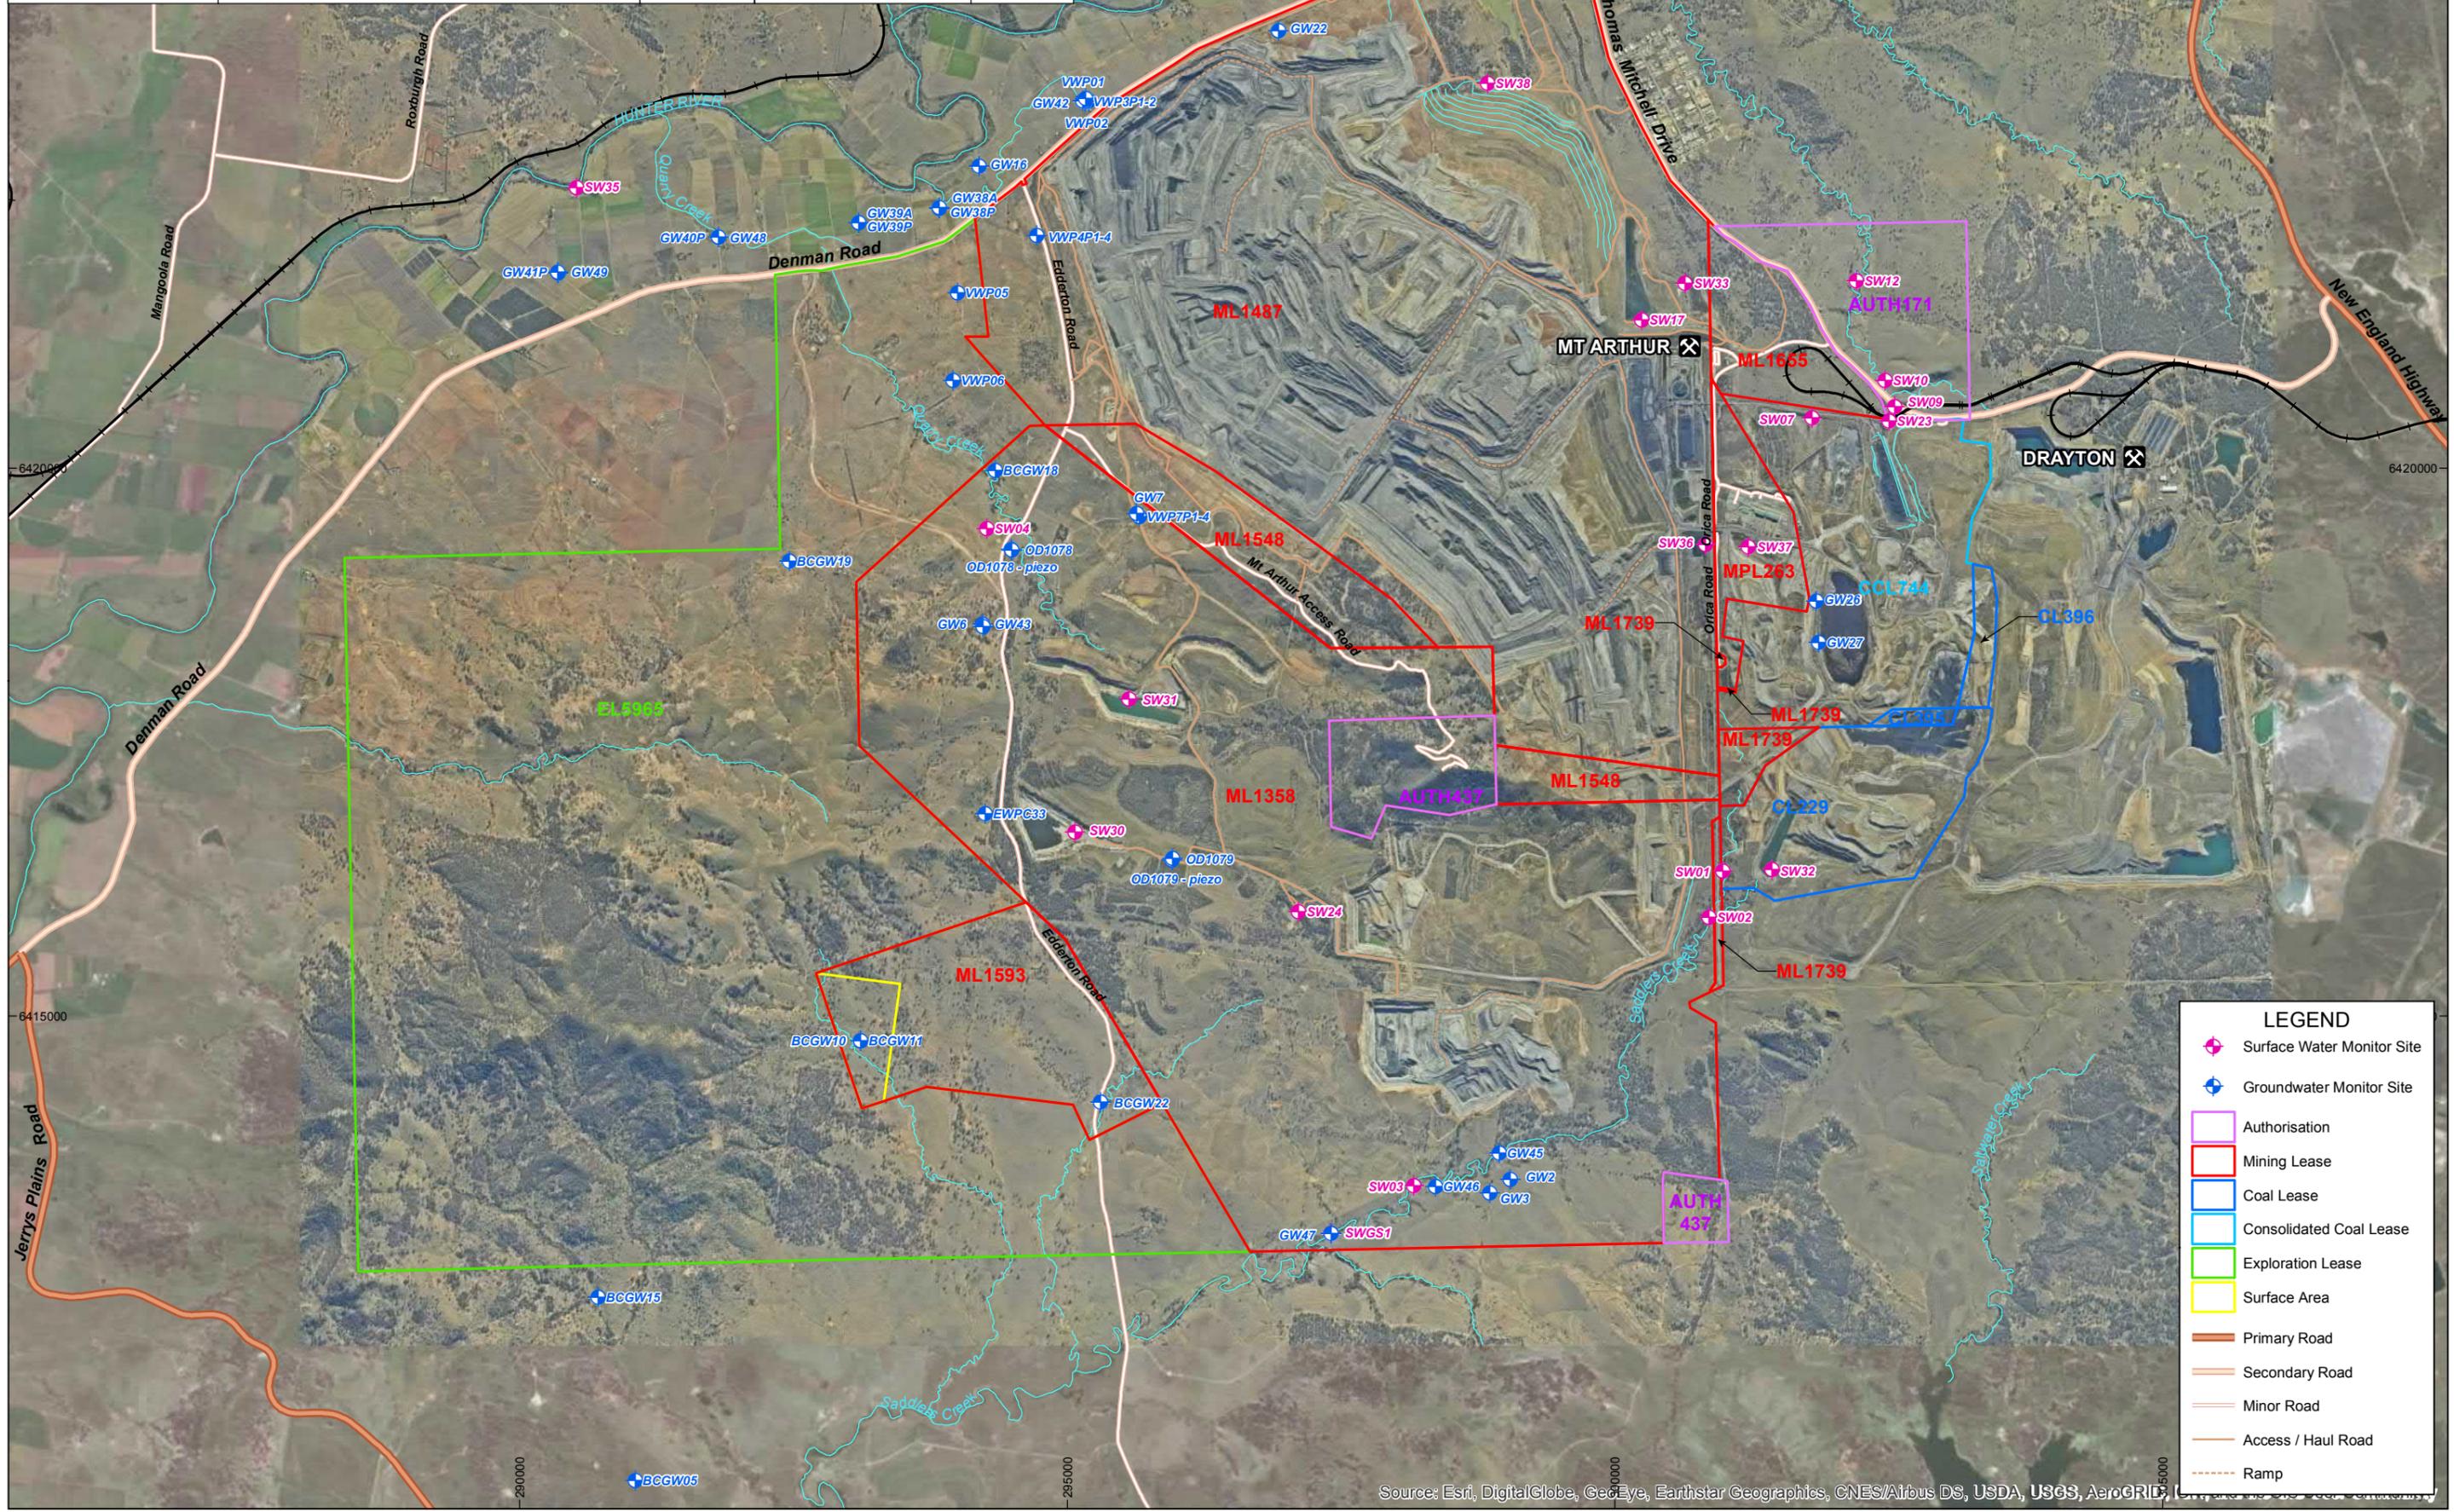
FIGURE 6

- Surface Water Monitor Site
- Groundwater Monitor Site
- Authorisation
- Mining Lease
- Coal Lease
- Consolidated Coal Lease
- Exploration Lease
- Surface Area
- Primary Road
- Secondary Road
- Minor Road
- Access / Haul Road
- Ramp

Surface water monitoring locations are shown in Figure 6.

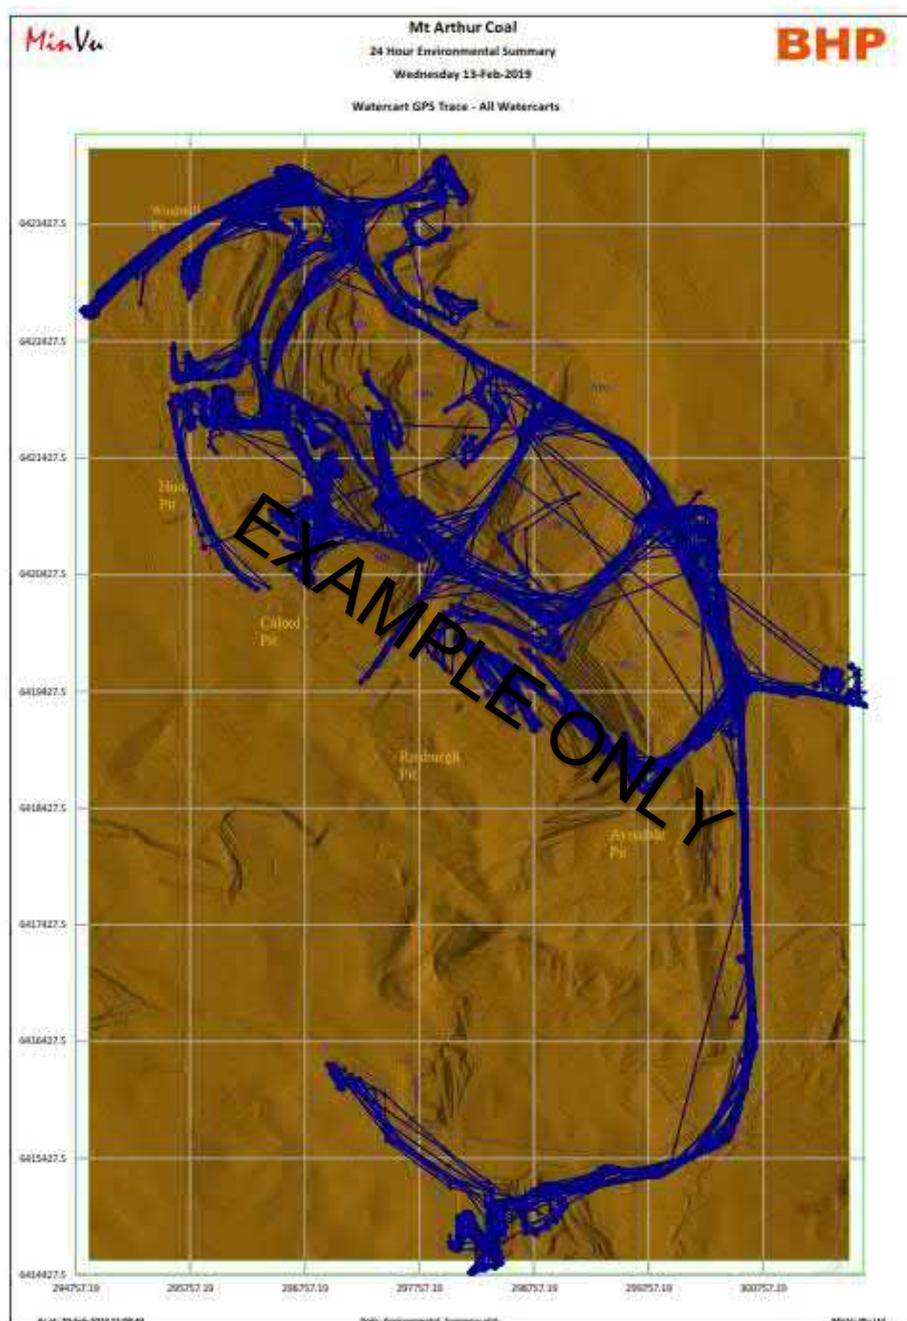
Watercart GPS trace for 24 hour period

Map of all locations/routes MAC watercarts travelled throughout the period represented by blue lines. Intensity of activity can be seen by thicker and more frequent blue lines.

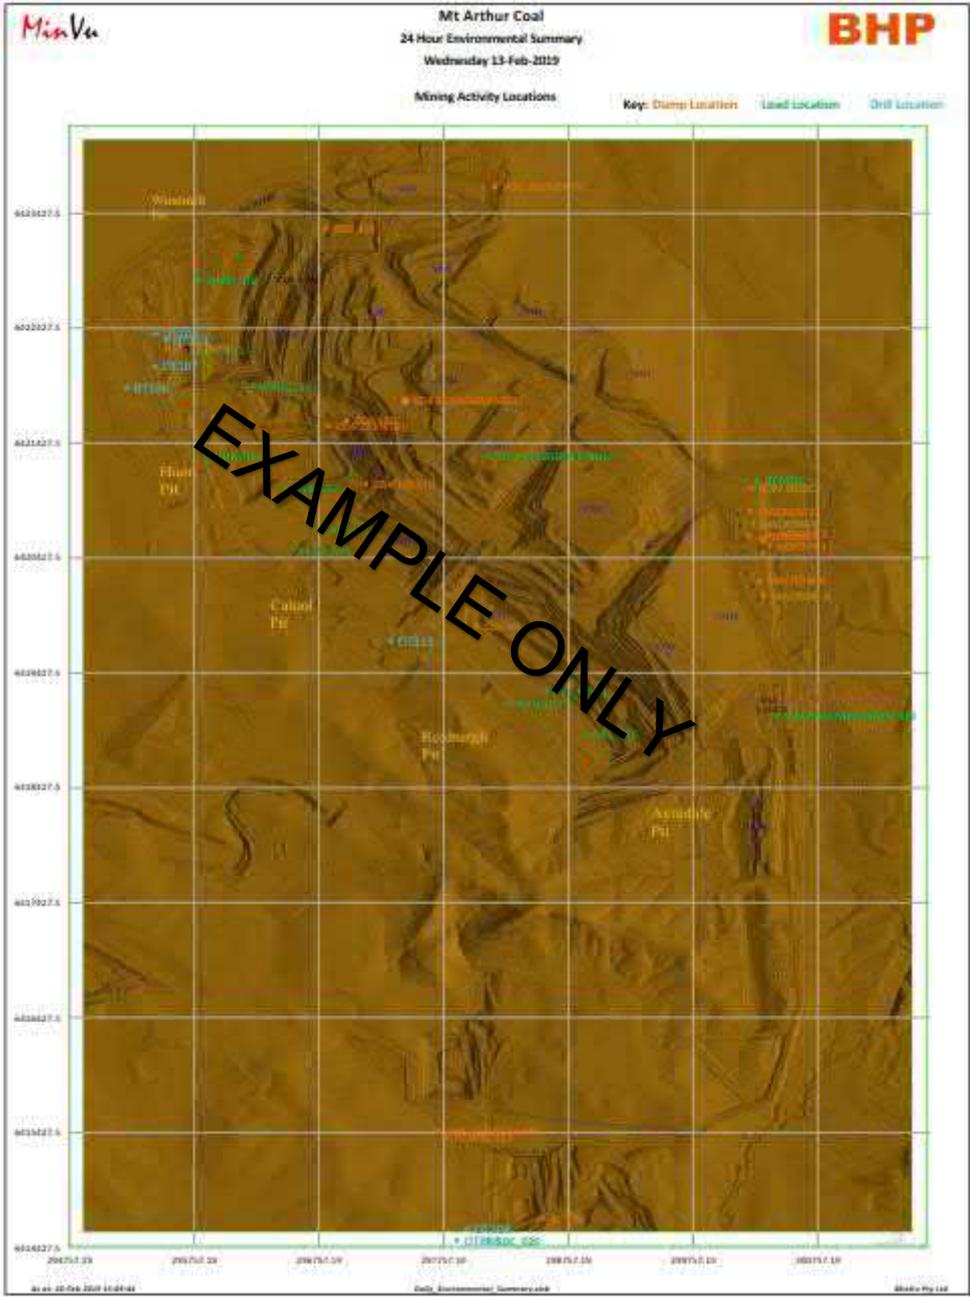
Mining Activity Locations for 24 hour period

Map of all dumping, loading/digging and drilling locations throughout the period.
Locations are colour coded as per legend.

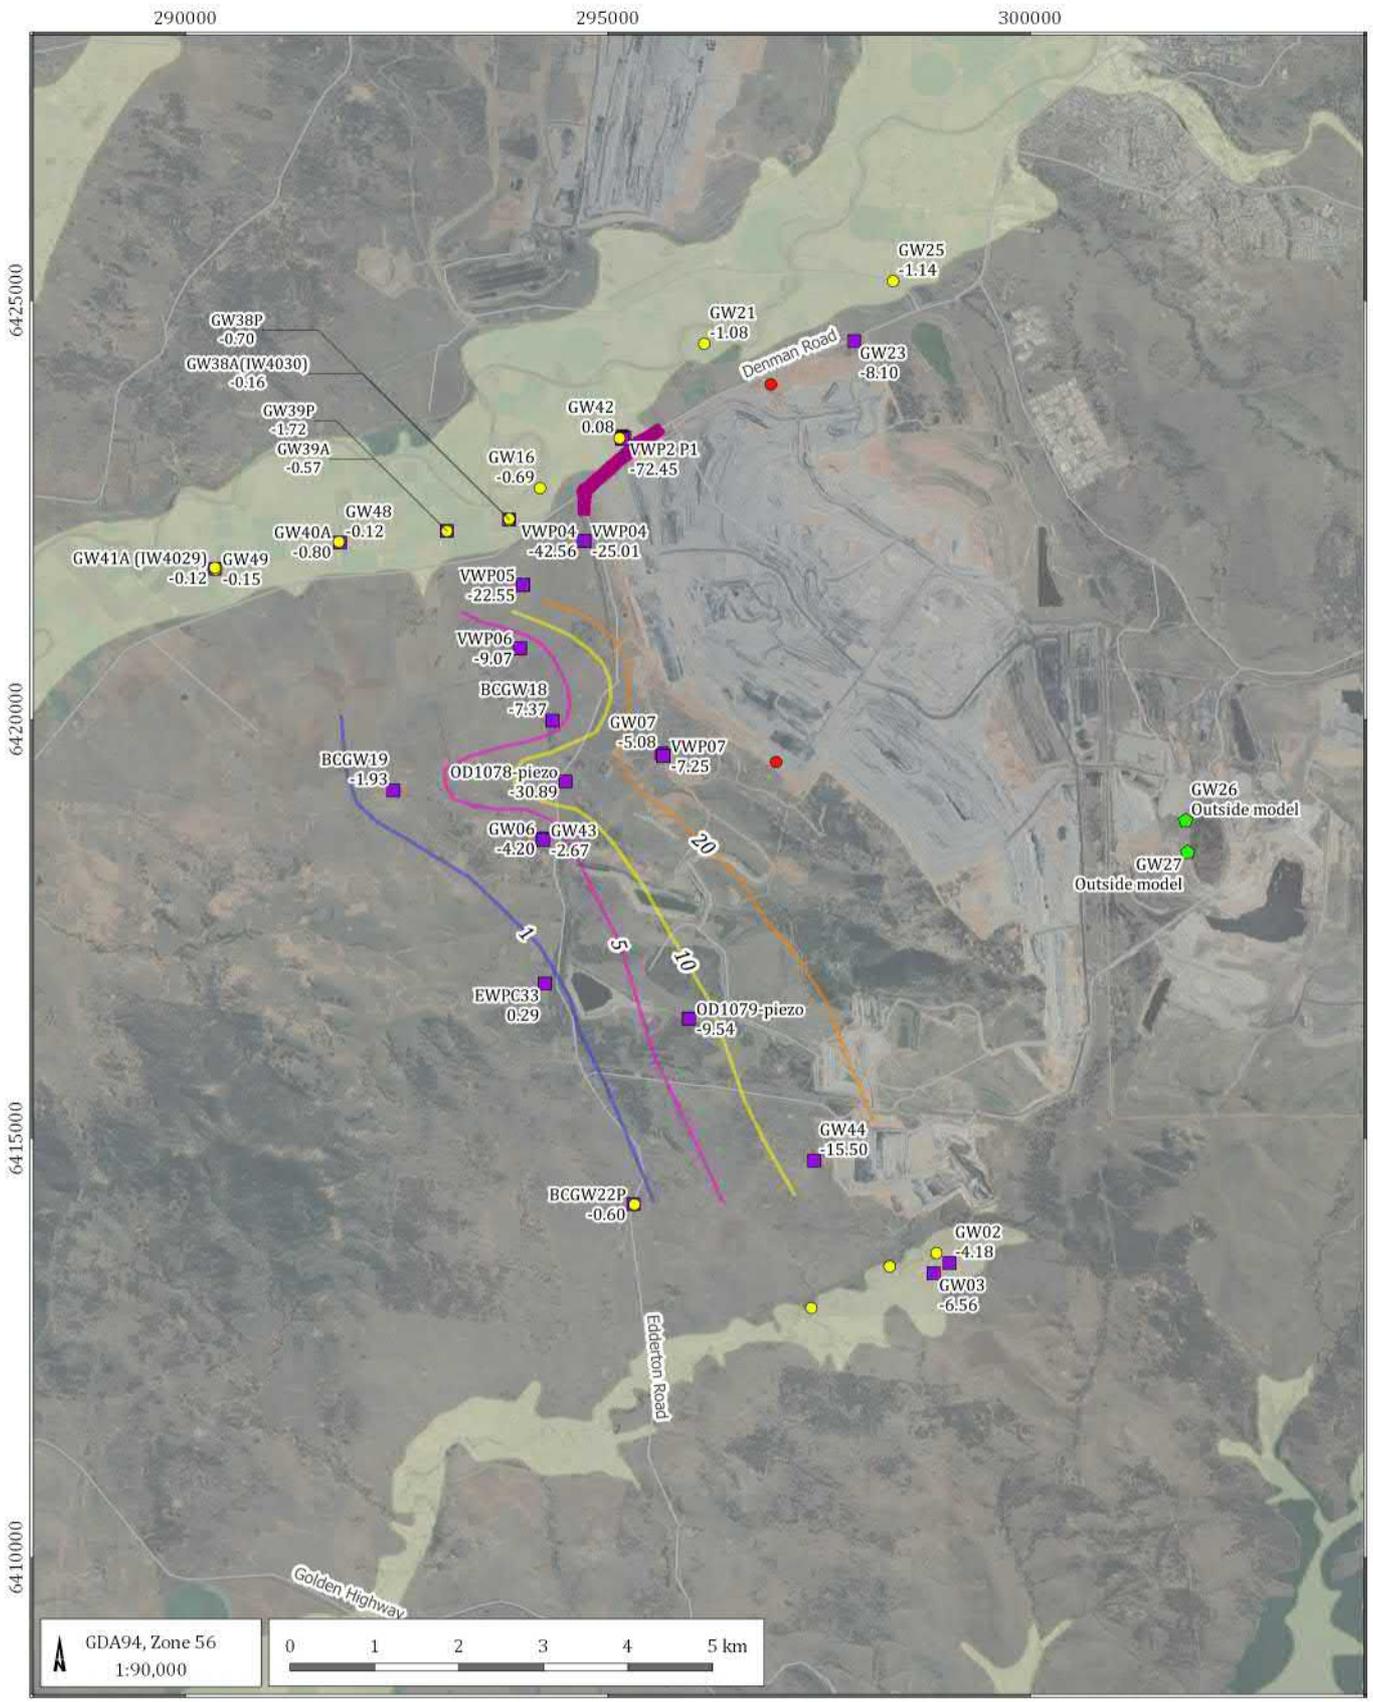
FIGURE No:
3.2

Monitoring locations and drawdowns

Figure 3.2 shows the total drawdown calculated at each monitoring bore between the start of the monitoring records and June 2019. The monitoring bores are colour coded based on installation within either the alluvium (yellow label) or Permian strata (purple label). Contours lines of equal drawdown are also shown for the Permian. The drawdown in the Permian layers occurs in a zone west of the active mining areas. The drawdown shown on Figure 3.2 is a function of mining impacts and climatic conditions over the monitoring period. In the case of the Permian layers the measured drawdown change is largely attributed to the mining activities as climatic conditions are not expected to create water level changes of the magnitude observed.

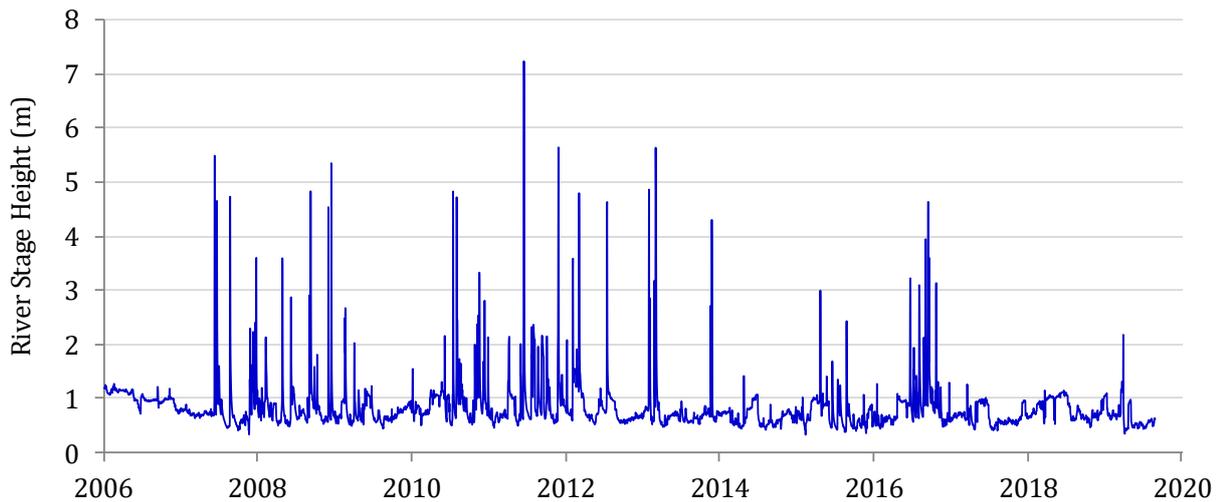
Figure 3.4 Hunter River stage height

Source: BOM river station 210002, Hunter River at Muswellbrook Bridge

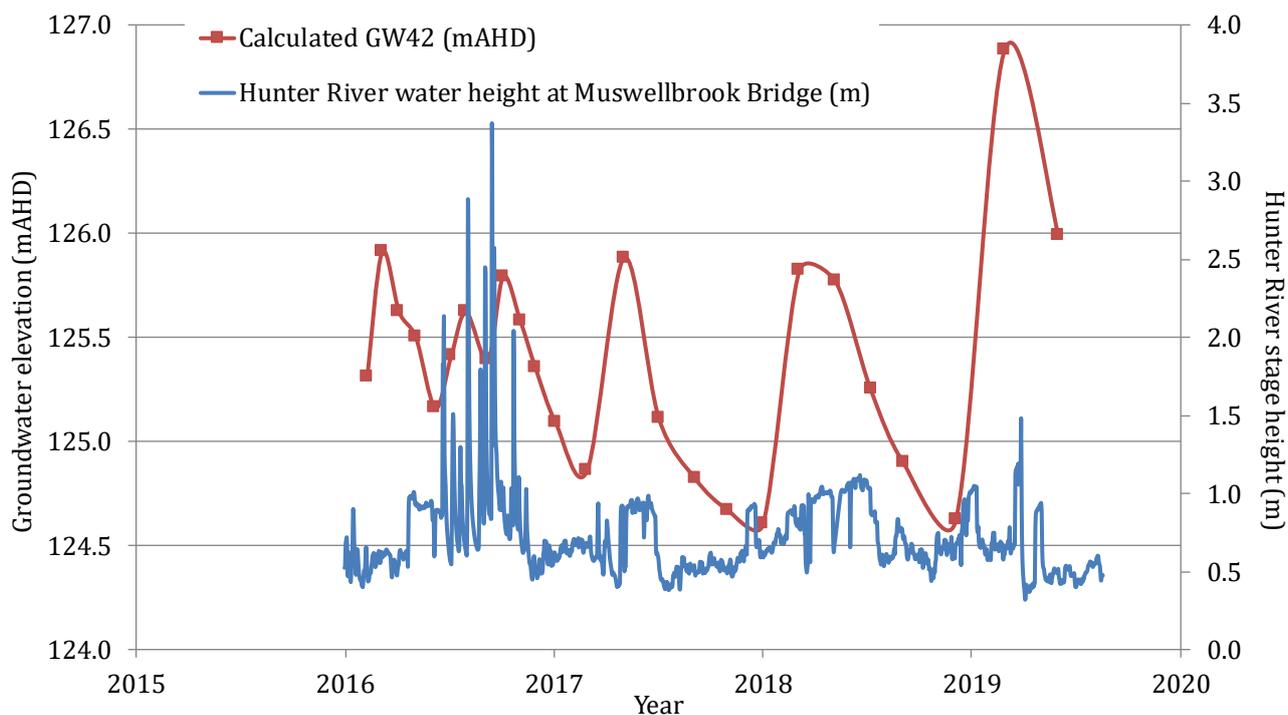
Figure 3.8 GW42 water level and Hunter River stage height

Source: BOM river station 210002, Hunter River at Muswellbrook Bridge.

Figure 3.6 and Figure 3.7 show groundwater levels within the Edinglassie and Ramrod Creek coal seams and the F4 Fault have declined 72 m in the F4 Fault, 83 m in the Edinglassie Seam and 85 m in the Ramrod Creek Seam since installation. In contrast, nearby Hunter River Alluvial aquifer monitoring bores GW16 and GW21, have recorded water level changes of 0.69 and 1.08 m respectively. GW42 is located adjacent to the VWP installations and has also remained relatively stable with no detected drawdown; instead, its groundwater level oscillates simultaneously with the level of the Hunter River (see Figure 3.8). The higher levels in GW42 coincide with periods of higher levels in the water level of the Hunter River.

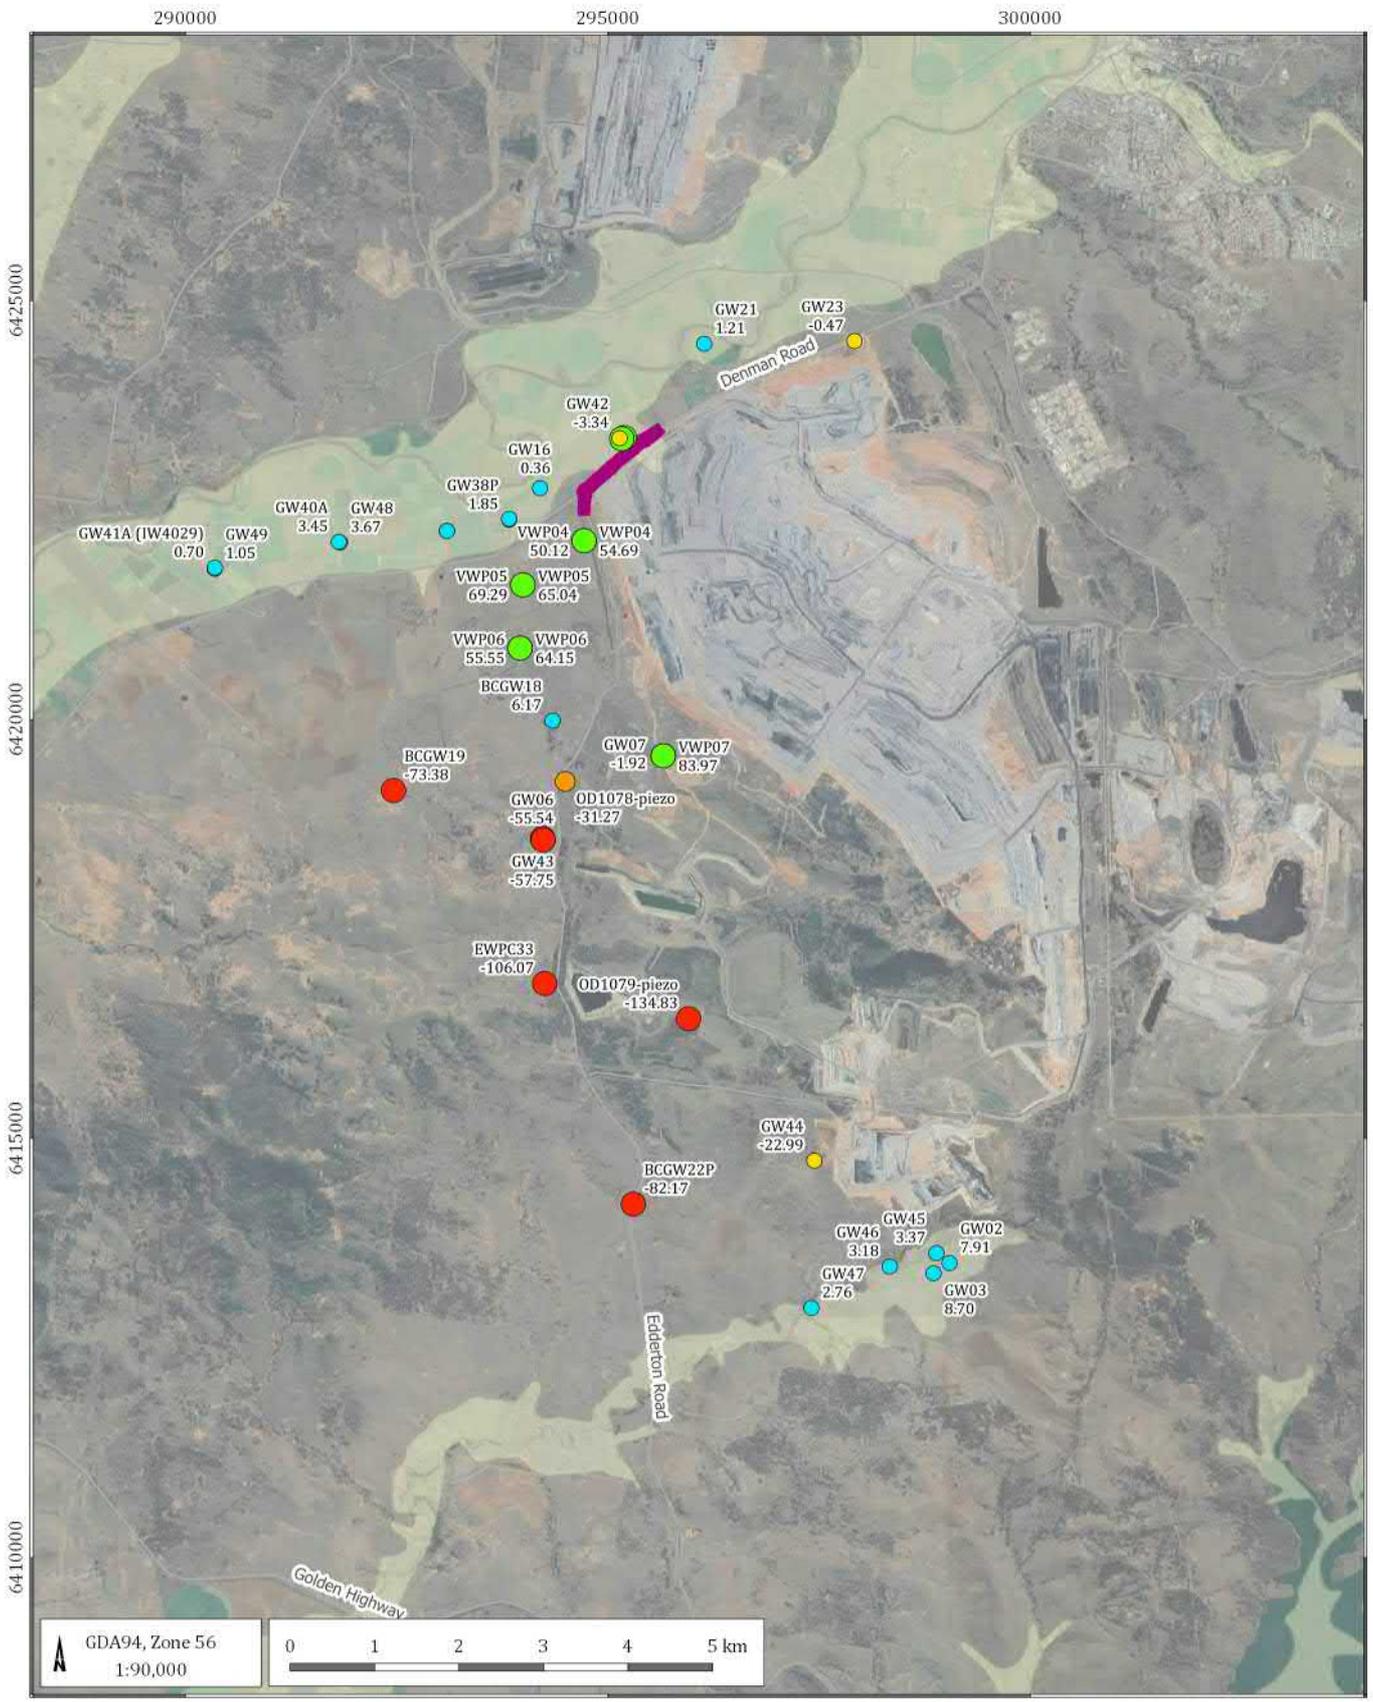
This figure shows that the groundwater model predictions close to the north-west of the Mount Arthur Pit and in the Hunter River alluvium are relatively good. Further to the southwest of the pit, the modelled predictions are less accurate. The VWP locations VWP1_P1, VWP2_P1, VWP3_P1 and VWP3_P2, for example, display mining drawdown approximately 100 m lower than modelled. Given the proximity of these VWPs to the mine pit, it is believed the model did not represent the mine drawdown accurately in this area, the same than in other areas and depths.

Modelled versus measured heads (m)

A recent review of the AGE (2013) groundwater model identified that when the data is ordered by model layer, the prediction discrepancies generally fall in order of model layers from top to bottom. The model over-predicts drawdown in the shallower model layers and underpredicts in the deeper layers. This is also a reflection of the observation that the deeper coal seams depressurise to a greater distance from the highwall compared to shallower coal seams. This discrepancy occurs because the numerical model represents the Permian sequence with a limited number of model layers. Additional layers may better represent the coal seams in more detail through the sequence and the intervening aquitards to better replicate the observed drawdown. The groundwater model is currently under review to improve the model's predictive capability. Throughout 2019 the site conceptual model has been reassessed to better inform the groundwater model.

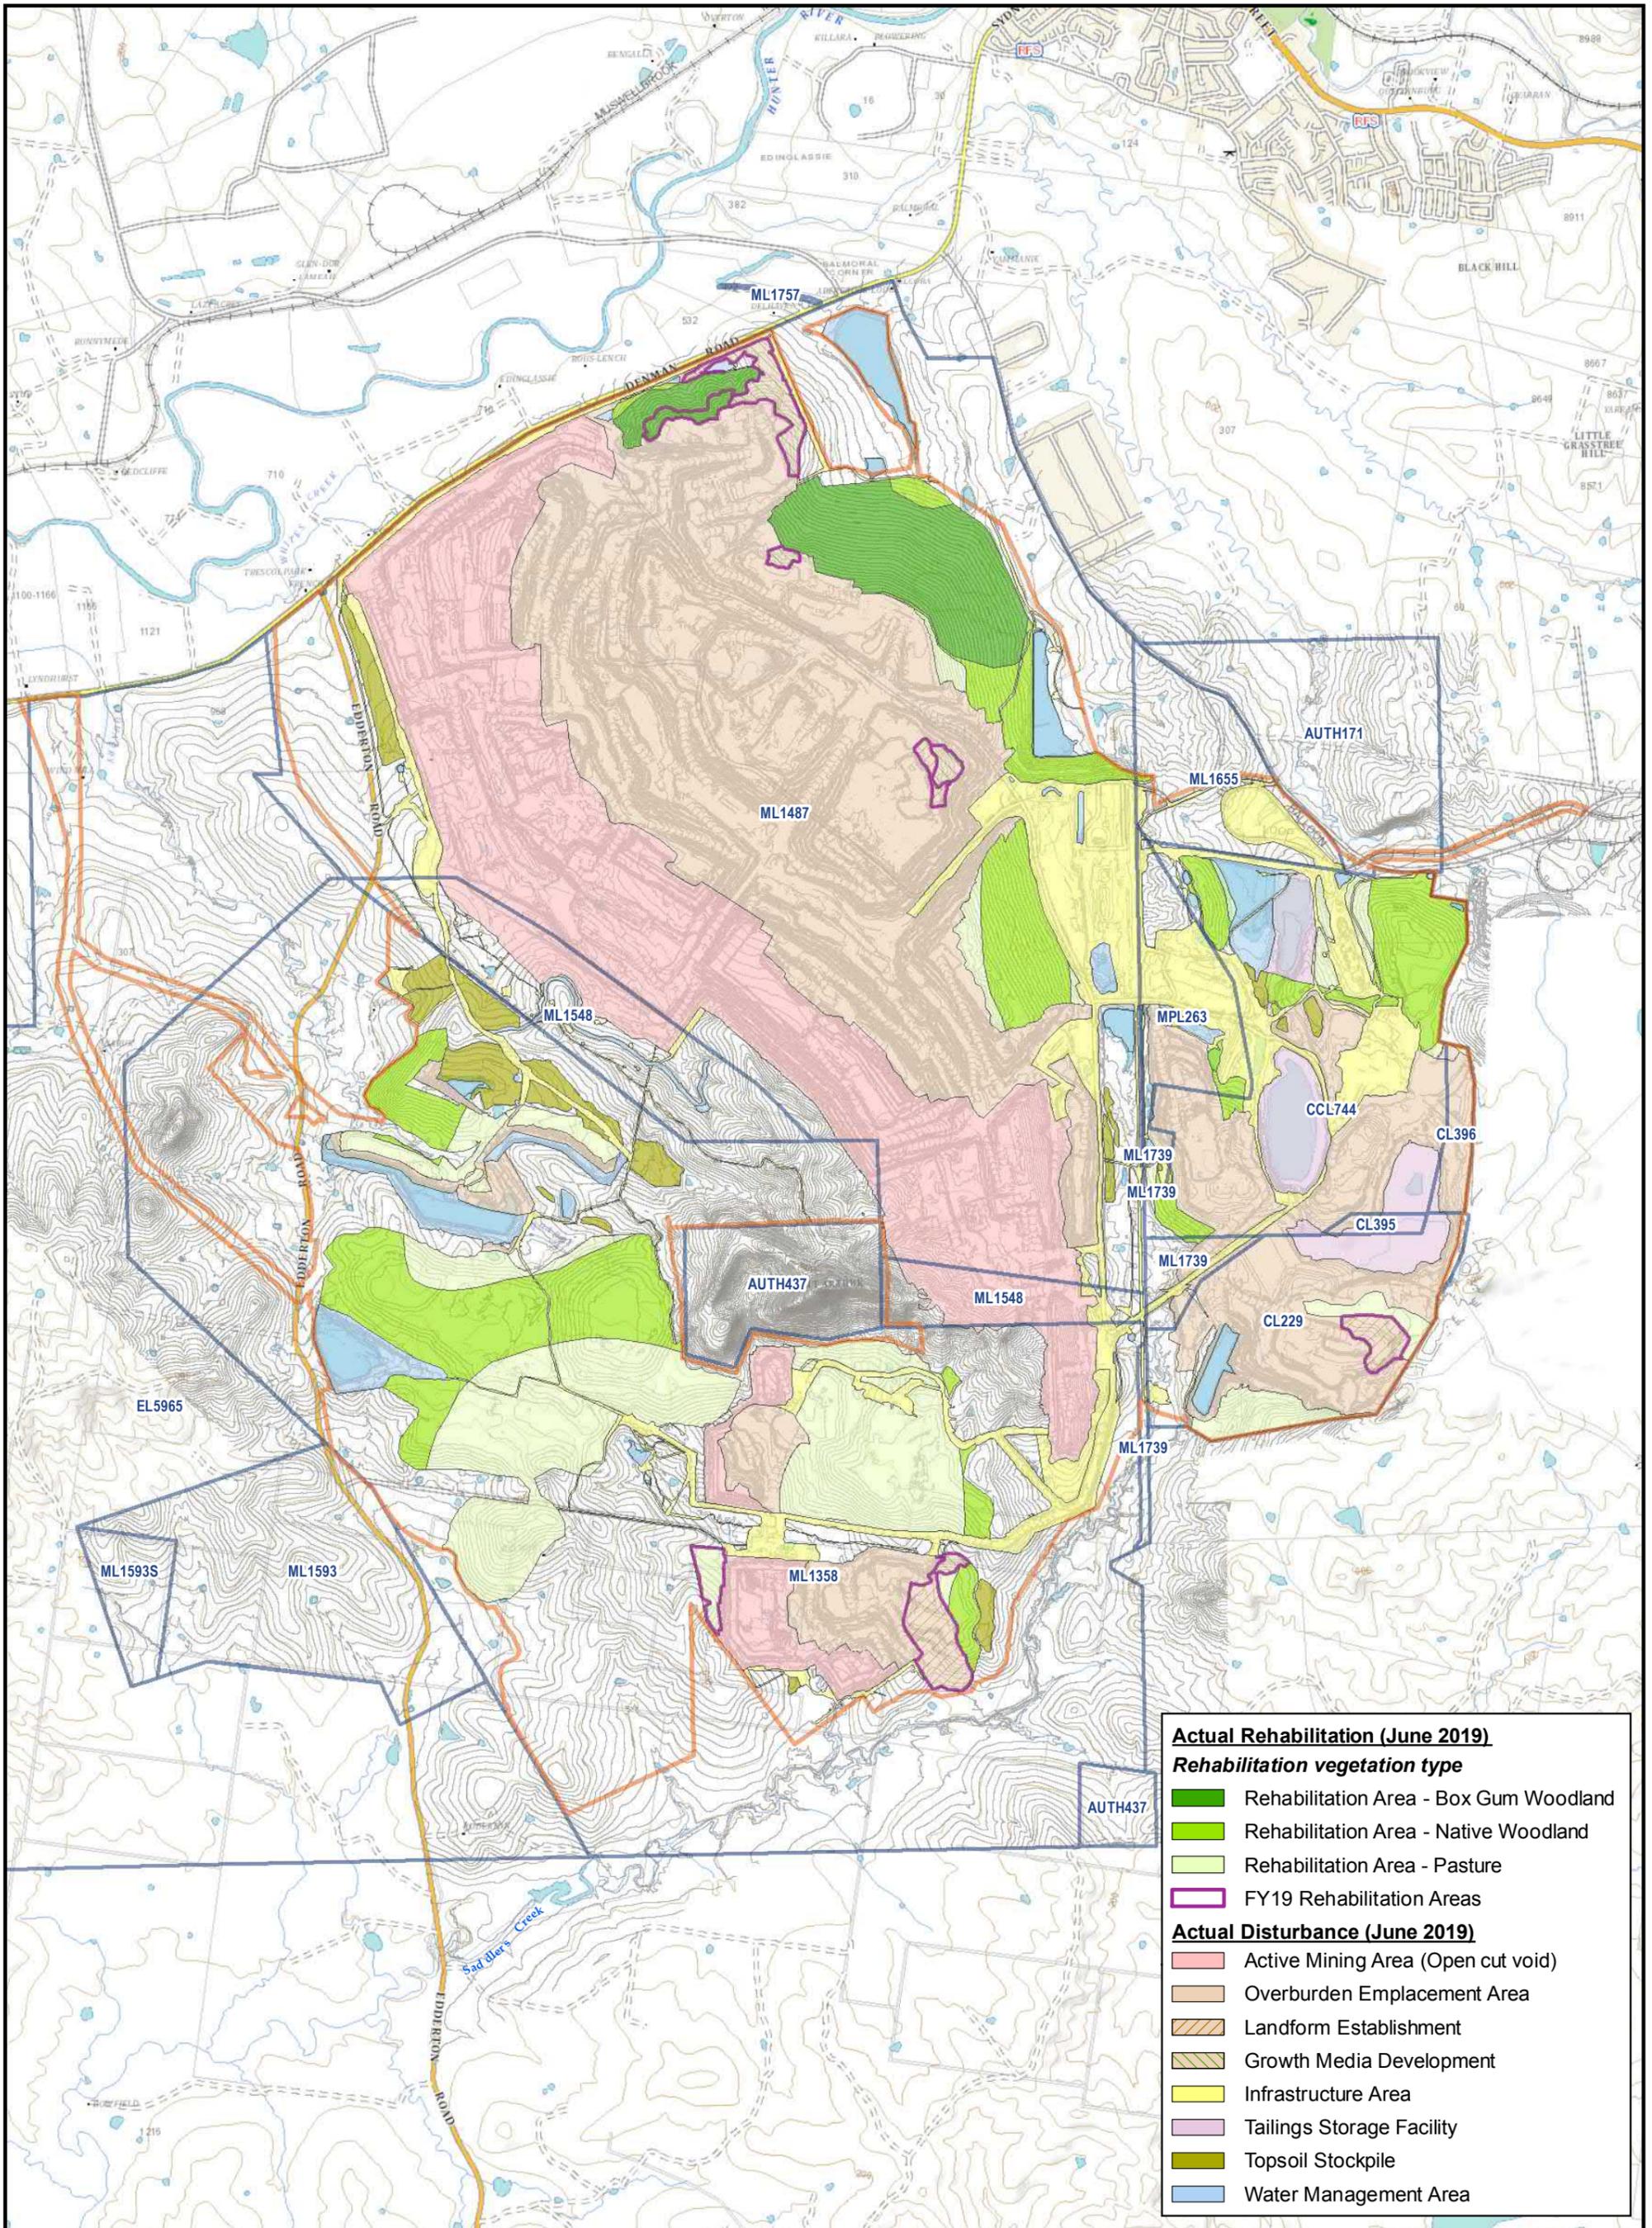
Appendix 5 – Rehabilitation Plan

Actual Rehabilitation (June 2019)
Rehabilitation vegetation type

- Rehabilitation Area - Box Gum Woodland
- Rehabilitation Area - Native Woodland
- Rehabilitation Area - Pasture
- FY19 Rehabilitation Areas
