Mt Arthur Coal

Annual Review FY22

11 November 2022

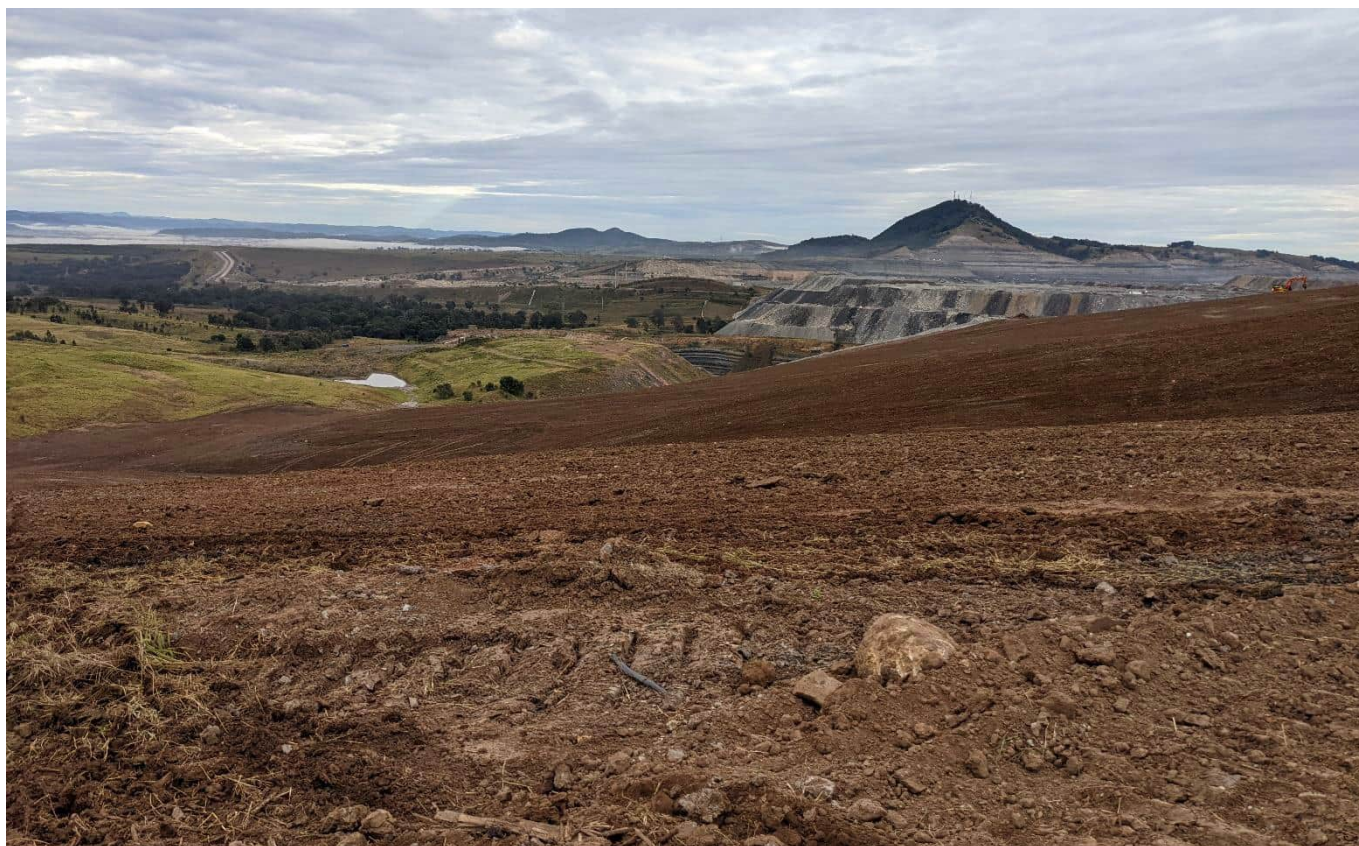
Figure 6: Topsoil spreading at Drayton Void emplacement

The final landform design can be seen in Figure 6 and Figure 7. Figure 6 and Figure 7 show the shaped waste rock with topsoil being placed. Although this geomorphic design has been implemented on other sites within NSW and also worldwide there are many defining characteristics that restrict its use such as space, waste characterisation, rainfall, availability of suitable rock, availability of mulch, final landuse, landform height and steepness of the landform. Mt Arthur Coal has larger higher landforms than other sites in the Hunter Valley, and is also space constrained for emplacement area. The resultant design aligns with industry best practice, but will be monitored over the coming years to ensure further natural landform design incorporates learnings and improvement from the current work.

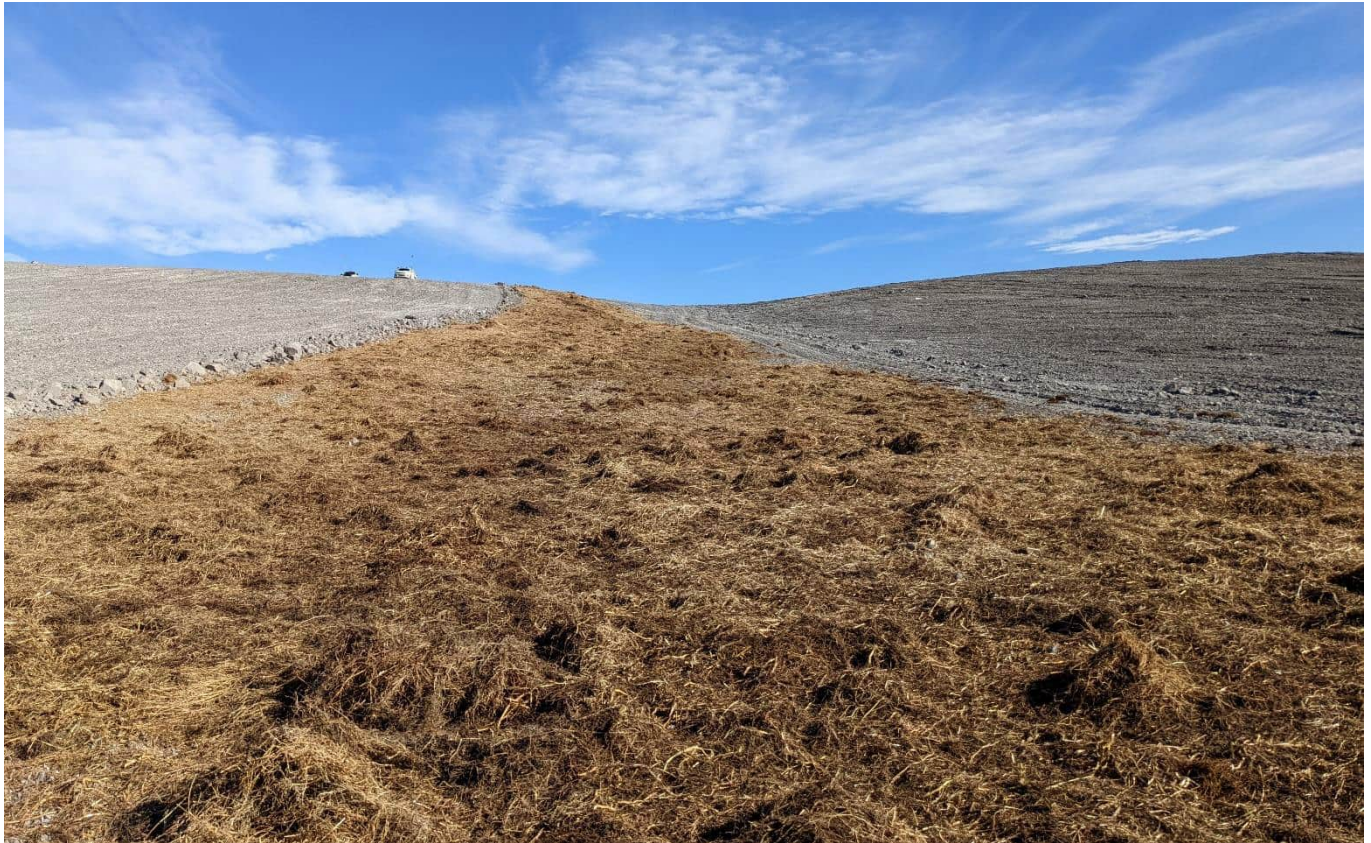
Figure 7 Growth media alternate trials commenced in the reporting period

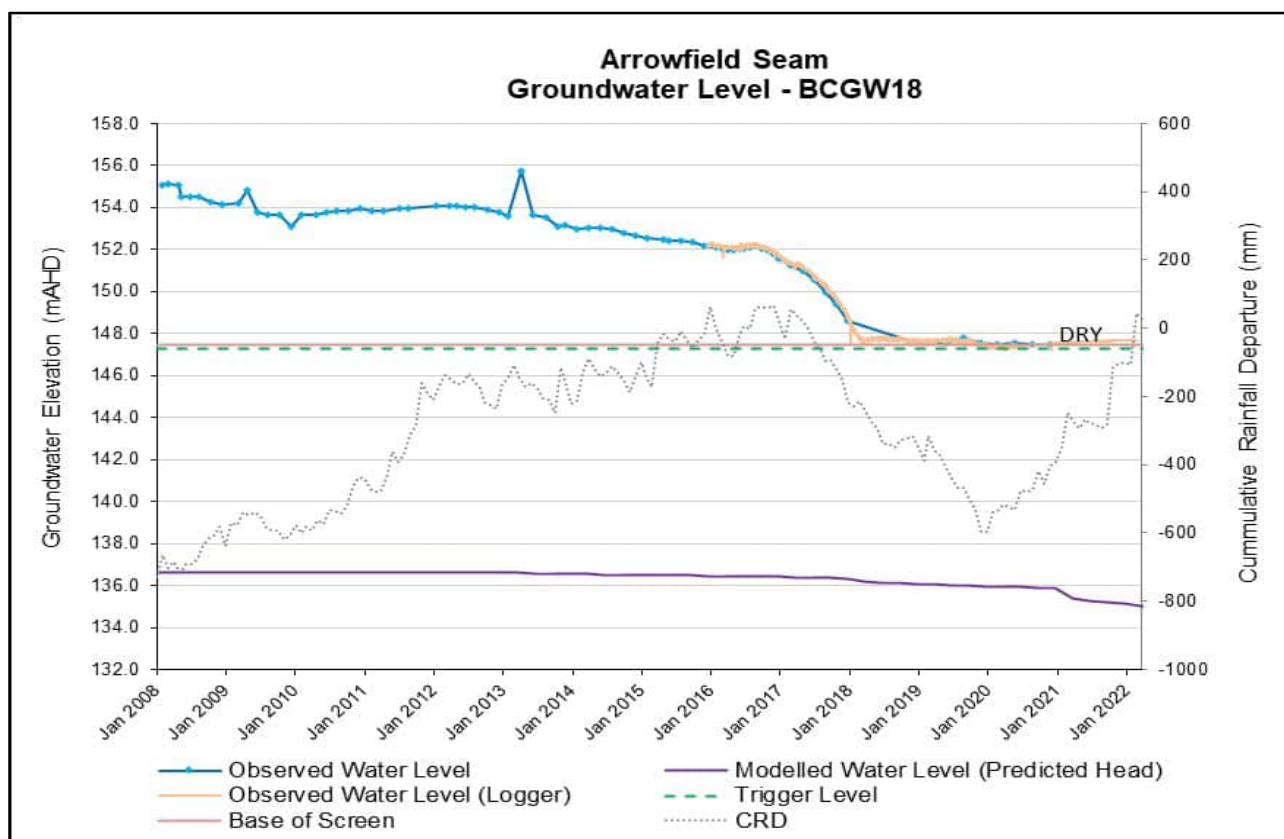
Figure 4.3 BCGW18 – Modelled and Observed Water Levels

Groundwater level data collected over the reporting period have been compared to the trigger values outlined in the WMP. Bores BCGW18 and GW44 and VWP VWP3 (P1), VWP04 (all seams), and VWP07 (Piercefield Seam) recorded groundwater level exceedances. A summary of the exceedances is presented in **Table 4.2**.
