BHP NEWMAN TOWNSHIP ELECTRICITY SUPPLY ANNUAL AUDIT REPORT 2018/2019

# EXECUTIVE SUMMARY

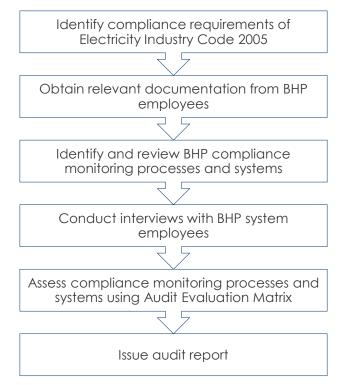
The methodology applied to perform the audit is as per the following flowchart:

Figure 1 | Audit Methodology Flowchart

Figure 1   Audit Methodology Flowchart 1	
--	--
