Global Industry Standard on Tailings Management

Public Disclosure

2024

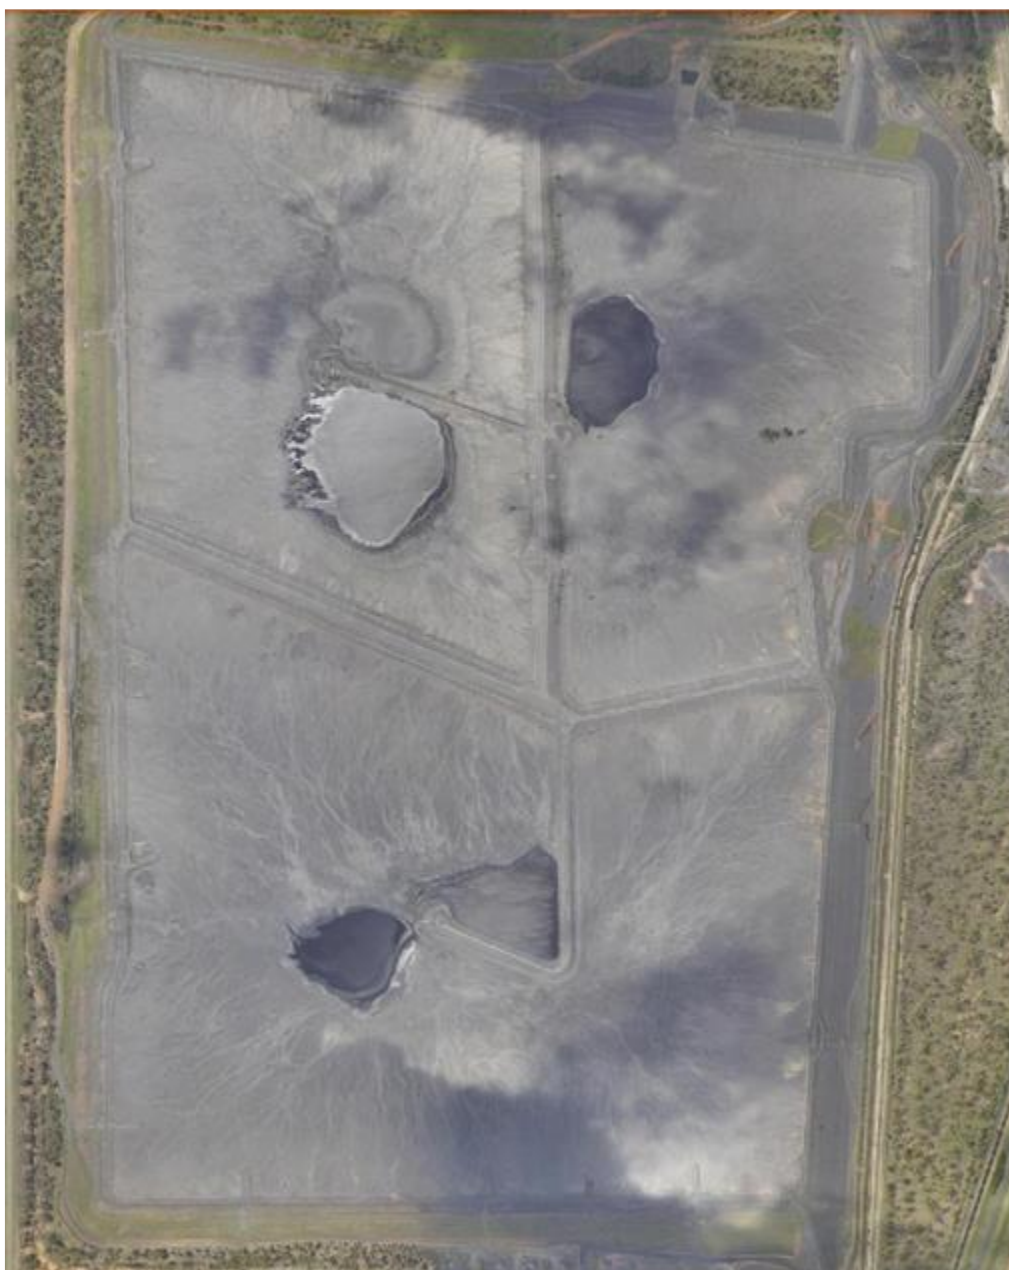
GS1 TSF, 2023

Stage (year completed)	Design description
Initial Construction (1975)	Construction of a 10-metre starter embankment to 264 metres relative level (mRL) using locally sourced sandy-clay engineered fill.
Continuous lifts (1980 -1992)	Embankment progressively raised using the downstream method with waste materials as part of day-to-day operational mining activities.
Pre-Stage 1 (1994)	Incremental downstream and centreline raises of embankments to varying heights between 269 mRL to 275 mRL using non-engineered fill.
Pre-Stage 1 (2005)	Upstream embankment raise of southern sections of the eastern and western embankments and downstream raise of the southern embankment to 272 mRL. Construction of southern, northern and internal spillways.
Stage 1 (2009)	Upstream embankment raise of northern sections of the western and northwestern embankments and the internal embankments on the northwestern cell to 277.7 mRL. Raise and construction of additional internal spillways and drainage structures.

Stage 2 (2011)	Upstream embankment raise of southern embankment and southern sections of the eastern and western embankments to 274-275 mRL. Southern emergency spillway raised and new northern emergency spillway constructed.
Stage 3 (2013)	GS1A water storage dam (north-east cell) repurposed and incorporated into the TSF.
Stage 4 (2014)	Downstream raise of northern embankment and downstream/upstream raise of eastern embankments to 277.7 mRL to amalgamate northeastern cells into a single cell.
Stage 5 (2016)	Upstream and centreline raise of southern cell embankments to 276.6 mRL. Raise of southern spillway.
Stage 6 (2020)	Upstream raise of northern cell embankments to 280.3 mRL.
Improvement projects	Various improvement projects, including updates to the knowledge base, and physical preparatory works transitioning the facility to a state of inactivity.

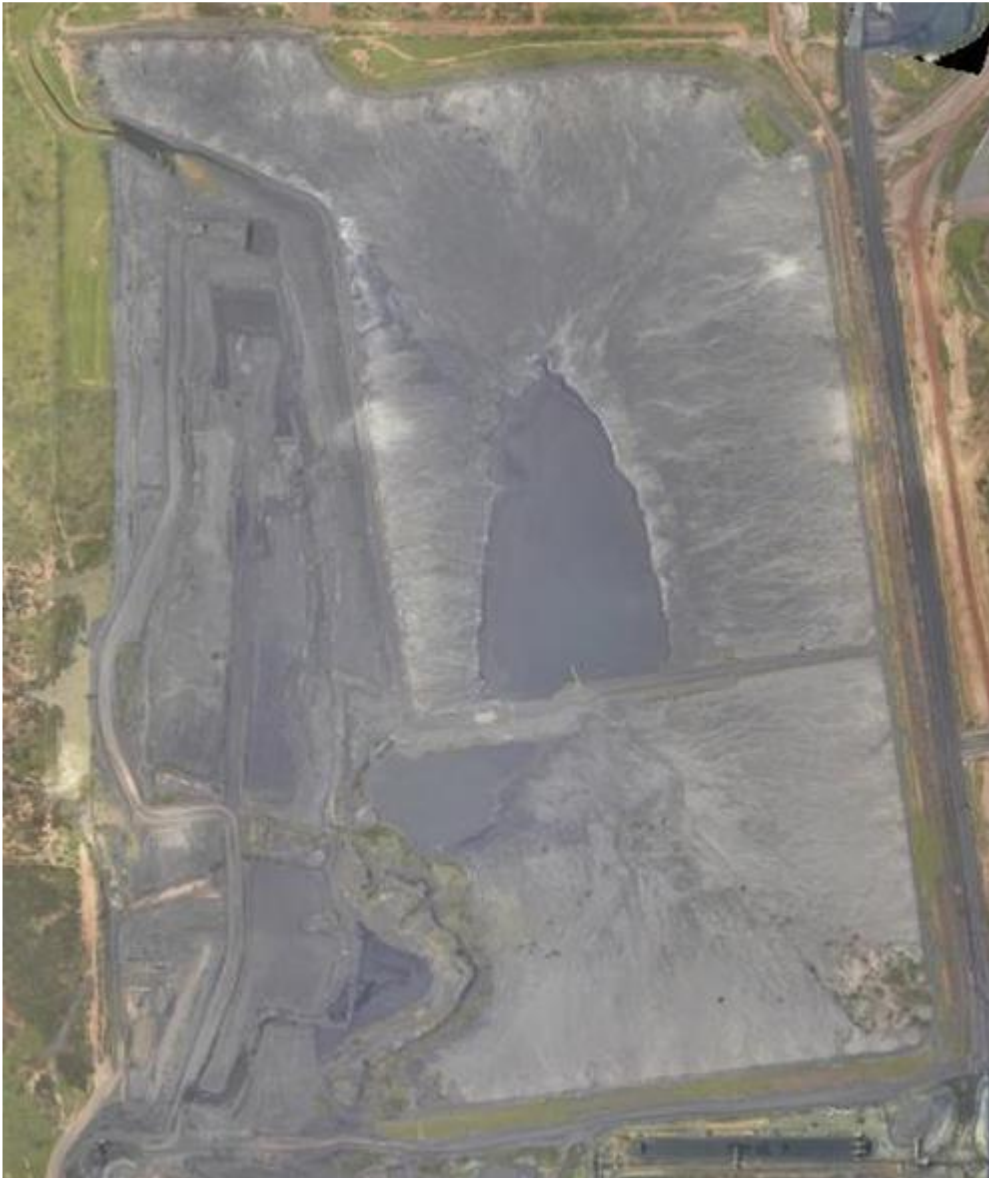
RS1 TSF, 2023

Stage	Year completed	Description of design
Initial construction	1983	Construction of starter embankment at the southern and eastern extent to 280 metres relative level (mRL). Construction of emergency spillway.
Continuous raises	1983-1986	Embankment progressively raised using the downstream method with waste materials as part of day-to-day operational mining activities.
1	1987	Downstream raise of southern and eastern embankments to 283 mRL. Raise of emergency spillway.
2	1993	Downstream raise of the southern and eastern embankments to 285.5 mRL. Raise of emergency spillway.

2 (North Dam)	1996	An external embankment constructed to prevent catchment run-off entering the facility from the north.
3	2006	Downstream raise of southeastern embankment to between 288 – 291 mRL. Upstream raise of eastern embankment to 288 mRL and construction of new western embankment to 286.6 mRL and internal embankment to 288 mRL. Previous spillway decommissioned and new emergency spillway constructed in northeast corner.
4	2008	Upstream and downstream raise of eastern and western embankments to 289.5 mRL and centreline raises of internal embankments.
5	2012	Upstream raise of southern, eastern and northern embankments to 291.3 mRL.
6	2015	Upstream and centreline raise of northern, eastern and internal embankments to between 291.3 mRL and 291.5 mRL
7	2020	Upstream raise of western embankments to 291.3 mRL.
Various improvement projects	Various improvement projects, including updates to the knowledge base, and physical preparatory works transitioning the facility to a state of inactivity.

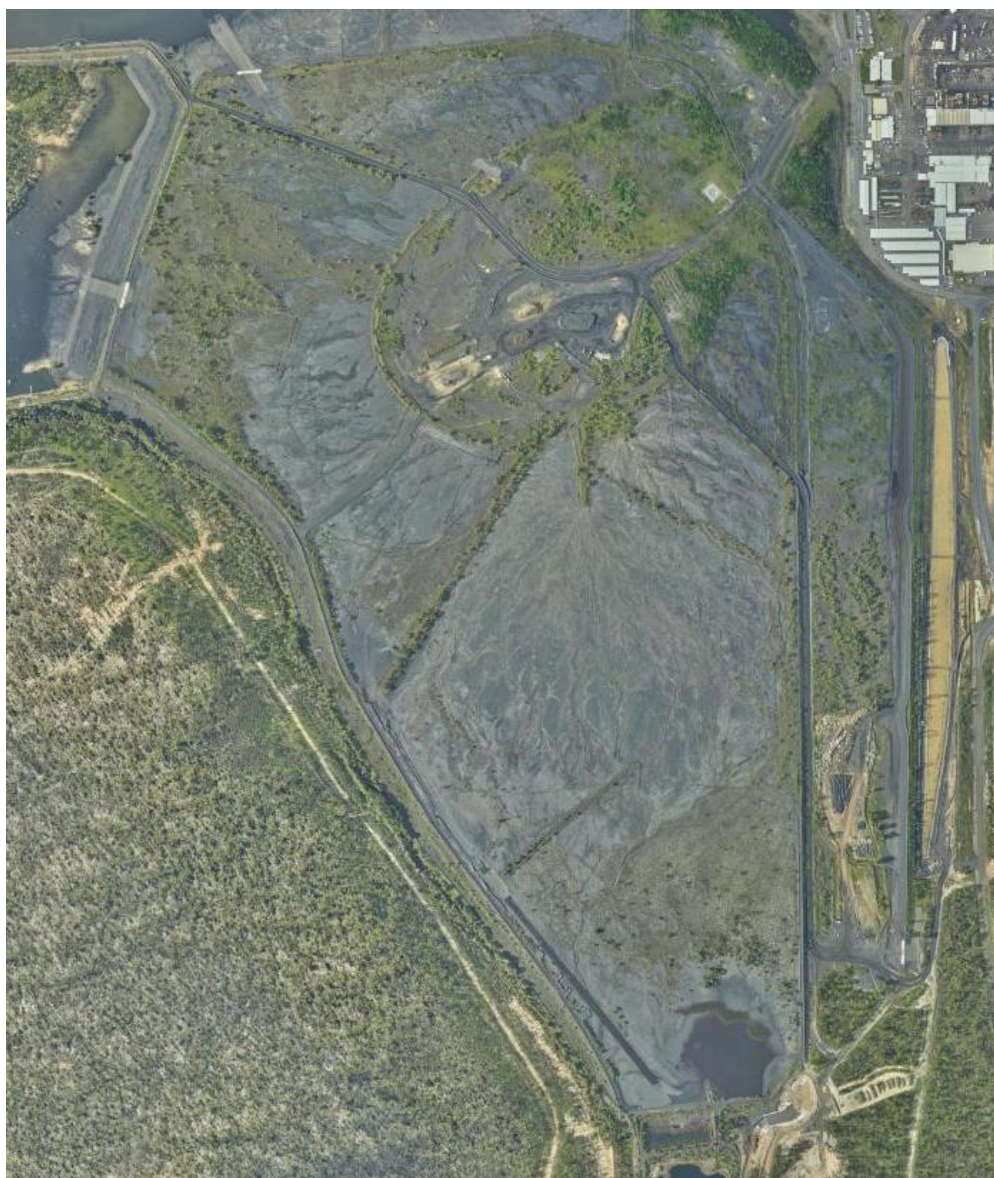
OTD TSF, 2023

The facility was commissioned in 1974 and has undergone six subsequent design changes (see table below). The OTD is an above-ground facility that relies on constructed embankments to contain the tailings. The embankments were built using the upstream or downstream raise methods. The original TSF consists of two cells, the northern cell (TD1) and southern cell (TD2) which merged into one cell in 1993.

Stage	Year completed	Description of design
1	1974	Construction of two starter embankment cells, TD1 (North) and TD2 (South) to 253.0 metres relative level (mRL). TD1 for tailings storage and TD2 for water storage.
2	1981	Embankments raised downstream to varying heights (256.0 mRL - 260.0 mRL)
3	1991	Embankments raised upstream to varying heights (262.0 mRL - 266.0 mRL)
TD1 Capping	1993	Capping of tailings surface in the northern cell extents.
4a	1993-1994	Embankments raised upstream to varying heights (260.0 mRL - 267.5 mRL). Facility merged into a single cell.
4B	1996	Embankments raised upstream and downstream to varying heights (266.5 mRL - 269.5 mRL).
4B Adjustment	1998	Embankments raised upstream and downstream to varying heights (266.5 mRL - 272.0 mRL).
5	2024	Upgrade of emergency spillway capacity and buttressing on North-western and eastern embankments.

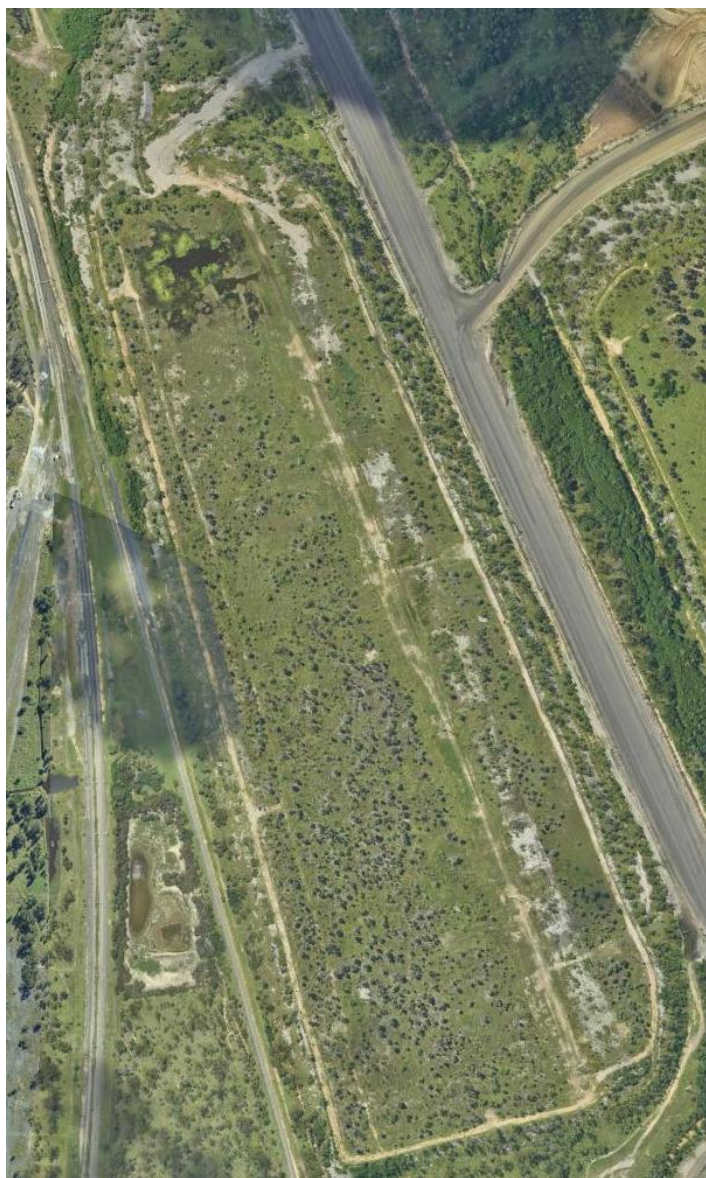
TSF No.3, 2023

The facility initial construction commenced after 1966 and tailings deposition started by 1977. TSF No.3 is an above ground facility that relies on constructed embankments to contain the tailings. The embankments were built using the downstream construction method in a single stage. Capping and rehabilitation works were undertaken between 2009-2014.

Stage	Year completed	Description of design
Initial construction	1966-1977	Construction of single stage embankments to 217 and 218 metres relative level (mRL) for tailings storage.
Deposition commenced	1977-1983	Deposition commenced around 1977.
Deposition ceased	1983-1985	Deposition ended in late 1980s.
No activity	1998-2009	No active deposition of tailings recorded. Surveyed embankment heights 12m above natural ground level.
Initial Capping	2009-2010	Capping 2/3 of tailings surface, raised embankment crest elevations between 218 mRL and 220 mRL.
	2010-2011	Construction of the closure spillway.
Final Capping	2012-2013	Completion of capping layer over existing decant pond and embankment. Rock mulching of the spillway.
Rehabilitation	2013-2014	Placement of topsoil as part of final stage of rehabilitation plan.

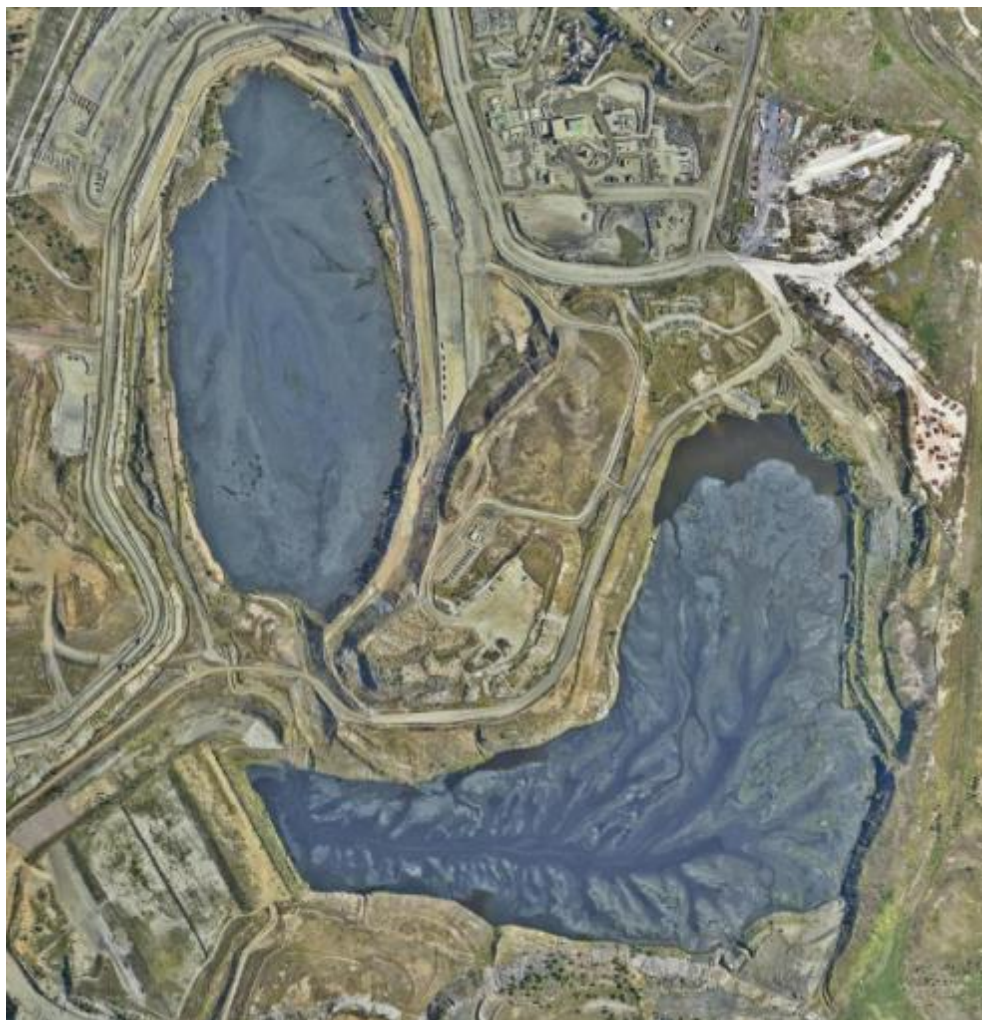
MAC TSF, 2022

The WCV embankment is 10 metres high and 750 metres long. The north-west embankment is 30 metres high and 580 metres long.

The SWV area has been created by the construction of a cross-valley embankment 400 metres long and 25 metres high, located at the western perimeter. The remaining perimeter comprises the natural material that hosted the coal seams and mine spoil waste dumps.

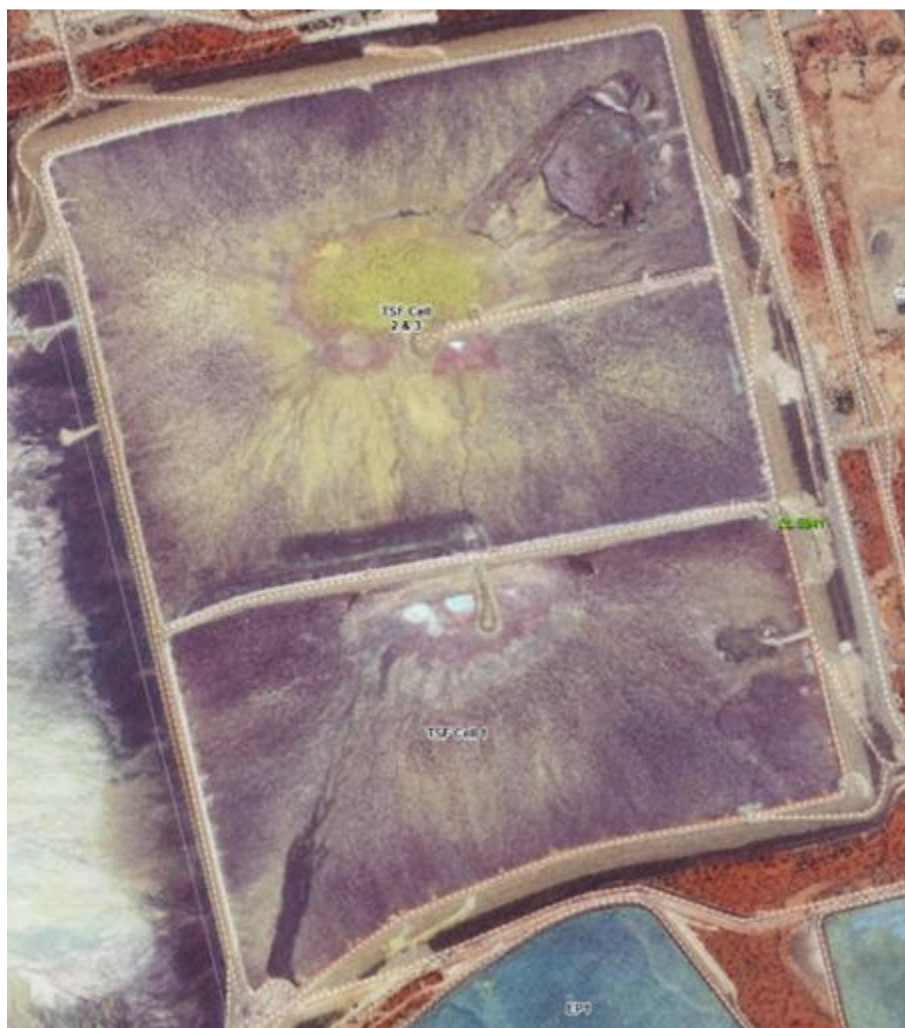
TSF1-3, 2024

each TSF are lined internally with a layer of clay rich soil and externally with a layer of rock armour. The initial TSF1 design had a downstream embankment slope of 1 metre vertical for every 2.5 metres horizontal (1V:2.5H) and was constructed approximately 7 metres high with a crest width of 6.5 metres. During the mid-1990s, the overall downstream slope of the embankment was modified to 1V:2.75H.

TSFs 1, 2 and 3 embankments were raised in the upstream method, initially with raises 3 metres high, and from July 2000 with raises 1 metre high. Embankment raises were constructed using a mixture of excavated tailings and imported clay as fill. The upstream raise consists of an outer clay layer that provides separation of tailings from the outside environment. The tailings maximum rate of rise was limited to 2 m/yr. Over time, TSF2-3 have been combined into a single cell with TSF1-3 now considered a single TSF based on similar life cycle stage, heights and management systems.

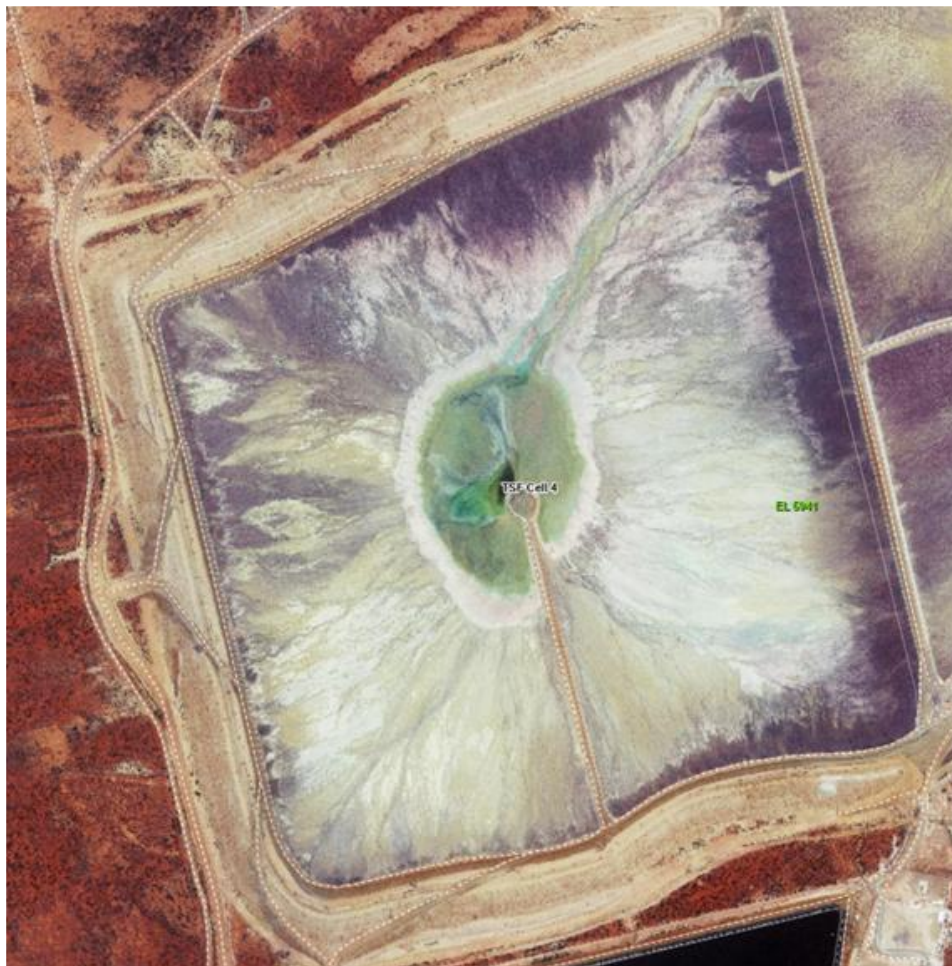
TSF4, 2024

embankment. TSF4 has a downstream embankment slope of 1 metre vertical for every 2.75 metres horizontal (1V:2.75H).

TSF4 was raised using the upstream method using a mixture of excavated tailings and imported clay fill. The upstream raise consists of an outer clay layer that provides separation of tailings from the outside environment and a subsequent layer of rock armour for erosion protection. The maximum rate of tailings level increase was limited to 2 metres per year.

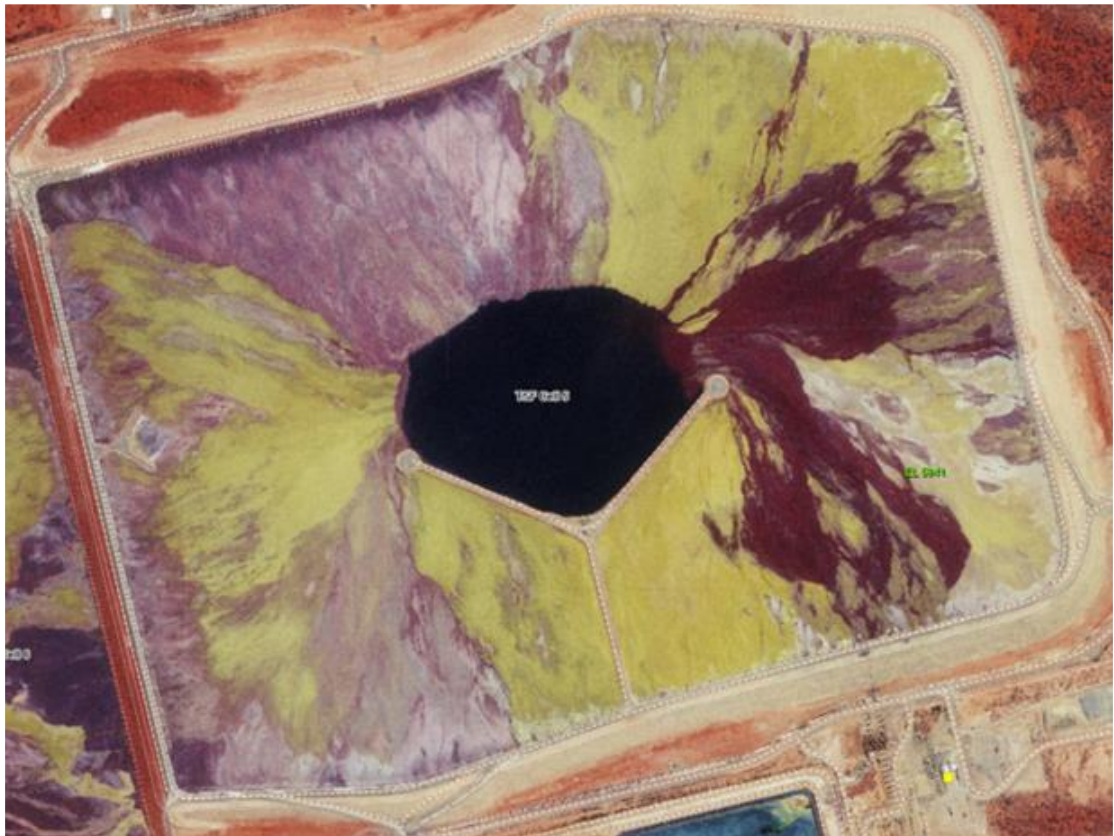
TSF5, 2024

8 metres, dependent on the natural sand dune level. TSF5 has a downstream embankment slope of 1 metre vertical for every 2.75 metres horizontal (1V:2.75H).

TSF5 is raised using the upstream method using a mixture of excavated tailings and locally sourced clay-rich material. The upstream raise consists of an outer clay-rich layer and a subsequent layer of rock armour for erosion protection. The maximum rate of tailings level increase is limited to 2 metres per year. The heights of the TSF5 raises range from 1 to 1.8 metres, with upstream and downstream slopes of 1V:2H and 1V:2.75H respectively.

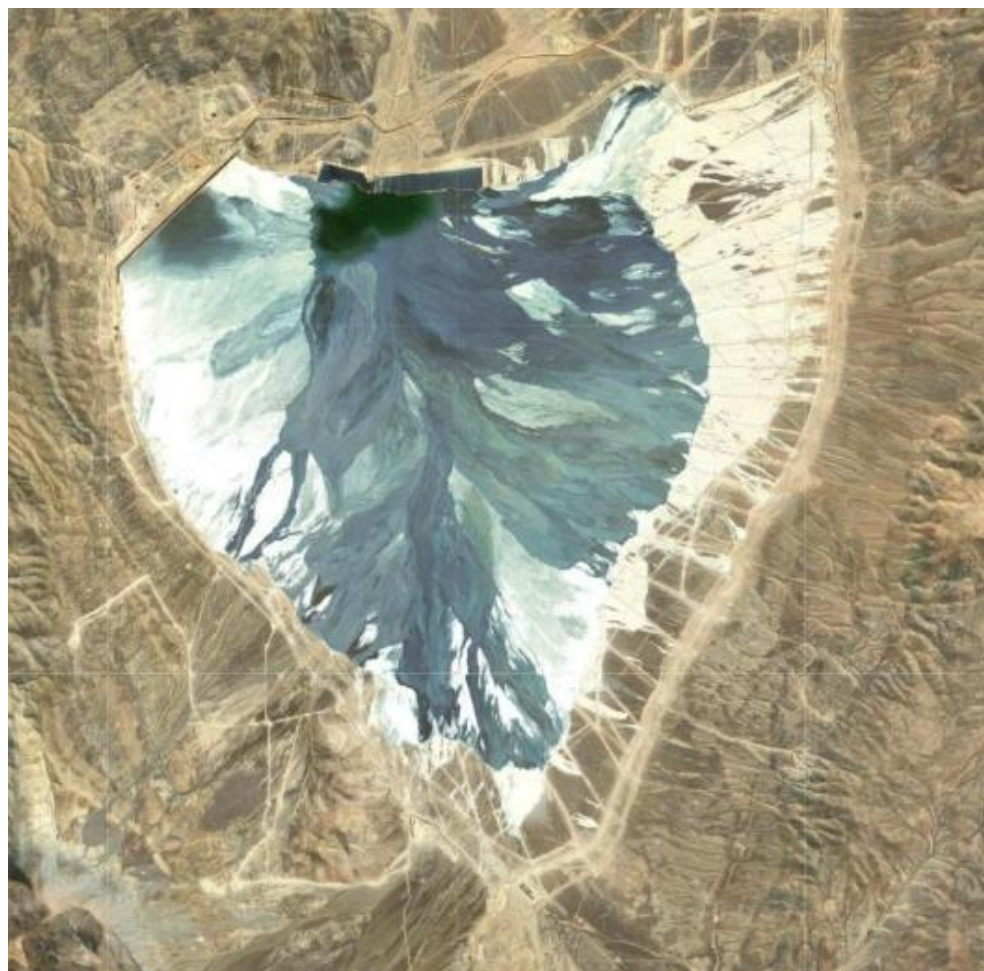
Laguna Seca TSF, 2022

Water is recovered from an embankment drainage system, a network of wells and the decant pond through a collection tower and pumping system.

For all stages, a minimum height between the tailings and the embankment crest of 5 metres, and a crest width of 15 metres is required to be maintained.

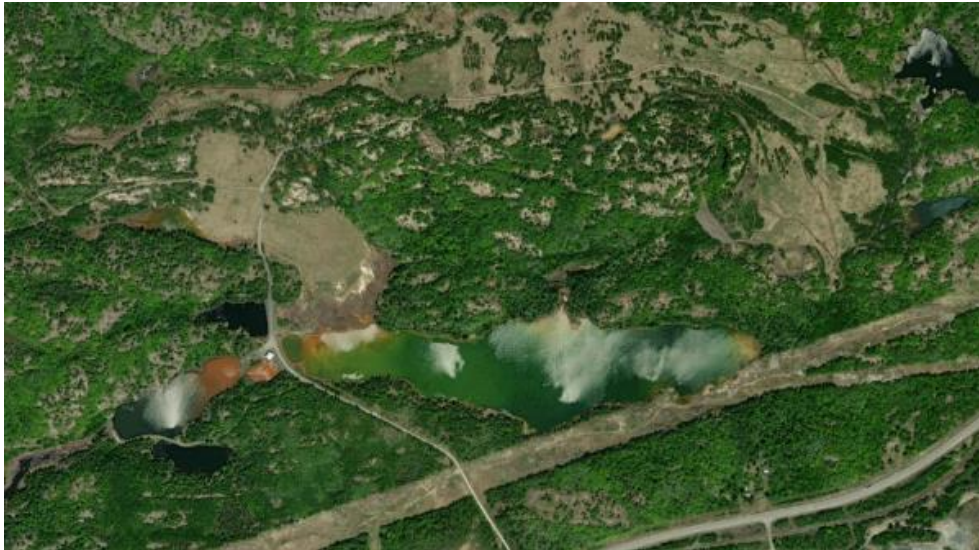
Pronto TMA, 2022

Dam A is a rock embankment that retains dry and re-vegetated tailings. The Causeway Dam retains contact water runoff and seepage from the tailings areas prior to treatment at the effluent treatment plant. Dams D, E and F retain treated water in the various water ponds. The ETP Diversion Berm creates a pond to maintain seepage gradients towards the holding pond. Dams A, D and E are constructed of rock or sand and gravel while Dam F has a silt and sand core and rock outer. The Causeway Dam is a zoned earth-fill embankment with a silt core, sand, gravel and rock layers. Key information about the structures at Pronto TMA is provided in the table below.

Structure	Crest length [metres]	Maximum height [metres]	Retained head at normal water level [metres]
Dam A	140	13	11.7
Dam D	60	3.5	1.4
Dam E	45	2	1.7
Dam F	75	5	3.7
Causeway Dam	150	10	3.4
ETP Diversion Berm	4	1.5	1.0

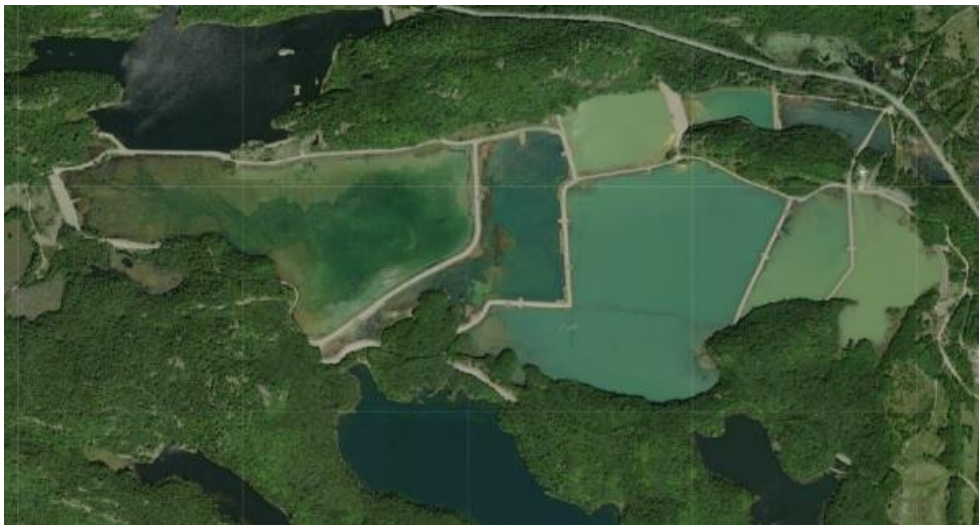
Quirke TMA, 2022

Structure	Crest length [metres]	Maximum height [metres]	Head pond depth retained [metres]
Main Dam	259	25.9	18.6
Dam G1	212	8.2	6.6
Dam G2	197	4.6	3.2
Dam I	292	7.6	4.0
Dam J	273	11.9	9.5
Dam K1	251	16.8	15.2
Dam K2	197	10.7	9.1
Dam L	650	12.2	10.7
Dyke 14	1280	6.1	3.9
Dyke 15	1224	9.1	4.3
Dyke 16	521	8.2	4
Dyke 17	517	4.9	2.1

The perimeter embankments were constructed during the mine operating periods. The main dam was originally constructed in 1970 and entirely rebuilt between 1989 and 1990. Dams G1, G2, I, J, K1, K2, and L were built between 1980 and 1989. Dam J and Dam L were the only embankments constructed in two stages: Dam J was constructed using the upstream raise method; while Dam L was built using the centreline raise method. During operation, embankments were constructed from waste rock and tailings as a platform for tailings deposition. As the tailings deposition progressed, new embankments were built over tailings and previous embankments were buried.

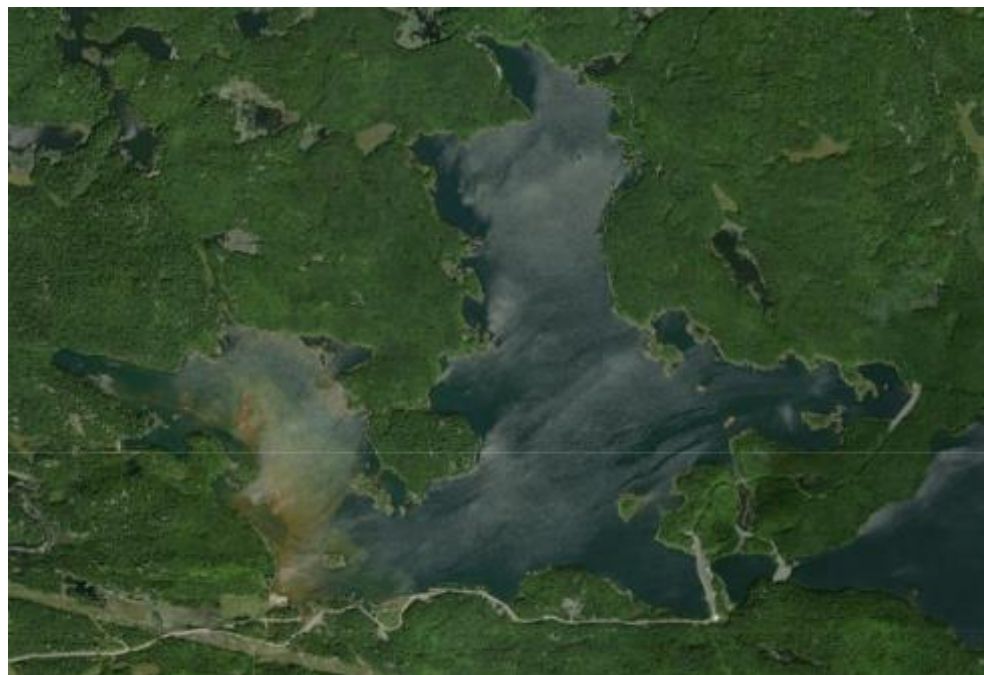
Stanleigh TMA, 2022

Dam E was constructed in 1992 in the valley crossing the south-west portion of the western end of the TSF. This valley was identified as presenting a potential seepage path for groundwater towards Lake 10 once the tailings water cover was established. Dam E was constructed to a Stage 1 crest elevation of 369.3 metres above sea level, however, was not raised as initially planned due to the cessation of mine operations and tailings deposition. It is currently operating at its Stage 1 configuration.

The crest elevations of Dams B and Dam C are lower so if the facility spillway is blocked, water will overtop Dams B and C instead of Dams A and A1. This diverts the flood path away from the Milliken TMA and Elliot Lake.

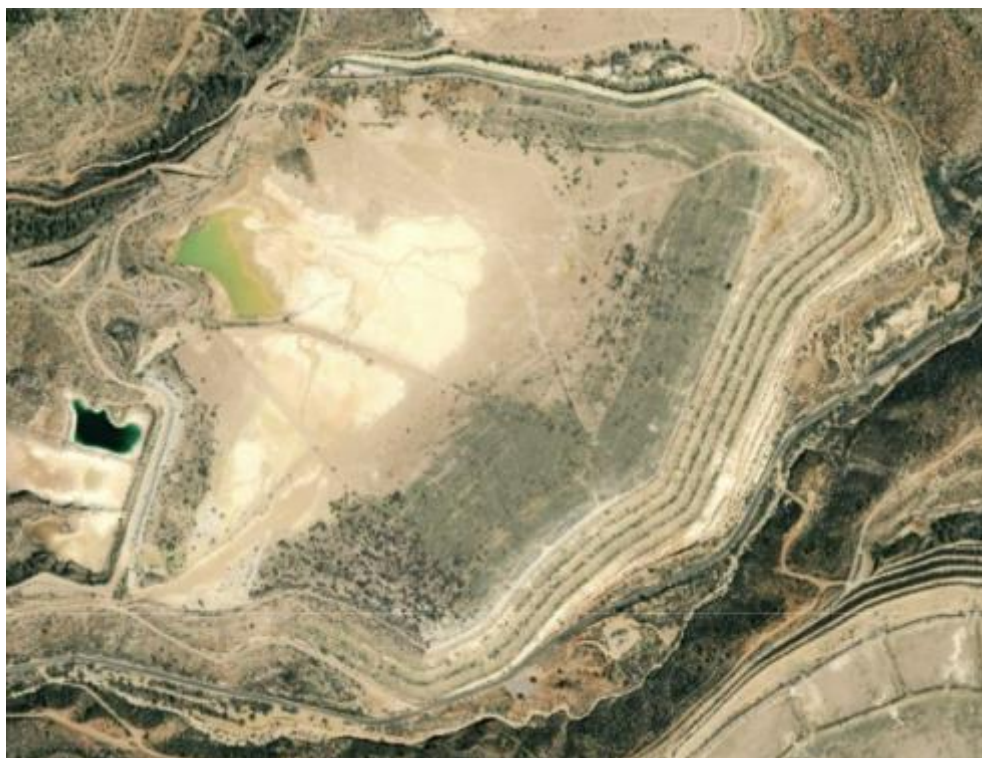
No.2 Tailings, 2022

Construction of No. 2 Tailings commenced in the 1950s with two perimeter starter embankments (Starter Dam 1 and 2) built of locally sourced conglomerate. Starter Dam 1 was built to an approximate height of 25 metres (1,000 metres above sea level) and a width of 9 metres. Starter Dam 2 was built to an approximate height of 7.5 metres (1,020 metres above sea level) and a width of 6 metres.

Tailings were discharged into No. 2 Tailings from the 1950s to 1975. The starter embankment crest was raised using the upstream method. Tailings were deposited from the crest with a decant pond maintained on the western side of the impoundment. The embankment was raised in stages of between 9.7 metres and 12 metres with a step in over the tailings of 8 metres. Raises were constructed of tailings sand sourced from the deposited tailings beach using a cable operated bucket excavator (dragline). Nominal compaction was applied to the outer 4.5 metres of each raise from the movement of the dragline over the embankment during placement. The greatest slope height of the final embankment is approximately 107 metres (1,088 metres above sea level).

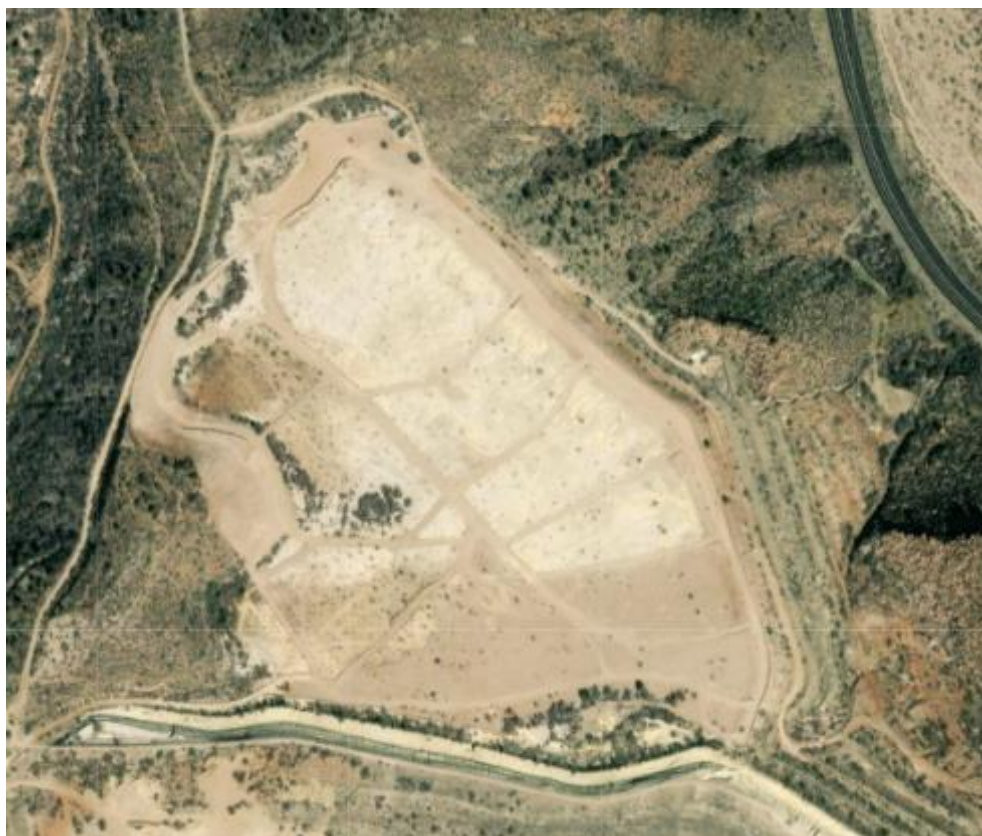
No.8 Tailings, 2022

Construction of No. 8 Tailings commenced in 1965 with one perimeter starter embankment made of clay, sand and gravel (believed to be locally sourced conglomerate). The starter embankment had a maximum embankment slope height of 10.5 metres (995 metres above sea level) and a crest width of 11 metres.

Tailings were deposited until 1975. The raises from the starter embankment were constructed using the upstream method, with incremental raise heights varying between 9.1 and 12.2 metres and step-ins over the tailings of up to 12.5 metres. The final maximum embankment slope height is approximately 91 metres (1,075 metres above sea level).

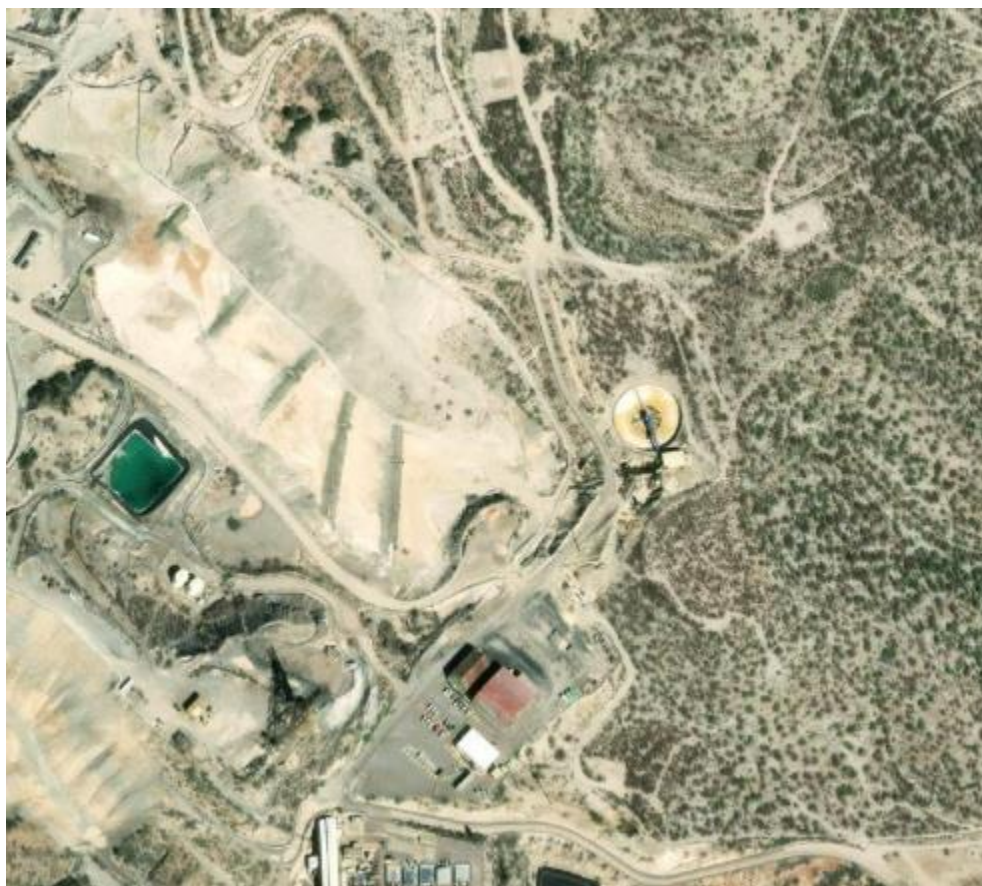
During operations, the south-east dam abutted an adjacent TSF (the Miami No. 2 Tailings facility). Some of the No. 2 Tailings are in place beneath the plant used to thicken the tailings, which was located near the contact between Canyon and No.2 Tailings. Tailings were transported and deposited within the TSF via a network of channels supported on wooden trestles.

Canyon Tailings, 2022

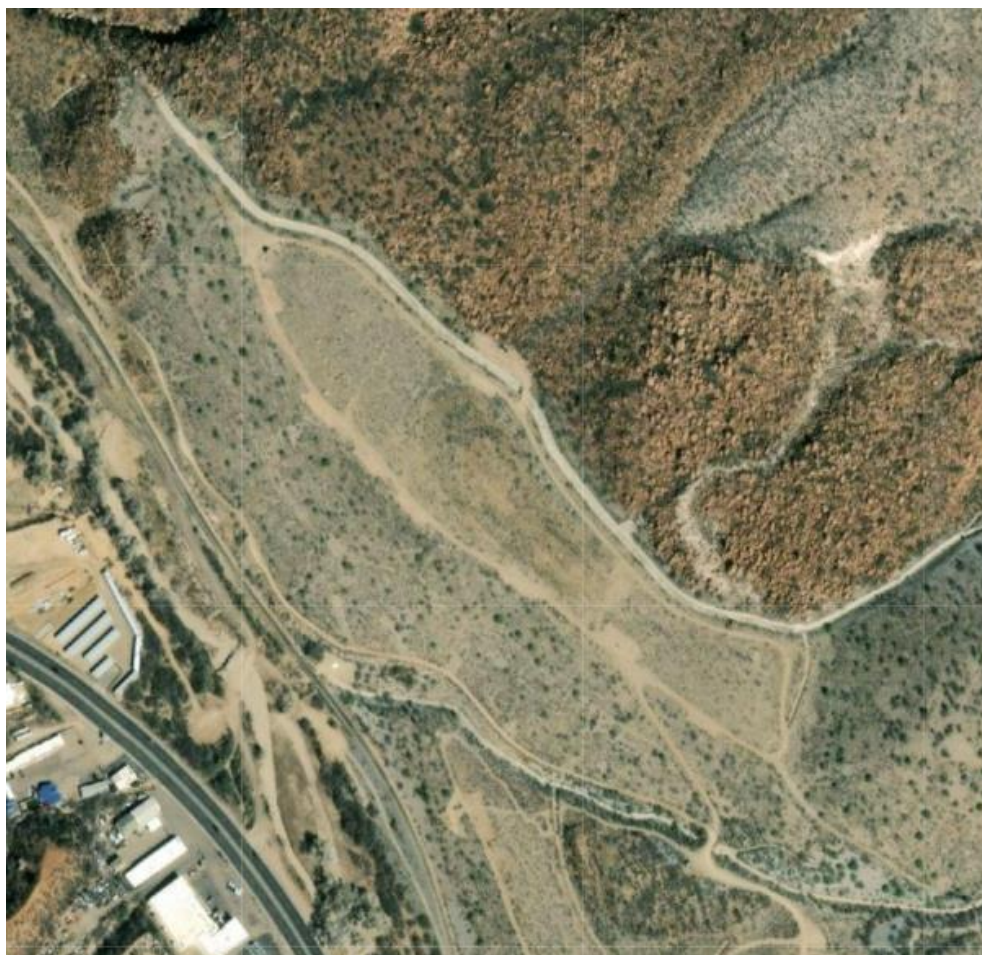
ODT1 TSF, 2022

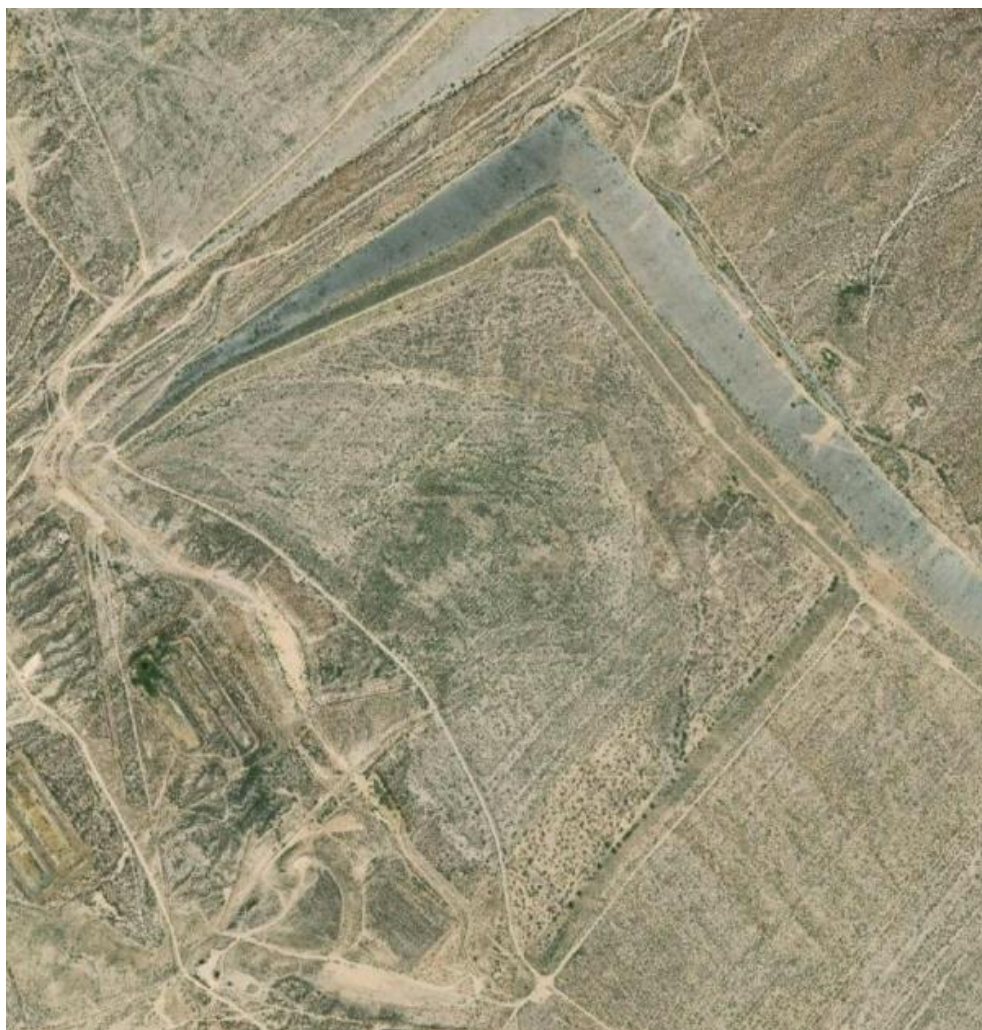
Tailings were initially deposited by a feeder pipe placed on the starter embankment with embankment raises constructed by dredging the pond with a cable operated bucket excavator (dragline). From 1960 to 1990, tailings were deposited at the facility via a centrifugal separator, with the underflow (coarse fraction) being used to construct embankment raises and the overflow (fine fraction) discharged into the TSF. During operations, No. 1 TSF and No. 2 TSF were merged to form the current configuration (No. 1/2 TSF). Background design information notes that during operation, the ponds were decanted via a series of buried pipelines that conveyed water to a collection pond at the base of the TSF.

Closure activities were carried out at San Manuel between 2005 and 2007. Embankment slopes were regraded to provide a uniform slope. Slopes were covered with 60 centimetres of soil and/or rock. Coarse soil cover was sourced from designated areas upslope of No. 5 TSF and No. 6 TSF. Fine materials were sourced from the clean water diversion channel excavation waste material. Tailings surfaces were covered with 30 centimetres of clean cover soil, sourced from natural ground immediately upstream of the impoundment, and vegetated. Limited material placement was used in the pond areas to facilitate drainage.

No.1/2 TSF, 2022

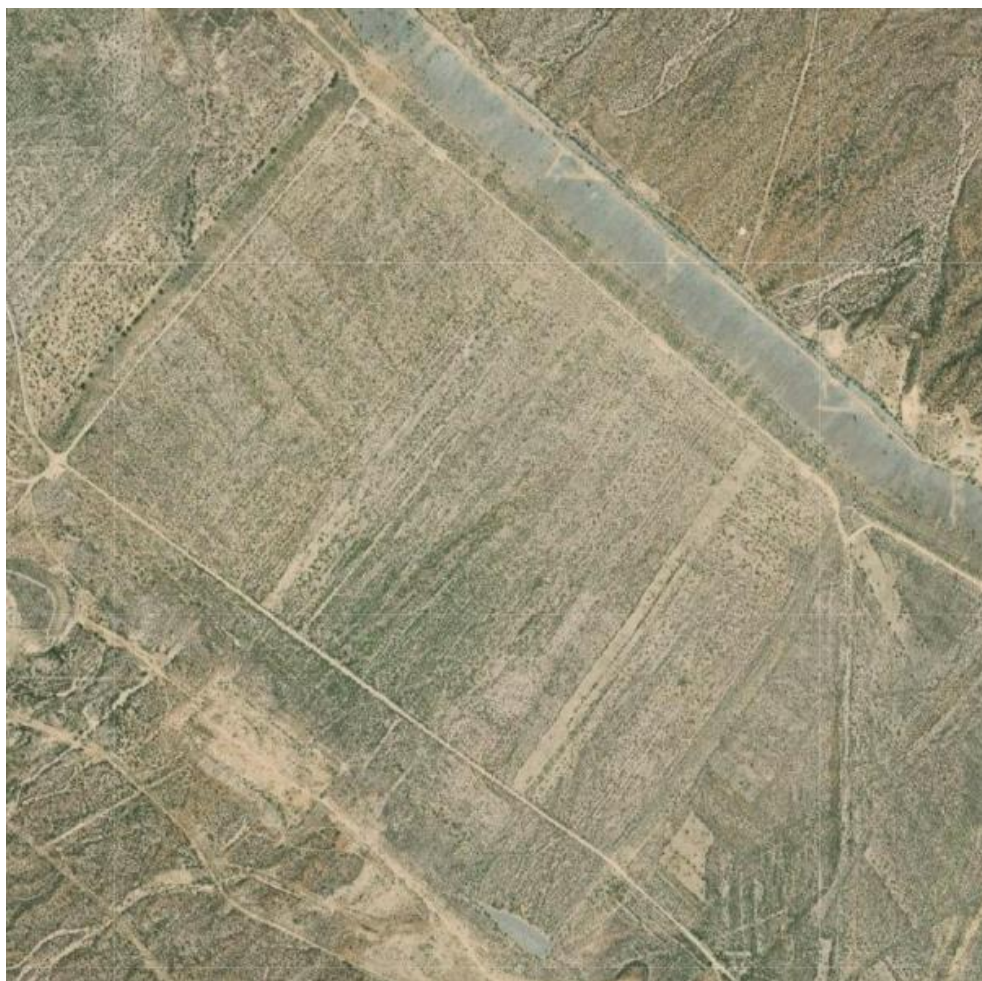
Tailings were deposited from 1957 to 1995 using centrifugal separators located on the starter embankment crest, with raises carried out using the upstream method. From 1995 to 1999, tailings were deposited from a series of perimeter discharge points. Available design information notes that during operation, the ponds were decanted via a series of buried pipelines that conveyed water to a collection pond.

Closure activities were carried out at San Manuel between 2005 and 2007. Slopes were covered with 60 centimetres of soil and/or rock. Coarse soil cover was sourced from designated areas upslope of No. 5 TSF and No. 6 TSF. Fine materials were sourced from the clean water diversion channel excavation waste material. Tailings surfaces were covered with 30 centimetres of clean cover soil sourced from natural ground immediately upstream of the impoundment and vegetated. Limited material placement was used in the pond areas to facilitate drainage.

No.3/4 TSF, 2022

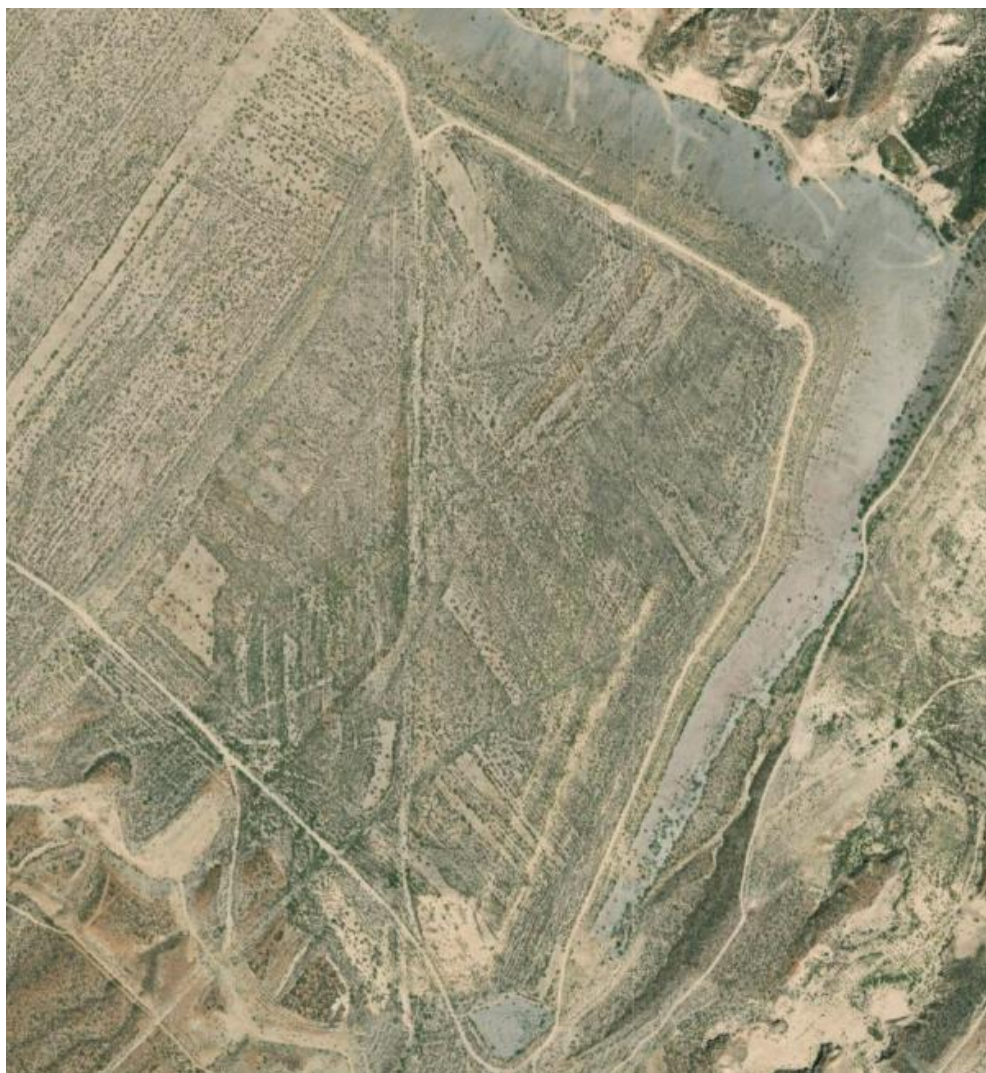
Tailings were deposited from 1964 to 1995 using centrifugal separators located on the starter embankment crest, with raises carried out using the upstream construction method. From 1995 to 1999, tailings were deposited from perimeter discharge points. Available design information notes that during operation, ponds were decanted via a series of buried pipelines that conveyed water to a collection pond.

No.5 TSF, 2022
