Global Industry Standard on Tailings Management

Public Disclosure

2024

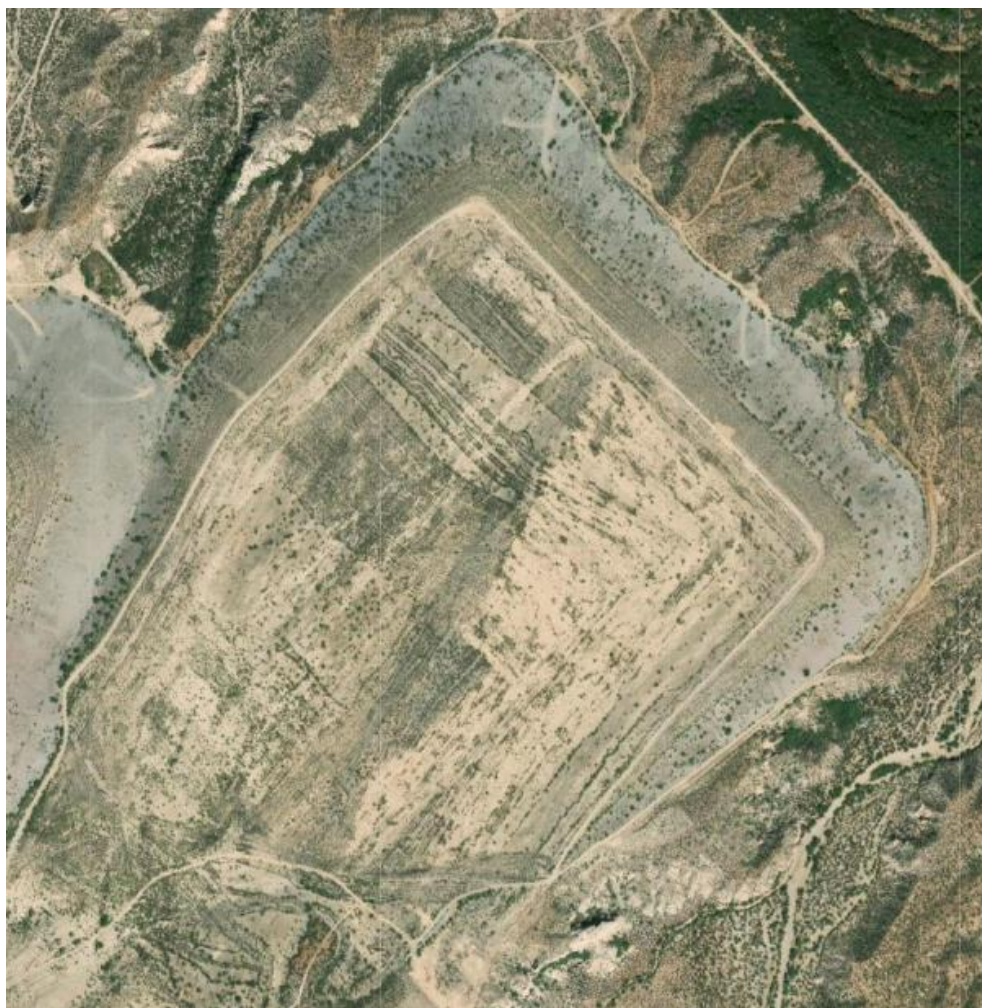
Closure activities were carried out at San Manuel between 2005 and 2007. Slopes were covered with 60 centimetres of soil and/or rock. Coarse soil cover was sourced from designated areas upslope of No. 5 TSF and No. 6 TSF while fine materials were sourced from the clean water diversion channel excavation waste material. Tailings surfaces were covered with 30 centimetres of clean cover soil, sourced from natural ground immediately upstream of the impoundment, and vegetated. Limited material placement was used in the pond areas to facilitate drainage.

No.6 TSF, 2022

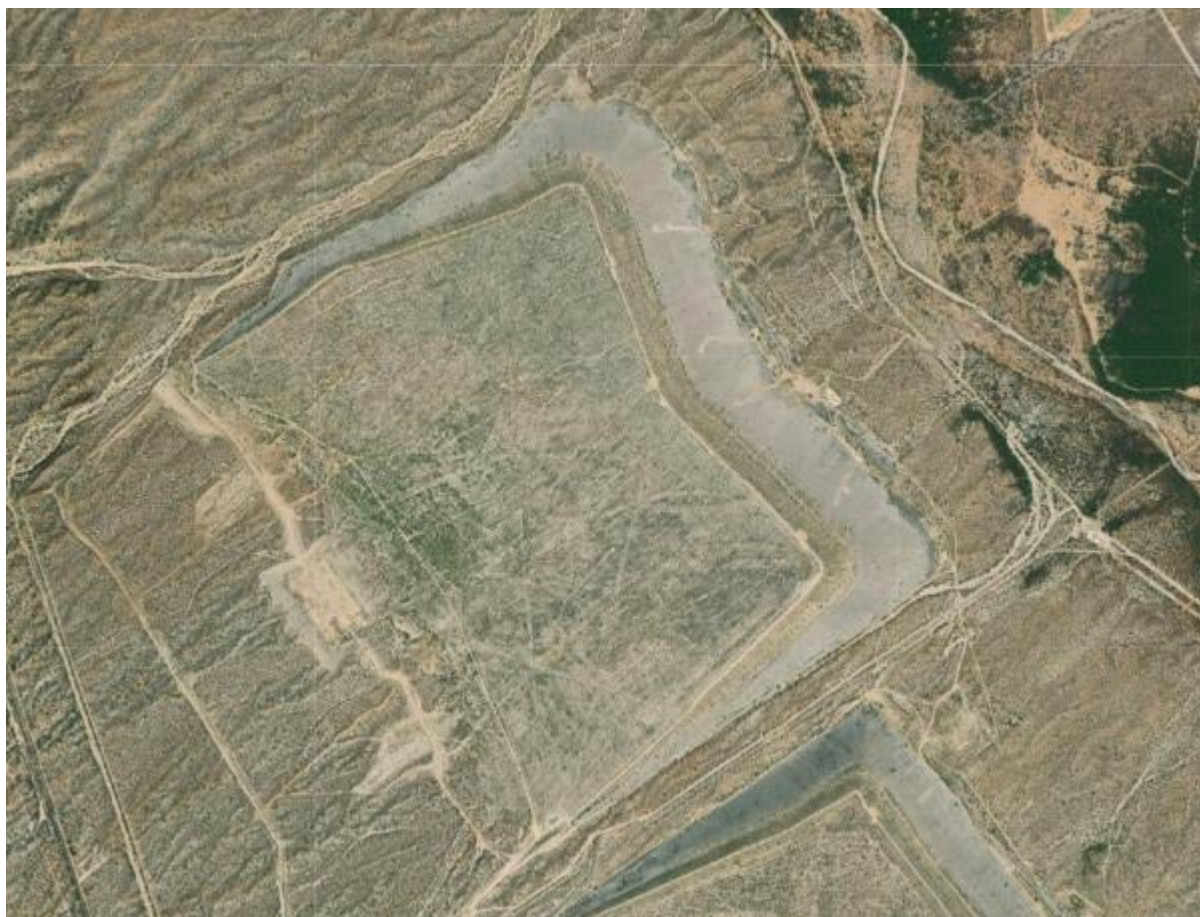
Tailings were deposited from 1970 to 1995 using centrifugal separators located on the starter embankment crest, with raises carried out using the upstream construction method. From 1995 to 1999, tailings were deposited using a series of perimeter discharge points. Available design information notes that during operation, the ponds were decanted via a series of buried pipelines that conveyed water to a collection pond.

Closure activities were carried out at San Manuel between 2005 and 2007. Embankment slopes were regraded to provide a uniform slope and covered with 60 centimetres of soil and/or rock. Coarse soil cover was sourced from designated areas upslope of No. 5 TSF and No. 6 TSF. Fine materials were sourced from the clean water diversion channel excavation waste. Impoundment surfaces were covered with 30 centimetres of clean cover soil, sourced from natural ground immediately upstream of the facility, and vegetated. Limited material placement was used in the pond area to facilitate drainage. The western half of No. 10 TSF impoundment surface was covered with clean cover soil and vegetation while the eastern half was covered with an alternative cover system as a trial to test long-term vegetation. On this half, the existing 10 centimetres of cover was mixed into the tailings and covered by a new cover 20 centimetres thick.

No.10 TSF, 2022

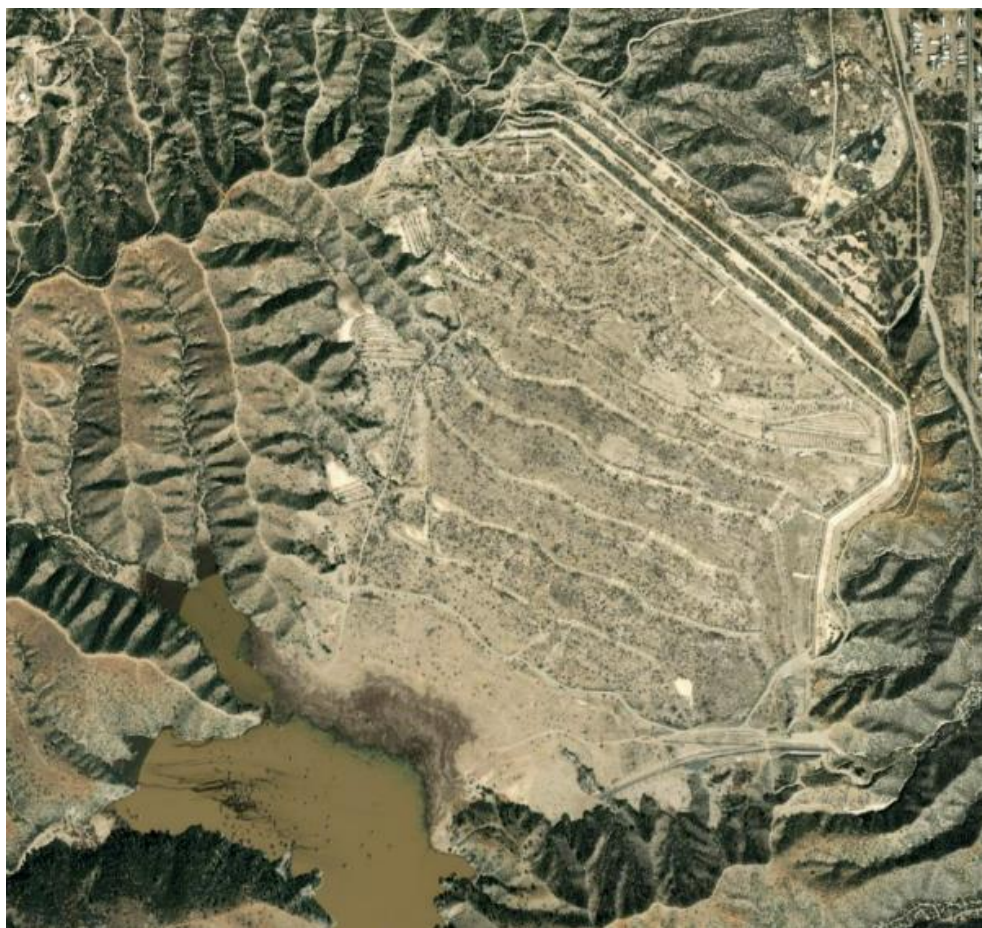
Solitude TSF, 2022

A buttress is currently being constructed on the downstream slopes of the perimeter embankment to establish factors of safety with respect to slope stability consistent with the requirements for extreme loading per GISTM Annex 2. Additional closure activities currently proposed at Solitude include:
