Global Industry Standard on Tailings Management Public Disclosure

2024

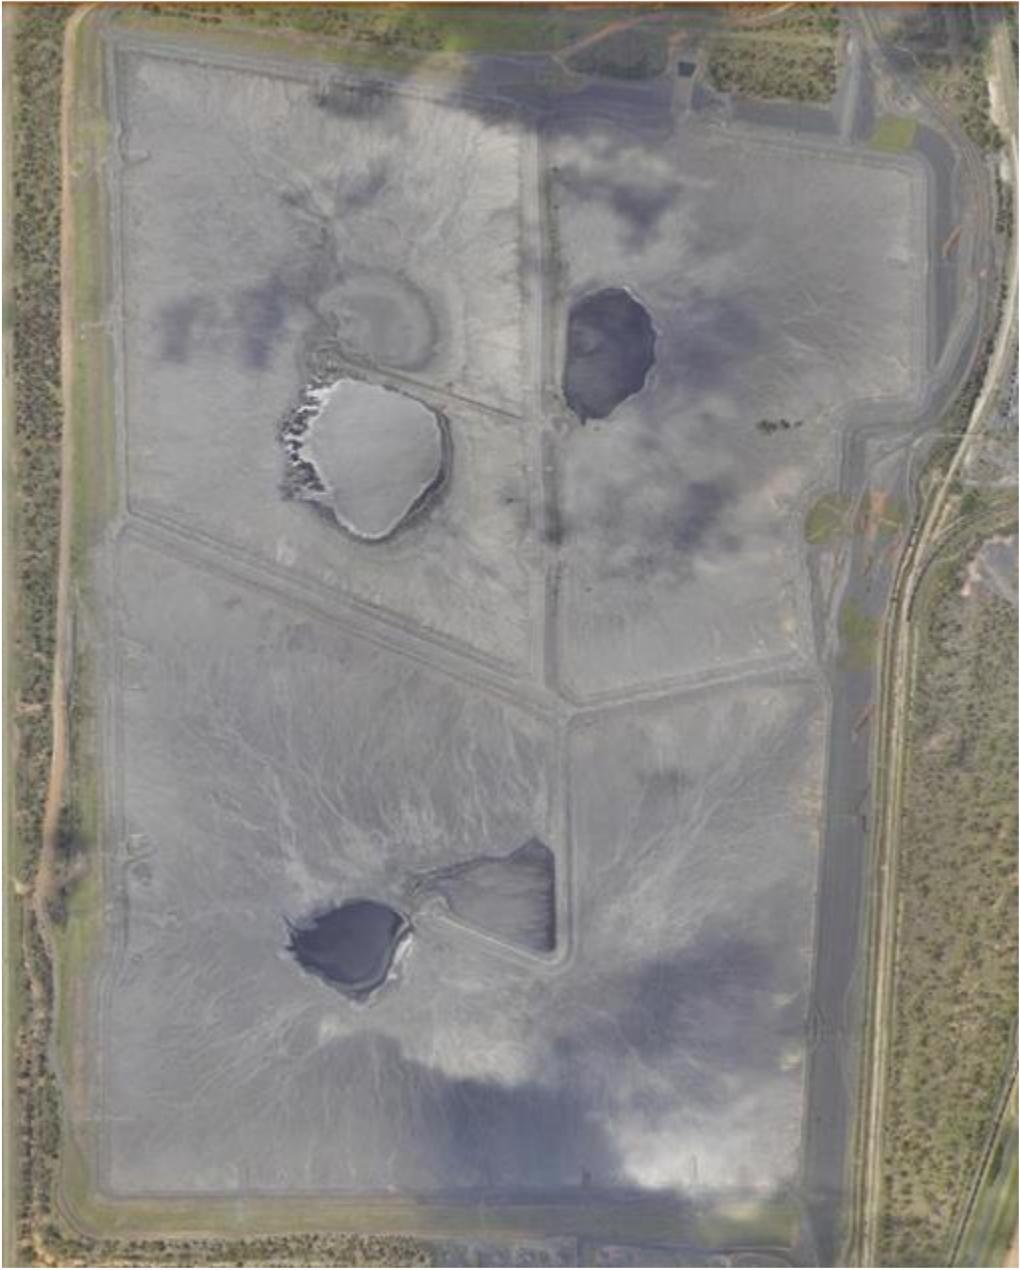
GS1 TSF, 2023

Stage (year completed)	Design description
Initial Construction (1975)	Construction of a 10-metre starter embankment to 264 metres relative level (mRL) using locally sourced sandy-clay engineered fill.
Continuous lifts (1980 -1992)	Embankment progressively raised using the downstream method with waste materials as part of day-to-day operational mining activities.
Pre-Stage 1 (1994)	Incremental downstream and centreline raises of embankments to varying heights between 269 mRL to 275 mRL using non-engineered fill.
Pre-Stage 1 (2005)	Upstream embankment raise of southern sections of the eastern and western embankments and downstream raise of the southern embankment to 272 mRL. Construction of southern, northern and internal spillways.
Stage 1 (2009)	Upstream embankment raise of northern sections of the western and northwestern embankments and the internal embankments on the northwestern cell to 277.7 mRL. Raise and construction of additional internal spillways and drainage structures.

Stage 2 (2011)	Upstream embankment raise of southern embankment and southern sections of the eastern and western embankments to 274-275 mRL. Southern emergency spillway raised and new northern emergency spillway constructed.
Stage 3 (2013)	GS1A water storage dam (north-east cell) repurposed and incorporated into the TSF.
Stage 4 (2014)	Downstream raise of northern embankment and downstream/upstream raise of eastern embankments to 277.7 mRL to amalgamate northeastern cells into a single cell.
Stage 5 (2016)	Upstream and centreline raise of southern cell embankments to 276.6 mRL. Raise of southern spillway.
Stage 6 (2020)	Upstream raise of northern cell embankments to 280.3 mRL.
Improvement projects	Various improvement projects, including updates to the knowledge base, and physical preparatory works transitioning the facility to a state of inactivity.

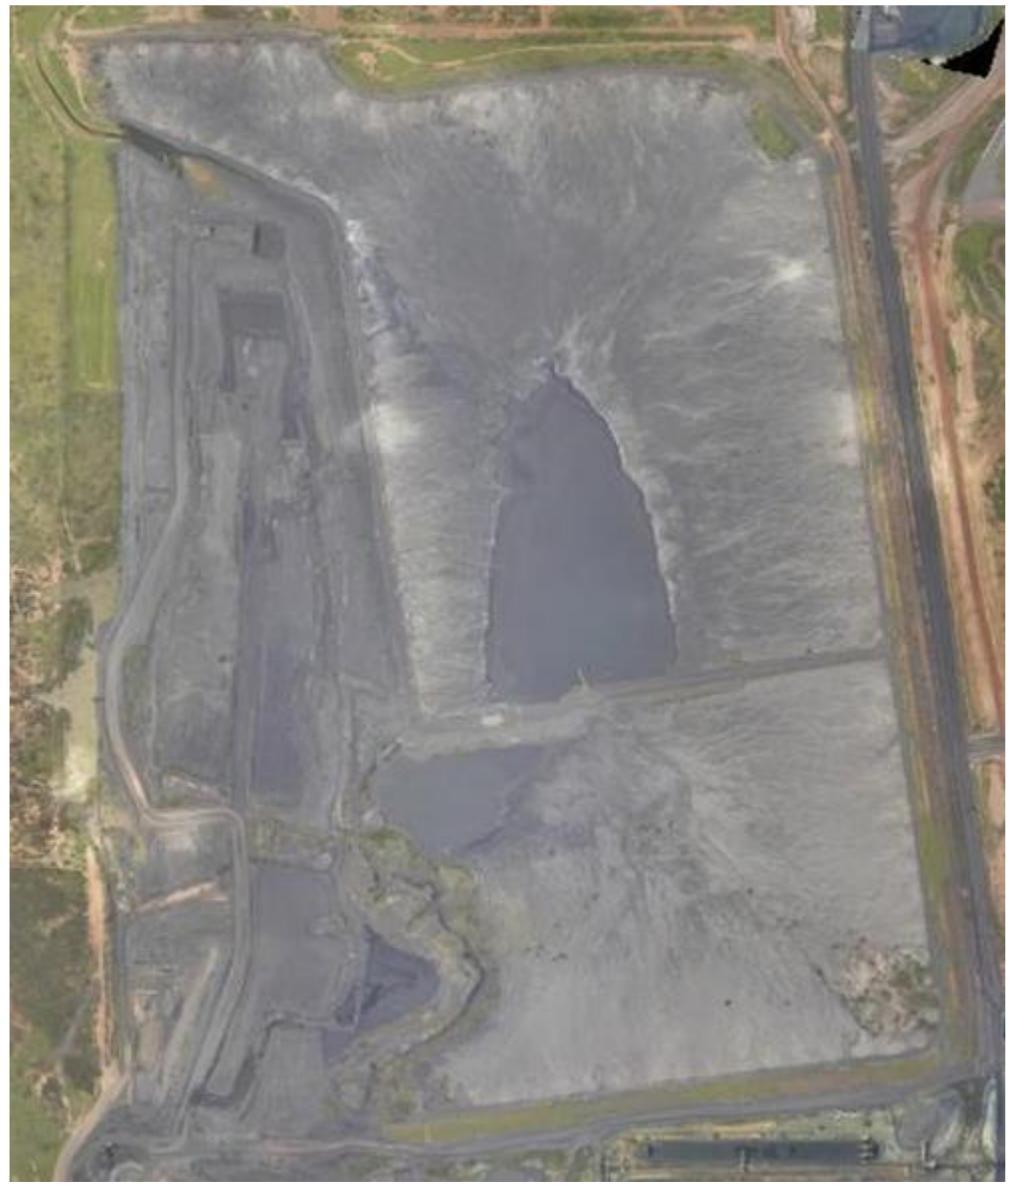
RS1 TSF, 2023

Stage	Year completed	Description of design
Initial construction	1983	Construction of starter embankment at the southern and eastern extent to 280 metres relative level (mRL). Construction of emergency spillway.
Continuous raises	1983-1986	Embankment progressively raised using the downstream method with waste materials as part of day-to-day operational mining activities.
1	1987	Downstream raise of southern and eastern embankments to 283 mRL. Raise of emergency spillway.
2	1993	Downstream raise of the southern and eastern embankments to 285.5 mRL. Raise of emergency spillway.

2 (North Dam)	1996	An external embankment constructed to prevent catchment run-off entering the facility from the north.
3	2006	Downstream raise of southeastern embankment to between 288 – 291 mRL. Upstream raise of eastern embankment to 288 mRL and construction of new western embankment to 286.6 mRL and internal embankment to 288 mRL. Previous spillway decommissioned and new emergency spillway constructed in northeast corner.
4	2008	Upstream and downstream raise of eastern and western embankments to 289.5 mRL and centreline raises of internal embankments.
5	2012	Upstream raise of southern, eastern and northern embankments to 291.3 mRL.
6	2015	Upstream and centreline raise of northern, eastern and internal embankments to between 291.3 mRL and 291.5 mRL
7	2020	Upstream raise of western embankments to 291.3 mRL.
Various improvement projects	Various improvement projects, including updates to the knowledge base, and physical preparatory works transitioning the facility to a state of inactivity.

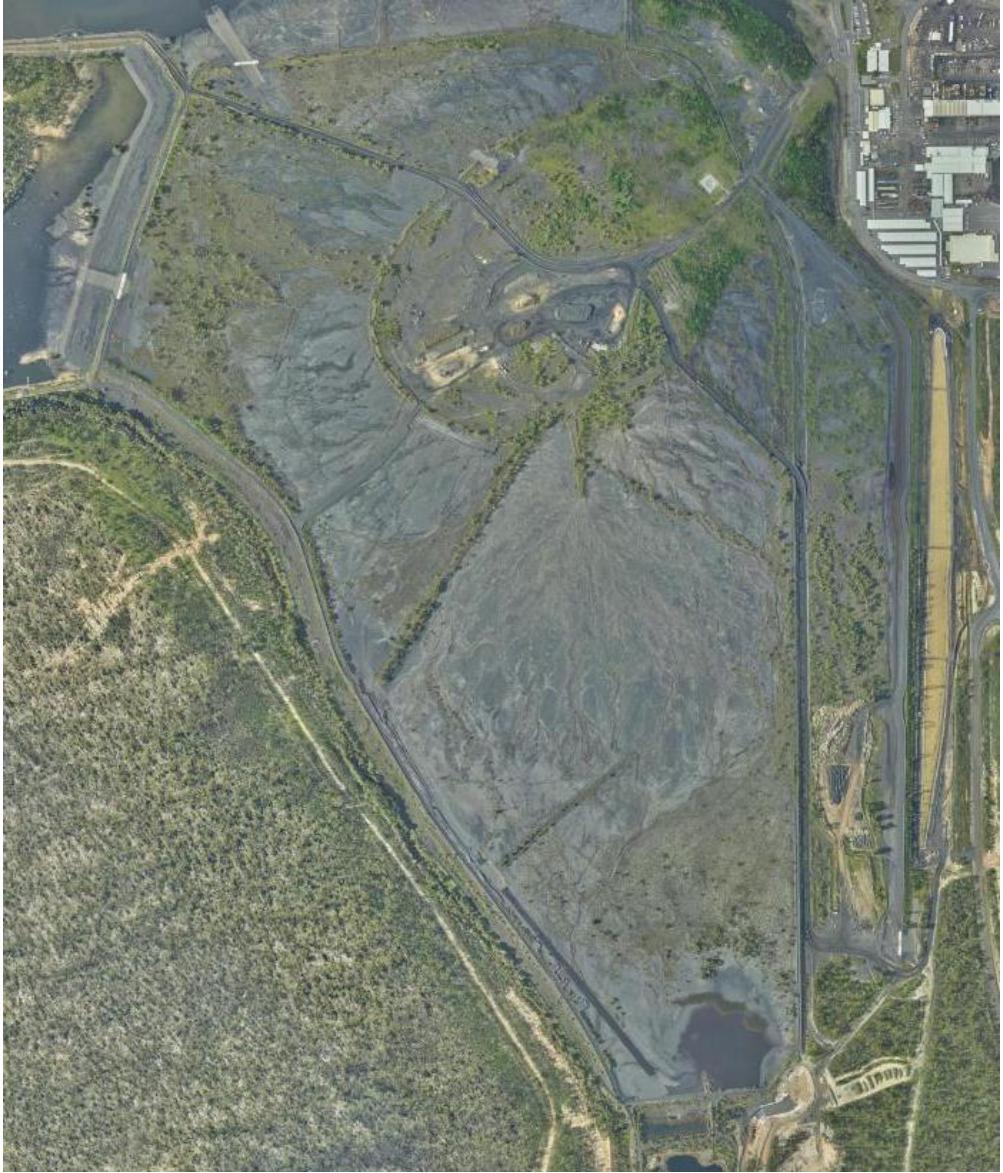
OTD TSF, 2023

The facility was commissioned in 1974 and has undergone six subsequent design changes (see table below). The OTD is an above-ground facility that relies on constructed embankments to contain the tailings. The embankments were built using the upstream or downstream raise methods. The original TSF consists of two cells, the northern cell (TD1) and southern cell (TD2) which merged into one cell in 1993.

Stage	Year completed	Description of design
1	1974	Construction of two starter embankment cells, TD1 (North) and TD2 (South) to 253.0 metres relative level (mRL). TD1 for tailings storage and TD2 for water storage.
2	1981	Embankments raised downstream to varying heights (256.0 mRL - 260.0 mRL)
3	1991	Embankments raised upstream to varying heights (262.0 mRL - 266.0 mRL)
TD1 Capping	1993	Capping of tailings surface in the northern cell extents.
4a	1993-1994	Embankments raised upstream to varying heights (260.0 mRL - 267.5 mRL). Facility merged into a single cell.
4B	1996	Embankments raised upstream and downstream to varying heights (266.5 mRL - 269.5 mRL).
4B Adjustment	1998	Embankments raised upstream and downstream to varying heights (266.5 mRL - 272.0 mRL).
5	2024	Upgrade of emergency spillway capacity and buttressing on North-western and eastern embankments.

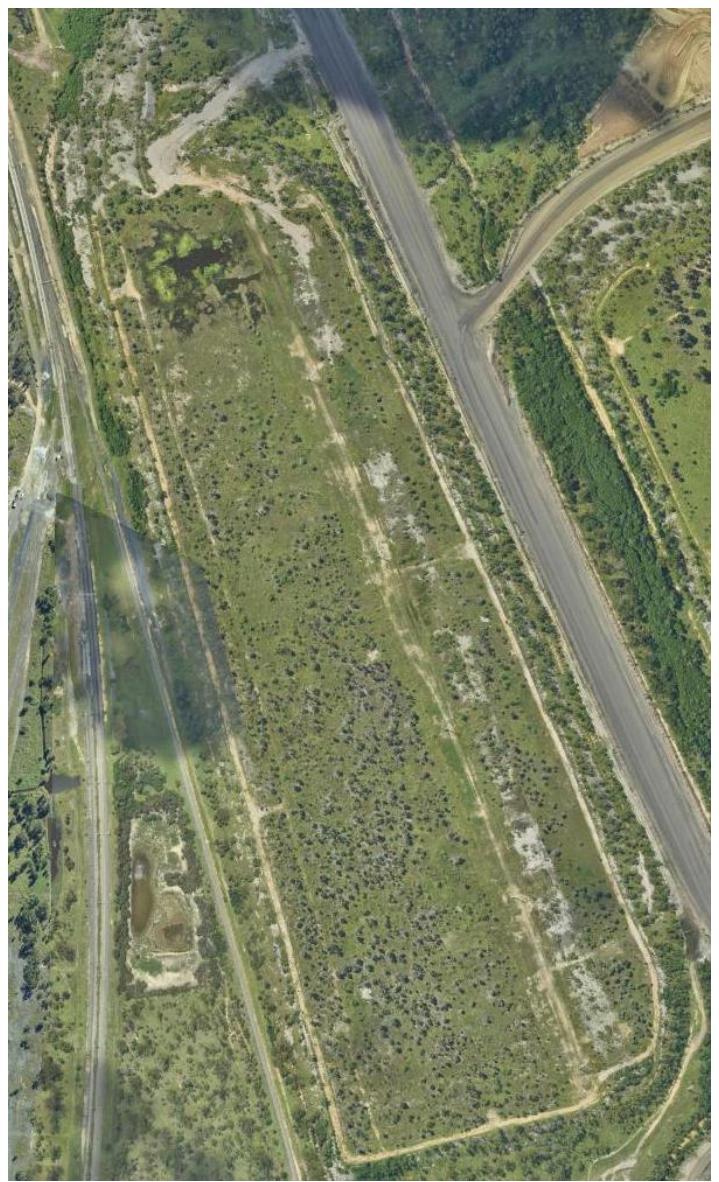
TSF No.3, 2023

The facility initial construction commenced after 1966 and tailings deposition started by 1977. TSF No.3 is an above ground facility that relies on constructed embankments to contain the tailings. The embankments were built using the downstream construction method in a single stage. Capping and rehabilitation works were undertaken between 2009-2014.

Stage	Year completed	Description of design
Initial construction	1966-1977	Construction of single stage embankments to 217 and 218 metres relative level (mRL) for tailings storage.
Deposition commenced	1977-1983	Deposition commenced around 1977.
Deposition ceased	1983-1985	Deposition ended in late 1980s.
No activity	1998-2009	No active deposition of tailings recorded. Surveyed embankment heights 12m above natural ground level.
Initial Capping	2009-2010	Capping 2/3 of tailings surface, raised embankment crest elevations between 218 mRL and 220 mRL.
	2010-2011	Construction of the closure spillway.
Final Capping	2012-2013	Completion of capping layer over existing decant pond and embankment. Rock mulching of the spillway.
Rehabilitation	2013-2014	Placement of topsoil as part of final stage of rehabilitation plan.

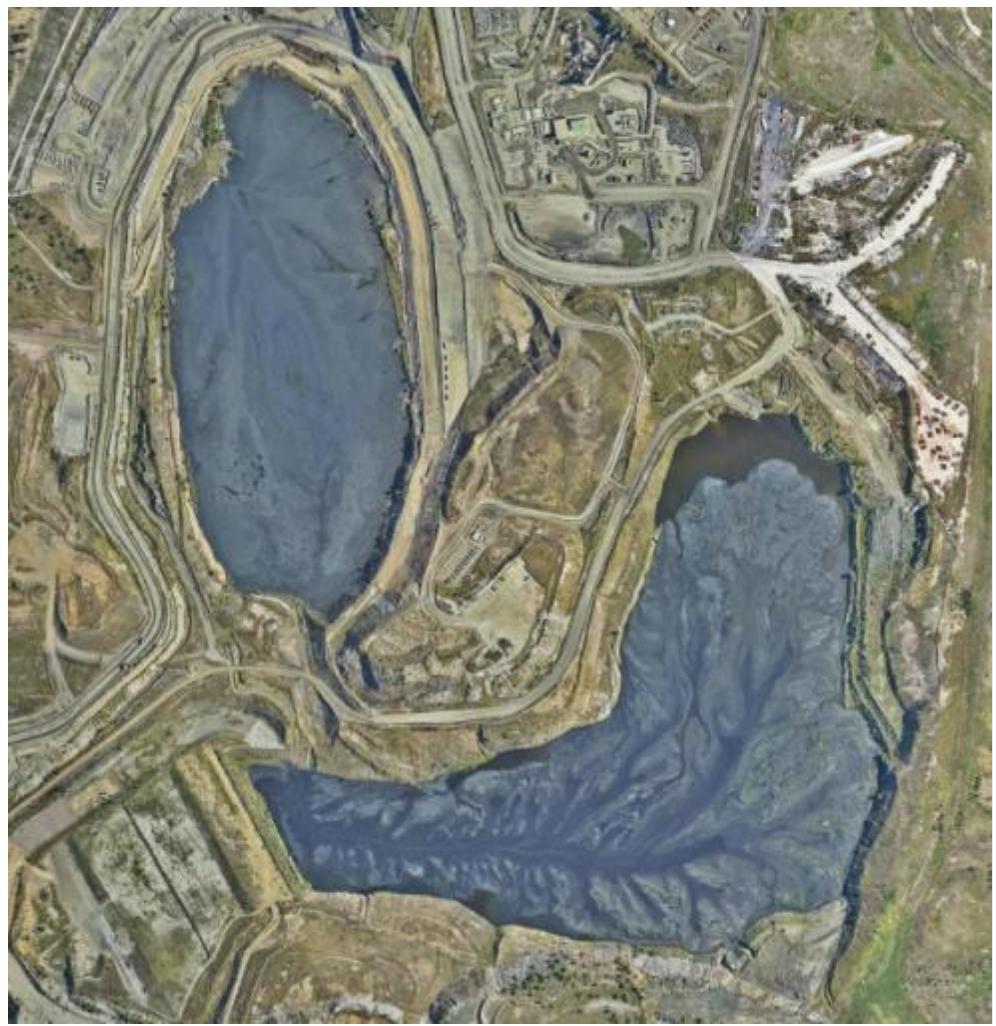
MAC TSF, 2022

The WCV embankment is 10 metres high and 750 metres long. The north-west embankment is 30 metres high and 580 metres long.

The SWV area has been created by the construction of a cross-valley embankment 400 metres long and 25 metres high, located at the western perimeter. The remaining perimeter comprises the natural material that hosted the coal seams and mine spoil waste dumps.

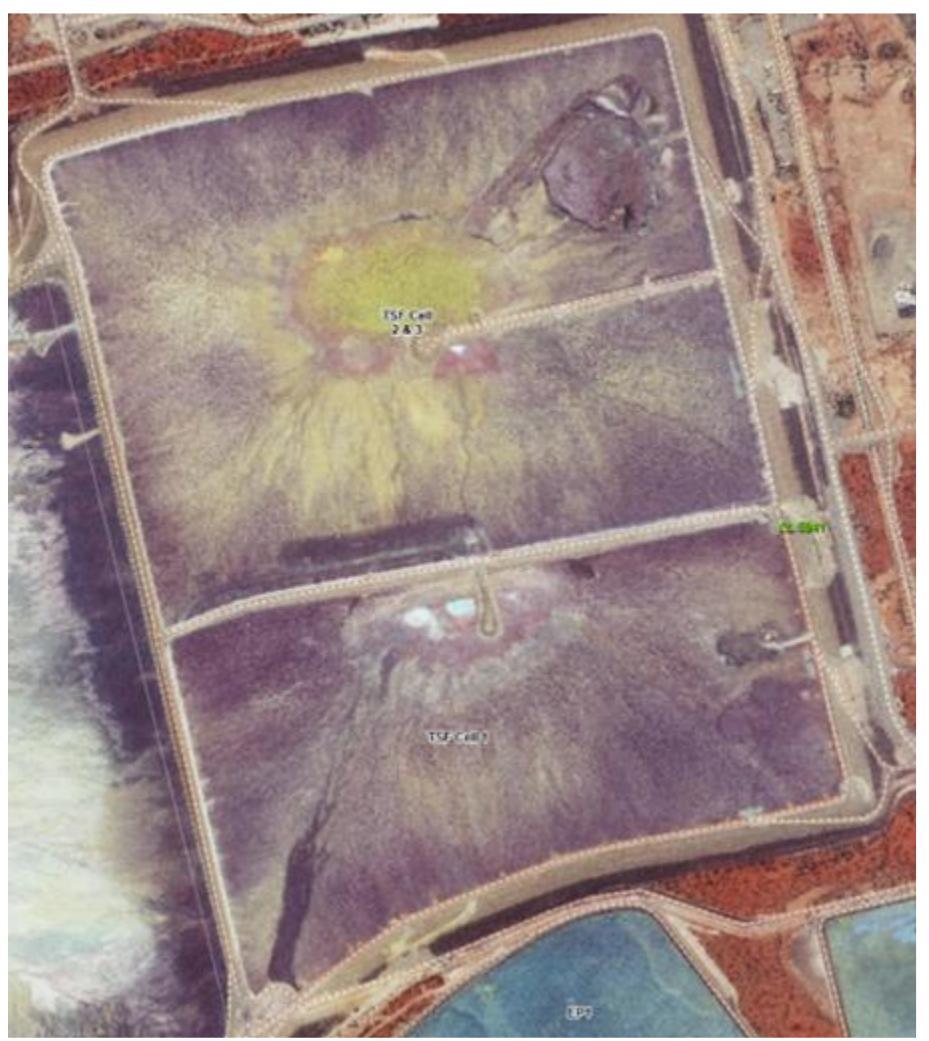
TSF1-3, 2024

each TSF are lined internally with a layer of clay rich soil and externally with a layer of rock armour. The initial TSF1 design had a downstream embankment slope of 1 metre vertical for every 2.5 metres horizontal (1V:2.5H) and was constructed approximately 7 metres high with a crest width of 6.5 metres. During the mid-1990s, the overall downstream slope of the embankment was modified to 1V:2.75H.

TSFs 1, 2 and 3 embankments were raised in the upstream method, initially with raises 3 metres high, and from July 2000 with raises 1 metre high. Embankment raises were constructed using a mixture of excavated tailings and imported clay as fill. The upstream raise consists of an outer clay layer that provides separation of tailings from the outside environment. The tailings maximum rate of rise was limited to 2 m/yr. Over time, TSF2-3 have been combined into a single cell with TSF1-3 now considered a single TSF based on similar life cycle stage, heights and management systems.

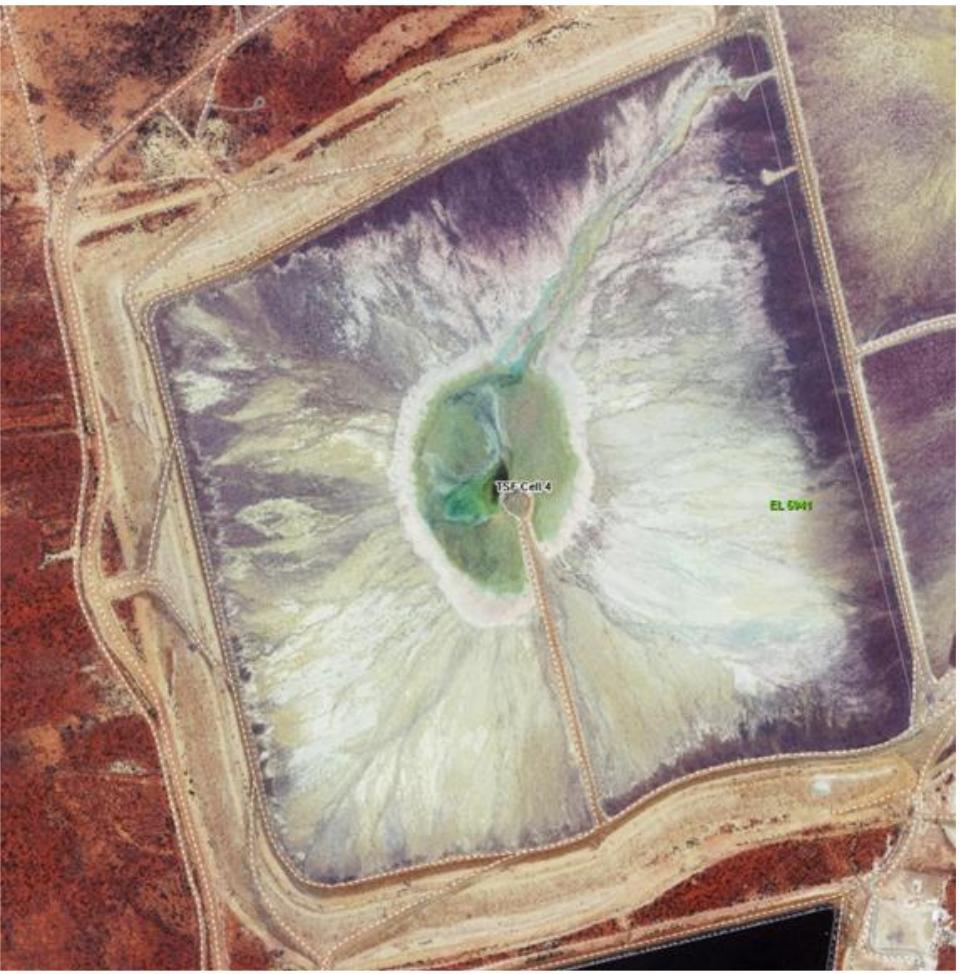
TSF4, 2024

embankment. TSF4 has a downstream embankment slope of 1 metre vertical for every 2.75 metres horizontal (1V:2.75H).

TSF4 was raised using the upstream method using a mixture of excavated tailings and imported clay fill. The upstream raise consists of an outer clay layer that provides separation of tailings from the outside environment and a subsequent layer of rock armour for erosion protection. The maximum rate of tailings level increase was limited to 2 metres per year.

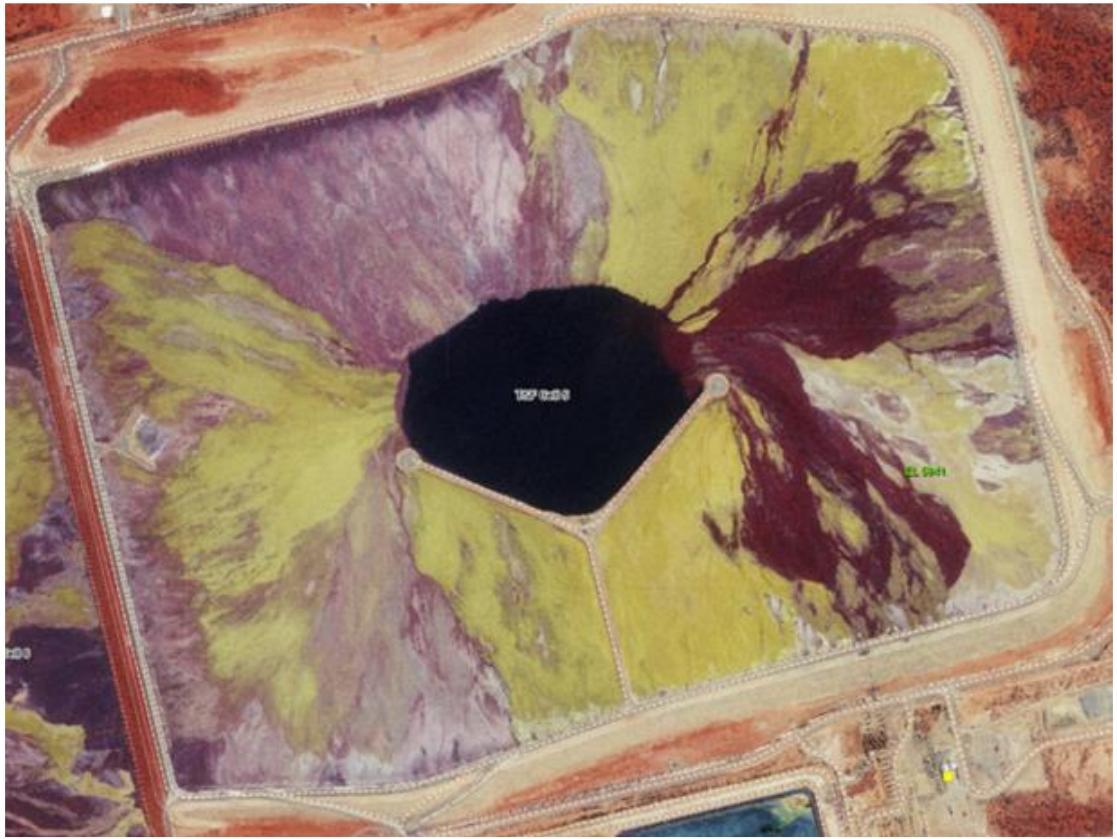
TSF5, 2024

8 metres, dependent on the natural sand dune level. TSF5 has a downstream embankment slope of 1 metre vertical for every 2.75 metres horizontal (1V:2.75H).

TSF5 is raised using the upstream method using a mixture of excavated tailings and locally sourced clay-rich material. The upstream raise consists of an outer clay-rich layer and a subsequent layer of rock armour for erosion protection. The maximum rate of tailings level increase is limited to 2 metres per year. The heights of the TSF5 raises range from 1 to 1.8 metres, with upstream and downstream slopes of 1V:2H and 1V:2.75H respectively.

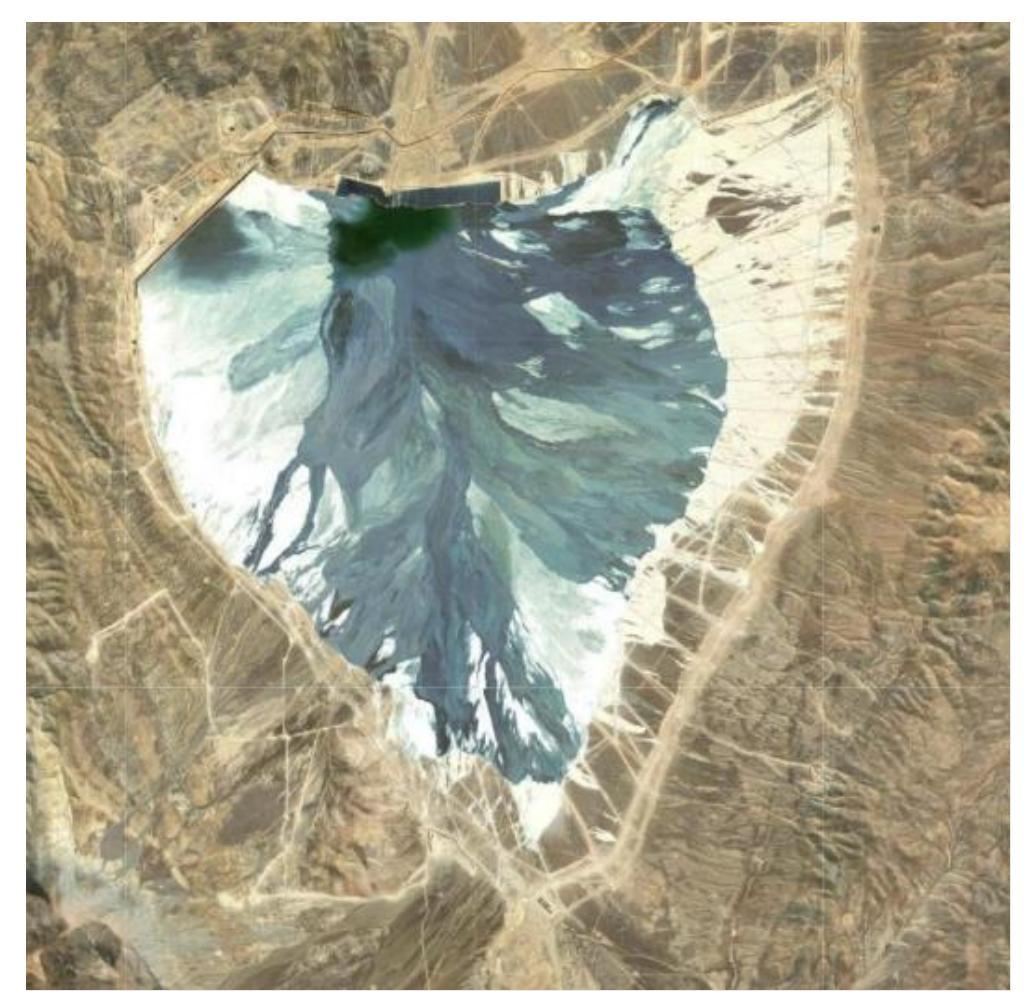
Laguna Seca TSF, 2022

Water is recovered from an embankment drainage system, a network of wells and the decant pond through a collection tower and pumping system.

For all stages, a minimum height between the tailings and the embankment crest of 5 metres, and a crest width of 15 metres is required to be maintained.

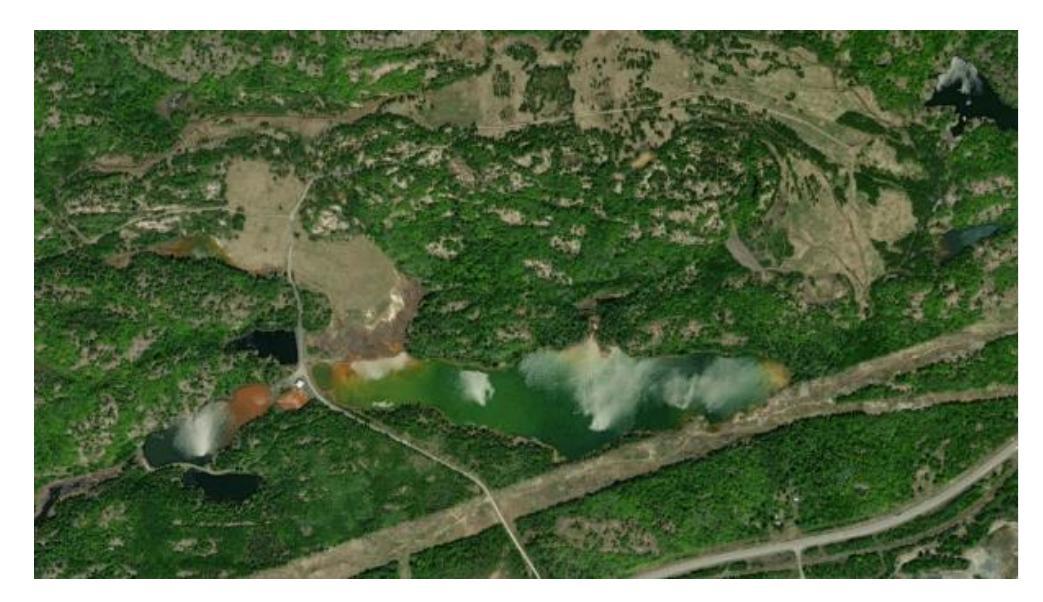
Pronto TMA, 2022

Structure	Crest length [metres]	Maximum height [metres]	Retained head at normal water level [metres]
Dam A	140	13	11.7
Dam D	60	3.5	1.4
Dam E	45	2	1.7
Dam F	75	5	3.7
Causeway Dam	150	10	3.4
ETP Diversion Berm	4	1.5	1.0

Closure activities began at the Pronto TMA in 1997 with the ultimate crest heights of all Pronto TMA embankments achieved between 1998 and 1999. Two spillways were constructed during closure activities (one south of Dam A and another at the western end of the west tailings area) to divert runoff from the east and west into a pond prior to treatment at the effluent treatment plant, then released into subsequent ponds before reaching Lake Huron. A monitoring program will continue to assess the performance of the TMA including review of instrumentation, seepage and water quality data.

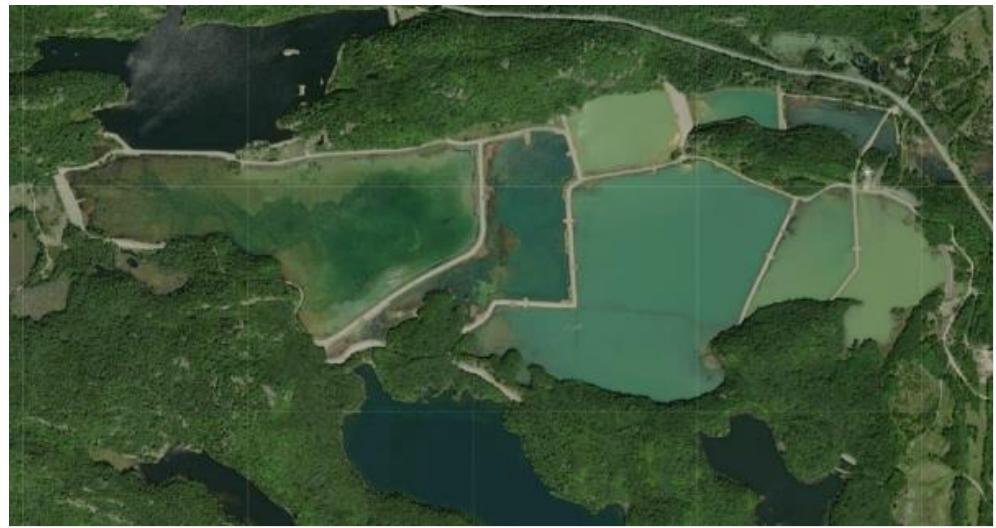
Quirke TMA, 2022

The perimeter embankments were constructed during the mine operating periods. The main dam was originally constructed in 1970 and entirely rebuilt between 1989 and 1990. Dams G1, G2, I, J, K1, K2, and L were built between 1980 and 1989. Dam J and Dam L were the only embankments constructed in two stages: Dam J was constructed using the upstream raise method; while Dam L was built using the centreline raise method. During operation, embankments were constructed from waste rock and tailings as a platform for tailings deposition. As the tailings deposition progressed, new embankments were built over tailings and previous embankments were buried.

The internal embankments were upgraded for closure and designed to retain tailings and maintain a flooded water cover over the tailings surface. The internal embankments are zoned earth structures that generally consist of a compacted glacial till cap placed on top of the original embankment crest and slopes, erosion protection zones placed on top of the till cap, and an upstream compacted glacial till blanket to limit seepage through the embankment. Spillways were constructed in each embankment to allow water to flow east from Cell 14 to Cell 18 and the effluent treatment plant and provide conveyance for flood flows during storm events. The tailings surfaces were also regraded to achieve a minimum water cover of 0.6 metres.

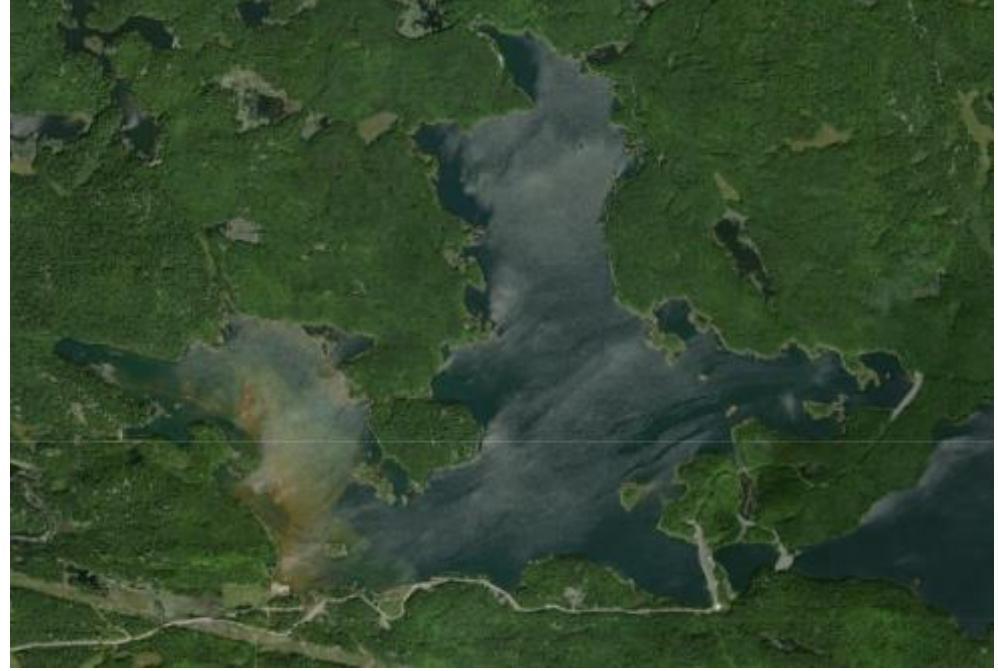
Stanleigh TMA, 2022

The crest elevations of Dams B and Dam C are lower so if the facility spillway is blocked, water will overtop Dams B and C instead of Dams A and A1. This diverts the flood path away from the Milliken TMA and Elliot Lake.

Closure activities commenced at the Stanleigh TMA in 1997 with the ultimate crest heights of all Stanleigh TMA perimeter embankments achieved in 1998. Perimeter embankment crest heights were designed to maintain flood conditions and freeboard (the space between the tailings surface and the embankment crest) required for closure. When operations ceased and tailings were no longer deposited into the TMA, the water balance no longer included operational uses for water reclaimed from the TSF. A flooded cover system was selected for closure, in which the tailings are flooded to effectively manage acid generation and radiation exposure caused by airborne releases from exposed tailings.

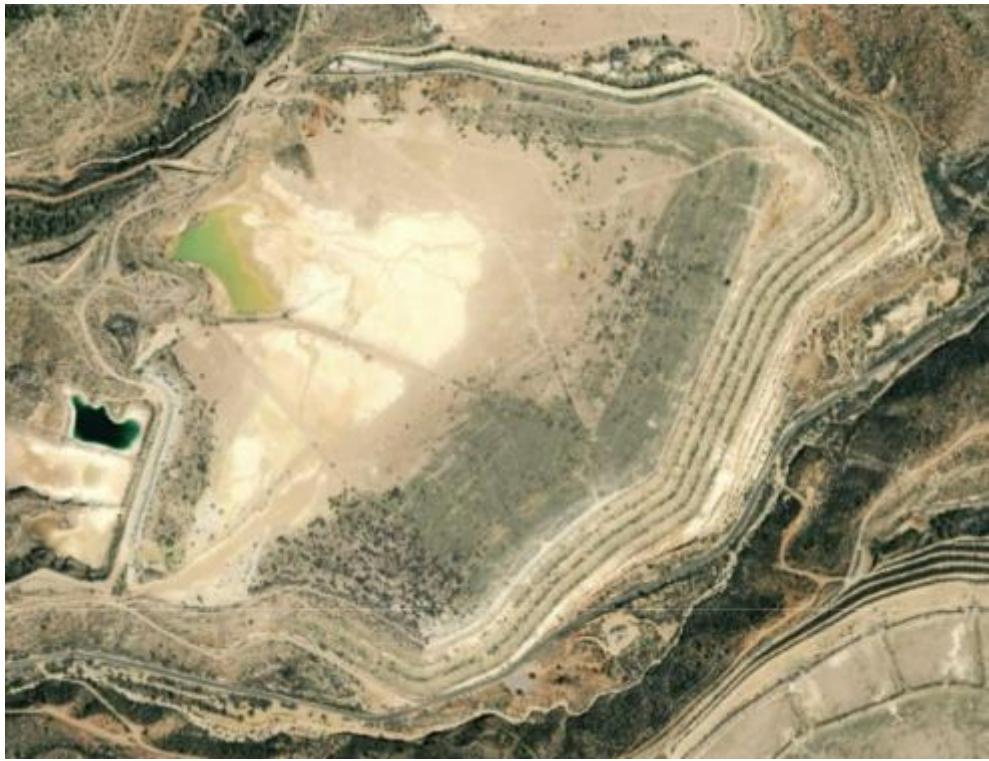
No.2 Tailings, 2022

Tailings were discharged into No. 2 Tailings from the 1950s to 1975. The starter embankment crest was raised using the upstream method. Tailings were deposited from the crest with a decant pond maintained on the western side of the impoundment. The embankment was raised in stages of between 9.7 metres and 12 metres with a step in over the tailings of 8 metres. Raises were constructed of tailings sand sourced from the deposited tailings beach using a cable operated bucket excavator (dragline). Nominal compaction was applied to the outer 4.5 metres of each raise from the movement of the dragline over the embankment during placement. The greatest slope height of the final embankment is approximately 107 metres (1,088 metres above sea level).

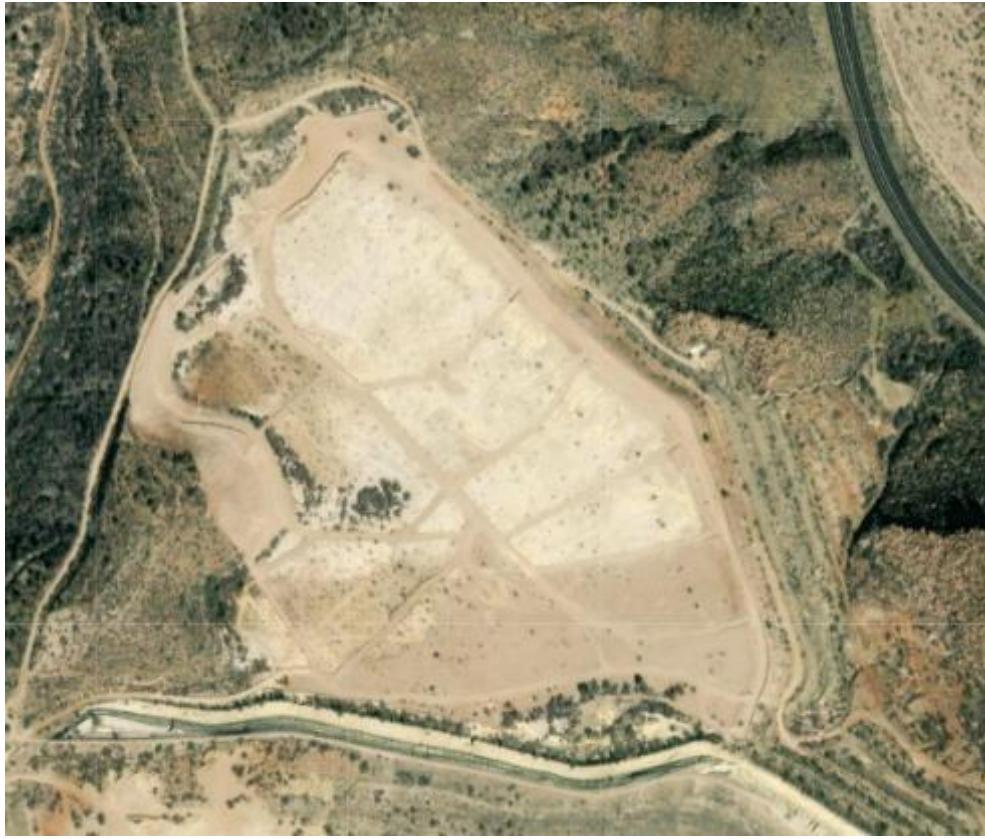
No.8 Tailings, 2022

Tailings were deposited until 1975. The raises from the starter embankment were constructed using the upstream method, with incremental raise heights varying between 9.1 and 12.2 metres and step-ins over the tailings of up to 12.5 metres. The final maximum embankment slope height is approximately 91 metres (1,075 metres above sea level).

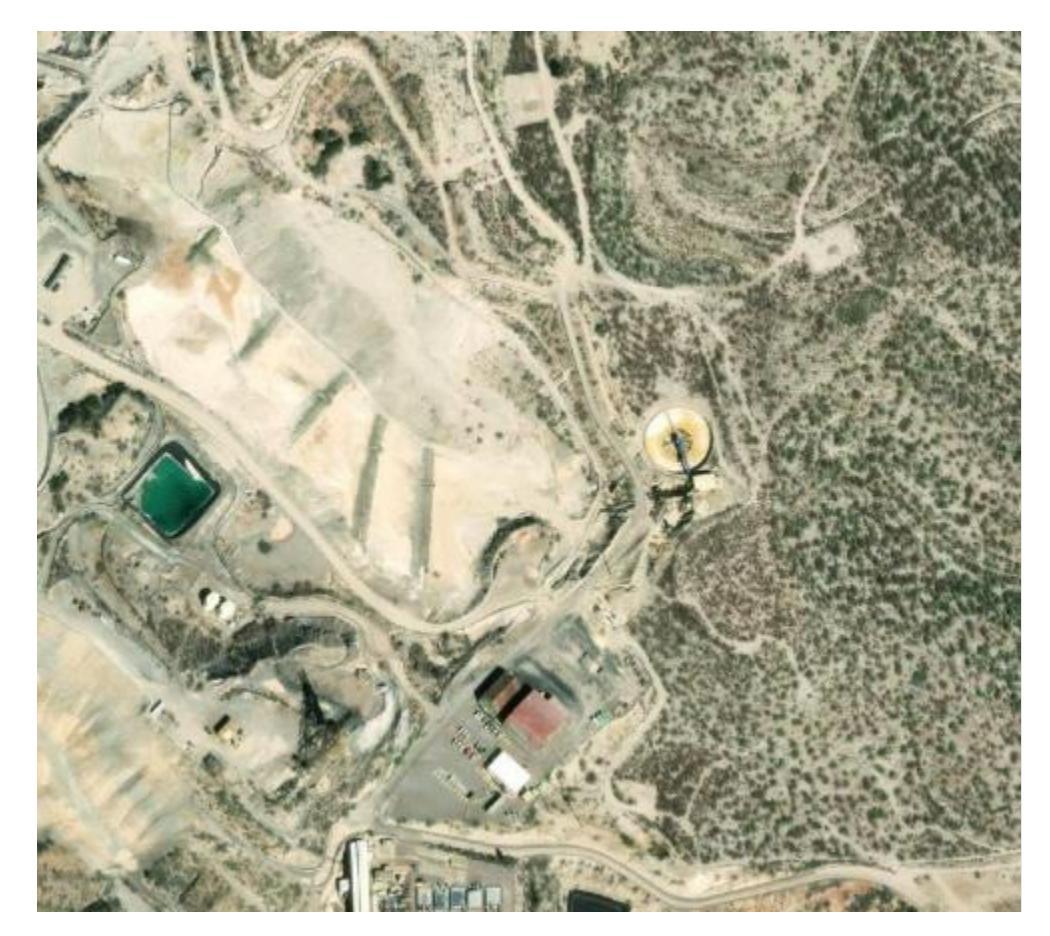
Canyon Tailings, 2022

From 1988 to 2001, some Canyon tailings were re-processed for metal extraction using hydraulic mining methods. The re-processed tailings were subsequently deposited into Deep Pit at the Copper Cities site, north of Miami Unit.

Once the Canyon TSF is closed, further mitigation work may be required to meet BHP expectations for long-term tailings risk. Presently, we are investigating a sunken area to determine its suitability as a repository for storing tailings, should the relocation of tailings from Canyon TSF be required to mitigate the long-term tailings risk. A closure strategy is being developed with input from ongoing assessments and a multi-criteria alternatives analysis (MCAA).

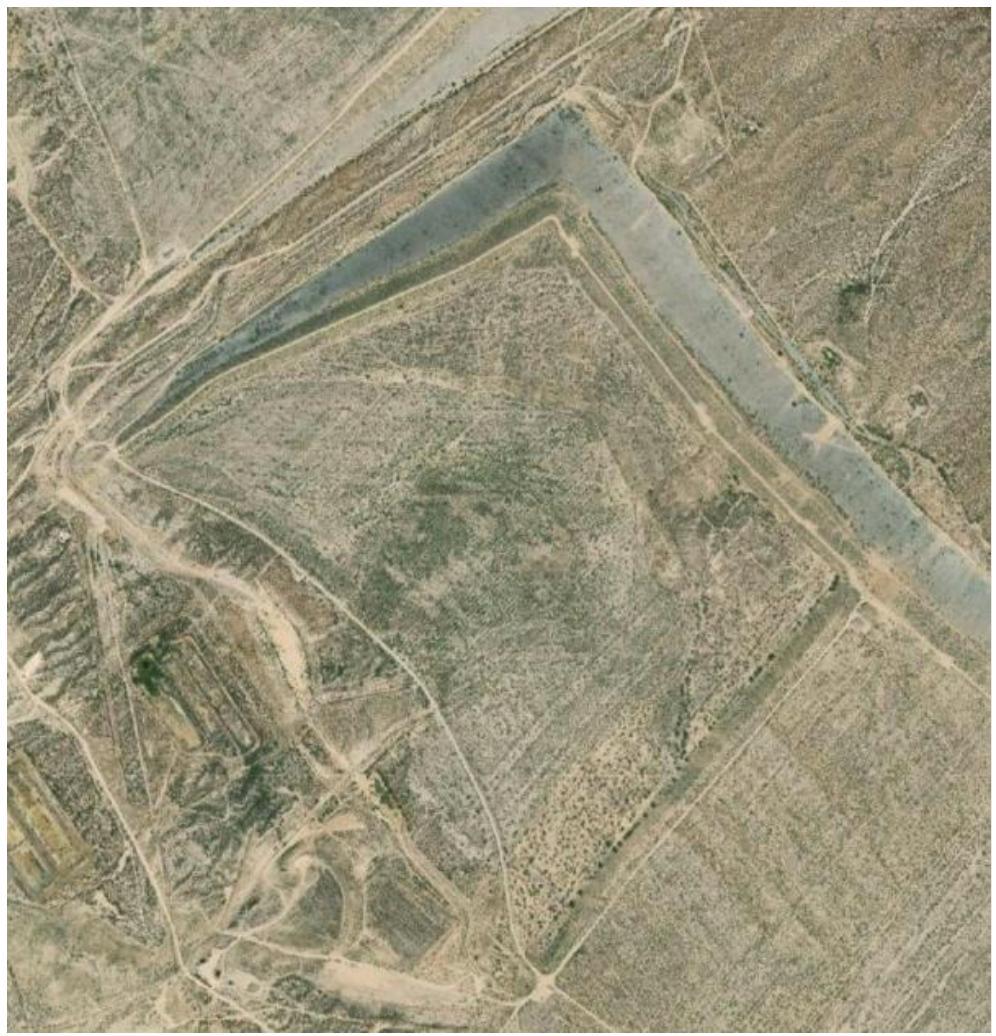
No.1/2 TSF, 2022

Closure activities were carried out at San Manuel between 2005 and 2007. Embankment slopes were regraded to provide a uniform slope. Slopes were covered with 60 centimetres of soil and/or rock. Coarse soil cover was sourced from designated areas upslope of No. 5 TSF and No. 6 TSF. Fine materials were sourced from the clean water diversion channel excavation waste material. Tailings surfaces were covered with 30 centimetres of clean cover soil, sourced from natural ground immediately upstream of the impoundment, and vegetated. Limited material placement was used in the pond areas to facilitate drainage.

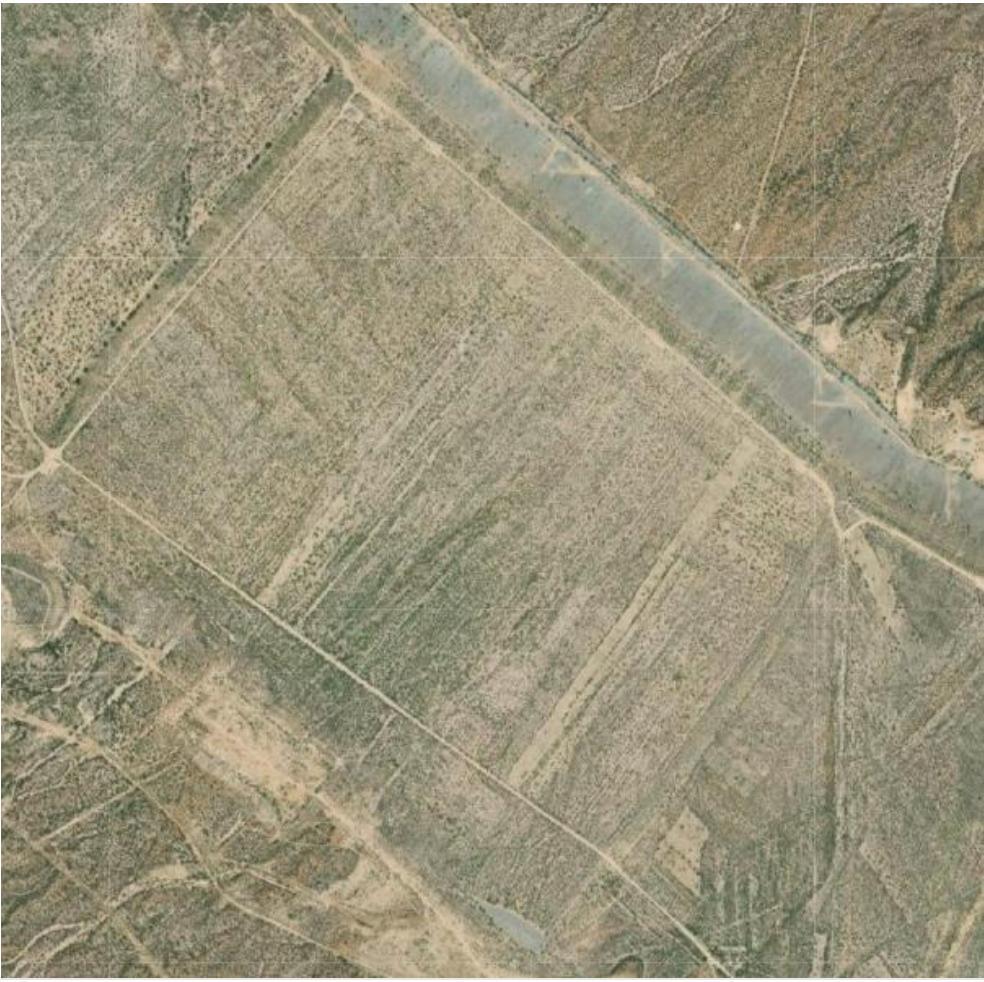
No.3/4 TSF, 2022

Closure activities were carried out at San Manuel between 2005 and 2007. Slopes were covered with 60 centimetres of soil and/or rock. Coarse soil cover was sourced from designated areas upslope of No. 5 TSF and No. 6 TSF. Fine materials were sourced from the clean water diversion channel excavation waste material. Tailings surfaces were covered with 30 centimetres of clean cover soil sourced from natural ground immediately upstream of the impoundment and vegetated. Limited material placement was used in the pond areas to facilitate drainage.

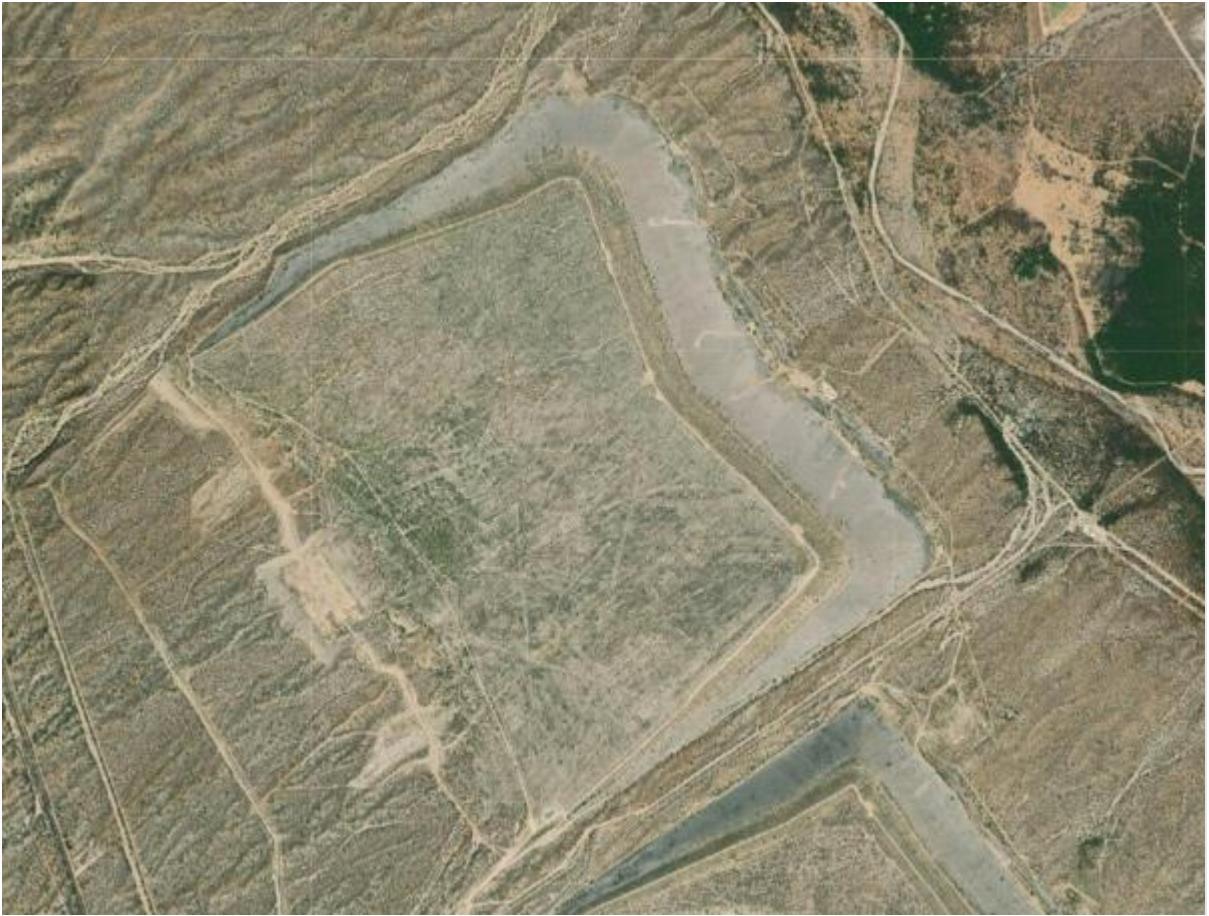
No.10 TSF, 2022

Closure activities were carried out at San Manuel between 2005 and 2007. Embankment slopes were regraded to provide a uniform slope and covered with 60 centimetres of soil and/or rock. Coarse soil cover was sourced from designated areas upslope of No. 5 TSF and No. 6 TSF. Fine materials were sourced from the clean water diversion channel excavation waste. Impoundment surfaces were covered with 30 centimetres of clean cover soil, sourced from natural ground immediately upstream of the facility, and vegetated. Limited material placement was used in the pond area to facilitate drainage. The western half of No. 10 TSF impoundment surface was covered with clean cover soil and vegetation while the eastern half was covered with an alternative cover system as a trial to test long-term vegetation. On this half, the existing 10 centimetres of cover was mixed into the tailings and covered by a new cover 20 centimetres thick.

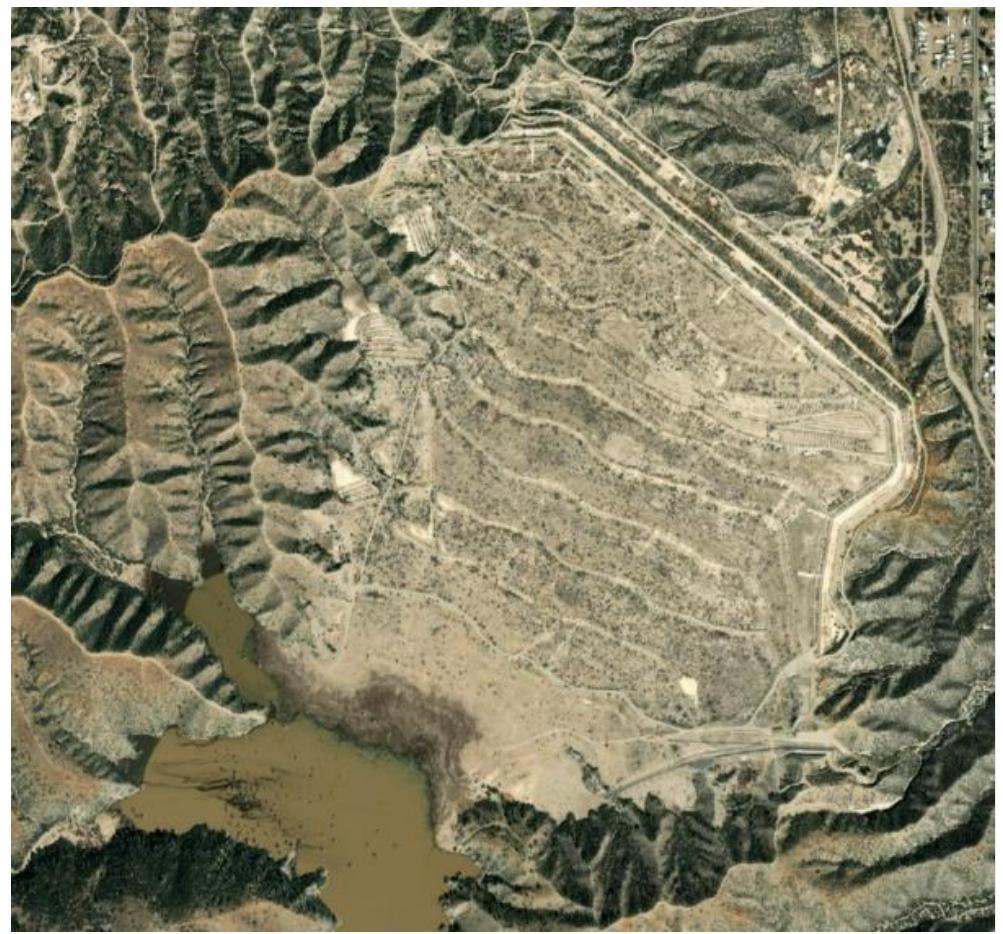
Solitude TSF, 2022

Planning and design for long-term closure began in 2015. The Solitude TSF is currently under active closure, in line with the Closure Management Plan, which includes all closed facilities in the BHP Globe-Miami complex. At present, the sites are working on implementing remedial measures, in accordance with BHP's tailings risk mitigation program.

A buttress is currently being constructed on the downstream slopes of the perimeter embankment to establish factors of safety with respect to slope stability consistent with the requirements for extreme loading per GISTM Annex 2. Additional closure activities currently proposed at Solitude include:
