R5 — BMA Guideline for the Design of Sustainable Mine Landforms

# BMA GUIDELINE FOR THE DESIGN OF SUSTAINABLE MINE LANDFORMS

**DRAFT**  
Last Review Date 21/1/2008

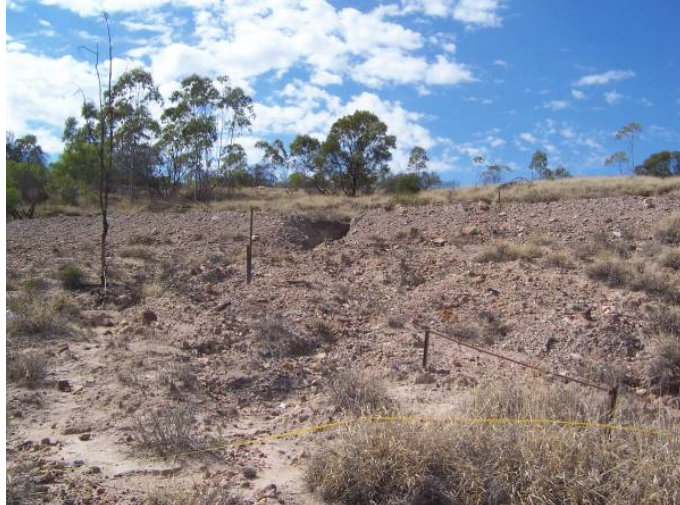
<p>Steep (17%) rehabilitation on Tertiary spoil – approximately 15 years after completion of rehabilitation work. Site is badly eroded with significant gully development.</p>

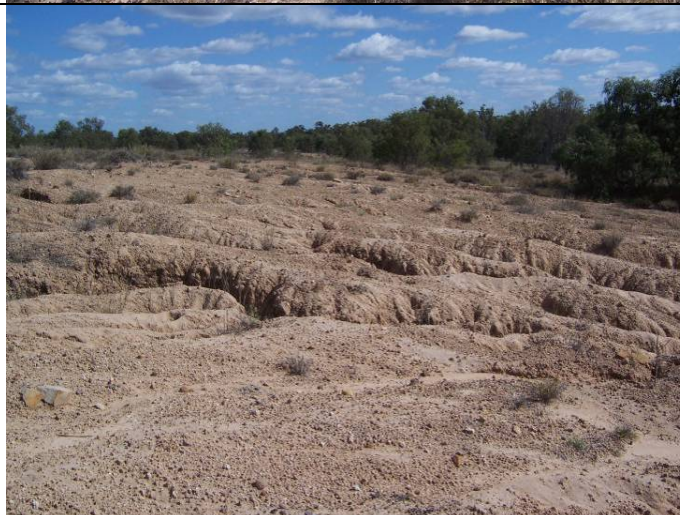
<p>Completely failed rehabilitation. Sodic Tertiary spoil on 12% slope – topsoil layer has eroded completely. Rills and gullies are levelling the landform.</p>

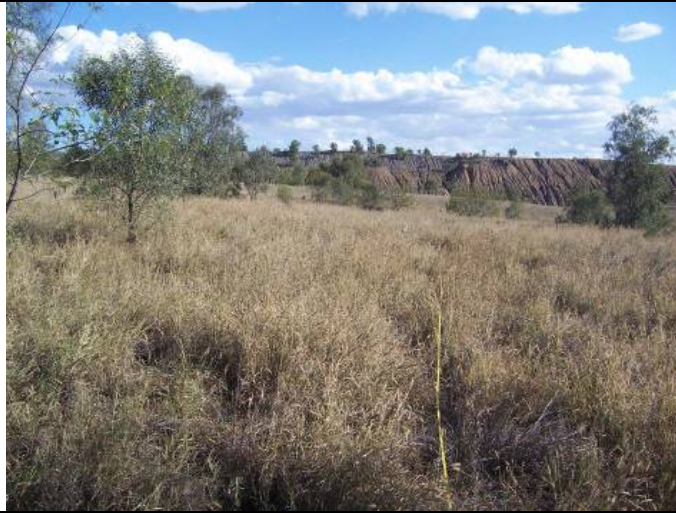
Permian spoil – at low 5% gradient, dense well established pastures with no evidence of erosion.

Background, ungraded spoil.

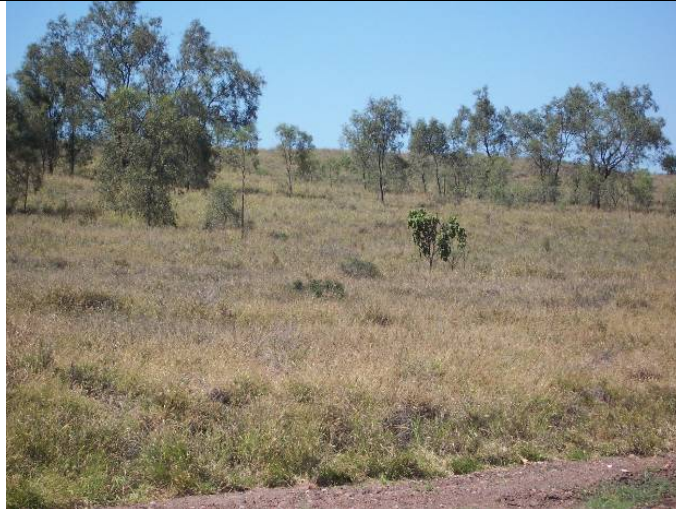
As above, another area of well established rehabilitation sited on Permian spoil at approximately 12% grade.

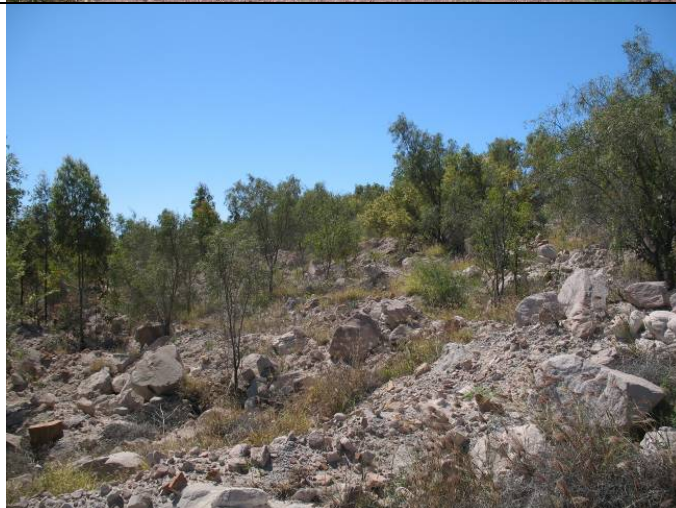
Tertiary Spoil out of pit dump, steeper 25% batters have been clad with sandstone. Native trees and shrubs establishing. A viable strategy for rehabilitation of Tertiary spoil dumps.

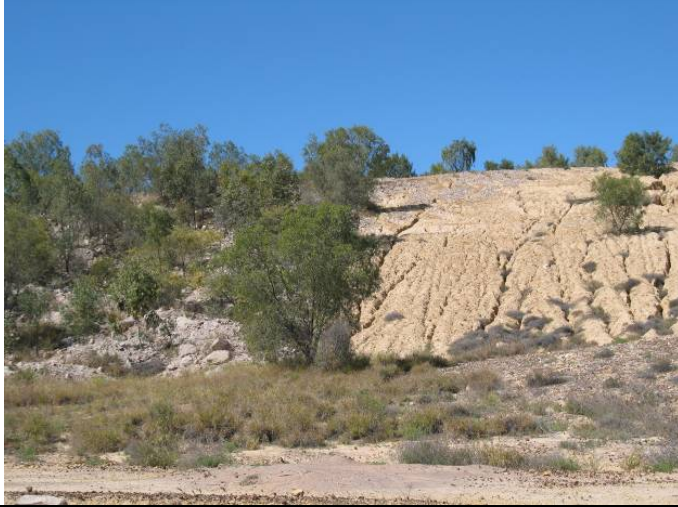
<p>As above, but also showing the marked difference between exposed Tertiary Spoil and rock mulched area.</p>

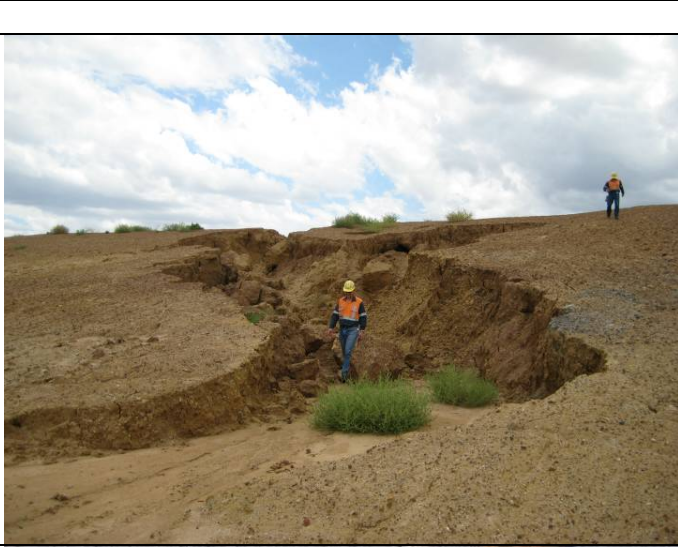
<p>14% Regraded Tertiary spoil slope below breach in a graded bank. Extreme erosion can occur when graded banks fail. The overall slope length on this outer batter approaches 450m in length. Failure of a graded bank, particularly one in the upper slope area can cause localised catastrophic gullying. Graded banks in Dispersive Tertiary spoil are high risk</p>

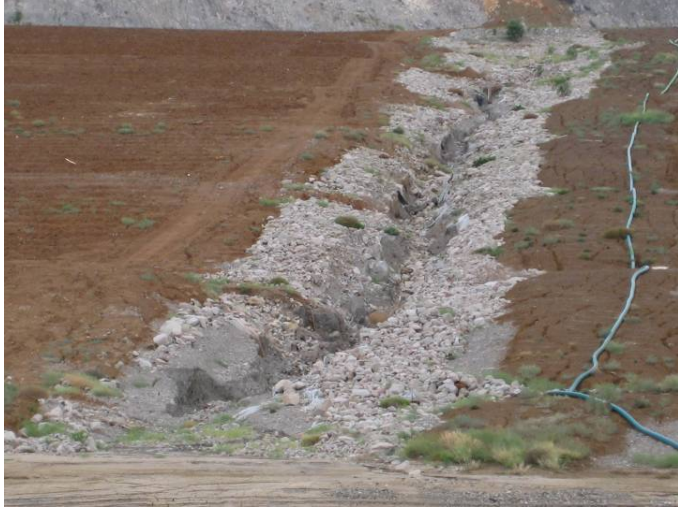
<p>Rock lined waterway established in Tertiary Spoil has been deeply scoured following storm event. Geofabric has been used but has not prevented failure of this structure.</p> <p>Use of big rock without benefit of a considerable percentage finer media such as non dispersible clays and gravels, has allowed water to flow through the open rock matrix at the interface of the geotextile and dispersible Tertiary spoil.</p> <p>The Tertiary spoil at the base of the waterway has simply dispersed and mobilised with low flows and the structure has eventually collapsed into the incised scour.</p>

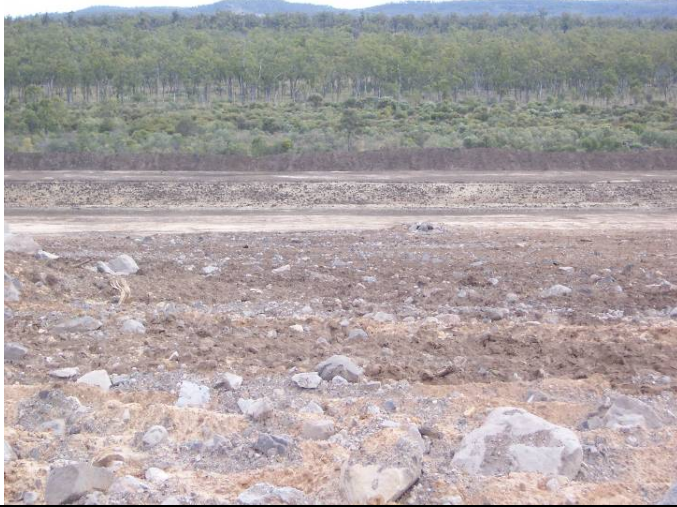
<p>10% regraded Tertiary slope with 0.5m of Permian spoil rubble spread across the area before topsoiling, ripping and seeding. This practice promises to provide good erosion control during the high risk pasture and shrub development stage.</p>

- i) Slopes established at 10% or less, Tertiary spoil material is covered with at least 0.5 m Permian spoil, then 300mm clay topsoil (if available), then ripped and seeded.
- ii) Slopes comprising Tertiary spoil 10% to 15% should be lined with no less than 1m of selected benign Permian spoil, then topsoiled and ripped and seeded.
- iii) Slope length on Tertiary spoil should be limited as far as practicable. Reliance on cross slope drainage structures artificially reduces slope length and may not be sustainable. Major erosional induced failures can occur on slopes with a total batter length greater than 200m.
- iv) On steep batters (15% - 20%) either a minimum of 1m of durable rock mulching over 1m minimum depth of Permian spoil cap or 2m of durable rock mulching.

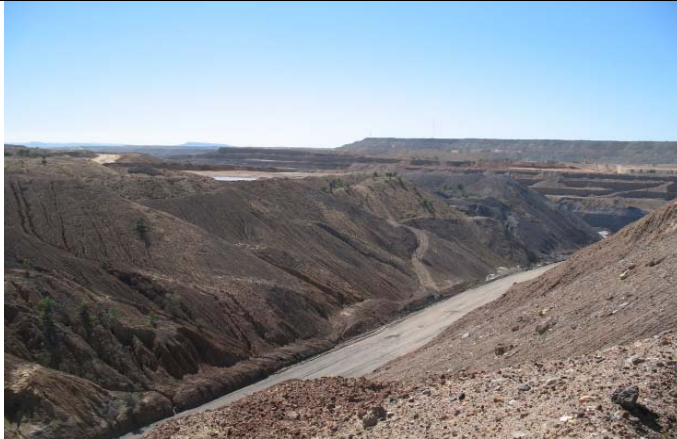
<p>Deep steep ramps, major liability if left insitu. Regrading or backfilling is required to enable these areas to form part of the rehabilitated landscape. The preference is to use these voids for spoil disposal.</p> <p>Unless rock mulched, these slopes require regrading to less than 12% for Permian spoil and less than 10% for Tertiary spoil.</p>
 	<p>Deep steep ramp with angle of repose batters below existing poor quality rehabilitation of Tertiary spoil. Unless ramps are regraded or backfilled, erosional processes will cause gullies and rills to extend into the rehabilitation above crest.</p> <p>Future regrading of ramp batters below existing rehabilitation will consume much of the rehabilitation, unless these ramps are backfilled with prestrip spoil.</p>

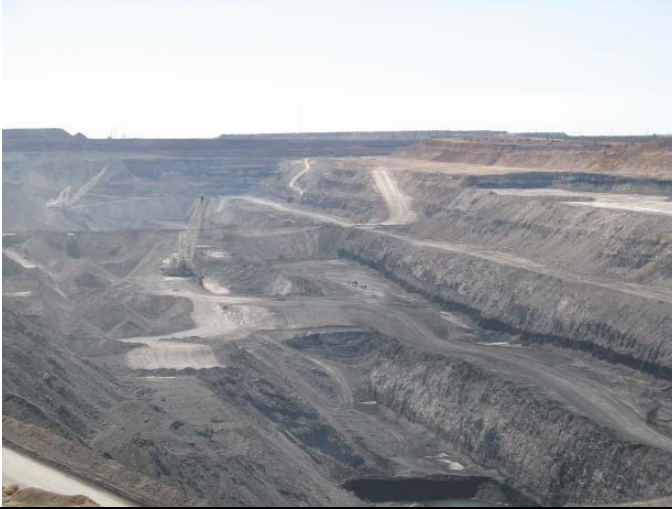
Major operational pit. Mines need to ensure that plans are in place to stabilise final voids using progressive backfill, major regrade efforts, benching with durable rock cladding and other techniques that ensures the area is safe and stable when the lease is relinquished.

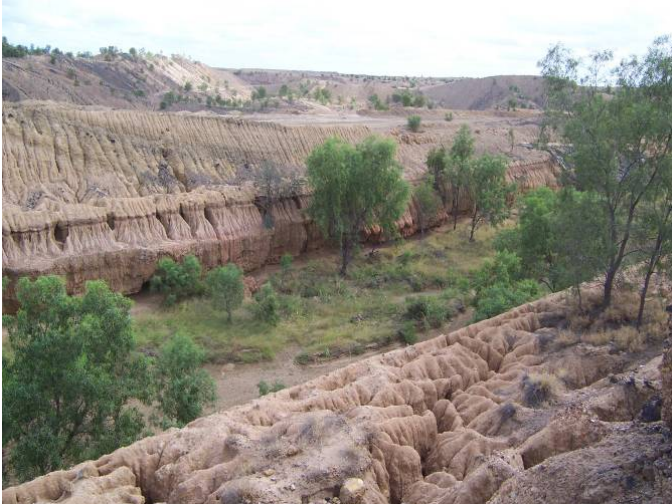
Creek Diversion through Tertiary spoil. A costly example of earlier poor diversion design outcomes with significant potential for downstream sediment impact.

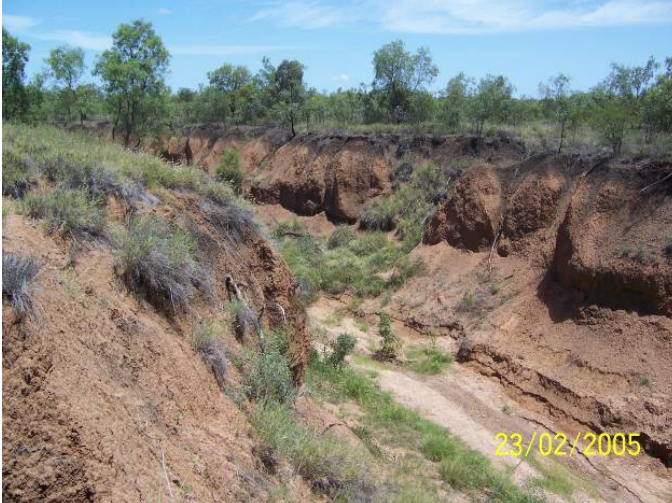
Severe back cutting of Quaternary alluvium in small creek diversion. Extreme erosion can occur when stream length and or substantial outlet protection is not catered for. Expensive repair undertaken as shown below in following image.

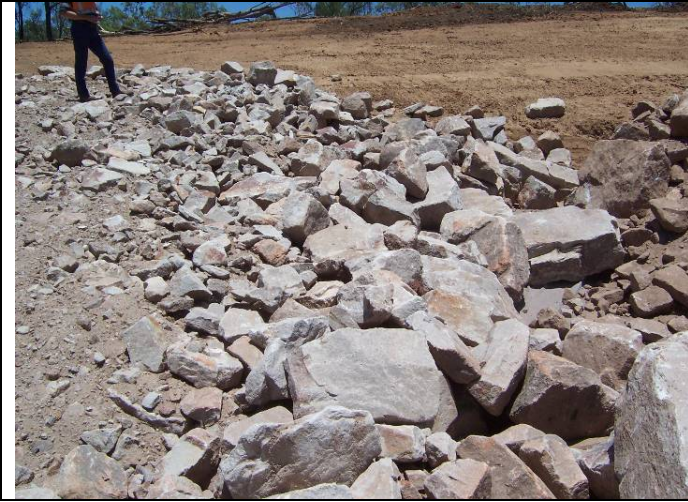
<p>Rebuilt above diversion. Work effort required new channel excavation, backfilling of original diversion channel and construction of a substantial rock lined waterway into the creek.</p>
 	<p>Rilled and piped out external wall of tailings dam. Wall constructed from extremely dispersive Tertiary spoil.</p>
 	<p>Gross instability of Tertiary spoil in water filled void.</p>

Durable rock being used to line re constructed diversion channel. Original diversion channel failed due to inadequate design.
