BHP

Annual Environmental Protection and Management Program Report

Olympic Dam

1 July 2017 – 30 June 2018

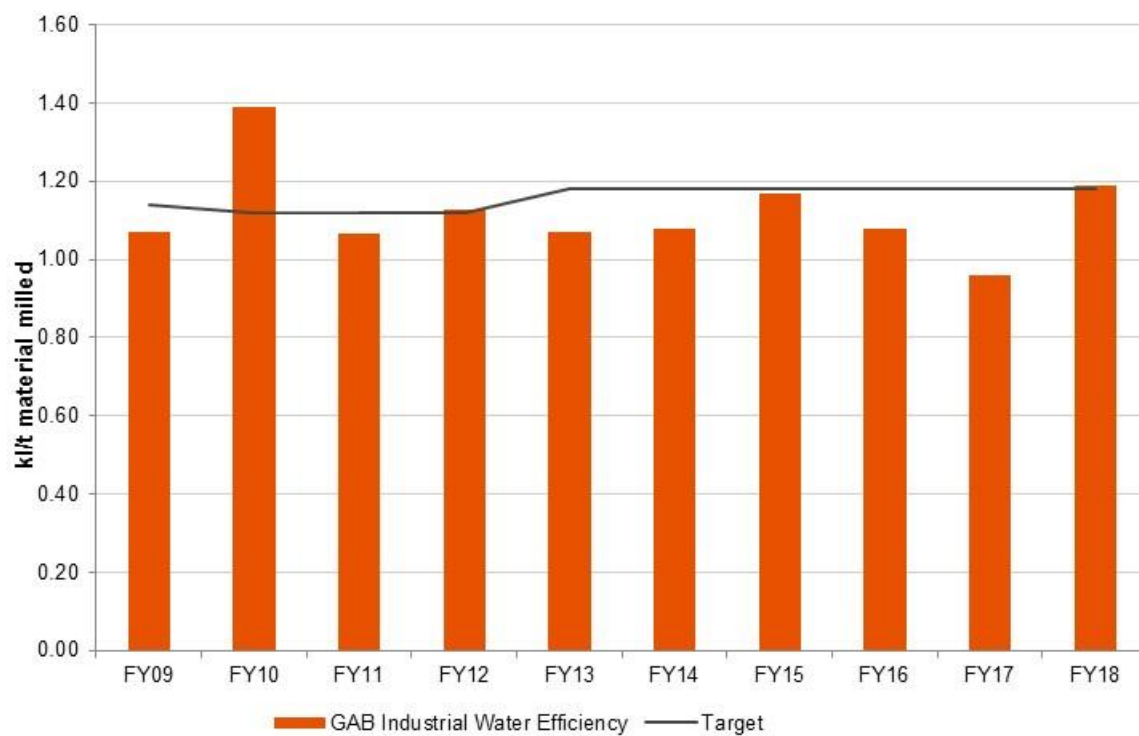
Figure 25: Historical industrial GAB water efficiency.

In FY18 the GAB Industrial Water Efficiency of the operation was 1.19kL/t compared to the target of 1.16 kL/t and 0.96kL/t for FY17. An increase in kL of GAB water used per tonne milled is due to the SCM17 Smelter Shutdown and decreased production efficiency during this time. Historical GAB industrial water efficiency is given in Figure 25.

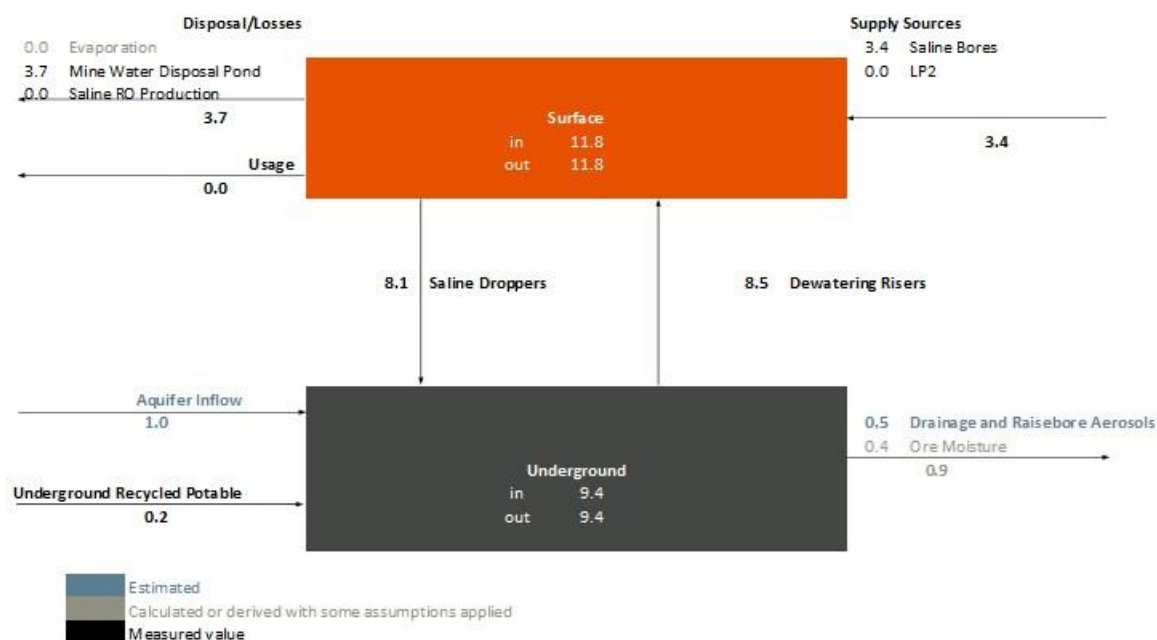
Figure 27: FY18 Saline (Mine) water balance summary (ML/d).

Groundwater inflow to the mine occurs at several intersections with the underground operations (Figure 27). Total natural inflow is estimated to be approximately 1.0 ML/d, the majority entering via upcast raise bores. Additional natural inflow comes into the mine via other entry points, including downcast raise bores, exploration drill holes and shafts. Much of the total inflow to the mine is transported to the surface as ore content or exhausted to the atmosphere as saline aerosols or moisture-laden air via upcast raise bores, estimated at around 0.9 ML/d.

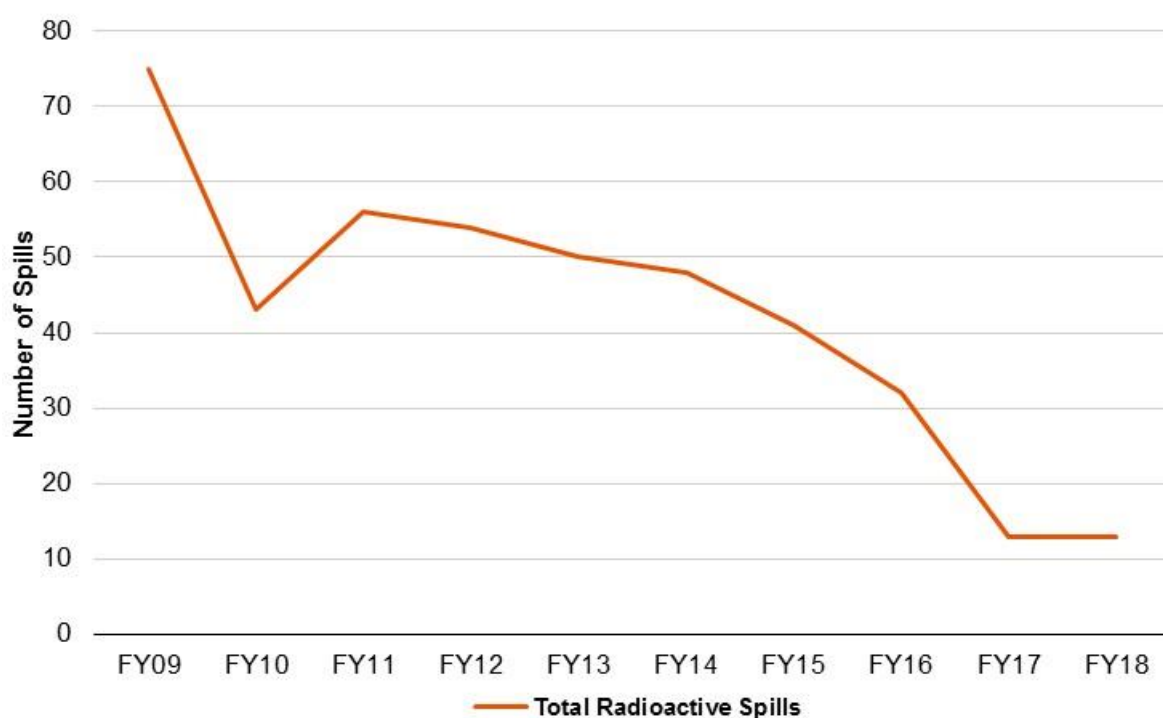
Figure 40: Historical radioactive process material spills

A register of recordable spills was maintained. During FY18, there were 13 radioactive process material spills across site, which occurred at the SX, hydromet; concentrate and TRS areas. The number of radioactive process material spills shows a decreasing trend since FY11 as shown in **Figure 40**. This is attributed to planned maintenance and work management through 1SAP.
